# Repairs to Teacher Training Academy RC Building in North Cyprus–Case Study

# REPAIRS TO TEACHERS TRAINING ACADEMY RC BUILDING IN NORTH CYPRUS – CASE STUDY

Huriye Bilsel, Mürüde Çelikağ, Özgür Eren, Serhan Şensoy  
Department of Civil Engineering  
Eastern Mediterranean University  
Gazimağusa, Kibris  
Mersin 10 Turkey

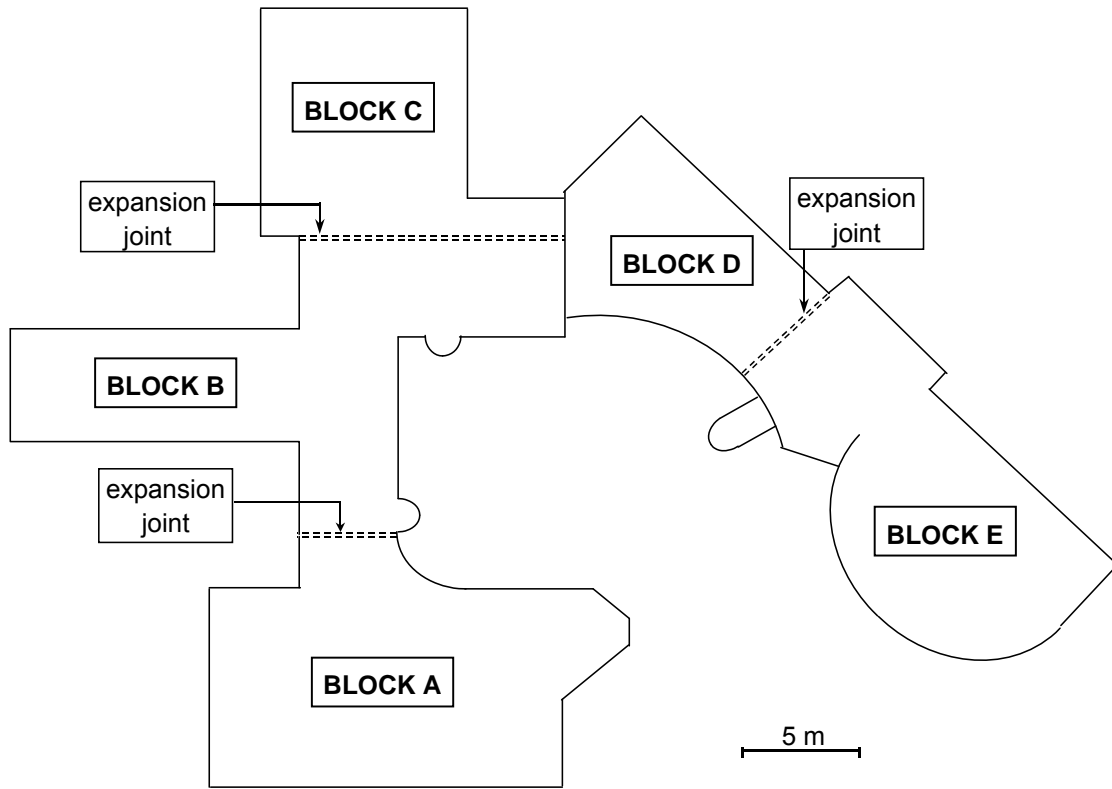
Figure 1. Plan of the Teachers Training Academy.

Figure 1 shows the plan of the Teachers Training Academy built in a suburb of Nicosia situated near a river- bank. The building is comprised of 5 blocks over an area of 3000 m<sup>2</sup> connected by expansion joints. Most of the structural problem occurred in block A, which is on the southeast flank of the building.

The building is situated on a recent deposit on a sloping terrain, descending toward a river- bank in the east, with an infinite slope of 20° from horizontal. A test pit excavated to ascertain the soil stratification at the corner of Block A (Figure 1) revealed that the problem area sat on an unconsolidated fill of silty clay, used to level the site, below which is a firmer stratum of the same soil type. The block A is carried by single footings except the columns on axes GK and GM (Figure 2), connected by eccentrically loaded combined footings. The footing depth, observed during excavation of a test pit near the outermost axis (G11) of Block A (Figure 2), is as shallow as 0.40 m. The soil samples recovered from the fill material at the footing depth and from the natural soil, 2 m below the

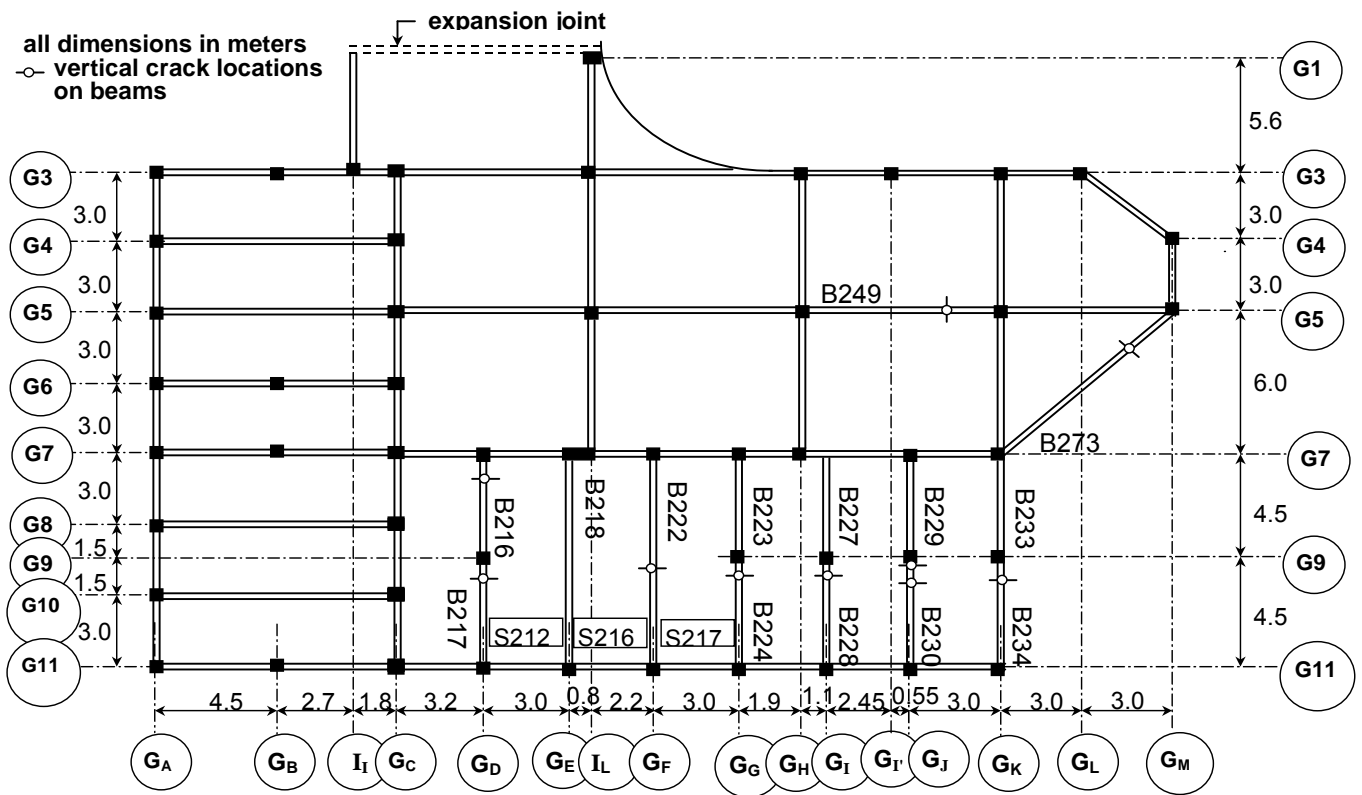
Figure 2. Sketch plan of Teachers Training Academy Block A.

In order to measure the depth of cracks on beams of the suspect part of the building Ultrasonic Pulse Velocity Test was applied according to BS 4408:Part 5:1974 [5]. Readings were taken from 10 main points. The width of the cracks was measured by a microscope. The results of these readings are as given in Table 1. Readings indicate that the beams B224, B230 and B273 (Figure 2) have quite deep cracks, which are greater than the reinforcement cover (25 mm).

The construction of the apron around the building, and the placement of the downspouts were done long after the completion of the main parts of the building, hence providing easy access for water to reach the soil around foundation. The fill under Block A was not properly compacted and collapsed upon wetting during the wet season. The single footings along the outermost edge of the eastern part of the building are very close to each other, causing overlapping stresses in the underlying compressible soils, and therefore differential settlements. The collapse of the fill, which is thicker at the corner of Block A, together with the differential settlements of the interior footings along axis G11, caused additional tensile stresses in the beams, which in turn caused cracks in the concrete. These cracks occurred near column supports (Figure 2, Figure 3).

iii) Connecting footings to each other at the eastern part of the building by rigid tie-beams: The edge footings along the axes G11, GK and GM, should be strapped to the interior footings to increase the rigidity of the structure and to avoid eccentricity in the foundations of the latter two axes.

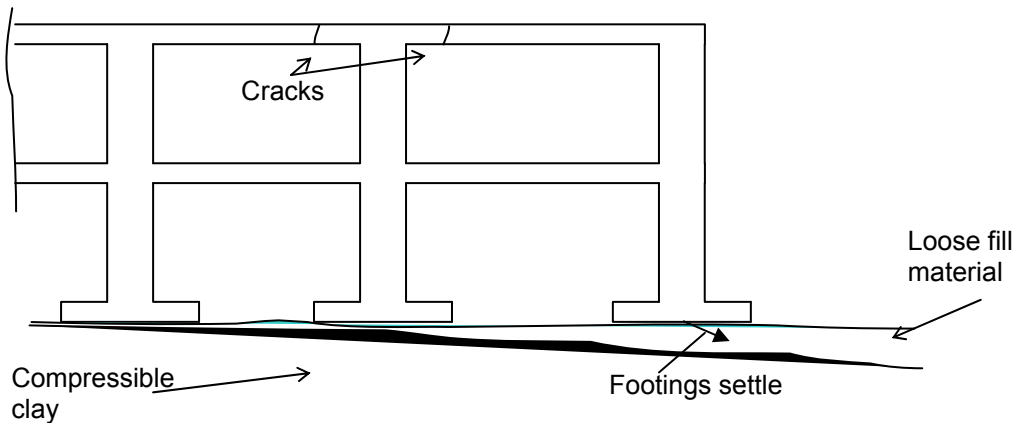
The columns on the eastern edge of the Block A are supported by eccentrically loaded combined footings, which are situated in the thickest part of the fill. Both the collapse and the consolidation settlement of the fill might have also caused buckling of the eccentric footings, imposing additional strain to the elements of superstructure.

Figure 3. Typical frame: uneven thickness of the fill over the sloping ground.

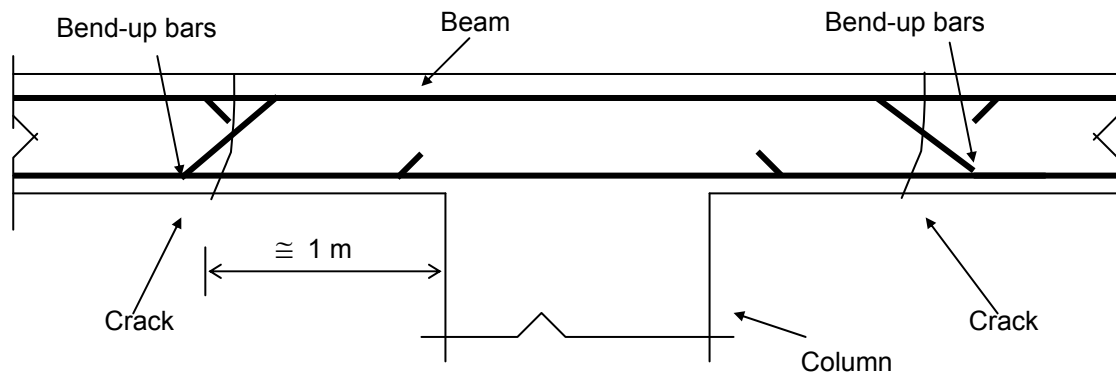
It was observed that, the location of such systematic vertical cracks coincides with the location of the bend-up bars in the beams as indicated in Figure 4. Therefore, these cracks could not have been due to lack of shearing capacity. At these sections, steel area at the bottom is reduced due to the use of bent-up bars. Such applications are common in North Cyprus, as in most of the cases only vertical loads are considered in the structural analysis. However, when a structure is affected by support settlements or lateral forces, cracks might be observed at such weak sections. In other words, beams may not sustain tensile stresses caused by additional forces coming from support settlements. In general, cracks in beams of the suspect building are as shown in Figure 4. These cracks will not have a significant effect on the beam capacity under service loads. However, it should be noted that, during an earthquake, plastic hinges would be formed at the beam-ends, which might cause redistribution of moments through beams and columns. Such phenomenon would not cause structural instability, since the two-storey building considered here has highly rigid columns capable of resisting lateral forces.

Figure 4. A typical beam detail and location of cracks formed in the beam.

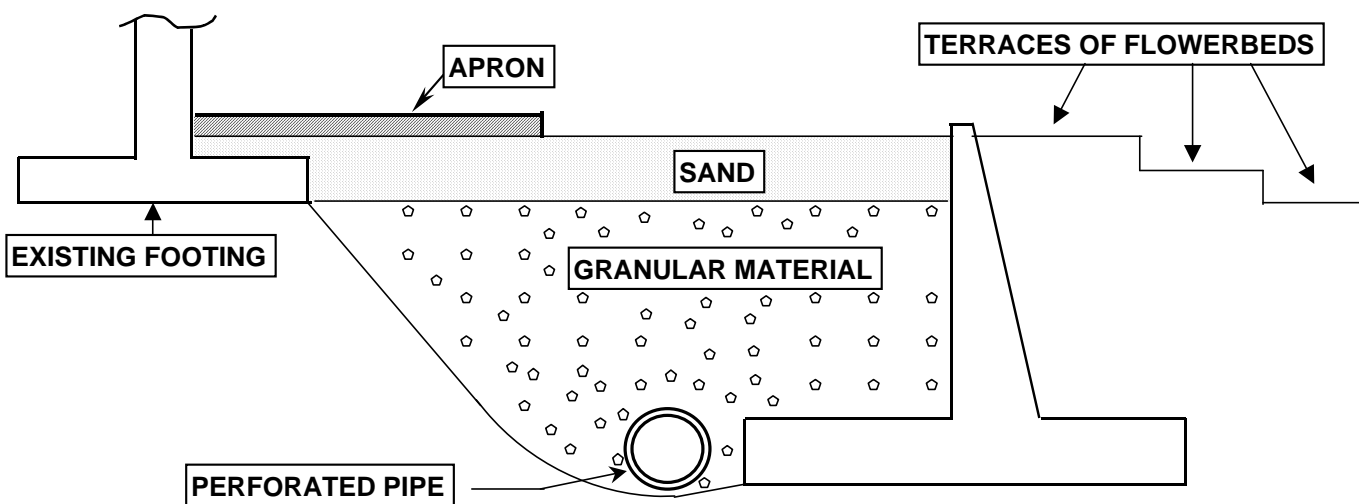
Figure 5. Cross-section of the recommended retaining wall and the drainage system.

- i) Improving the drainage system around the building to prevent wetting of the soil around foundation: A French drain should be constructed during the dry season

around Block A, with perforated pipes installed wrapped in geotextile to prevent clogging of the holes. The drainage trench should not be closer than 1 m to the side of the foundations and it should be placed at a depth lower than the bottom of the foundation. It should be backfilled with granular soil. Reinforced concrete apron should be constructed all around the blocks at a minimum width of 1 m. The downspouts should be directed to the drainage system, which will collect the surface water and direct it to the river.

iv) Surrounding the eastern part of the building by a retaining wall system to prevent sliding of Block A. The retaining wall can be a cantilever type, and should be placed deep enough to prevent the movement of the building towards the river- bank (Figure 5).
