Rural carob warehouses in Cyprus: an assessment of architectural and structural characteristics

Beser Oktay Vehbi, Hülya Yuceer & Yonca Hurol

To cite this article: Beser Oktay Vehbi, Hülya Yuceer & Yonca Hurol (2016) Rural carob warehouses in Cyprus: an assessment of architectural and structural characteristics, Journal of Architectural Conservation, 22:1, 18-47, DOI: [10.1080/13556207.2016.1208473](https://doi.org/10.1080/13556207.2016.1208473)

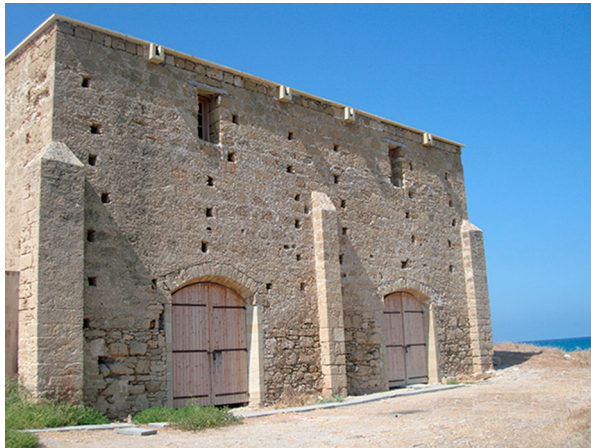
Figure 6. Small holes on the façade (Mersinlik 1) (Photo by Beser Oktay Vehbi).

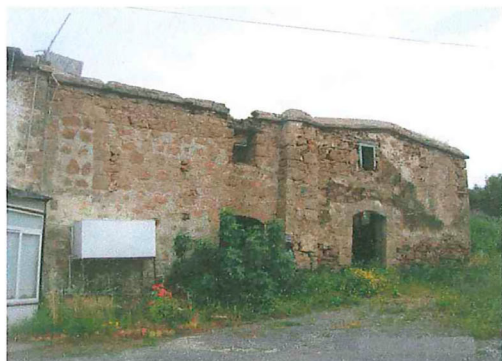
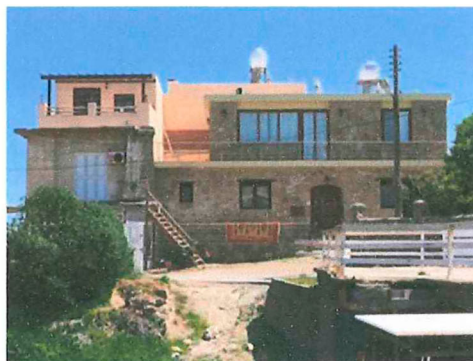
Figure 8. Karşıyaka-house (Photos by Beser Oktay Vehbi).

The first five alterations are more common than the others. Some of these alterations damaged the architectural character of the building, such as the Karşıyaka-house ([Figure 8](#)), whilst some others respected the original character of the buildings, such as

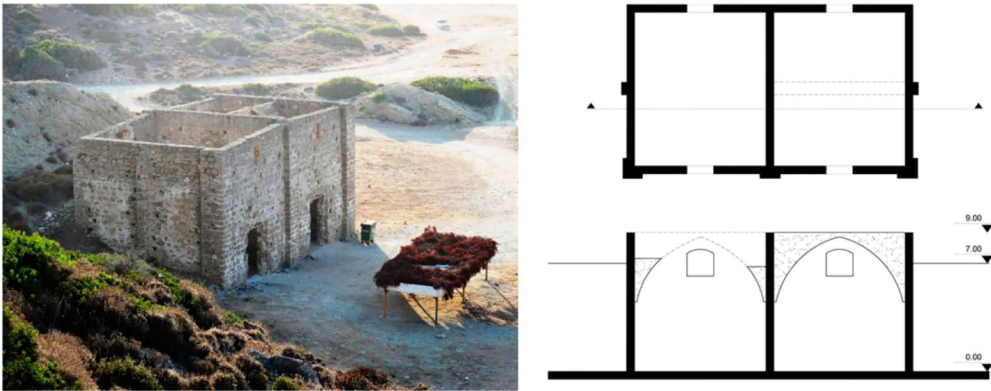
Figure 14. Photo, plan and section of Kayalar warehouse (Photo by Beser Oktay Vehbi, Figure drawn by Sanaz Nezhadmasoum and Beser Oktay Vehbi).

There were stone pointed arches in two bays of the structure. However, one of these arches has collapsed. This has created a structural problem for the interior wall because of the horizontal forces created by the remaining arch which is no longer balanced by the collapsed arch. The timber beams and roof coverings have completely disappeared.

There were some alterations carried out during the British period on the Kayalar warehouse but this only entailed the widening of the two doors on the front façade. These doors had arches in their original forms but, they were changed into rectangular doors by adding timber lintels under the arches. The arches are still visible on the facade. This alteration caused damage on the two sides of these doors and some stone sections were displaced. There is also an inappropriate use of gypsum as mortar which caused damage especially around the two enlarged doors.

Unlike the other warehouses the small ventilation holes of this building are not distributed well on its façades. Since they are very close to each other and form approximately vertical lines, a medium vertical crack has occurred between them.

Stone erosion and salt crystallization has occurred on both external and internal walls. The building also has some minor cracks and detachment of mortar due to vegetation. The current state of the building is due to the destructive effects of weathering and the biological degradation of the stone, ageing of materials, which reduces its load bearing capacity. It needs urgent conservation.

The collapse of one arch and the presence of a medium vertical crack put this warehouse into the category of a moderately damaged structure. This is why restoration is proposed.

Since there are cracks and effects of deterioration present on the walls, it is suggested that horizontal and vertical steel tie-beams are installed inside the structure in order to support both the roof and the walls. These tie-beams can be connected to the walls with the help of drilled-in steel bars and grout which should be injected into the drilled holes. Roof lights could be considered within the roof structure in order to avoid opening new windows in the walls.

The masonry walls should be strengthened; this is especially required around the vertical crack. Metal bars and tendons can be placed at certain intervals to connect the two sides of this crack. It might also be necessary to close some of the small holes. It is also suggested to have a wire-mesh and plaster application on the internal face of this wall. Wall strengthening is also recommended by injecting puzolanic lime based grout into

the cracks and wherever appropriate. Securing walls against rainwater is needed and gutters should be installed on the roof.

The damaged stone pieces on two sides of the enlarged doors should be removed and the missing pieces should be reconstructed with the same type of stone.

The earth mortar used in the interior wall should be partially replaced with a more durable and stronger type of mortar.
