**Geotechnical Asset Management for the Highway
Route Between Değirmenlik and Kyrenia, North
Cyprus**

Master of Science
in
Civil Engineering

Eastern Mediterranean University
January 2017
Gazimağsa, North Cyprus

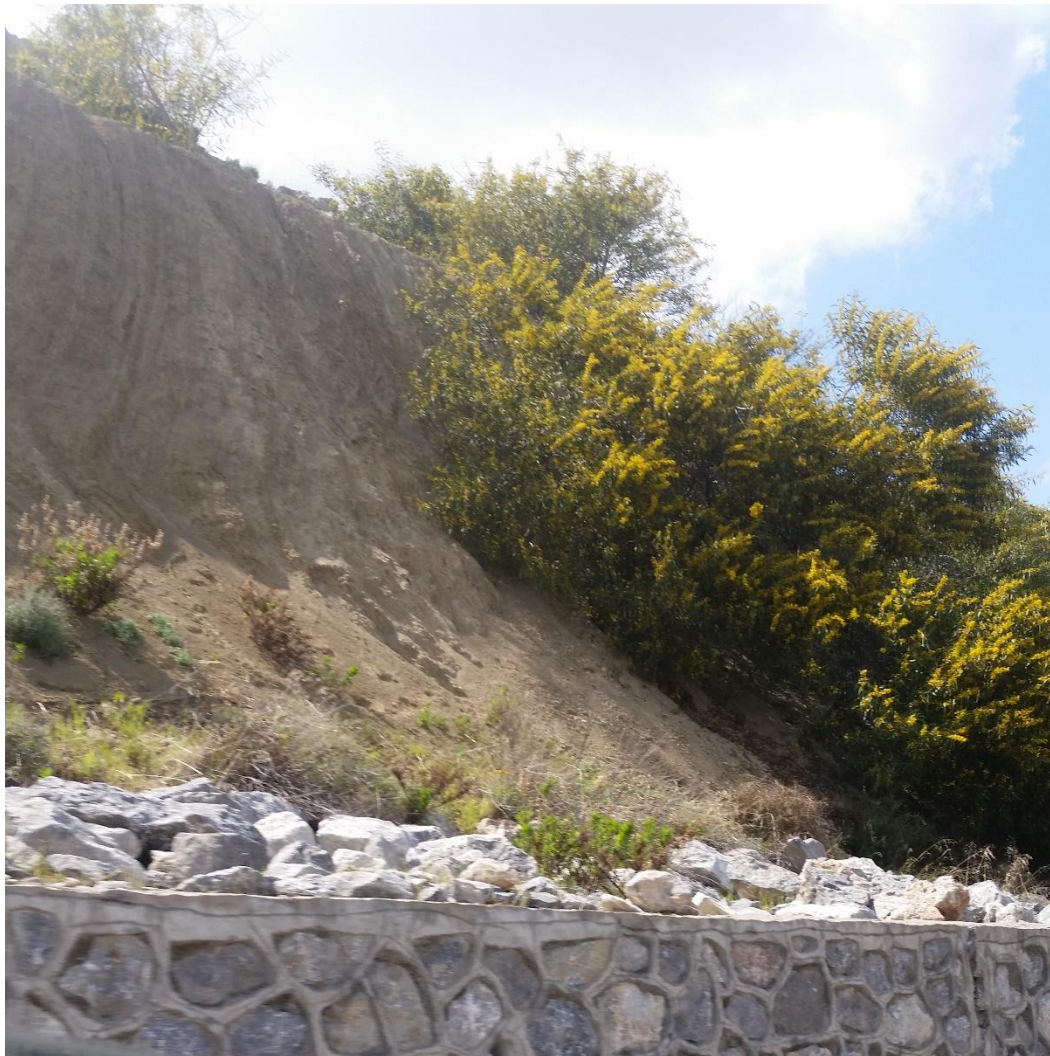
Figure B.1. Site 9.

Settlement or heaving in front of the wall:	No, there is not any evidence for settlement or heaving in front of the wall.
ERS condition appraisal form	
Evidence of erosion or scour:	No, there is not any type of erosion or scour.
Evidence of excessive moisture in backfill:	There is an evidence of moisture in backfill as plants are there but not excessive.
Material from upslope adding load to wall like rocks or new soils:	Yes, as there is some landslide and earth moving. These moves will lead to adding load to the wall.
Drainage	
Drainage outlets are clogged:	Some of them are clogged.
Drainage channels along top of wall are not working properly:	Yes, according to the bulges that found on the top of the wall.

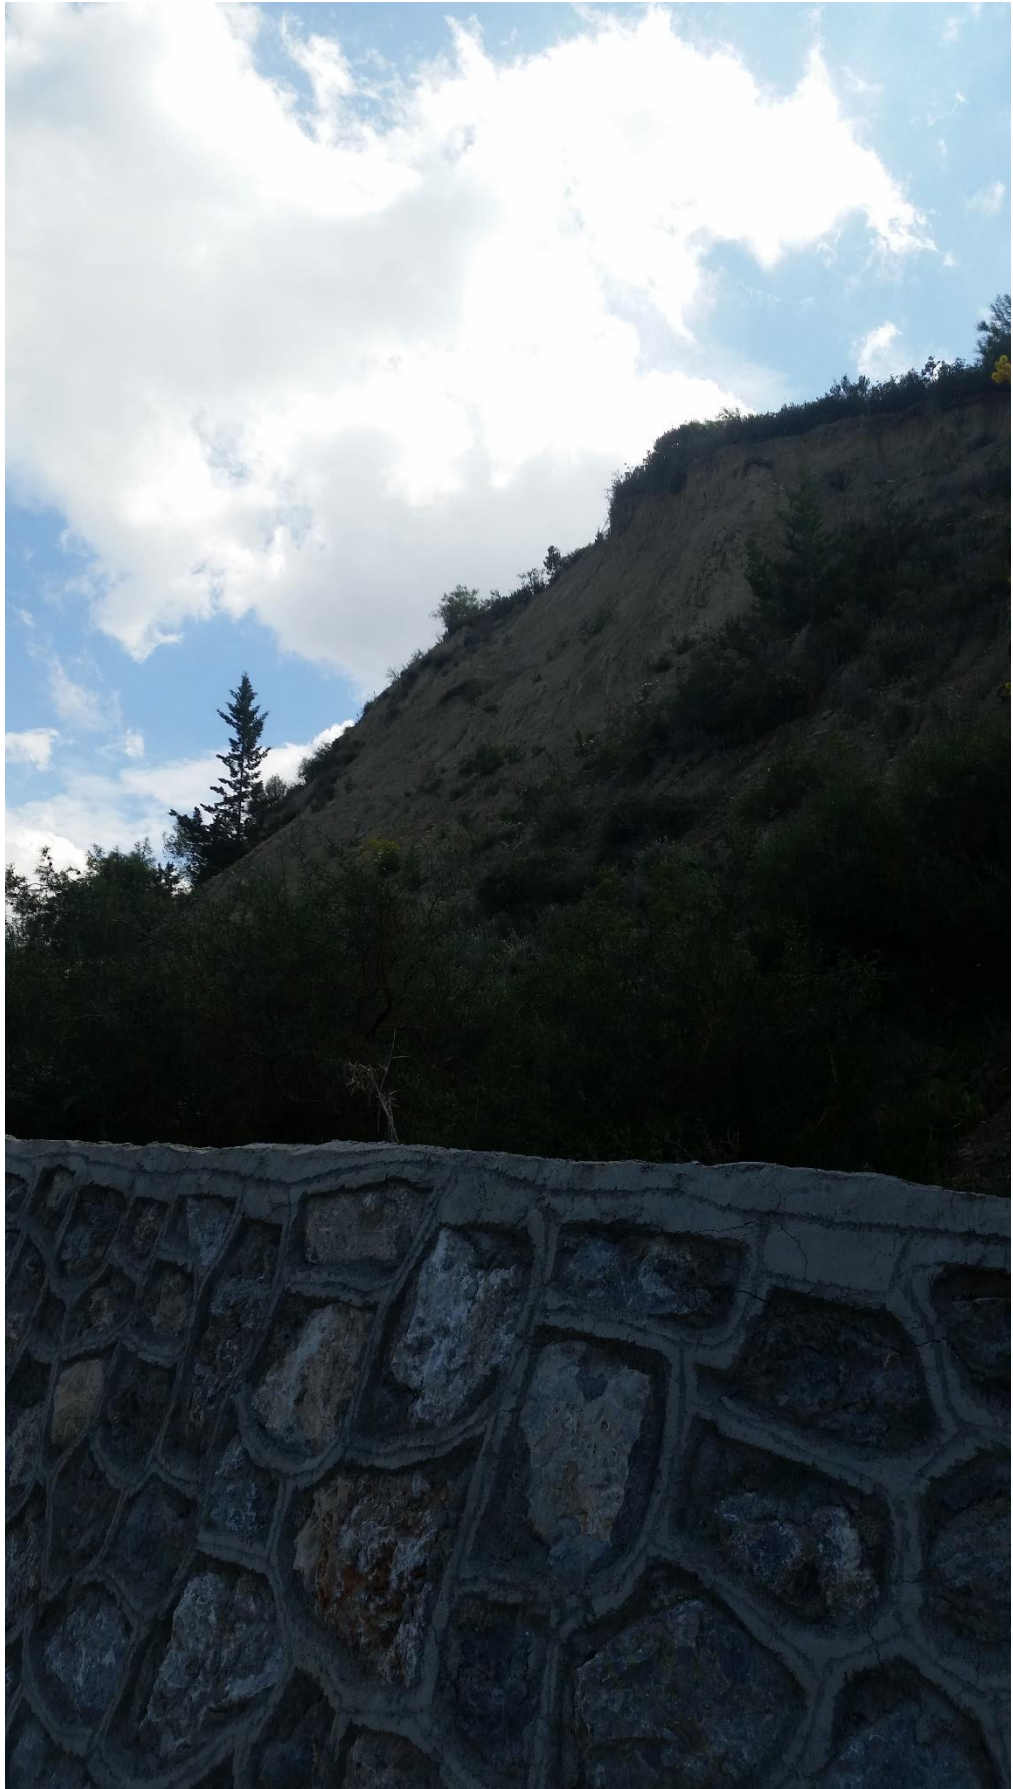
Figure B.2. Site 10.

Evidence of landslide or earth moving:	Yes, there is landslide happened to the soil.
Settlement or heaving in front of the wall:	Yes, there is some settlements happened in front of the wall.
Evidence of erosion or scour:	No, there is no evidence for erosion or scour.
Evidence of excessive moisture in backfill:	Yes, there is.
Material from upslope adding load to wall like rocks or new soils:	Yes, according to the landslide there are some upslope soil that added load to the wall (see figure 2).
Drainage	
Drainage outlets are clogged:	Yes, some of the drainage outlets are clogged by new culverts placed in front of them (see figure.2.).
Drainage channels along top of wall are not working properly:	Yes, they are not working properly.

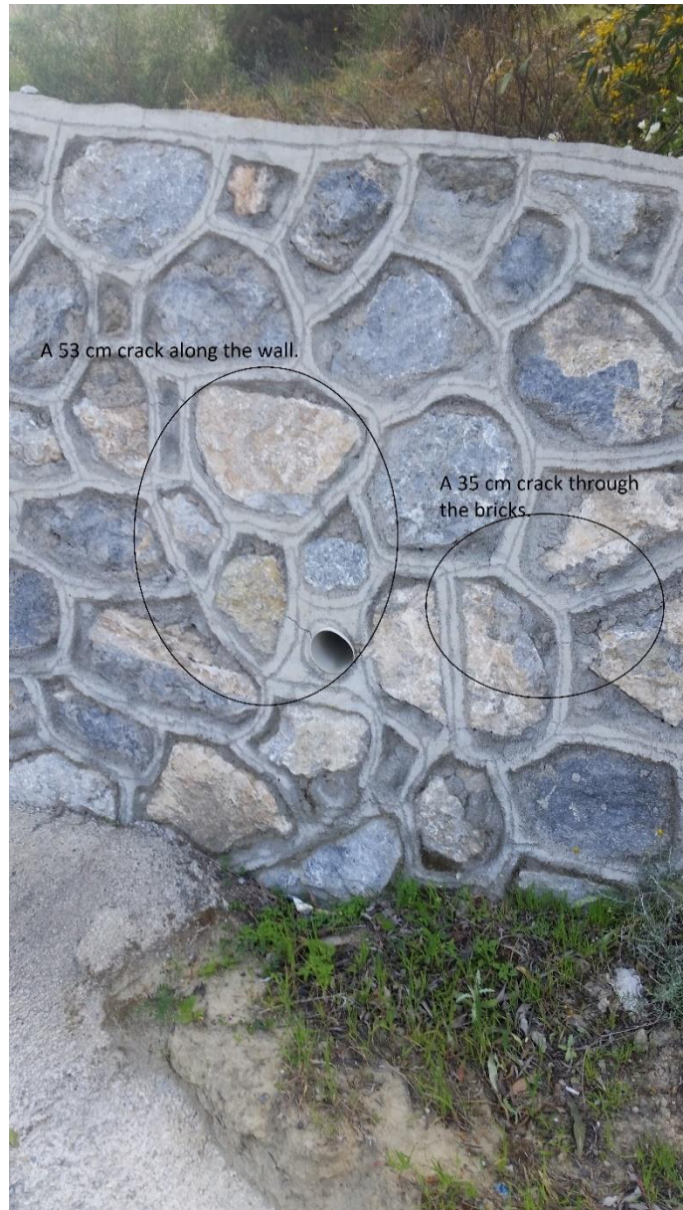
Figure B.3. Site 10-cracks along the wall.

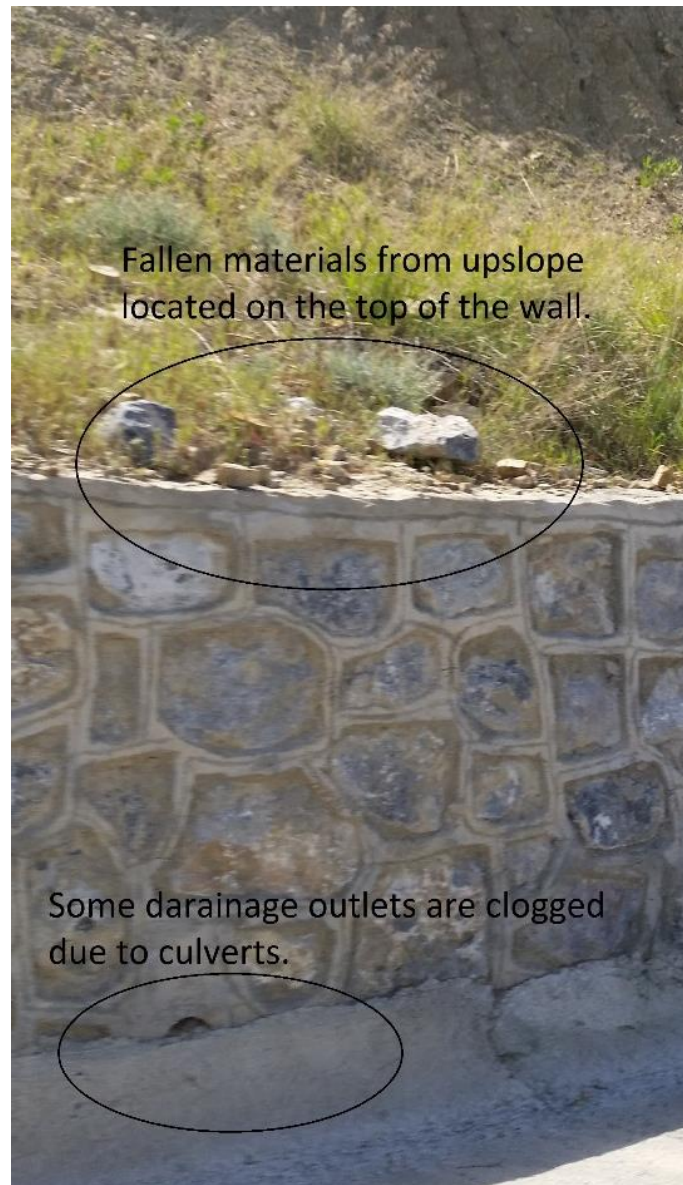
Figure B.4. Clogged drainage outlets.

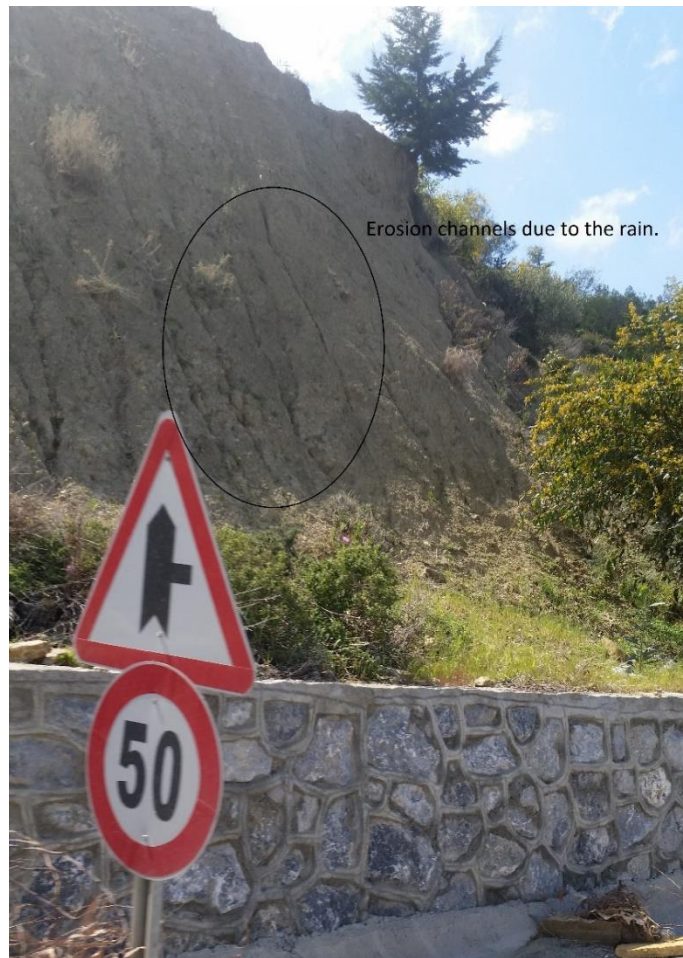
Figure B.5. Erosion channels in the backfill soil.

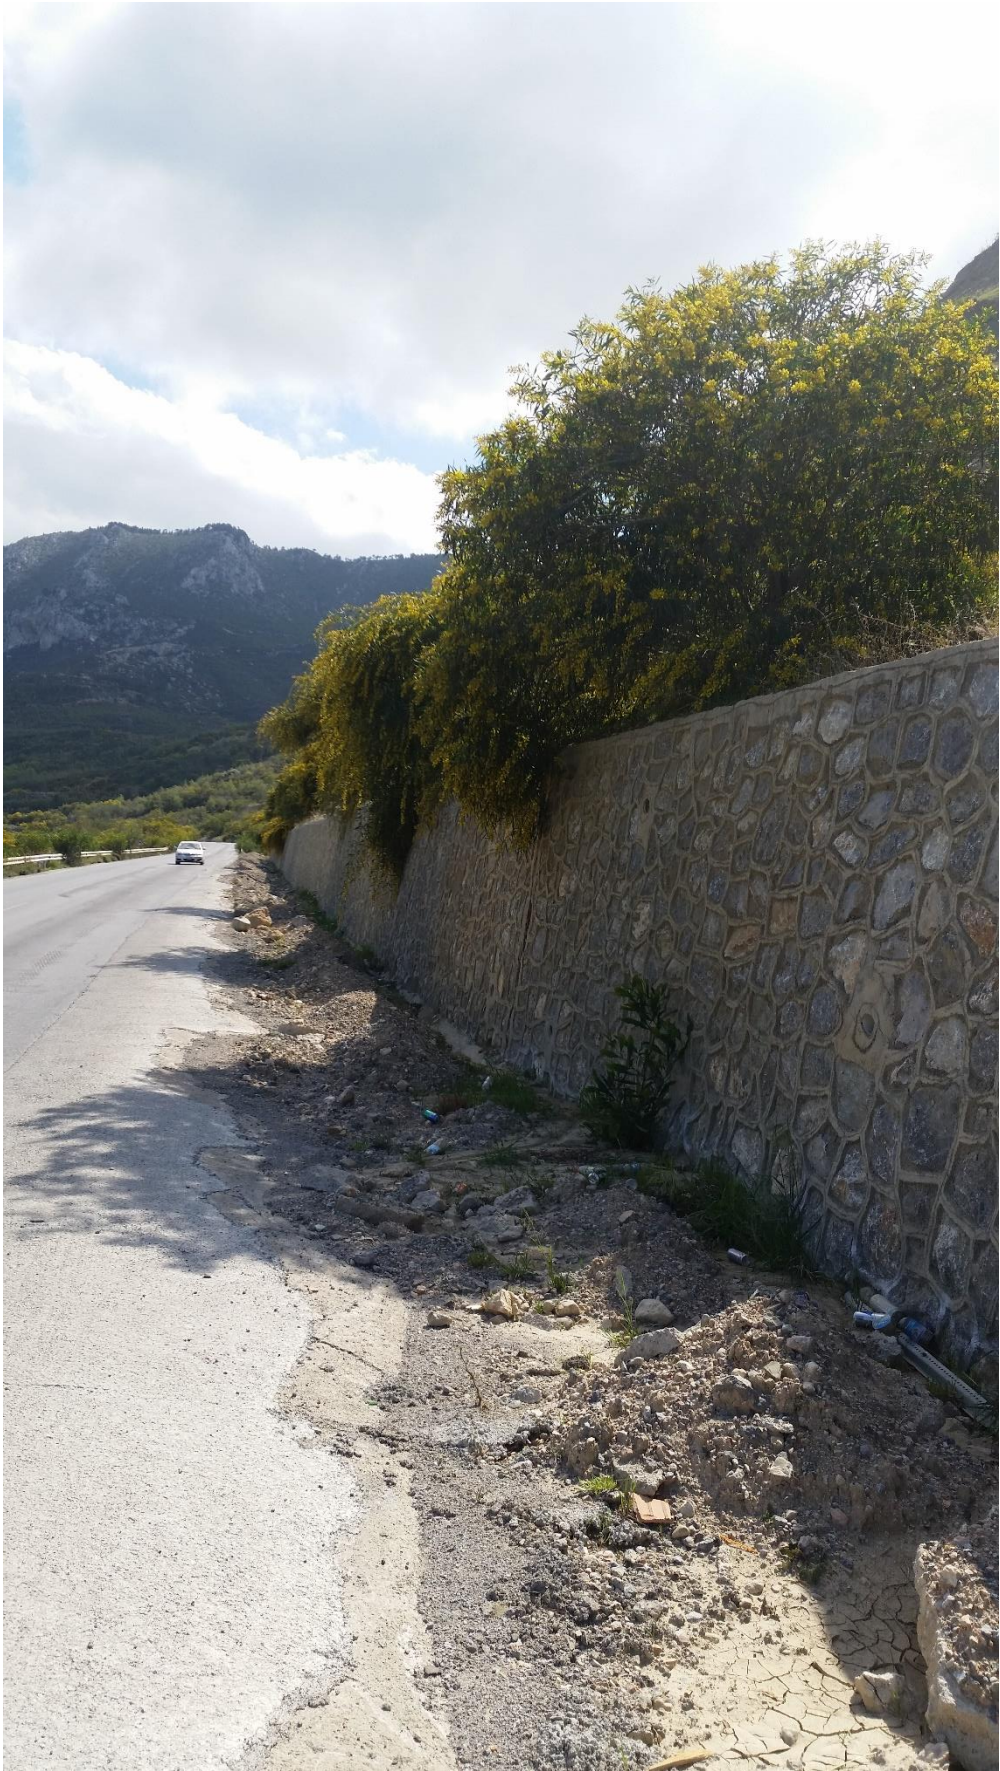
Figure B.6. Site 11.

Evidence of erosion or scour:	No, there is no evidence for scour or erosion.
Evidence of excessive moisture in backfill:	Yes, there is evidence for existing moisture behind the wall.
Material from upslope adding load to wall like rocks or new soils:	Yes, some soil added load to the wall.
Drainage	
Drainage outlets are clogged:	Yes, some of the drainage outlets are clogged.
Drainage channels along top of wall are not working properly:	Yes, they are not.

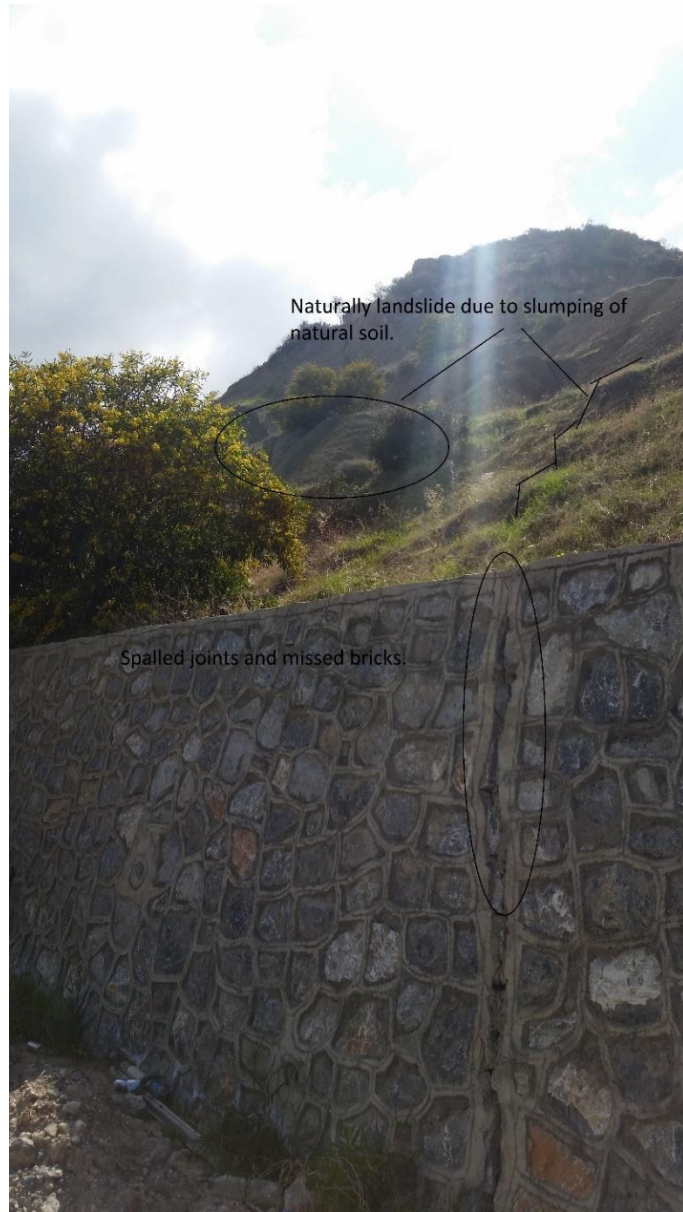
Figure B.7. Spalled joints and earth moving.

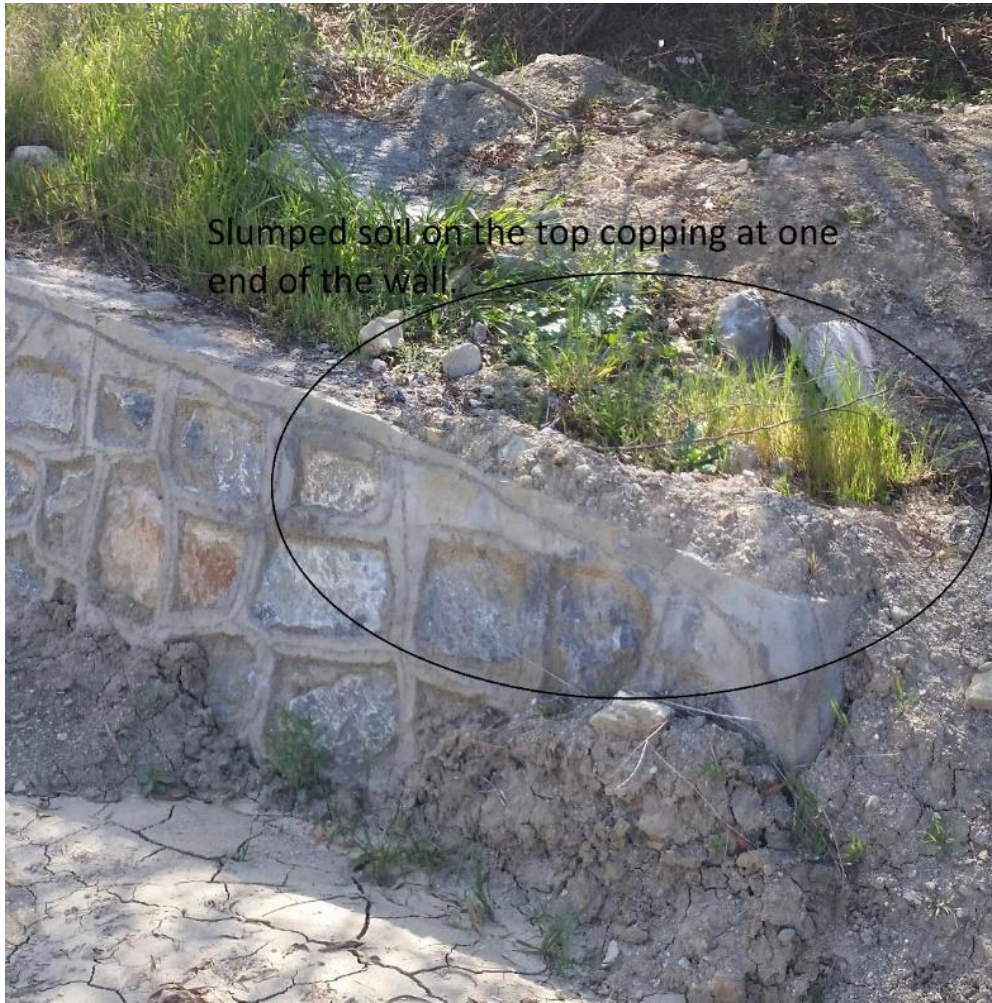
Figure B.8. Copping of the wall.

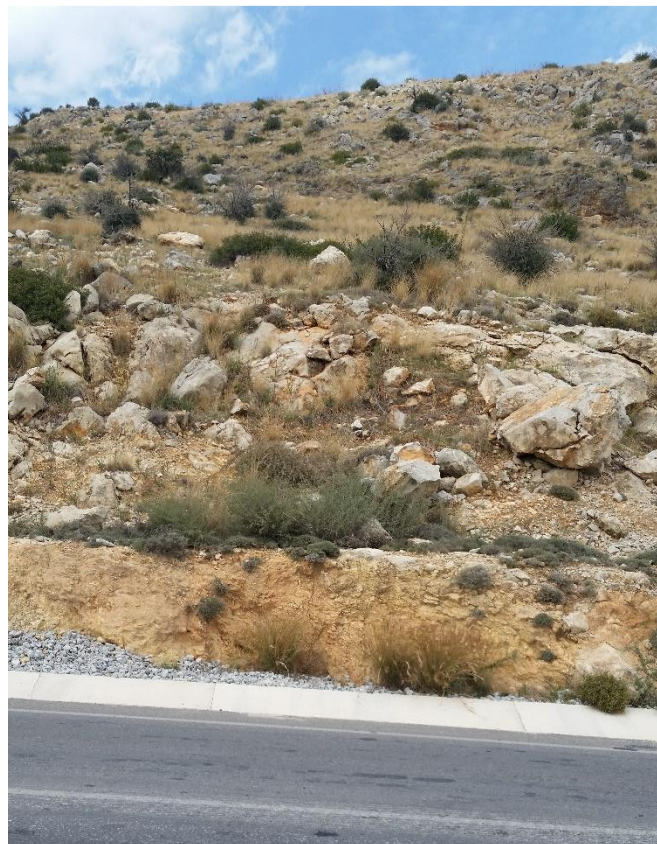
Figure C.1. Site 5.

Current condition data collector system for rockfall sites	
Number of site on map	5
Coordinates:	
Longitudinal	33.484505
Latitudinal	35.274696
Date:	21.07.16
Name of inspector:	Ahmad Alkhouzei
Approximate slope height:	10m
Ditch width:	1m
Approximate slope length:	100m
Daily traffic (vehicle/day):	9416
Speed limit:	80km/hr
Actual sight distance:	179m
Decision sight distance:	
Approximate roadway width (from paved edge to another):	5.5m
Structural condition for rocks:	Discontinuous joints, favourable orientation
Rock friction:	planar
Block size (from peak to peak):	80cm
Presence of water on slope:	No water on the slope.

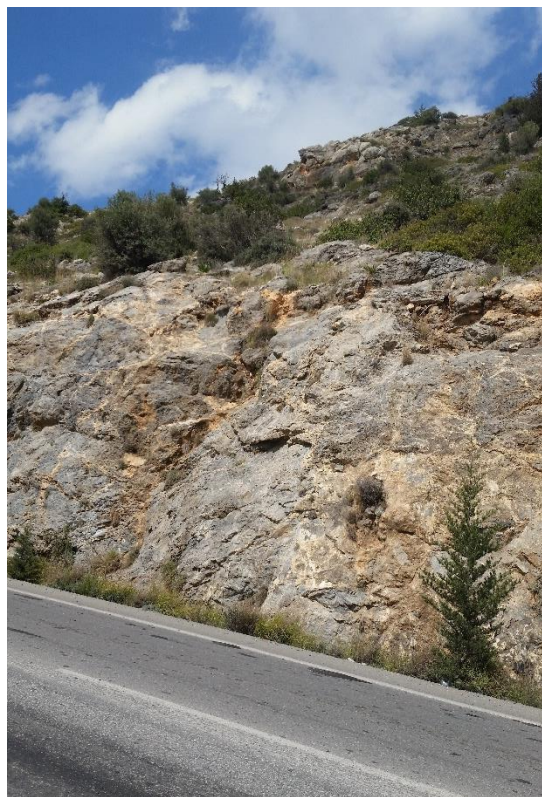
Figure C.2. Site 6.

Current condition data collector system for rockfall sites	
Number of site on map	6
Coordinates:	
Longitudinal	33.473293
Latitudinal	35.278458
Date:	21.07.16
Time:	
Name of inspector:	Ahmad Alkhouzei
Approximate slope height:	20m
Ditch width:	0.75m
Approximate slope length:	150m
Daily traffic (vehicle/day):	9416
Speed limit:	80km/hr
Actual sight distance:	432m
Decision sight distance:	
Approximate roadway width (from paved edge to another):	6m
Structural condition for rocks:	continuous joints, adverse orientation
Rock friction:	undulating
Block size (from peak to peak):	40cm
Presence of water on slope:	Unable to observe.

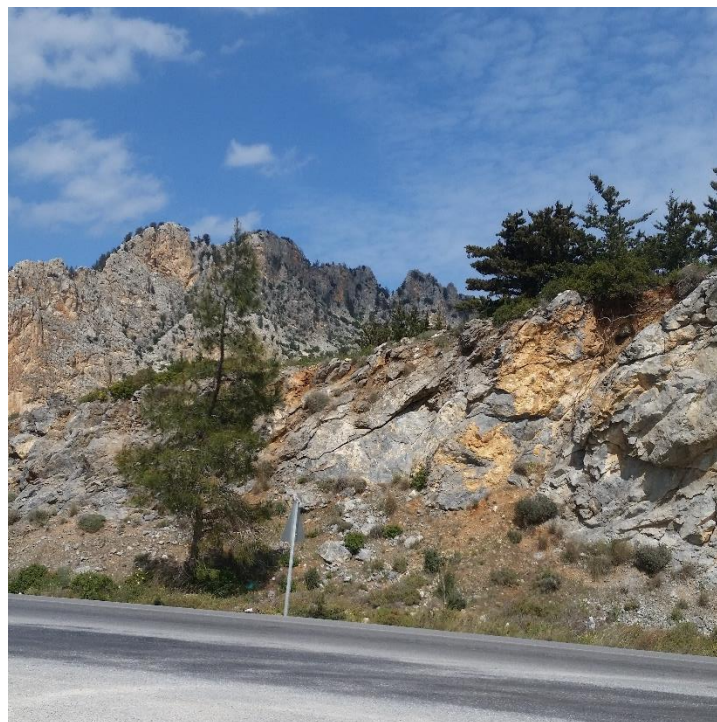
Figure C.3. Site 7.

Current condition data collector system for rockfall sites	
Number of site on map	7
Coordinates:	
Longitudinal	33.470406
Latitudinal	35.27309
Date:	21.07.16
Time:	
Name of inspector:	Ahmad Alkhouzei
Approximate slope height:	30m
Ditch width:	1m
Approximate slope length:	250m
Daily traffic (vehicle/day):	9416
Speed limit:	80km/hr
Actual sight distance:	208m
Decision sight distance:	
Approximate roadway width (from paved edge to another):	7m
Structural condition for rocks:	continuous joints, adverse orientation
Rock friction:	planar
Block size (from peak to peak):	35cm
Presence of water on slope:	Unable to observe.

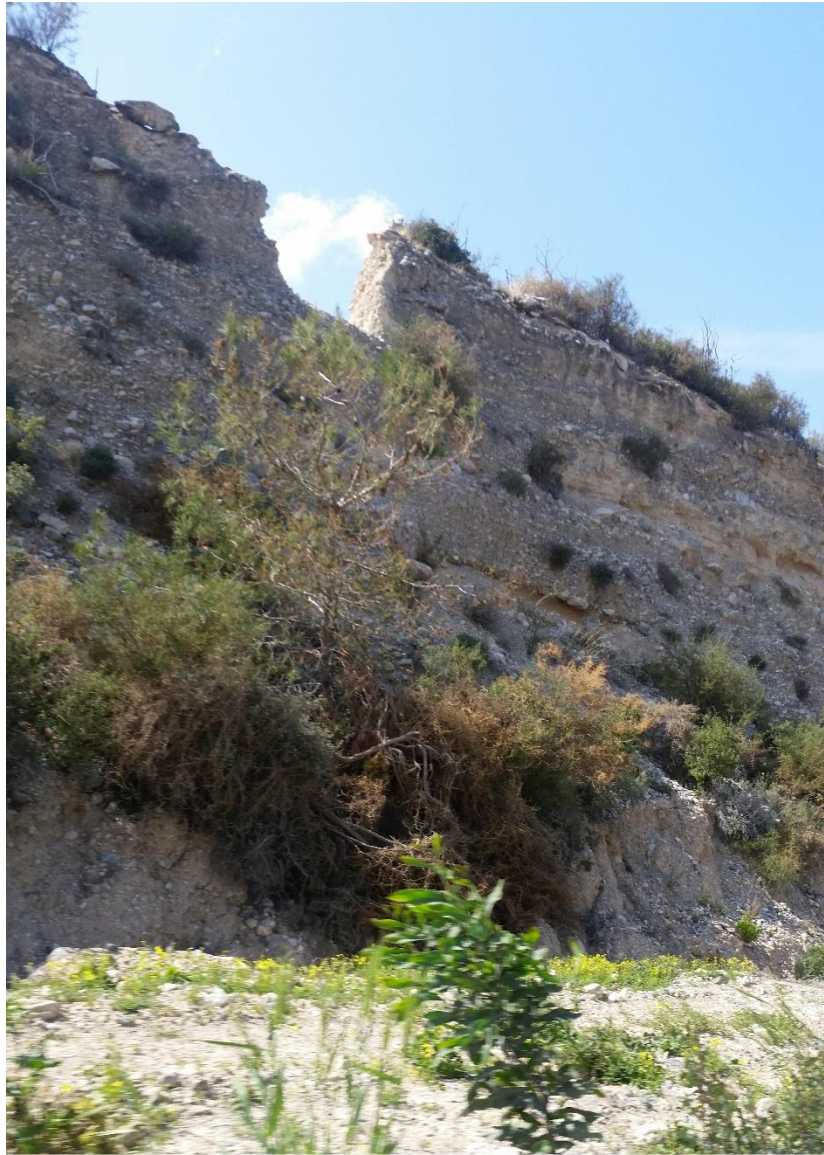
Figure C.4. Site 12.

Current condition data collector system for rockfall sites	
Number of site on map	12
Coordinates:	
Longitudinal	33.423023
Latitudinal	35.315132
Date:	21.07.16
Time:	
Name of inspector:	Ahmad Alkhouzei
Approximate slope height:	6m
Ditch width:	5m
Approximate slope length:	300m
Daily traffic (vehicle/day):	9416
Speed limit:	80km/hr
Actual sight distance:	526m
Decision sight distance:	
Approximate roadway width (from paved edge to another):	6m
Structural condition for rocks:	continuous joints, adverse orientation
Rock friction:	slickensided
Block size (from peak to peak):	Small boulders
Presence of water on slope:	No presence of water.
Additional comments:	Large amount of boulder could fail in any moment

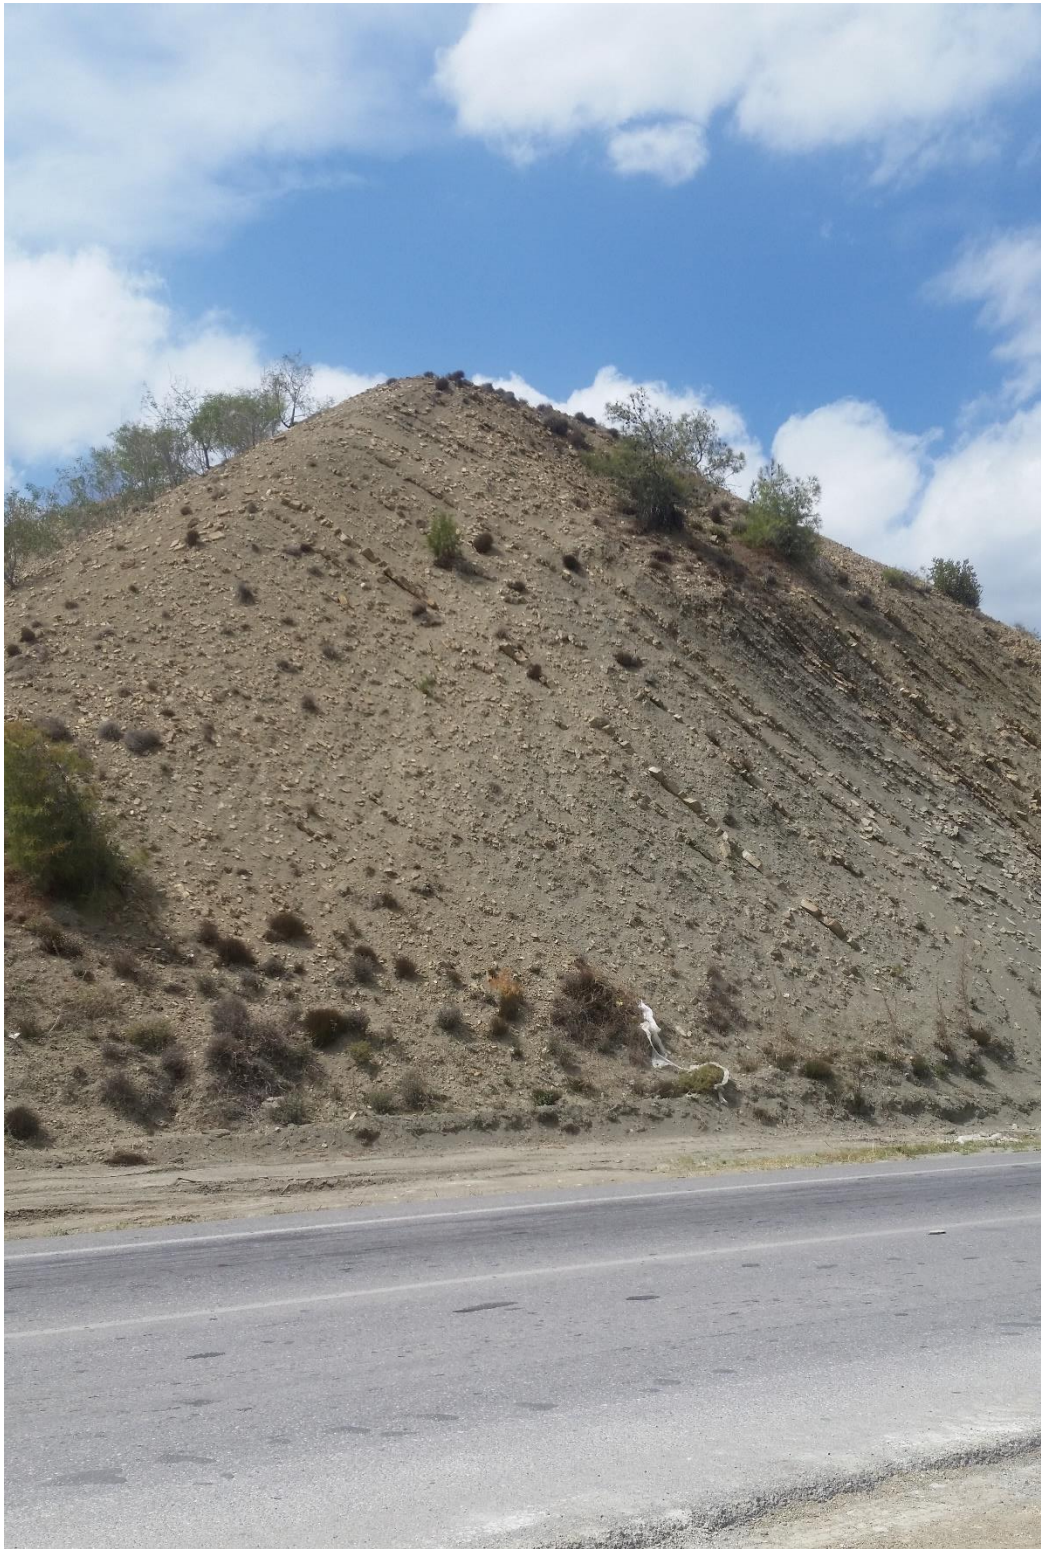
Figure D.1. Site 1-Western.

Tilting of telephone poles , trees, fences or retaining walls:	Yes, there are no fences, retaining walls or telephone poles next to the site but there are tilting in the trees.
Broken water lines or other underground utilities inside the slopes:	No
Sunken or down dropped paths or roads:	No
Additional comments

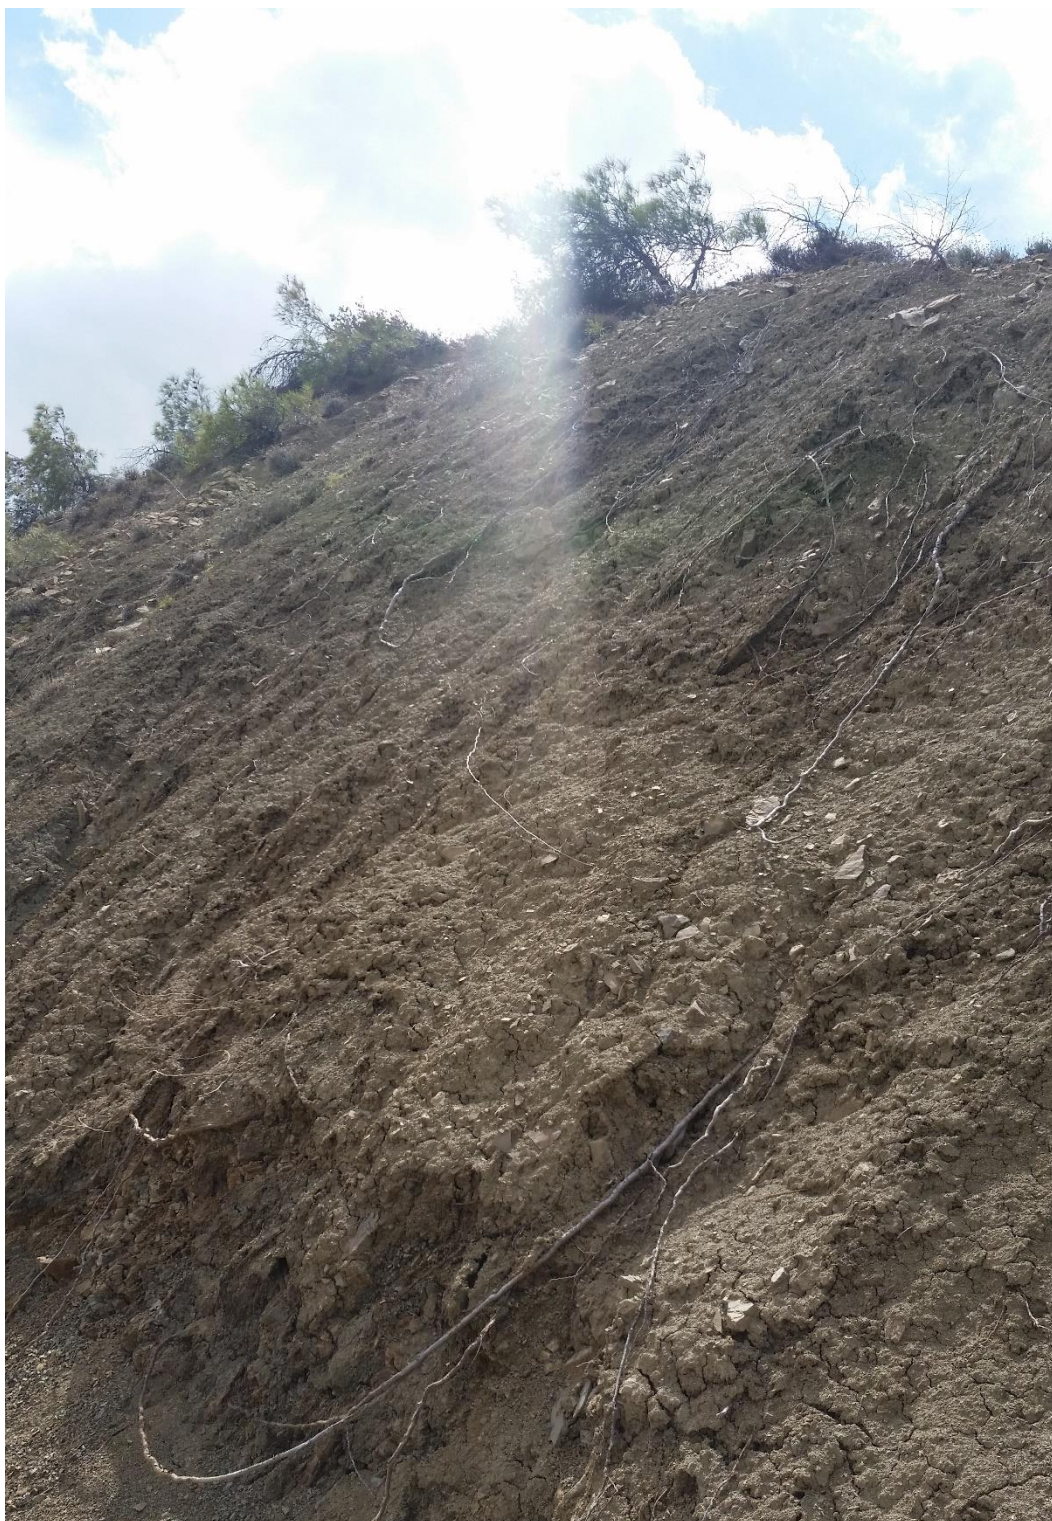
Figure D.2. Site 1-Western-Rain channels.

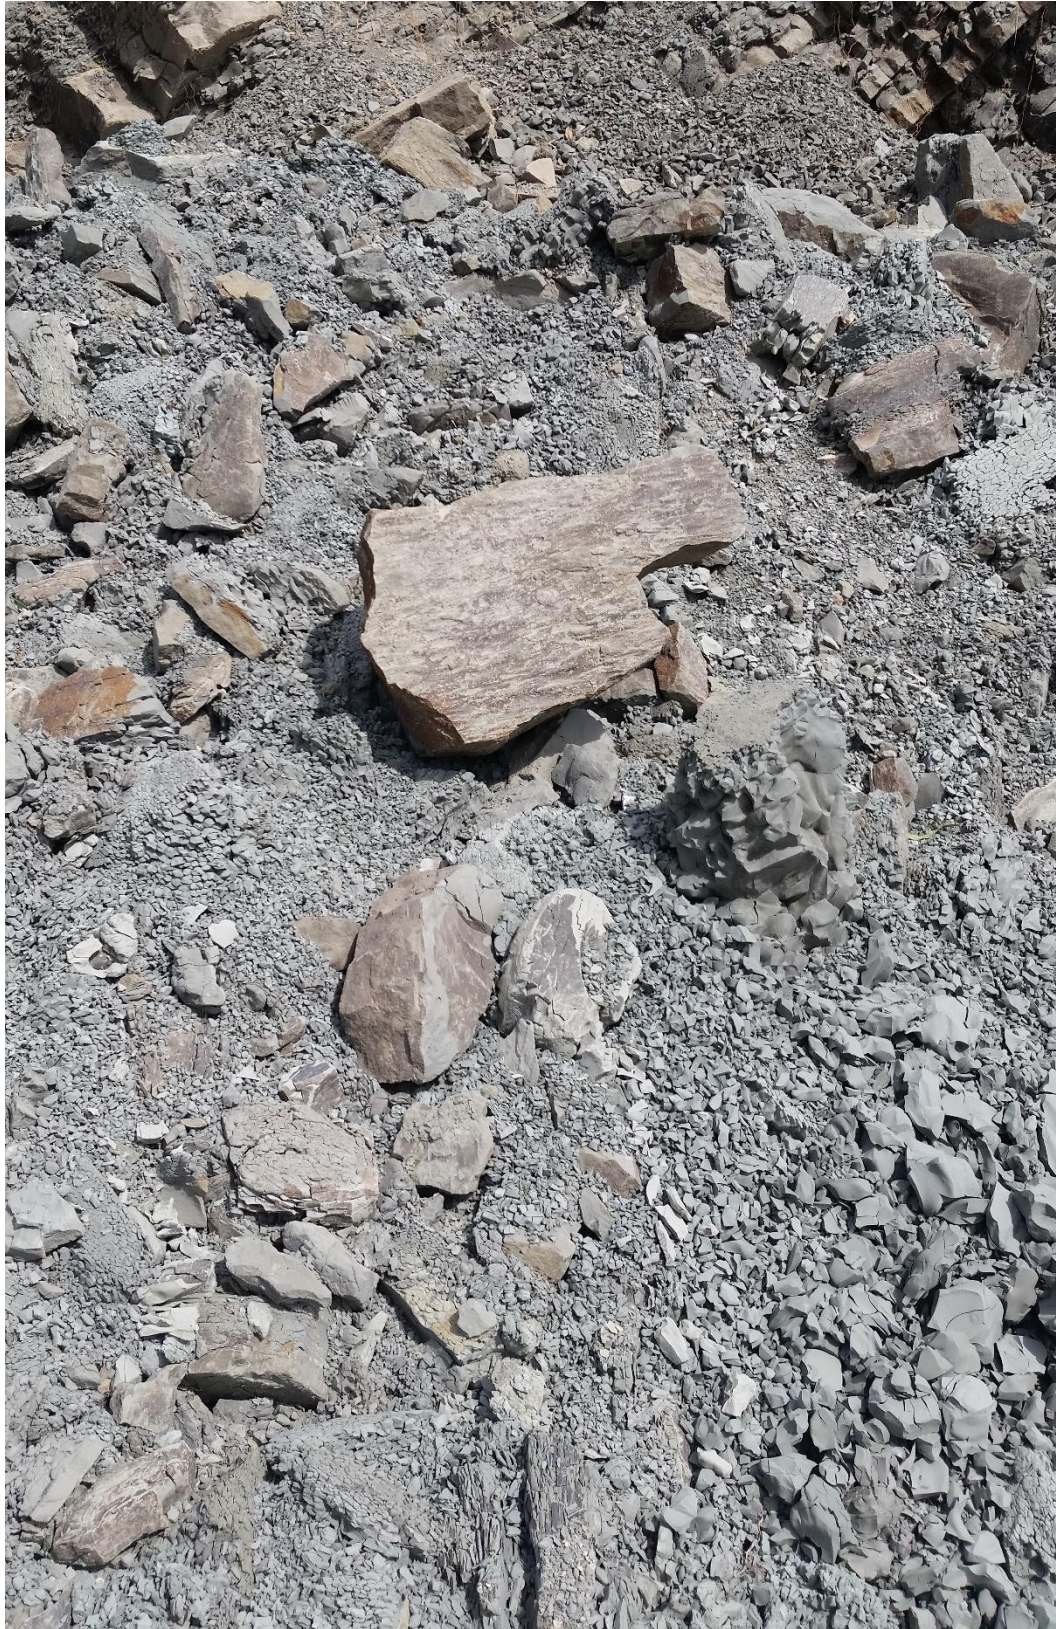
Figure D.4. Site 1-Eastern-Fallen materials.

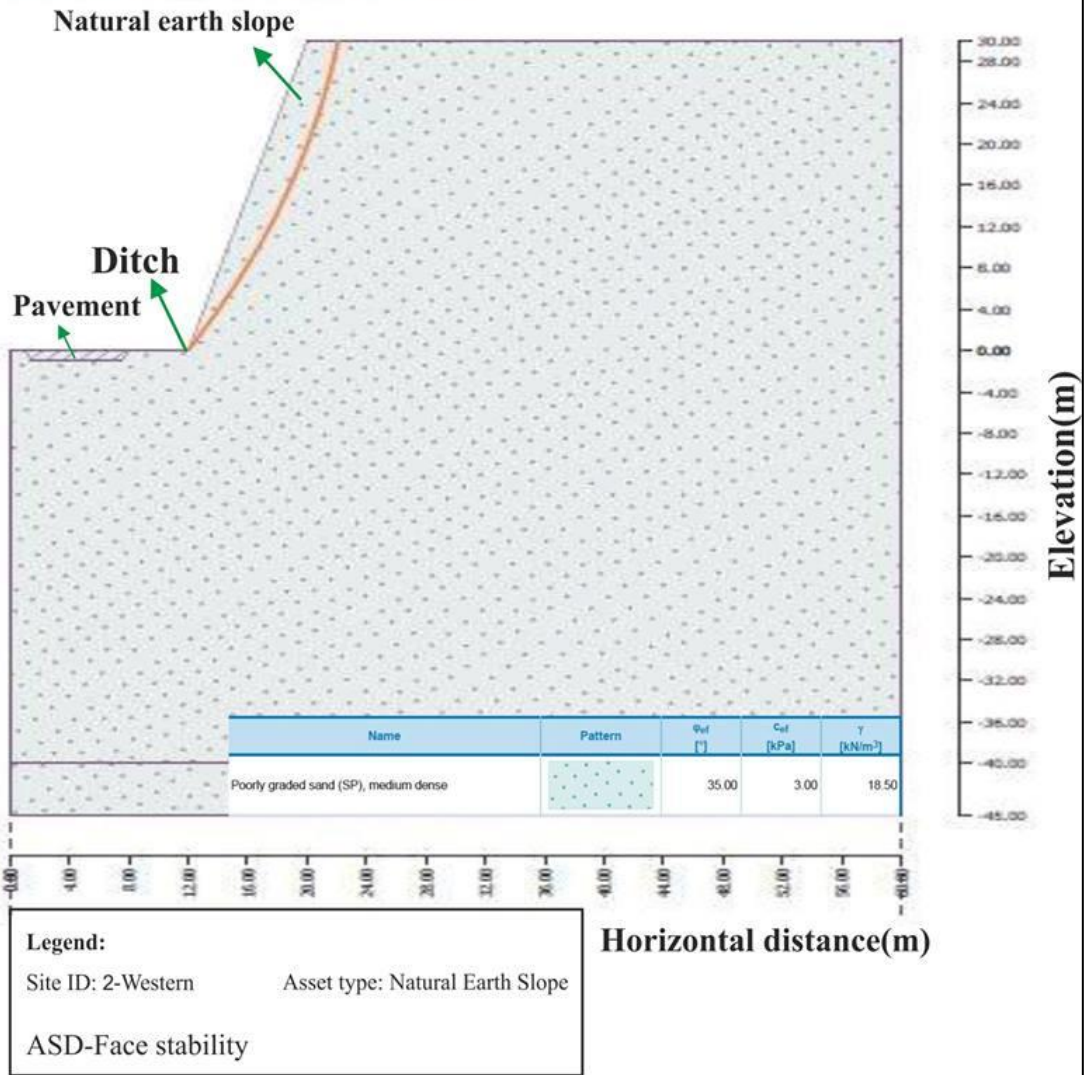
Slope stability NOT ACCEPTABLE

Figure G.13. Site 2-Western-ASD-Face stability.

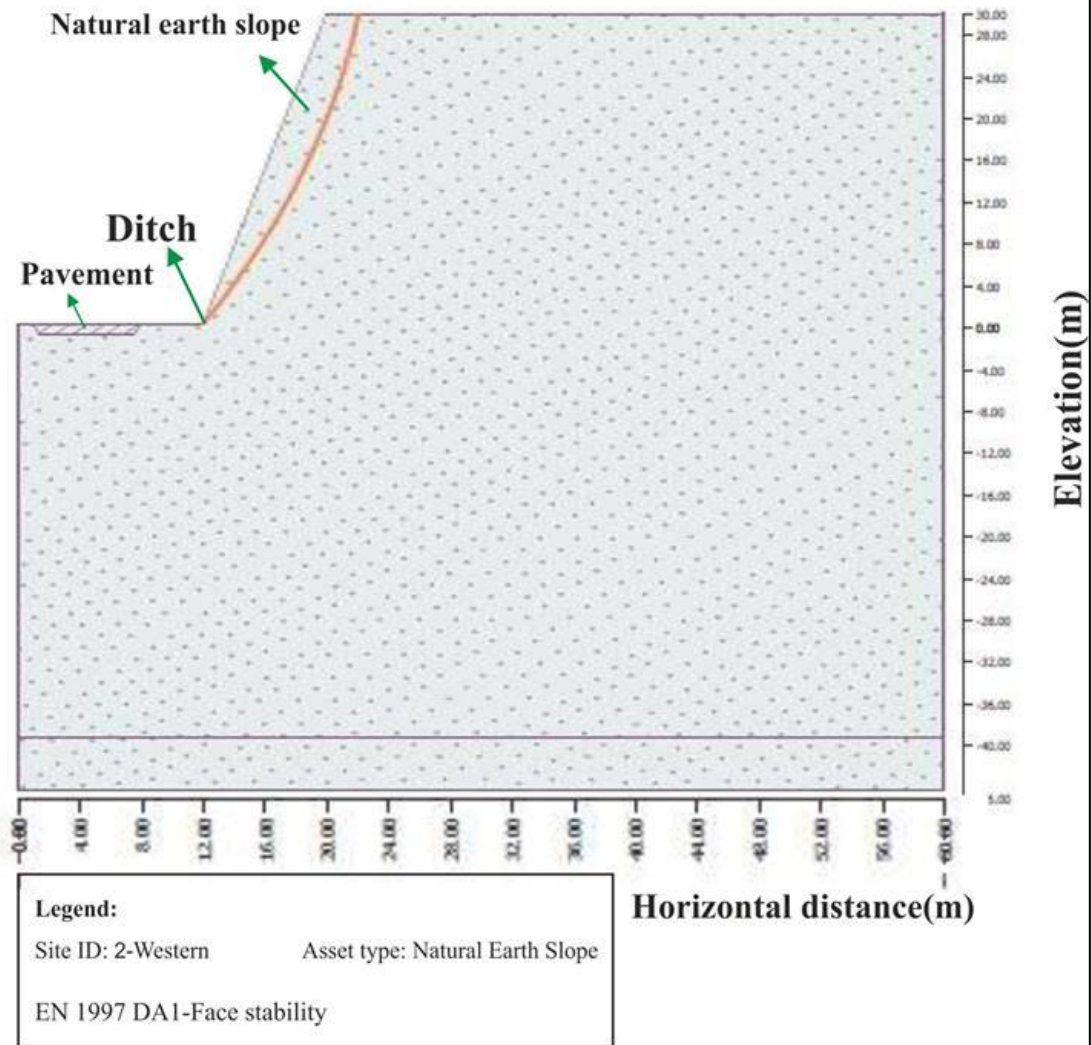
Slope stability NOT ACCEPTABLE
 Optimized slip surface for : Combination 2

Figure G.14. Site 2-Western-EN1997-Face stability.

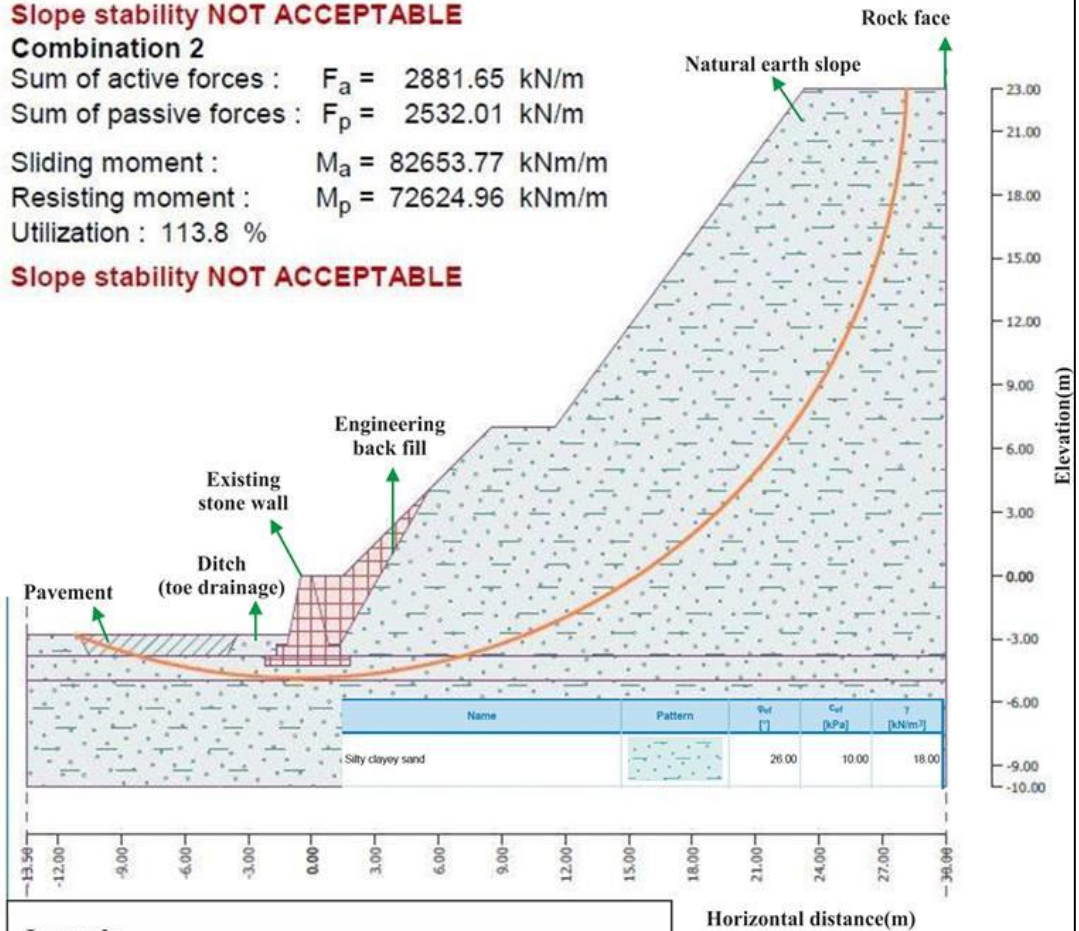
Site ID:11

Slope stability NOT ACCEPTABLE

Figure G.37. Site 11-EN1997-Global stability.
