Common Defects and Structural Problems in the Buildings of Northern Cyprus, their Reasons and Prevailing Applicable Solutions

Master of Science
in
Civil Engineering

Eastern Mediterranean University
August 2017
Gazimağusa, North Cyprus

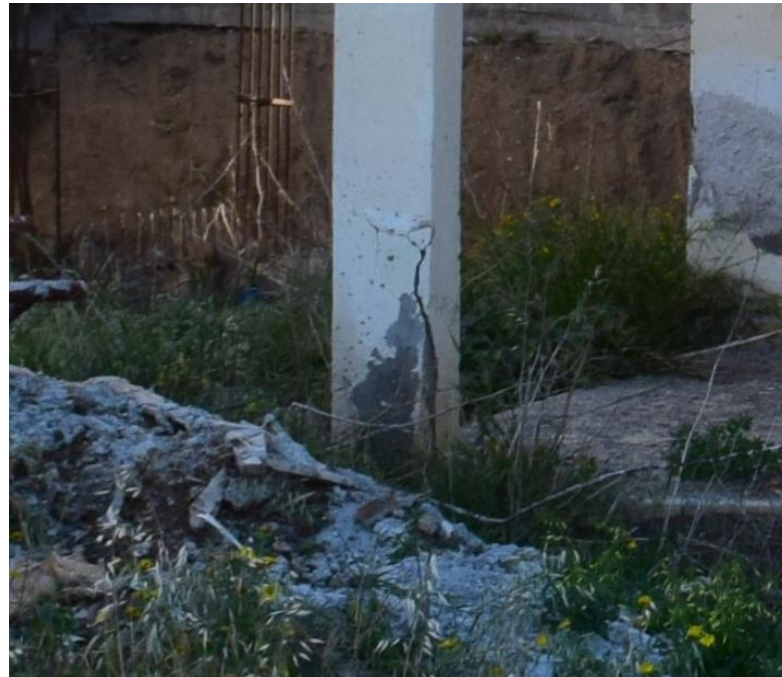
Figure 3.2: Corrosion Crack in the Lower Part of a Column. Mağusa, North Cyprus. (Case Study #1 (Page 93)).

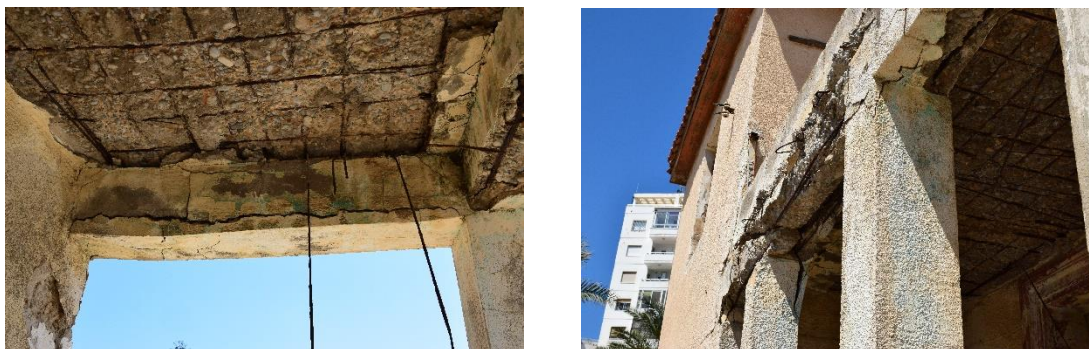
Figure 3.3: Corrosion-Induced Spalling and Cracking Due to Cast-in Chlorides in an Abundant Old Building. Palm Beach Area, Mağusa, North Cyprus. (Case Study #23 (Page 115)).

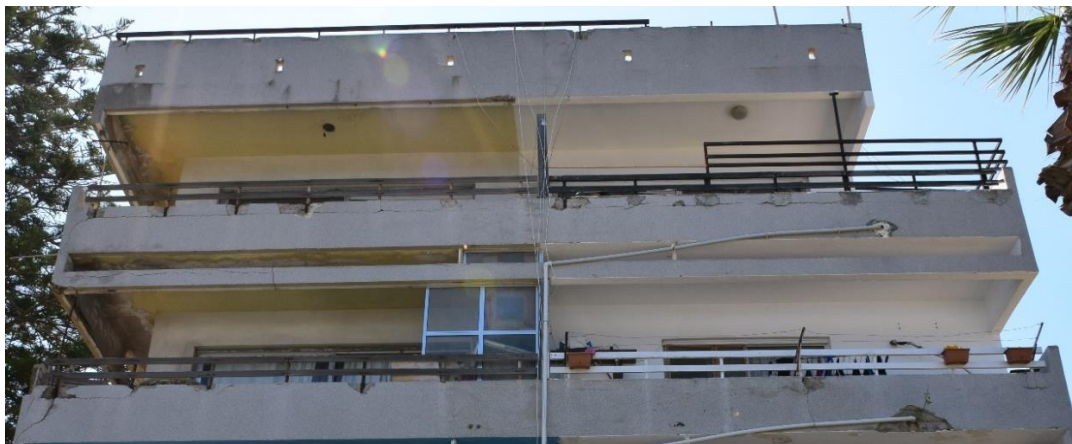
Figure 3.4: Cracks Due to Dissimilar Metal Corrosion around Handrail's Embedded Metal Balusters of Balconies. Residential Building, Palm Beach, Mağusa, North Cyprus. (Case Study #24 (Page 116)).

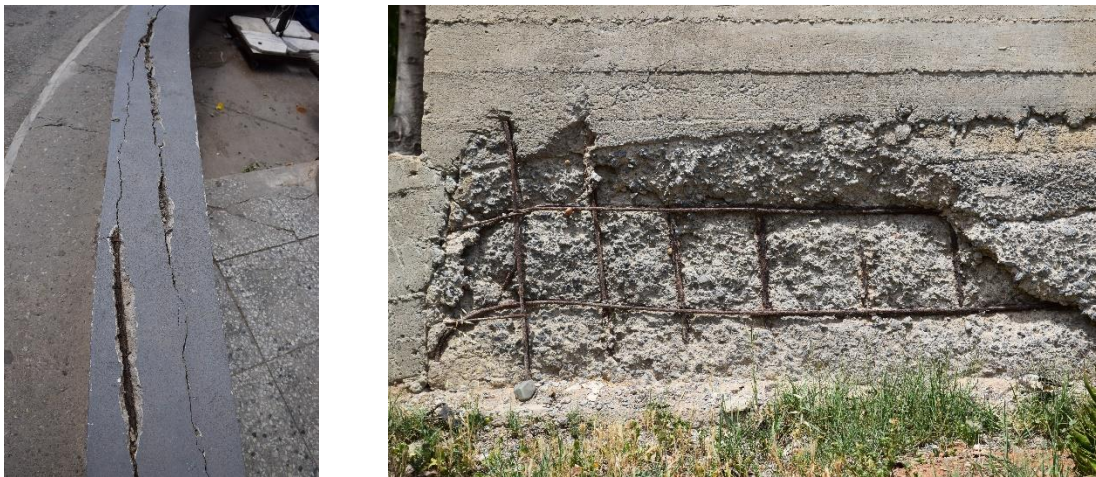
Figure 3.5: Cracks and spalls in concrete short walls. Public structures, Mağusa, North Cyprus.

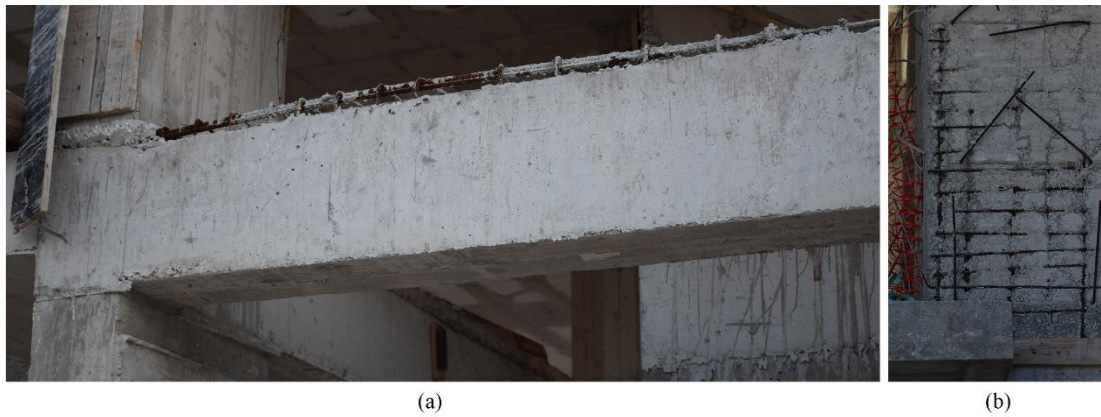
Figure 3.9: Shifted Reinforcing Bar Cages in: a Beam (a) and in a Sheer Wall (b). Residential Buildings, Mağusa, North Cyprus. (Case Study #111 (Page 203)).

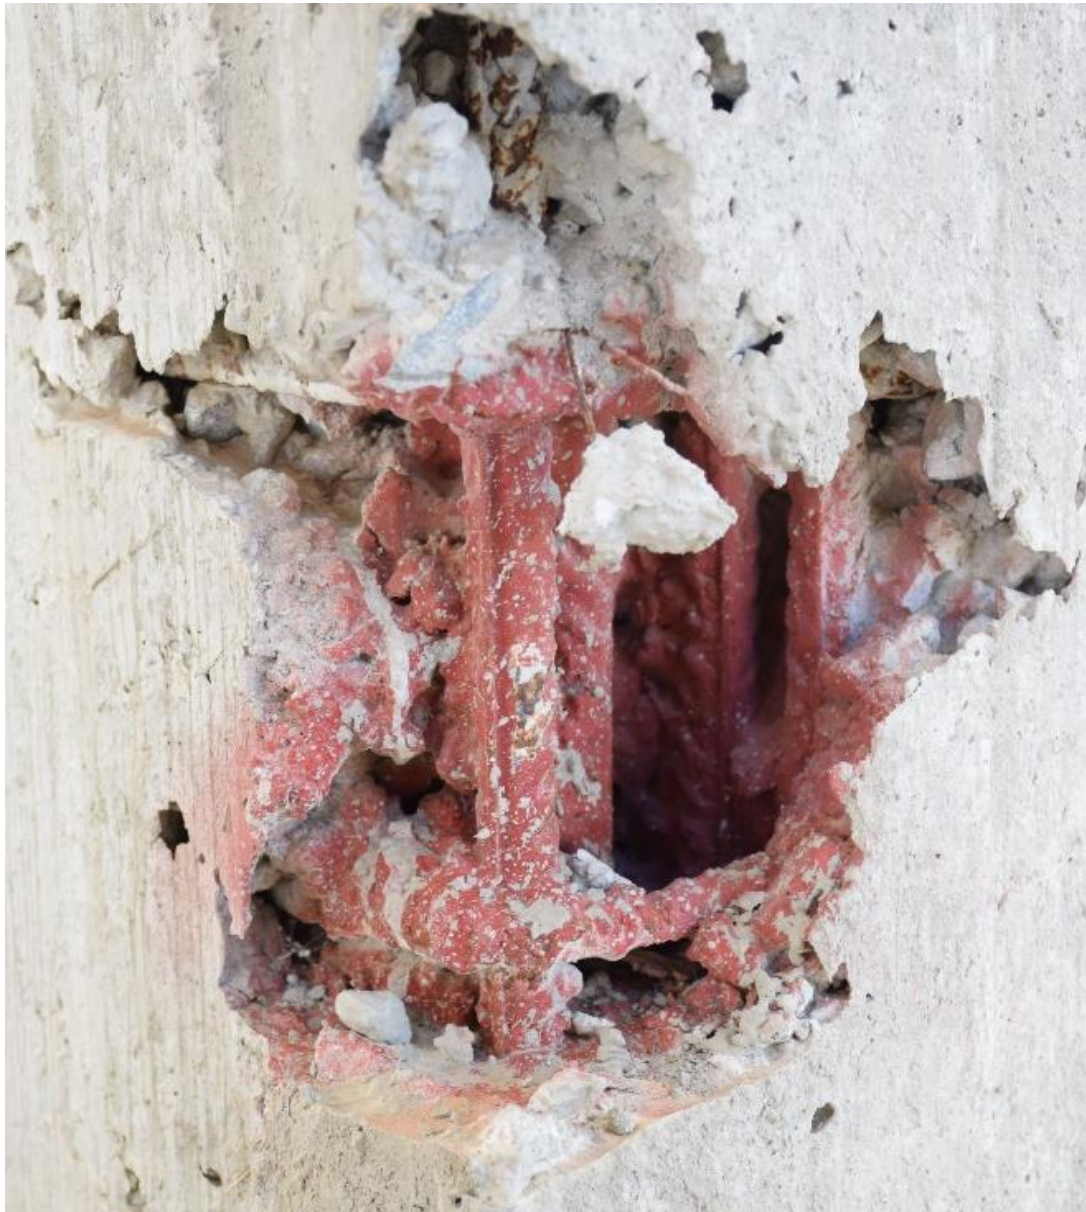
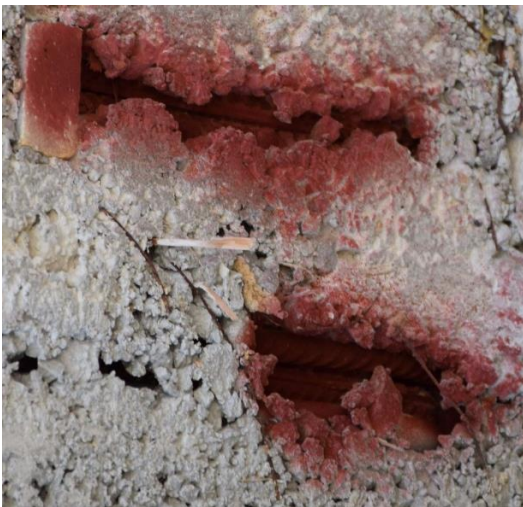
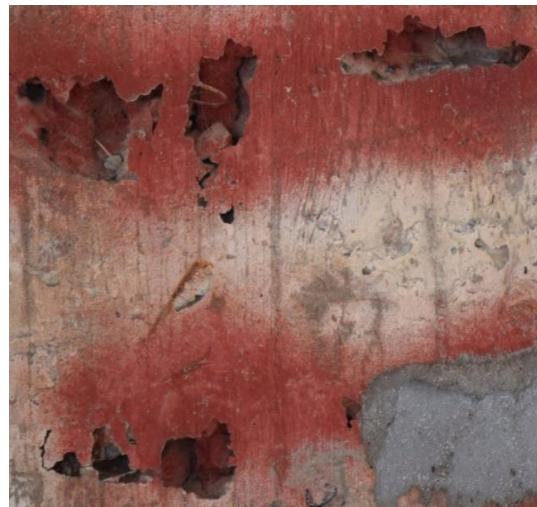
Figure 3.10: Visible Voids around Reinforcements Due to High Congestion.
Residential Building, Mağusa, North Cyprus.
(Case Study #104 (Page 196)).

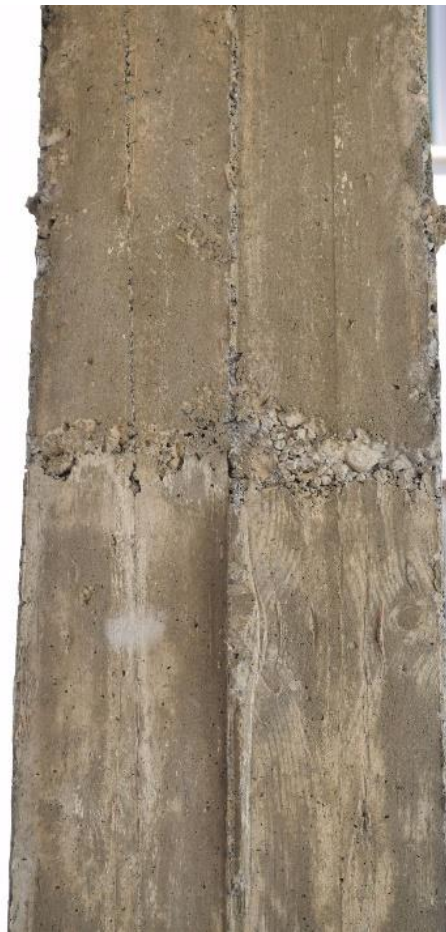
Figure 3.13: Cold Joint in Column. Residential Buildings, Mağusa, North Cyprus. (Case Study #104 (Page 196)).

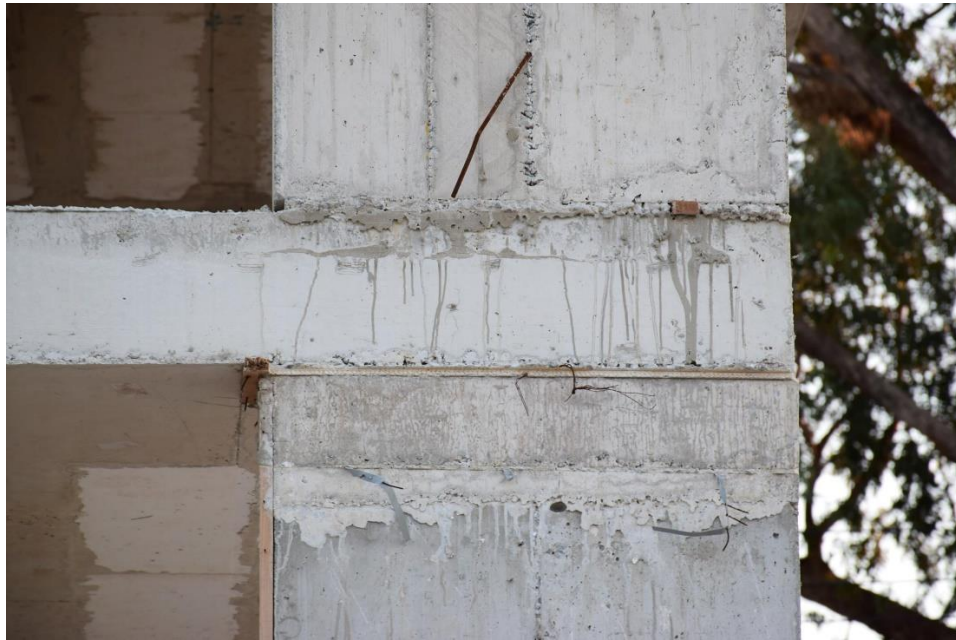
Figure 3.14: Cold Joint Between Column and Slab. Residential Buildings, Mağusa, North Cyprus. (Case Study #111 (Page 203)).

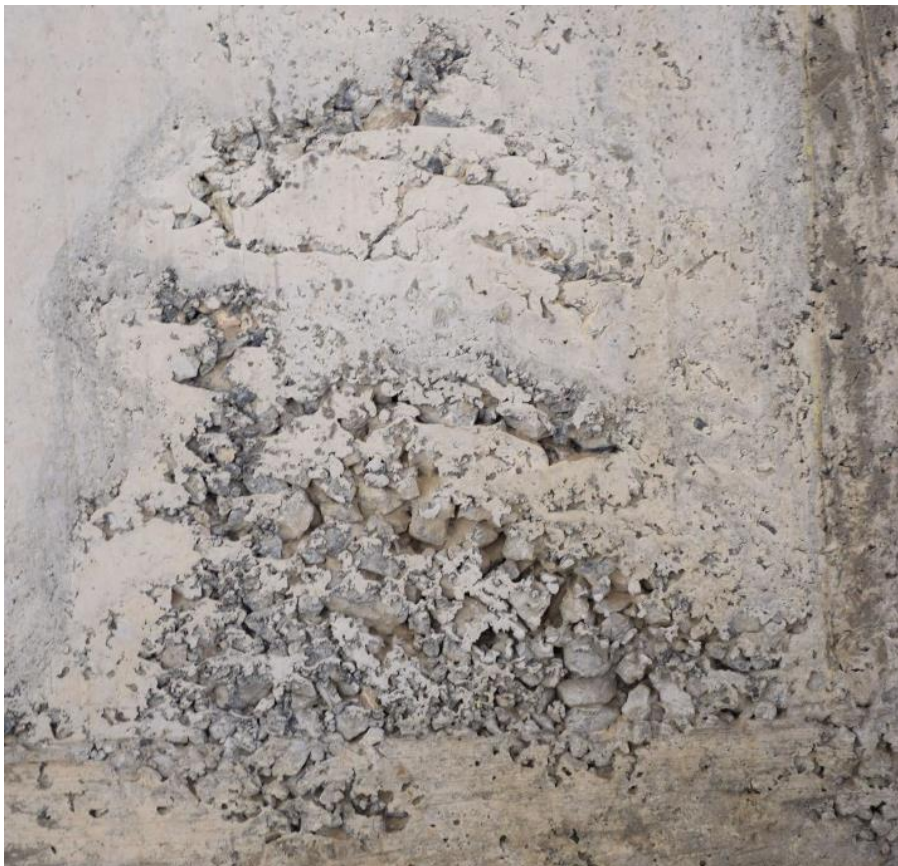
Figure 3.16: Honeycomb in a Column. Residential Building, Magusa, North Cyprus. (Case Study #104 (Page 196)).

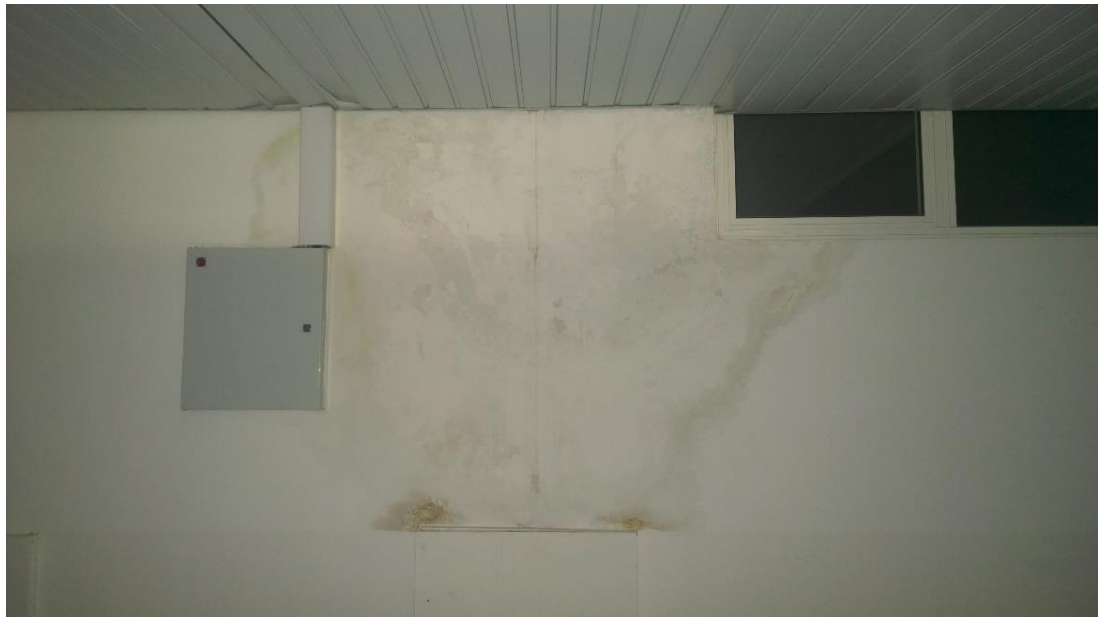
Figure 4.1: Dampness on the Upper Section of the Wall Due to Rain Penetration. Civil Engineering Department, Eastern Mediterranean University (EMU), Mağusa, North Cyprus.

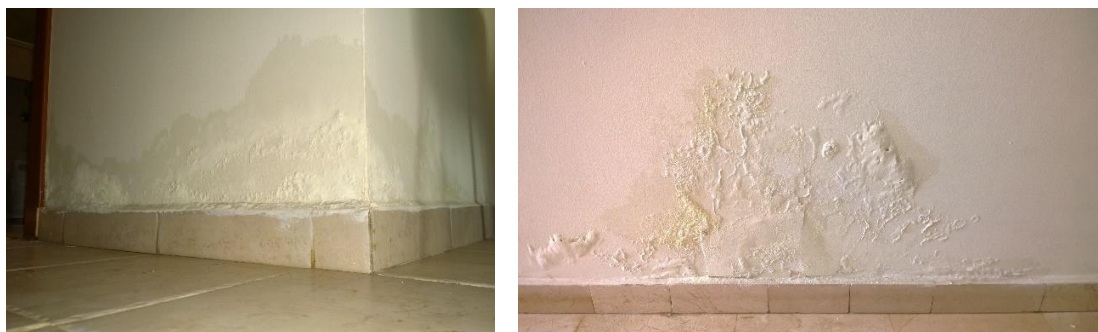
Figure 4.2: Dampness on The Lower Part of Second Floor Walls Due to Wet Floors Caused by Frequent Floor Washing Using Too Much Water Which Can Be Mistaken Easily as Rising Damp. Akdeniz Gormitory, Eastern Mediterranean University (EMU), Mağusa, North Cyprus.

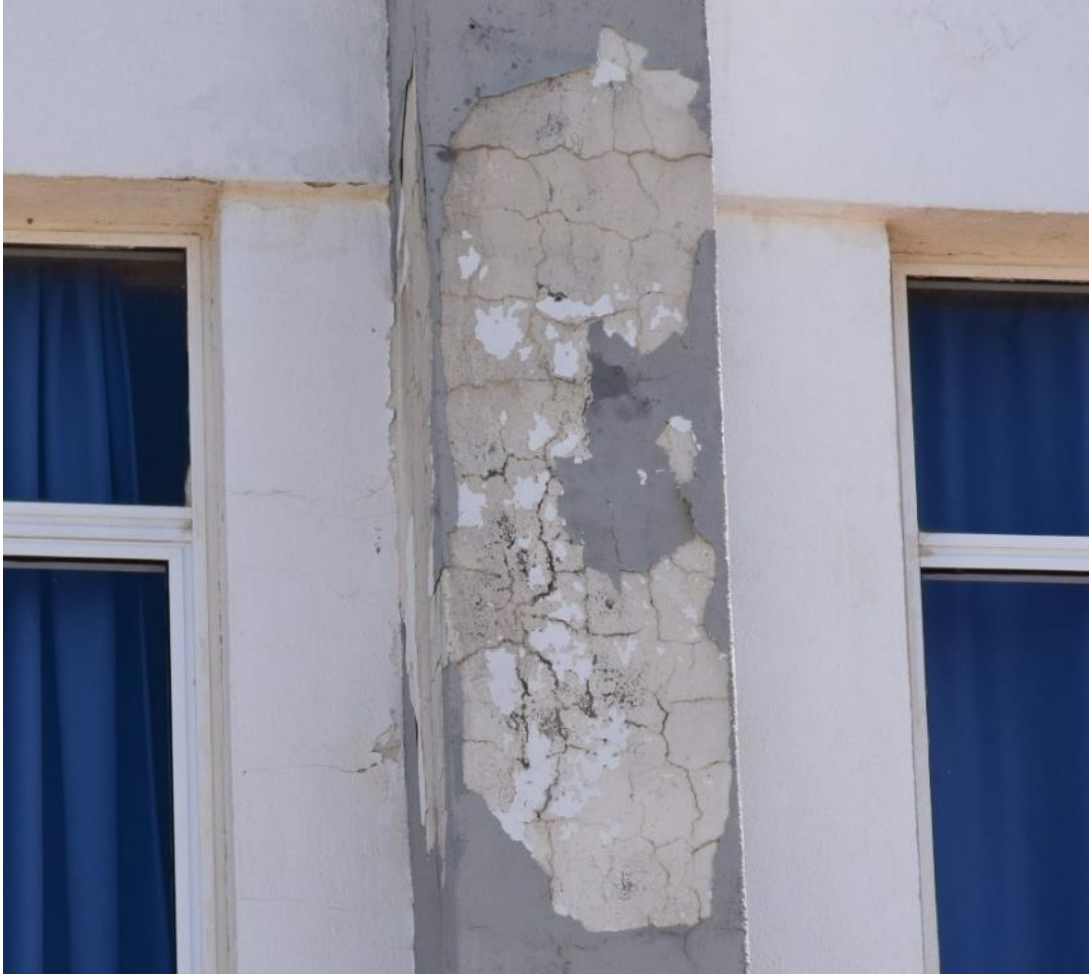
Figure 4.3: Map cracking on the Column of the Top Floor That Led to the fall of some of the Paint Cover. English Preparatory School, Eastern Mediterranean University, Mağusa, North Cyprus.

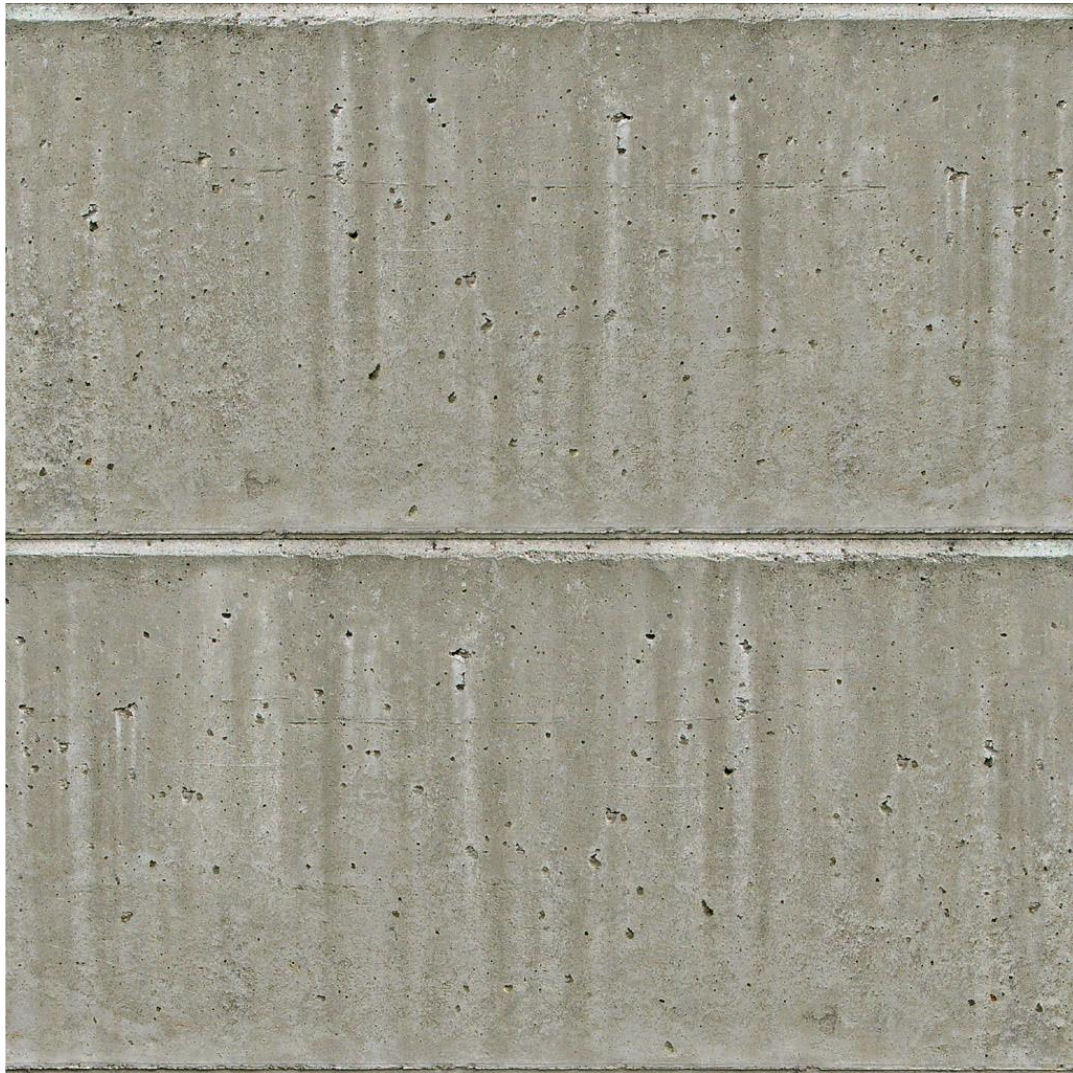
Figure 4.4: Efflorescence on Concrete Surface.

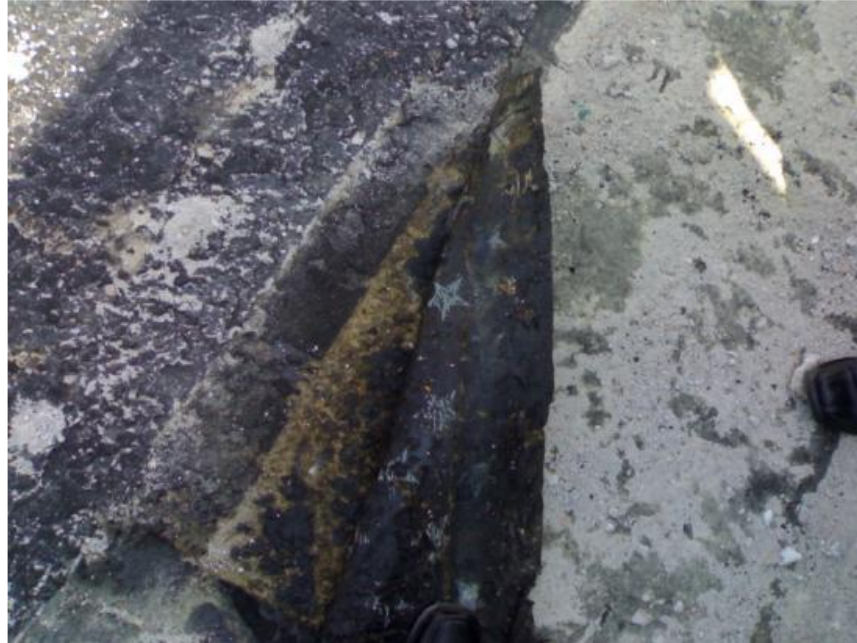
Figure 4.5. Failed Torch-on Membrane at Social Security Organisation (SOC SO) in Seberang Jaya, Malaysia (Suffian, 2013).
