Repair and Maintenance of Historical Buildings of Cyprus Made of Natural Building Stones

Master of Science
in
Civil Engineering

Eastern Mediterranean University
February 2022
Gazimağusa, North Cyprus

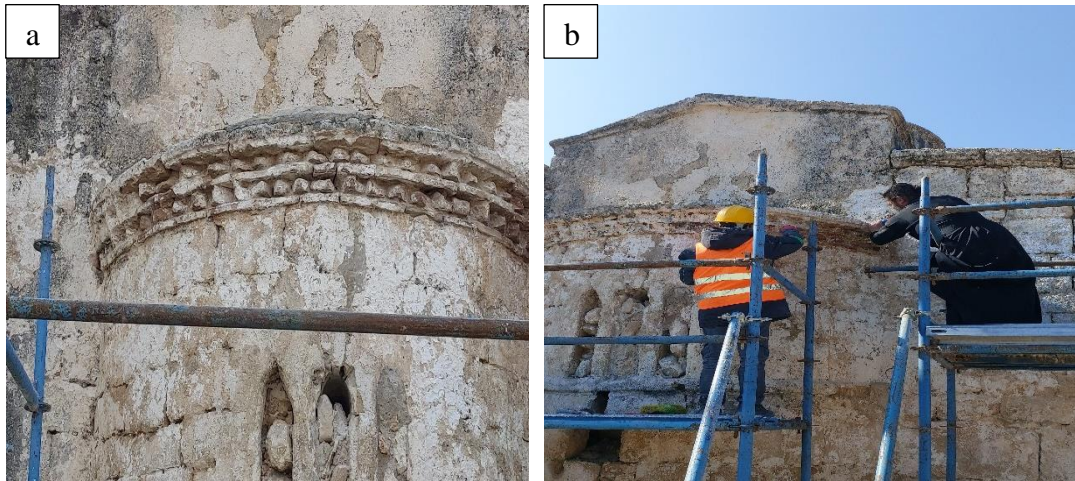
Figure 2.3: a) Initial condition b) Removal of plaster from external walls of the church

Portland cement or other plaster type were used in previous repair works in extended areas of walls. Being incompatible with the stone structure, as was harder than the stones underneath and as it did not allow breathing of the wall (moisture could not escape), it was needed to be removed.

- Existing Portland cement or other plaster types were removed from external walls of church and belfry (see Figure 2.3).

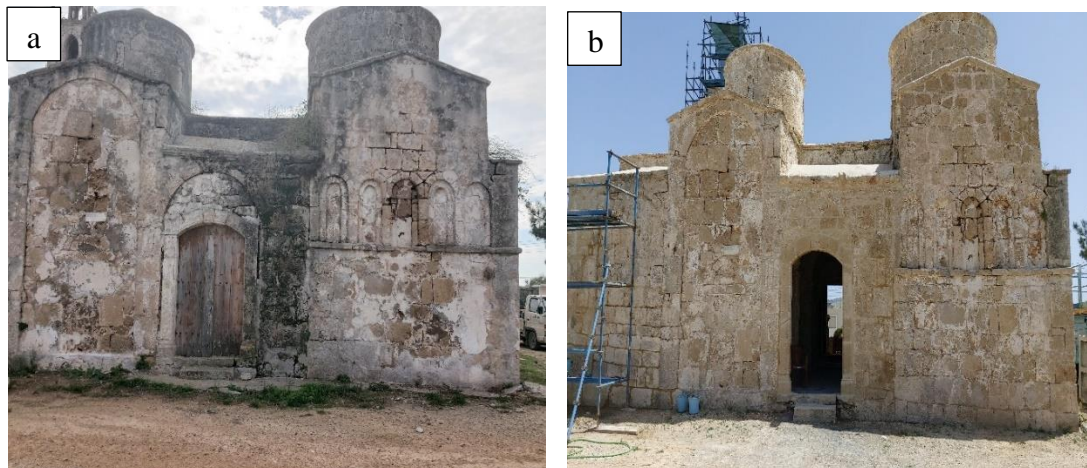
Figure 2.4: a) Initial condition b) Condition after cleaning of surface deposits from stone surfaces

Extended areas of the church external walls were either lime washed (several layers) or present natural weathering, staining, biological growth and other dirt. The work of cleaning had to be carried out by means of low-pressure clean water spraying and soft brushes. In case of soft stone material, work had to be done with maximum care in order to prevent crumbling of the stone surface.

- Surface deposits were cleaned from stone surfaces using flat brushes, natural fibre brooms and sandblasting (see Figure 2.4).

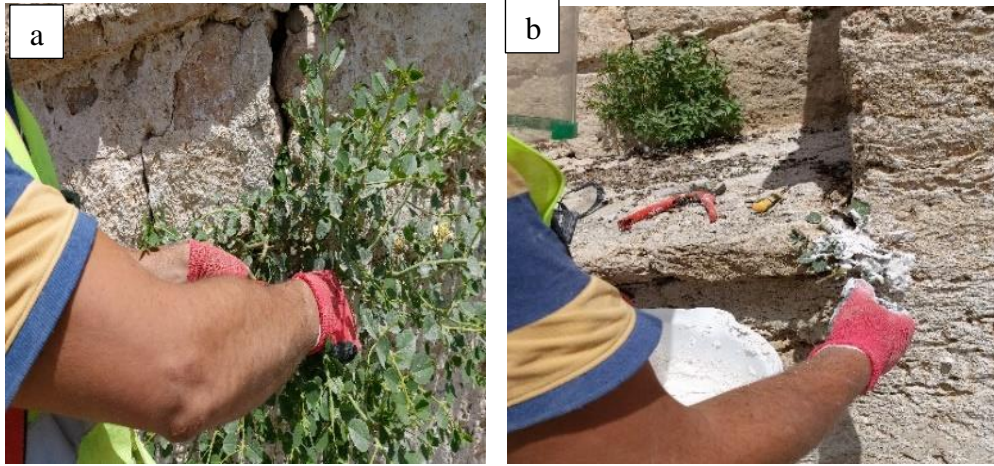
Figure 2.5: a) Vegetation removal stage 1 b) Stage 2

- Vegetation (roots etc.) removed from walls after application of approved biocide (see Figure 2.5).

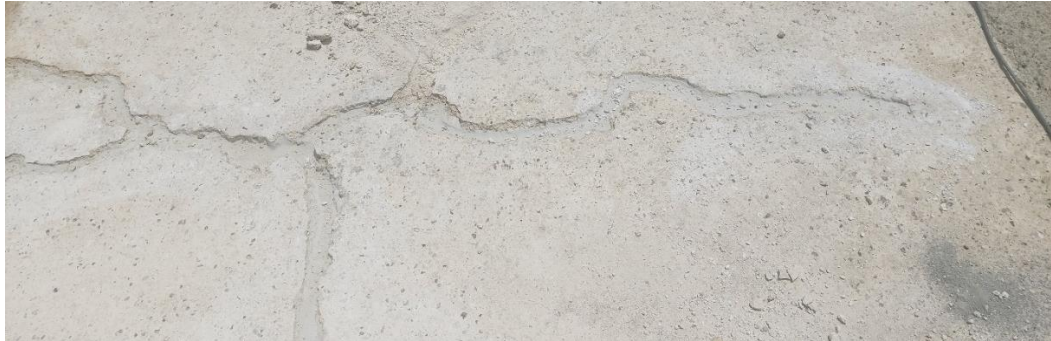
Figure 2.8: Cracks at roof

Cracks on the walls, arches and vaults were existing. Few of those were considered as more serious (eg. Byz. church NE corner internally and externally) and some were minor. Also, mortar failure and wash out along with plants' (roots) growth lead to voids in the walls and vaults. All of them treated by grouting in order to strengthen and improve the mechanical properties of the building.

- Cracks on the walls, arches, vaults and domes repaired by injecting fine hydraulic lime mortar (see Figure 2.8, 2.9, 2.10 and 2.11).

- 1) Cleaning of crack or area to be treated,
- 2) Insertion of plastic injection tubes at a distance of about 50 cm,
- 3) Sealing of crack/joints with mortar,
- 4) Injection with fluid mortar starting from bottom to top of wall,
- 5) Sealing of first point of injection when material comes out from the second
etc.
- 6) If the work was applied to an extended area, the work was done from bottom to top in rows of about 1m each. Material of first row must be dry before going to the upper one.
- 7) Cleaning of stone surface, removal of plastic tubes and sealing of holes.

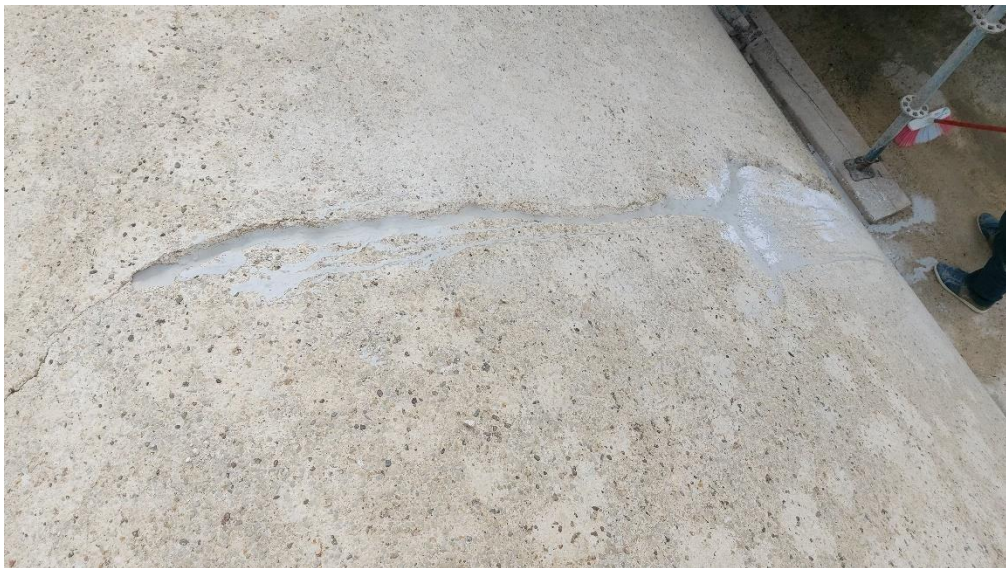
Figure 2.9: Cracks at roof

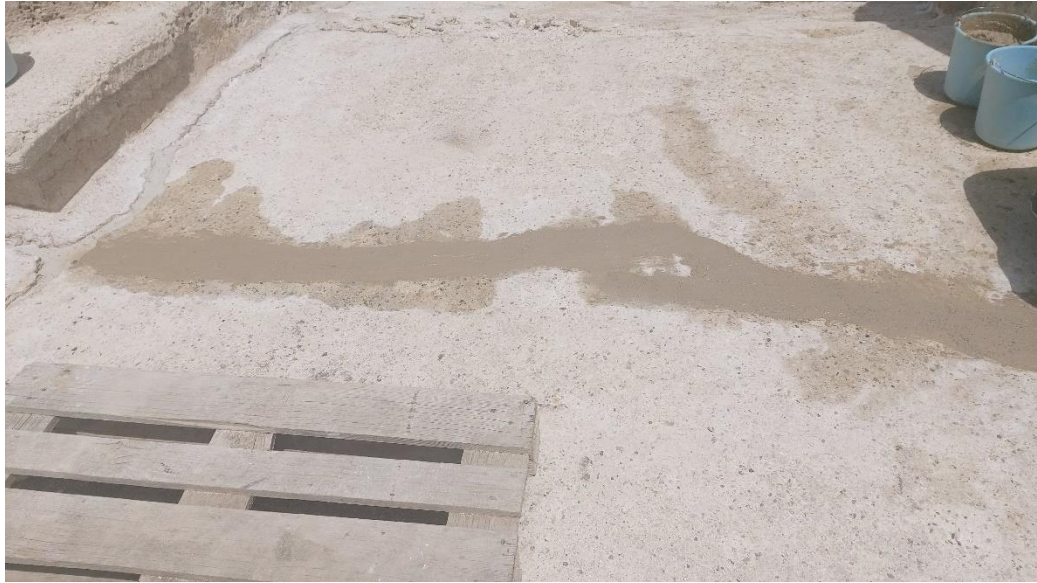
Figure 2.10: Repaired cracks at roof

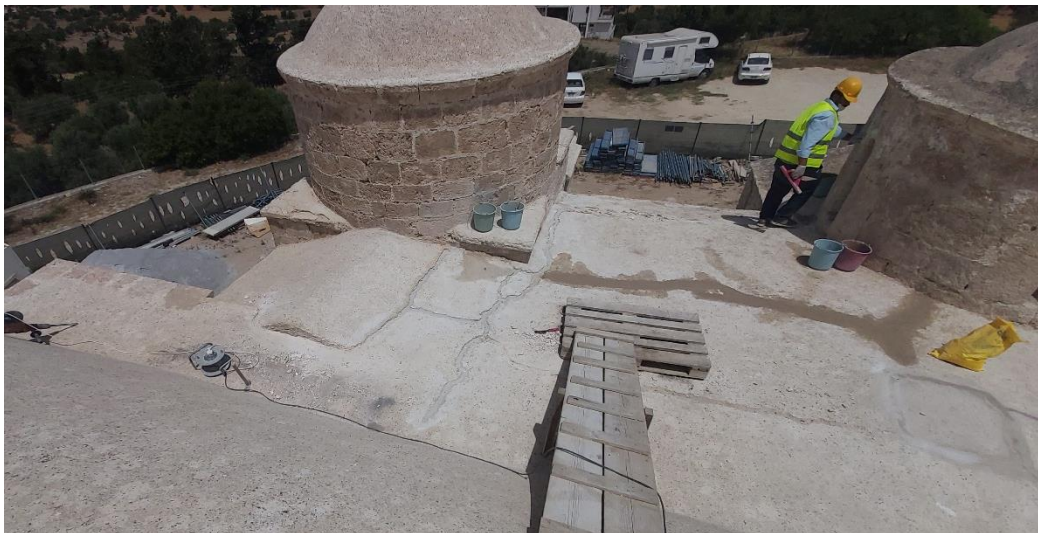
Figure 2.11: Repaired cracks at roof

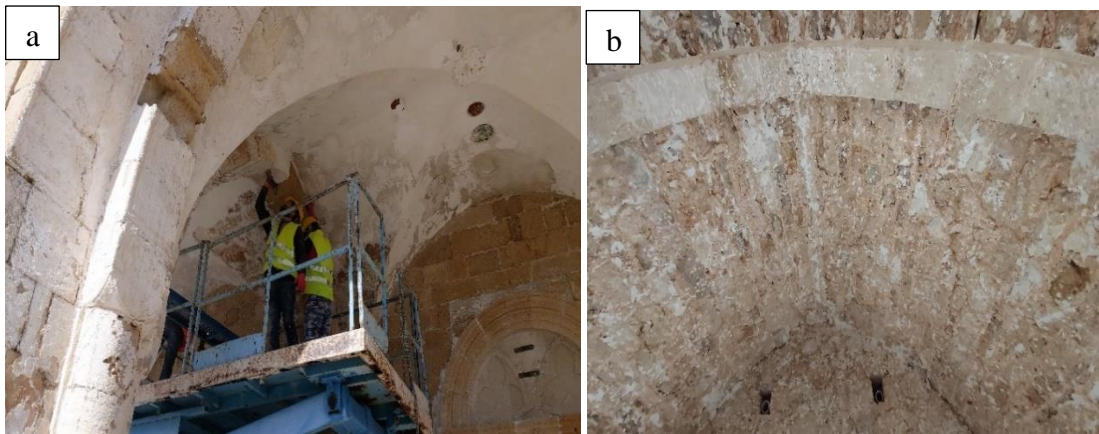
Figure 2.12: a) Initial condition b) After of cement removal

Internal surfaces were covered with lime or gypsum mortars. Due to severe cracking and defect, renders had to be removed where needed. Removal of renders gave chance to a better and close check of the masonry and vaults status (cracks, defected stones etc.). Initially, the most seriously damaged areas removed. After that, it was up to the Architect to check again and decide whether certain areas of original plaster was strong enough to remain or not.

- Existing lime or gypsum or cement removed from internal surfaces except areas with frescoes. Work had been done by hand tools only. Without use of heavy machinery. Loose deposits were removed by air under pressure (see Figure 2.12).

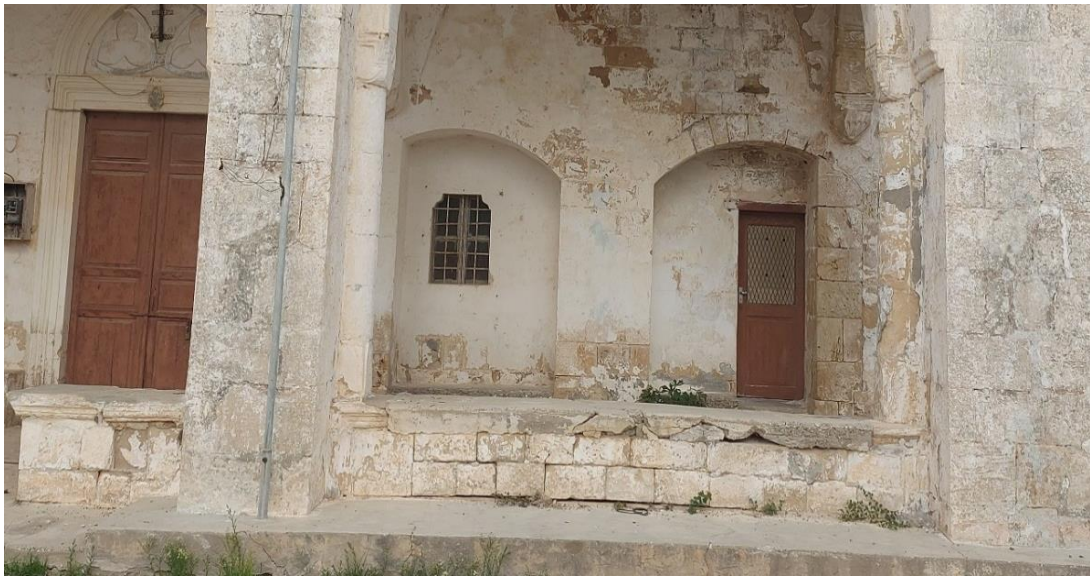
Figure 2.20: Existing cornice stones

- Existing cornice stones were removed, then area was cleaned and new cornice stones added, including lime mortar and small stones to fill gaps and voids (see Figure 2.20 and 2.21).

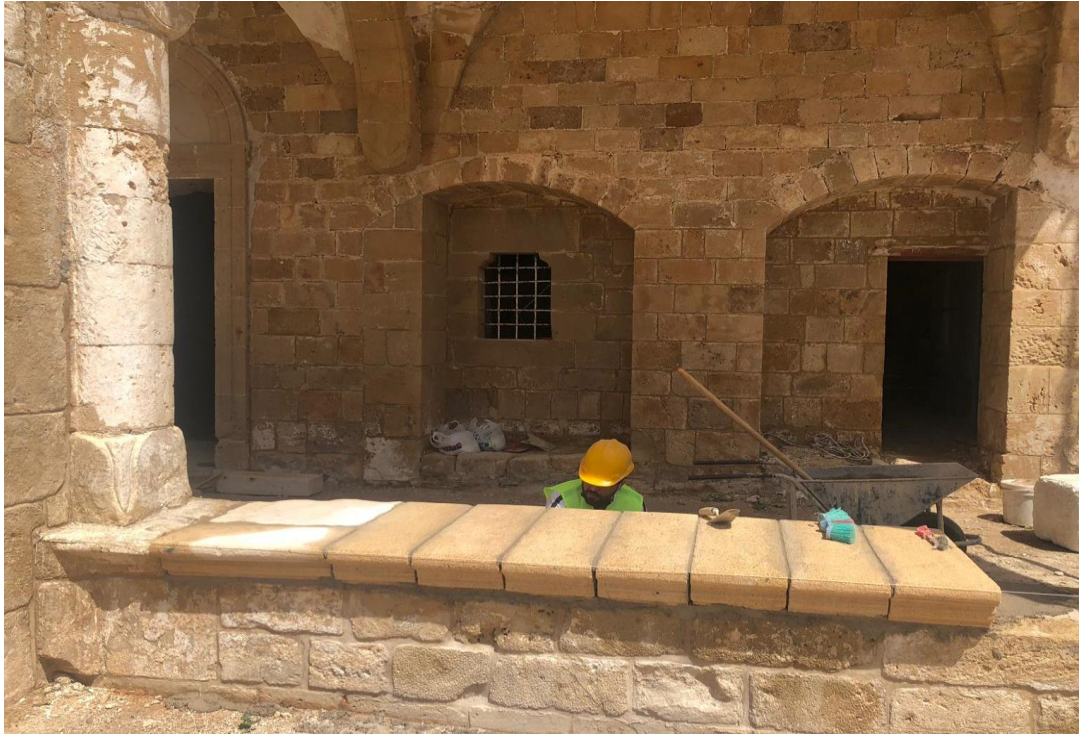
Figure 2.21 New cornice stones

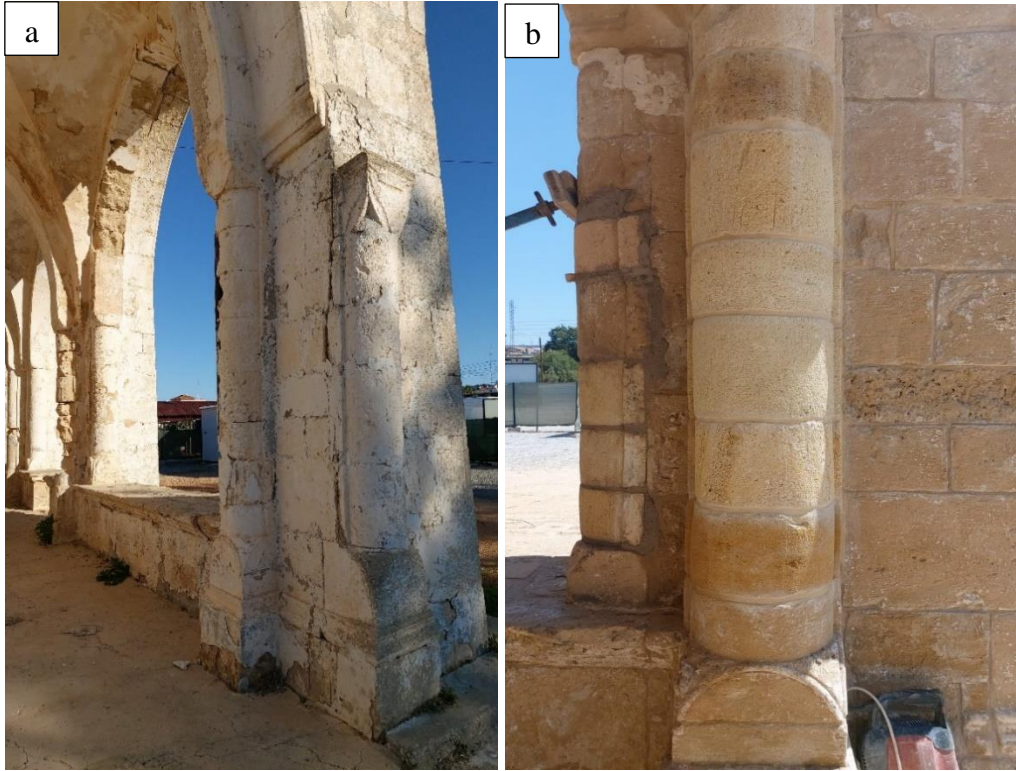
Figure 2.22: a) Initial condition of column drum 1 b) Final condition

- Existing column drums at south Porch semi columns were removed, then area was cleaned and new column drums added, including lime mortar and small stones to fill gaps and voids (see Figure 2.22 and 2.23).

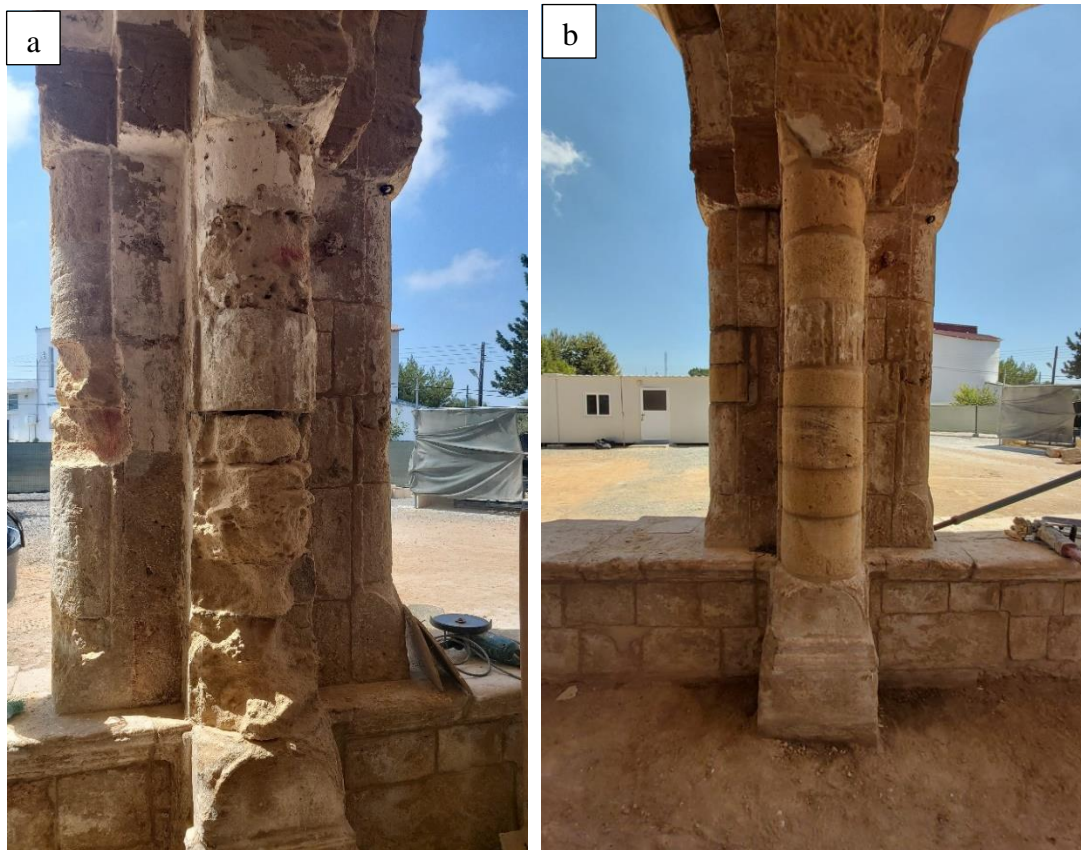
Figure 2.23: a) Initial condition of column drum 2 b) Final condition

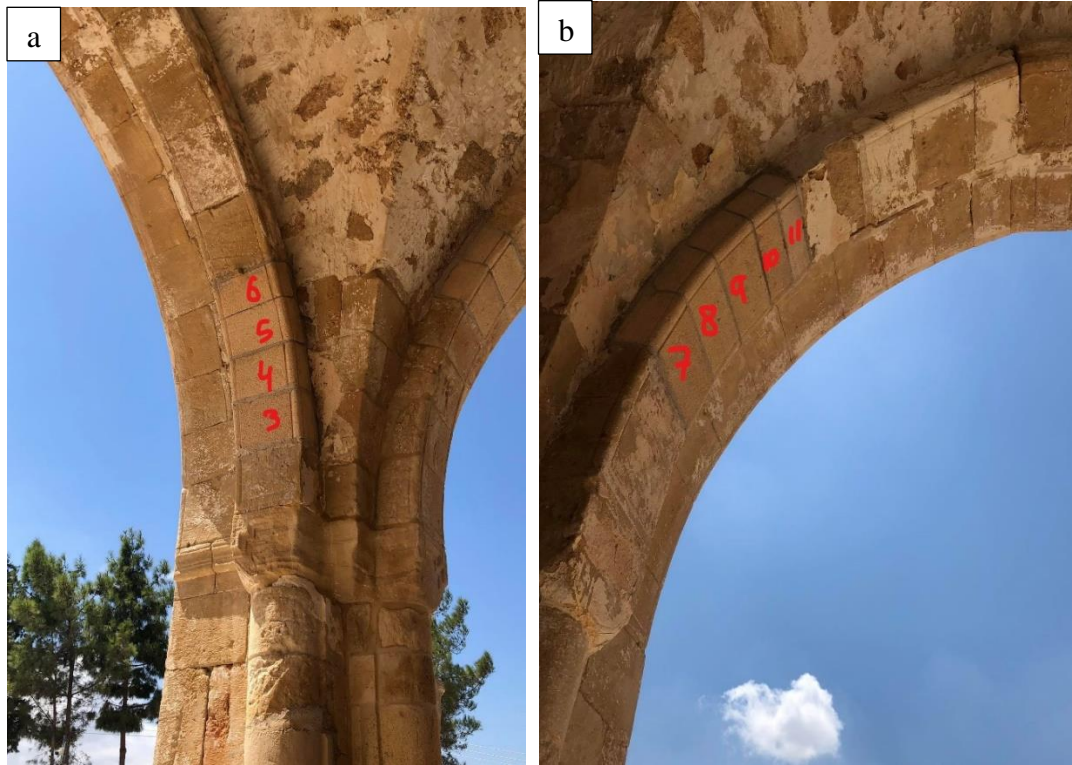
Figure 2.24: a) Replaced arch stones 1 b) Replaced arch stones 2

Broken (cracked) or heavily weathered stones (mainly dressed stones) replaced in several positions. New stones had to be similar characteristics as the stone to be replaced (colour, texture, hardness, size etc.)

- Existing arch stones from south porch arches were removed, then area was cleaned and new ones added, including lime mortar and small stones to fill gaps and voids (see Figure 2.24).

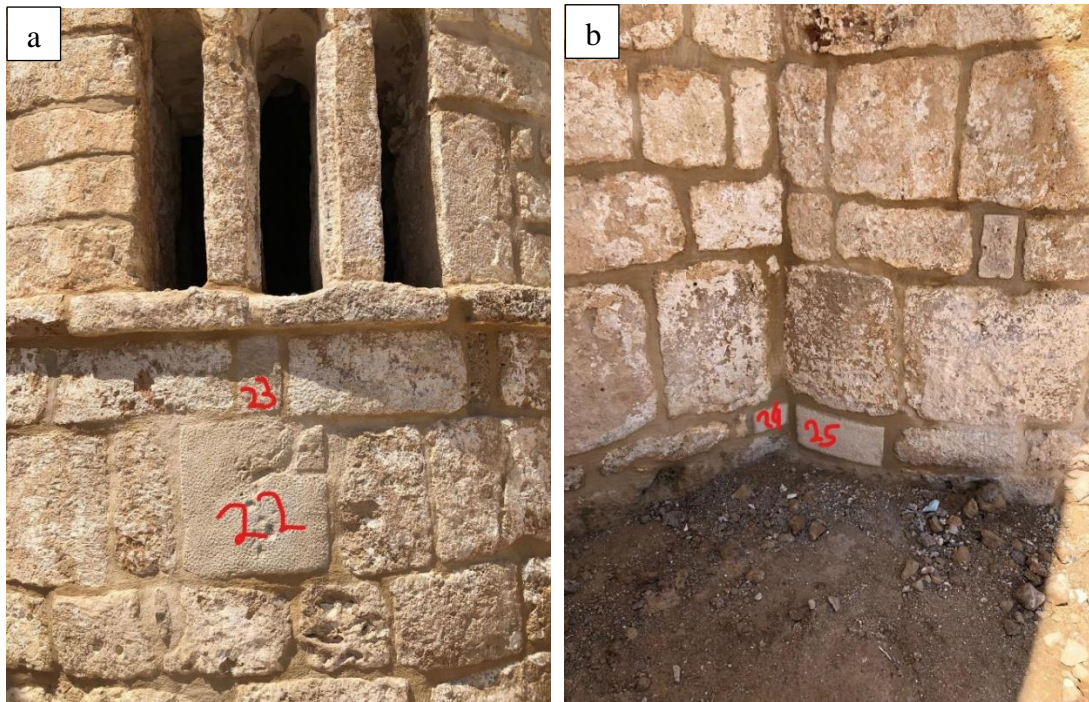
Figure 2.25: a) Replaced simple rectangular stones 1 b) Replaced simple rectangular stones 2

- Existing simple rectangular stones from several locations and different sizes were removed, then area was cleaned and new ones added, including lime mortar and small stones to fill gaps and voids (see Figure 2.25).

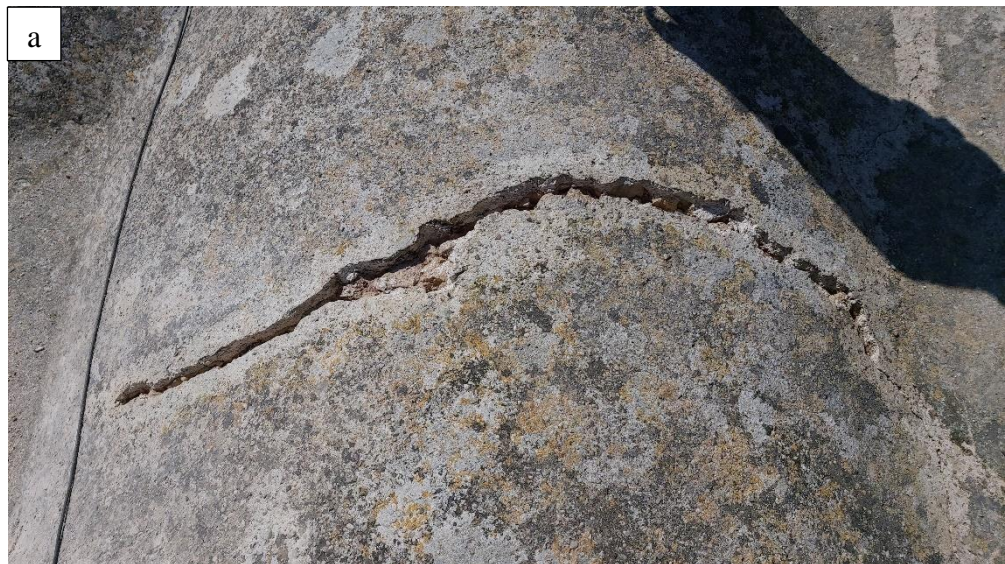
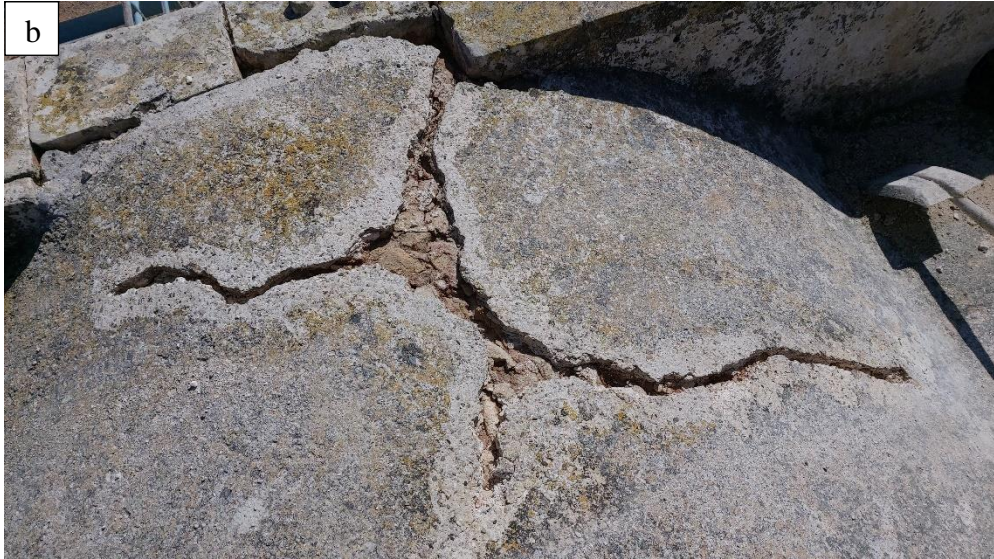
Figure 2.32: a) Removed lime mortar up to a depth of 15 cm 1 b) Removed mortar up to depth of 15 cm 2

The roof of the church was entirely covered by the traditional "lime-mortar" material. In certain areas the material was presenting surface failure and/or cracks.

- Lime mortar material were removed from defected areas up to depth minimum 15cm. Cleaned with water and soft brushes (see Figure 2.32).

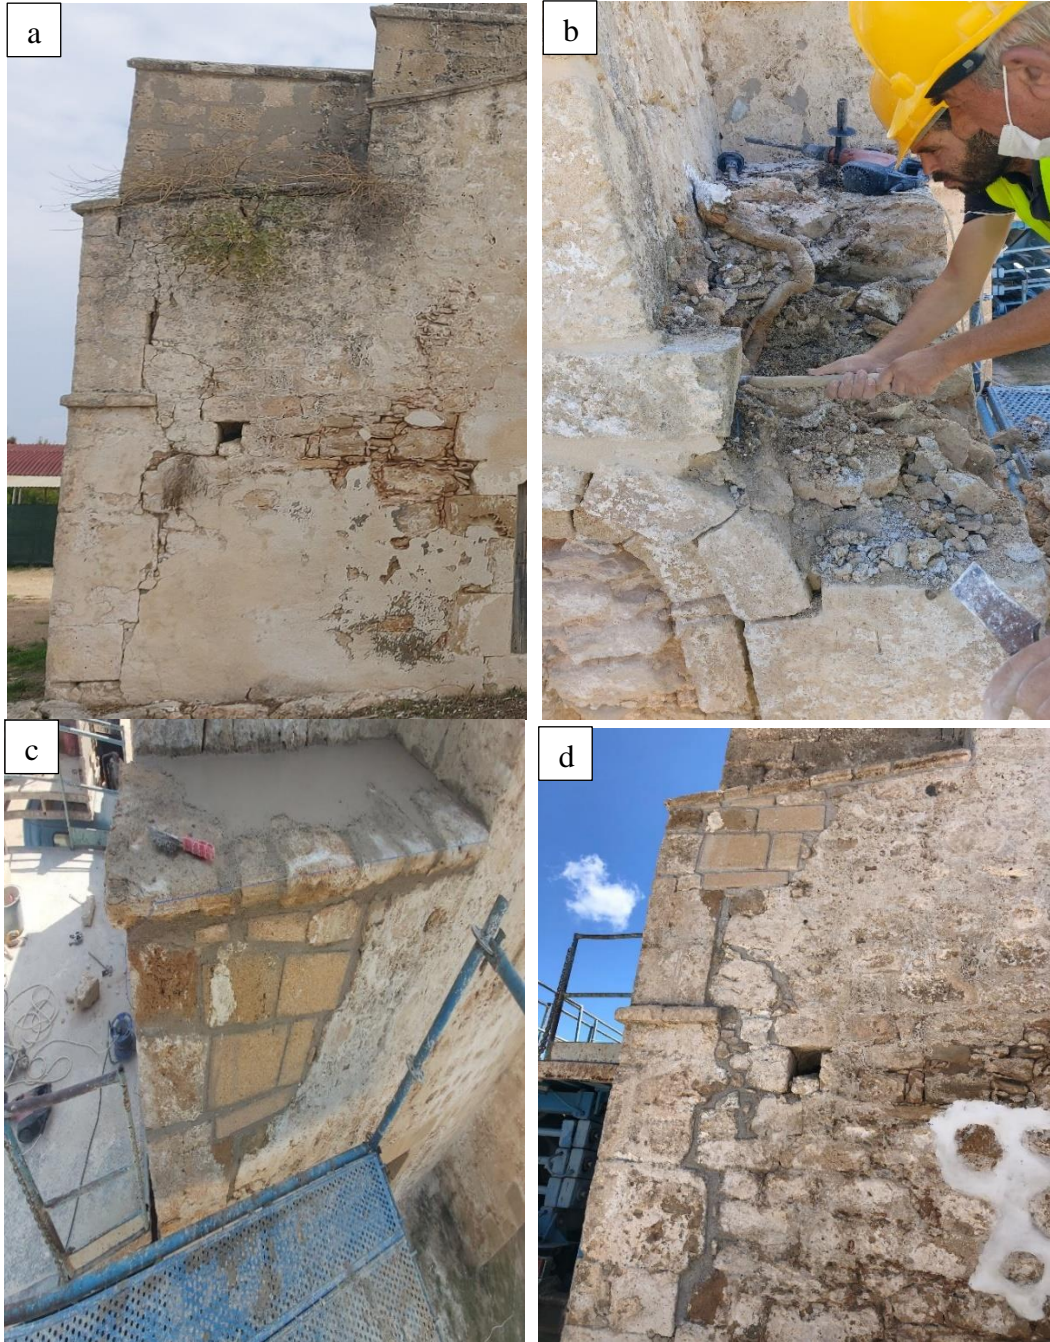
Figure 2.33: a) Dismantling and rebuilding of seriously damaged part stage 1 b) Stage 2 c) Stage 3 d) Stage 4

- Seriously damaged stone build areas totally dismantled and rebuilt (see Figure 2.33).

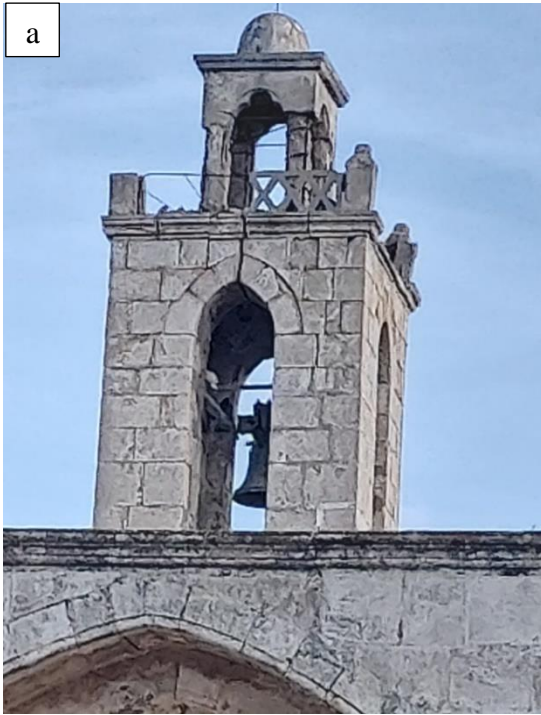
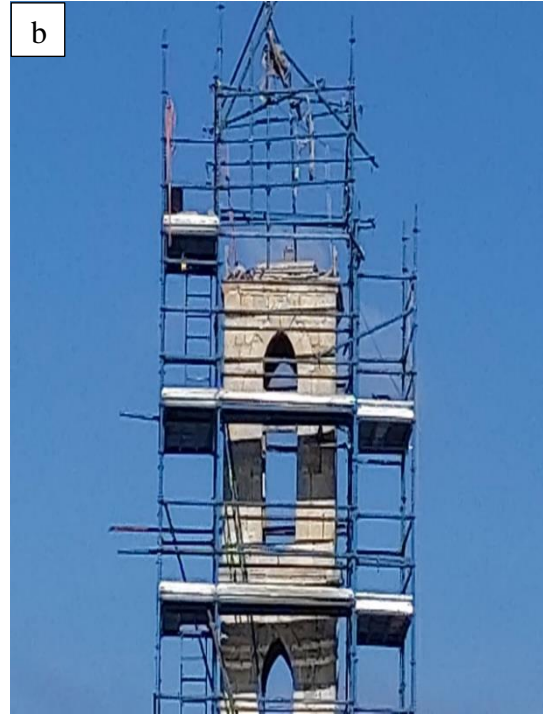
Figure 2.35: a) Initial condition b) Dismantling of upper part of belfry

Upper part of belfry from row 19th to 23rd (the top small cupola with four columns, the stone/cement rail with four corner posts, the cornice and five row of stones) dismantled and rebuilt. Then cracked cornice stones at row 23rd were removed and new ones added in same style and dimensions (see Figure 2.35 and 2.36).

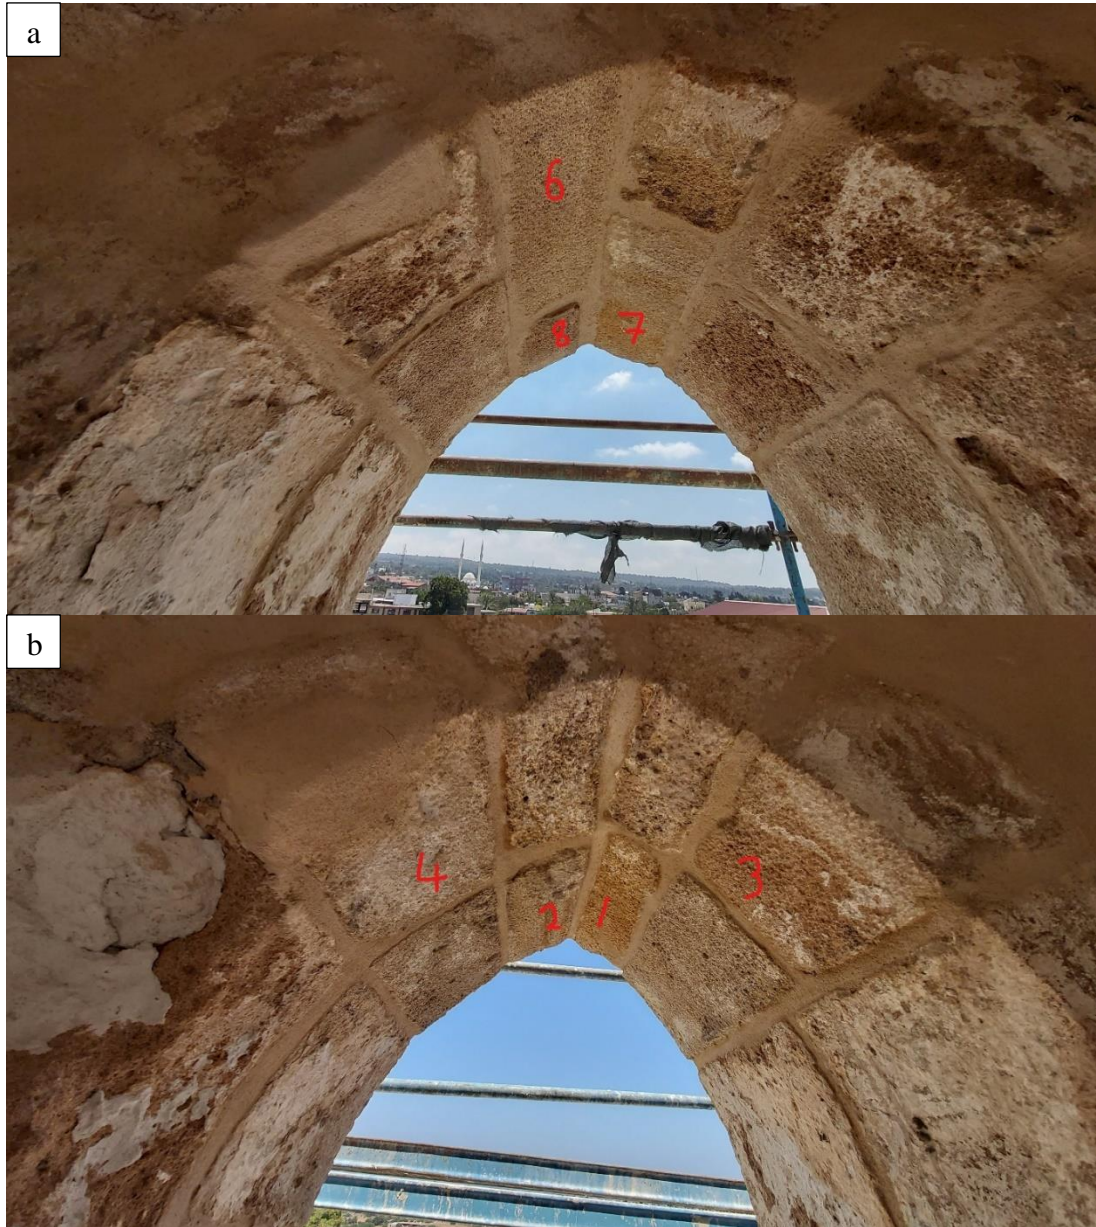
Figure 2.39: a) Replaced cracked stones 1 b) Replaced cracked stones 2

- Cracked stones were removed and replaced with new ones on different locations (see Figure 2.39).

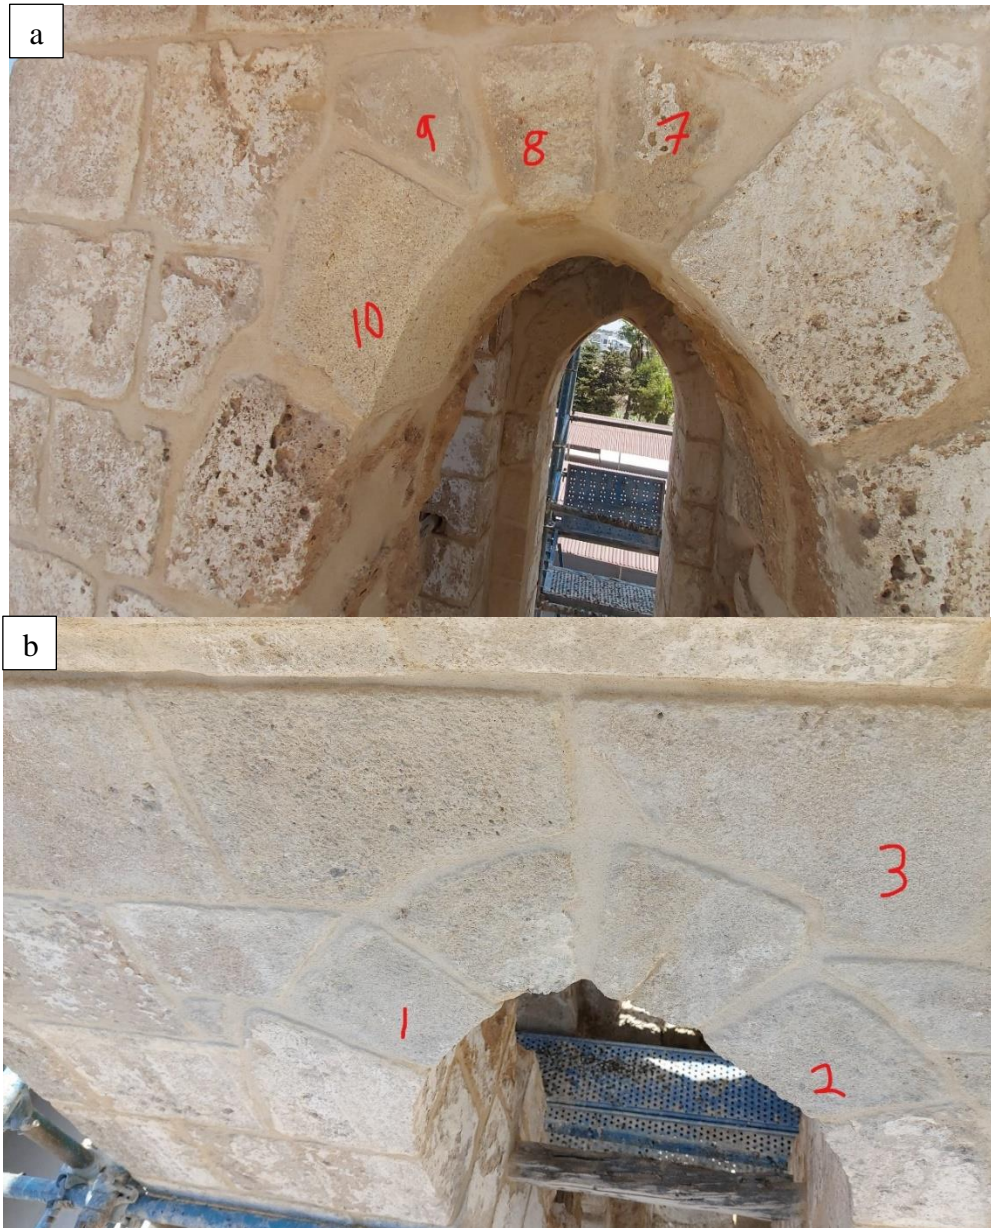
Figure 2.40: a) Replaced missing stones 1 b) Replaced missing stones 2

- Missing stones replaced at different locations (see Figure 2.40)

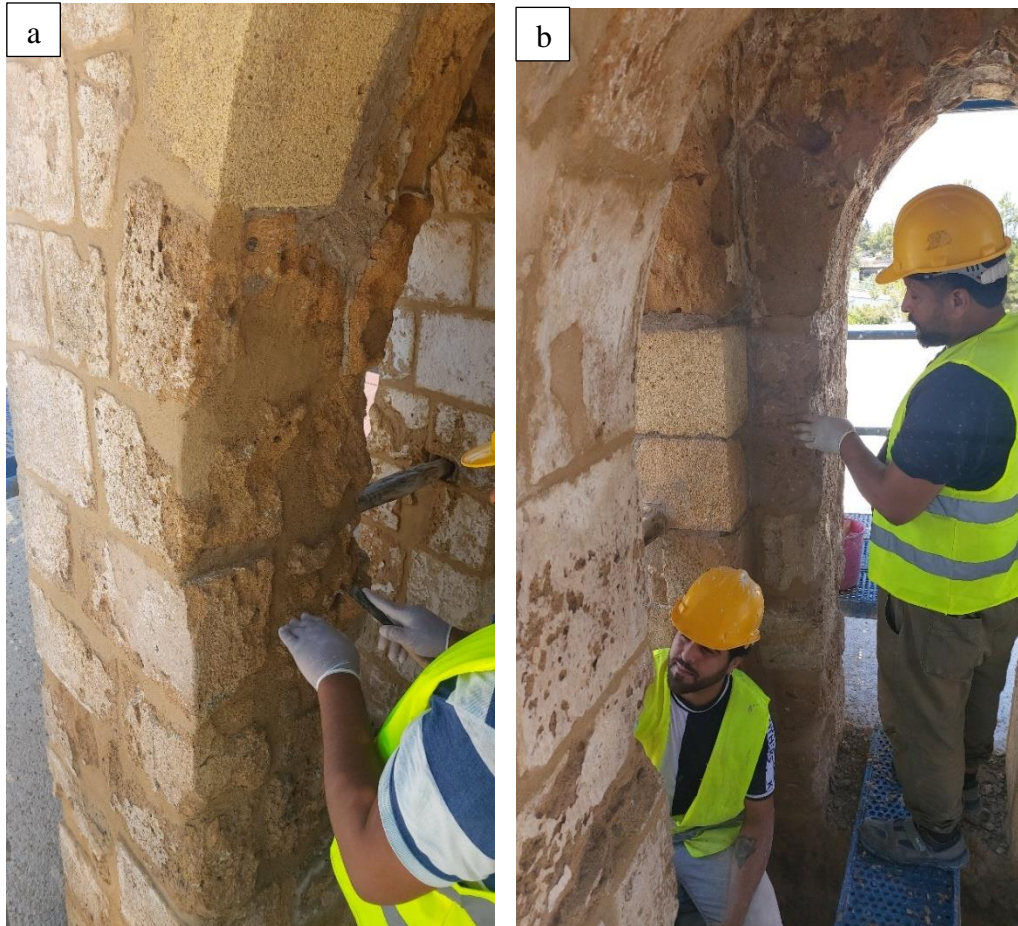
Figure 2.41: a) Repairing internal sides of columns 1 b) Replacing of internal sides of columns 2

- Rotten wooden ties rods were removed and replaced into belfry columns in three different levels (row 4th, 11th, 20th).
- Internal sides of columns were repaired (from row 2nd to 18th) (see Figure 2.41).

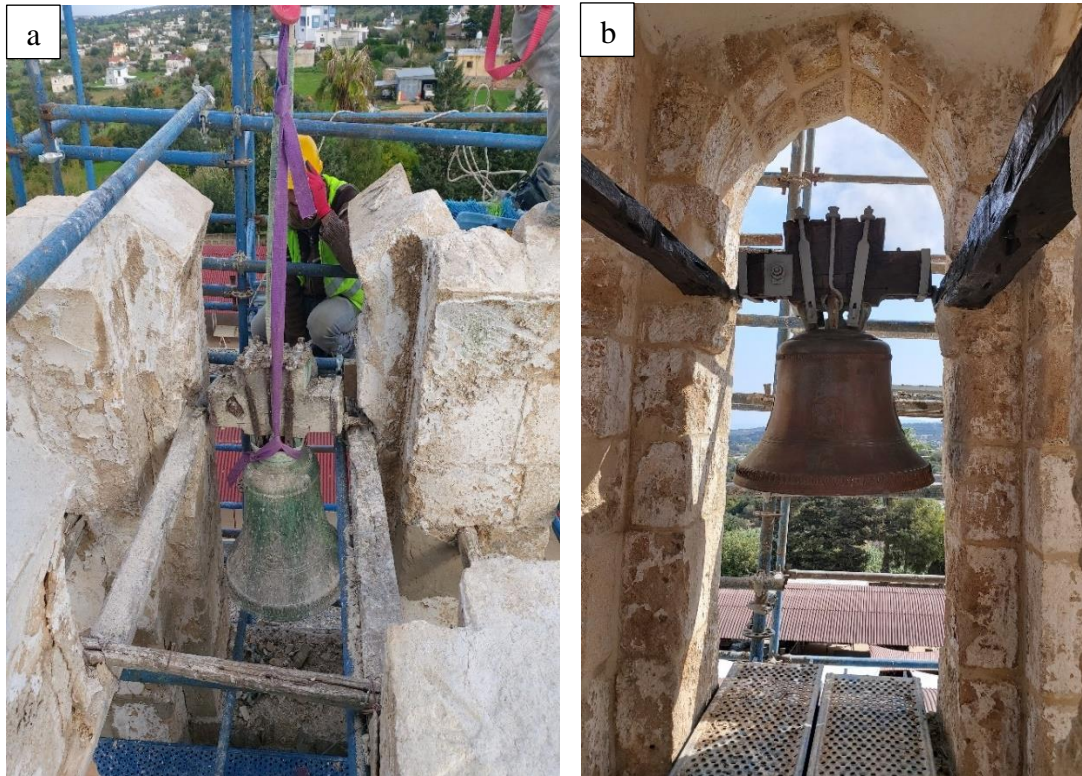
Figure 2.43: a) Initial condition of bell b) Bell and its' mechanism were removed and repaired

- Bell and its' mechanism were removed, repaired and placed back in order to function properly (see Figure 2.43).

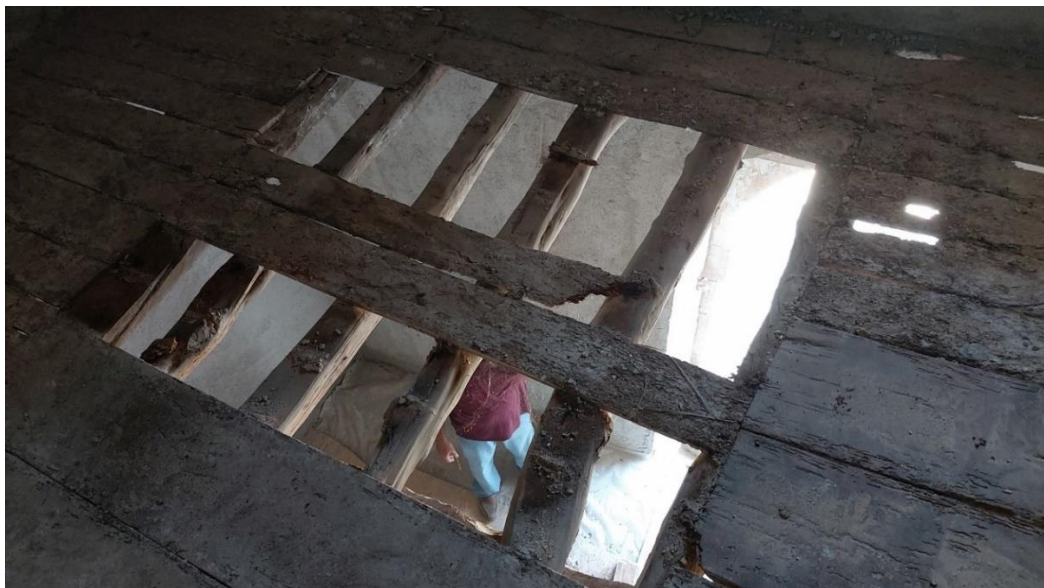
Figure 2.47: Damaged elements

- Wooden structure (planking and beams) was checked and damaged elements were removed and replaced (see Figure 2.47, 2.48, 2.49 and 2.50).

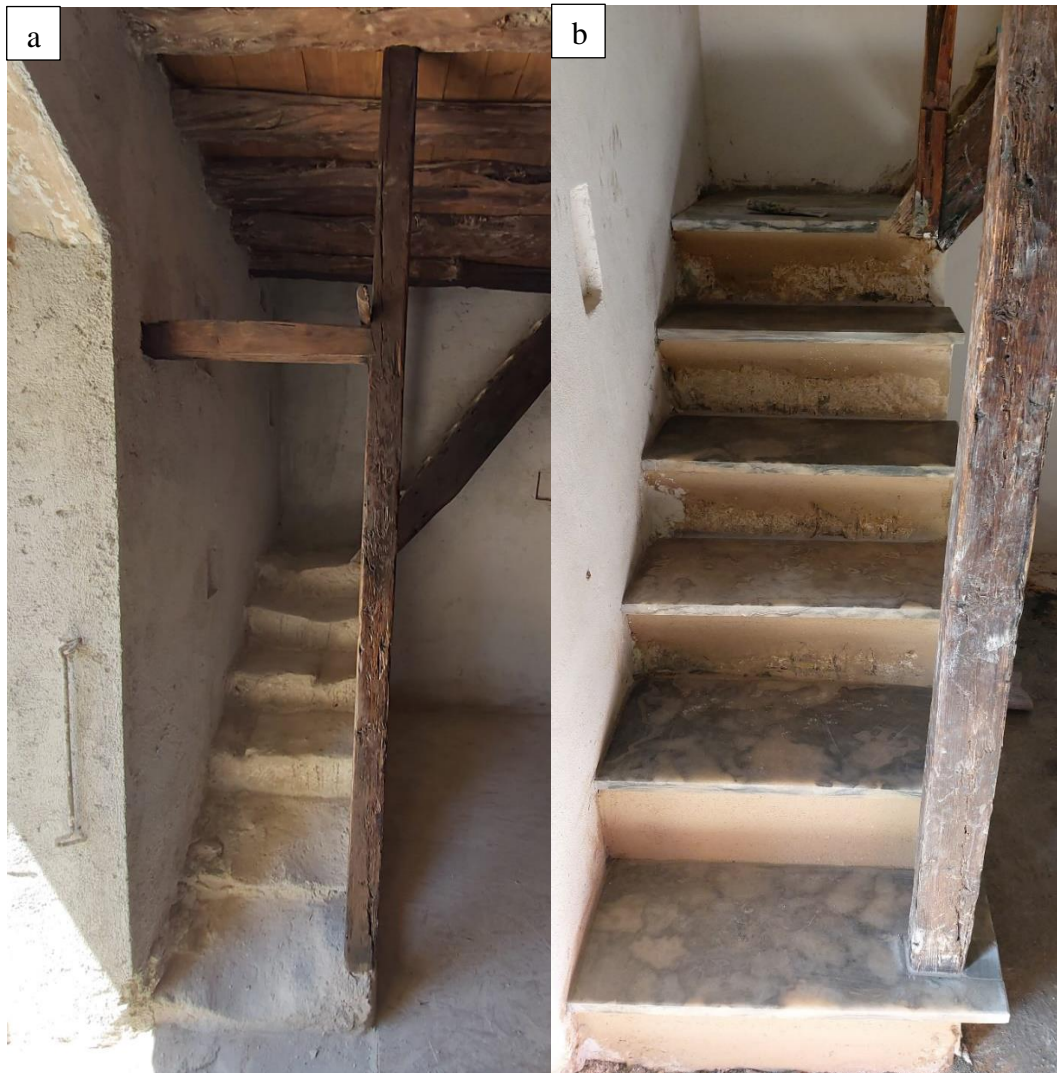
Figure 2.52: a) Initial condition of stairs b) Final condition of stairs

- Stairs were cleaned and repaired (see Figure 2.52).
