**Adaptive Re-Use Potentials of Post Office Buildings  
as Examples of British Colonial Heritage in Nigeria  
and North Cyprus**

Master of Science  
in  
Interior Architecture

Eastern Mediterranean University  
March 2015  
Gazimağusa, North Cyprus

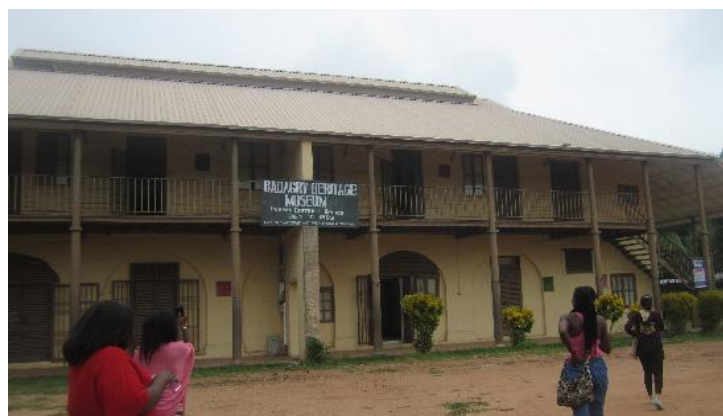
Figure 3.11: Colonial Museum Building at Badagry Lagos, Nigeria. (URL 10)

Figure 3.11 shows a British Colonial type Museum building built at Badagry area of Lagos, Nigeria. As seen from the photograph, the historic building is still in good condition. The wooden floor material from the Colonial Period is still in place till

present which shows the durability of building materials from historic times. The Museum was established by the Colonials at Badagry Lagos, Nigeria to preserve relics and artefacts from Colonial times. Badagry being the center of Colonial activities had lots of relics from the Colonial Period.

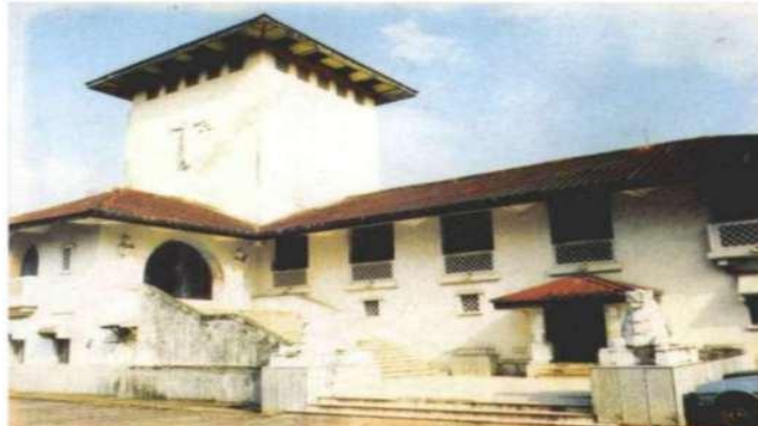
Figure 3.12: Old Colonial High Court Building Race Lagos Island. (URL 11)

Figure 3.12 shows the photograph of an old Colonial Court building at Race area in Lagos state Nigeria. The building is still in use till present as a Court building. From the photograph, though the building is seen to be in a state of disrepair and seeking urgent intervention, it is still strong structurally as other Colonial buildings built during its period. As a result of the lawlessness witnessed in the society and due to the need to prosecute slave trade traffickers who still engaged in the act after the abolition of slave trade, the British Colonials deemed it necessary to establish the Law Court buildings in Nigeria.

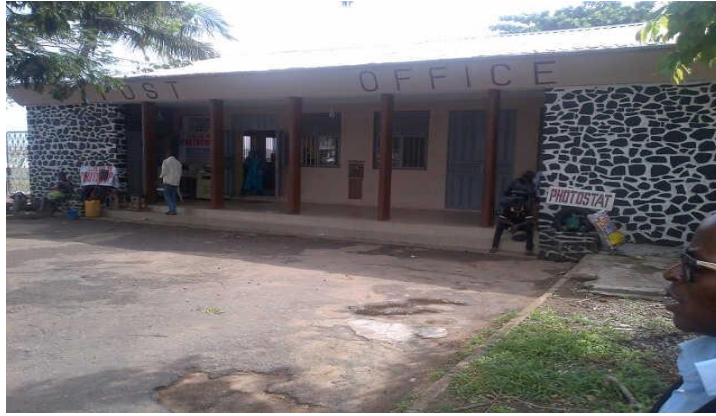
Figure 3.13: Agodi Post Office Ibadan, Nigeria. (Author, 2014)

Figure 3.13 Shows a Post Office building from Colonial time. As seen from the photograph, the stone walls from the Colonial time are still intact and in good condition. The need to establish a Post Office building in Nigeria by the British was as a result of the need to pass information from Nigeria back to Britain. The Colonials back in Nigeria needed to communicate with their superiors in Britain, so the Post Office buildings were established to serve as branches of the Post Offices in Britain.

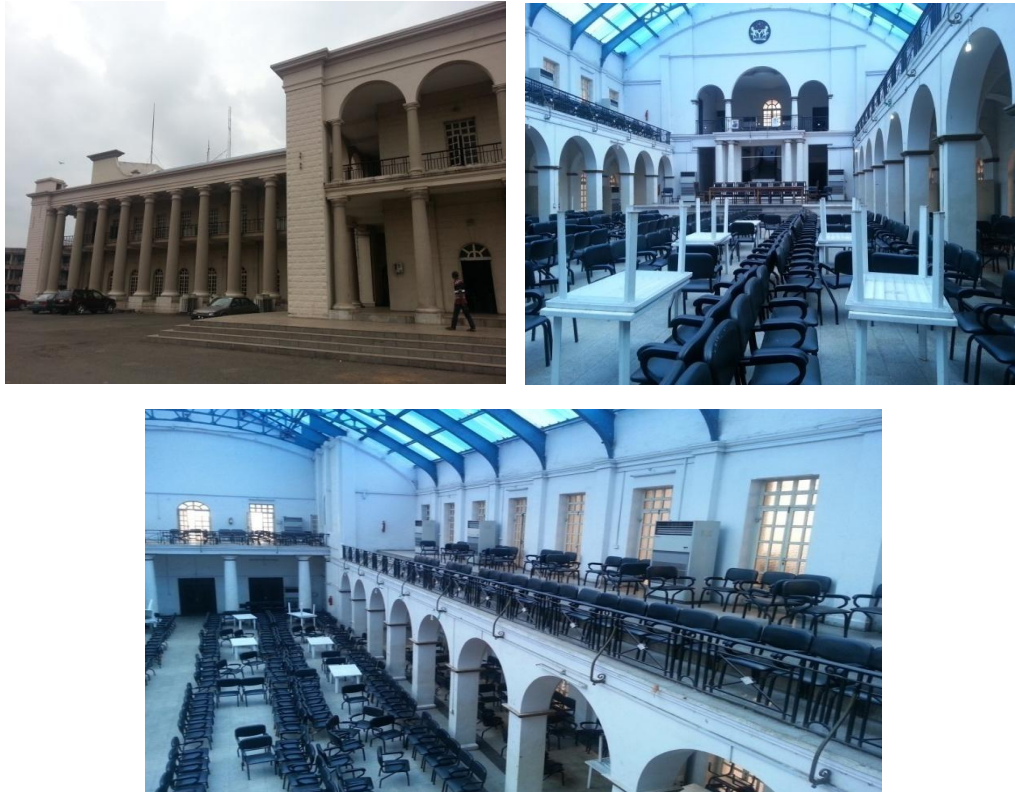
Figure 3.14: Colonial Hall Mapo Ibadan, Nigeria. (Author, 2014)

Figure 3.14 shows a Colonial era style City Hall in Mapo area of Ibadan Nigeria, as seen from the photographs the exterior and interior of the building shows evidence of British Colonial architecture. The building went through some rehabilitation works in the year 2007 after it was constructed in 1929. The building is seen to still stand strong. According to Mr. Kaseem an employee in the City Hall, the need for constructing a City Hall by the Colonials was as a result of the necessity to hold meetings with traditional rulers and members of the community. The Hall was used as a meeting point, were the people and the Colonial masters met to discuss on the growth and benefits of the society.

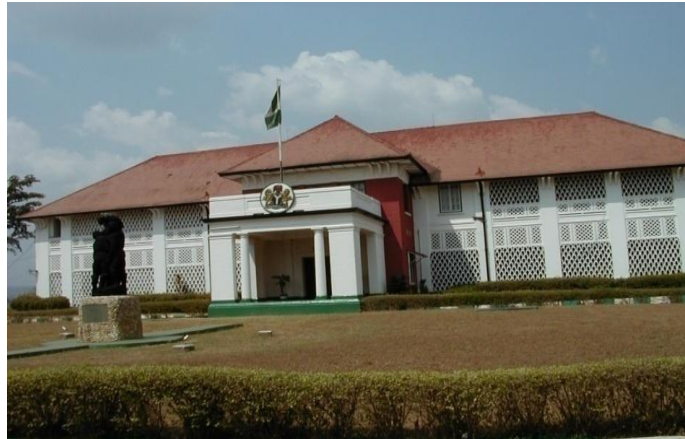
Figure 3.15: Government House Building Enugu, Nigeria. (URL12)

Figure 3.15 shows a Colonial government house building constructed at Enugu state in Eastern Nigeria. From the photograph, it is seen that the building is still in good condition and still possess its Colonial character.

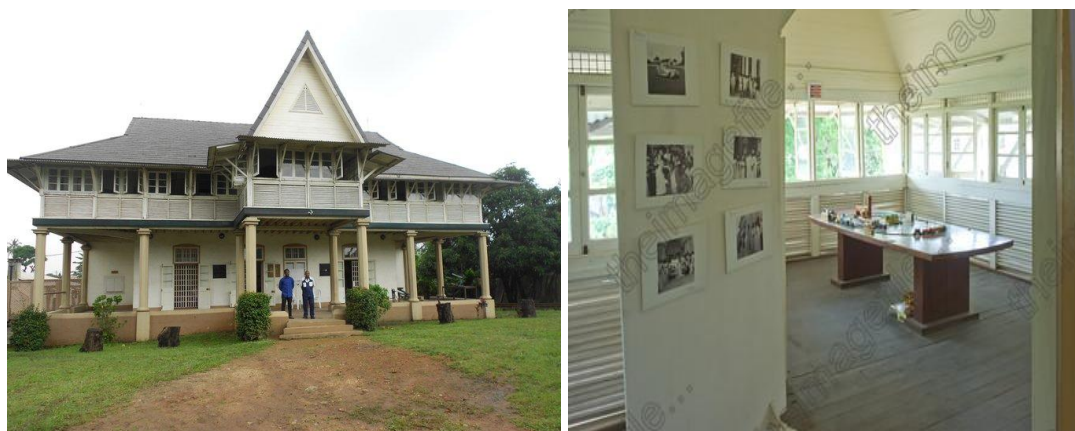
Figure 3.16: Approach and interior of Jakeal House at Lagos, Nigeria. (URL 13)

Figure 3.16 shows a residential Jakeal house Colonial building at Lagos, Nigeria. A residential building constructed for British railway workers during the Colonial period. The structure has undergone a restoration work but as seen from the photograph, all elements are as they were from Colonial times. Changes to the historic building are seen to be minimal. The building is presently used as a railway Museum.

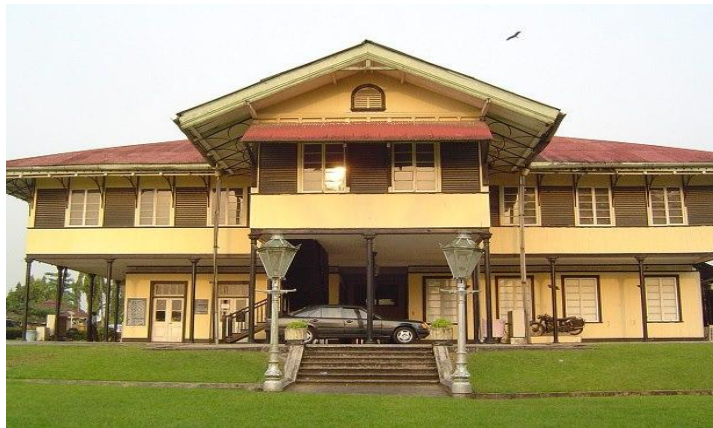
Figure 3.17: Colonial Residential Building at Calabar, Nigeria. (URL 14)

Figure 3.17 shows a typical residential building built by the Colonials at Enugu Eastern Nigeria. As seen from the photograph, the building is still in place and the upper floor raised on wooden pillars, a familiar technique of construction during the Colonial Period.

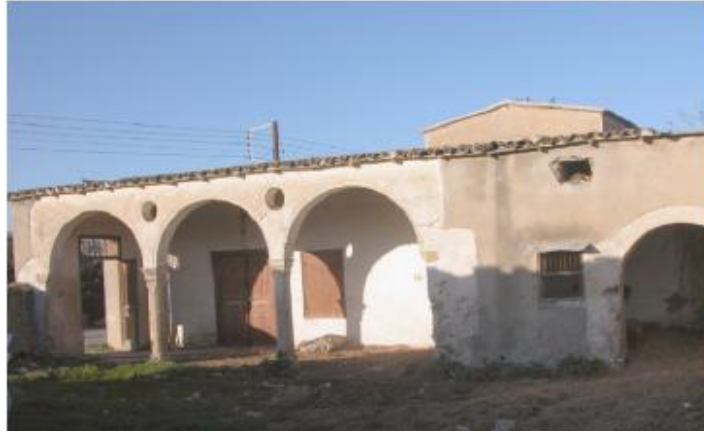
Figure 3.21: The unique traditional arcaded house of North Cyprus.  
(Dincyurek et al., 2006)

Fig 3.21 shows a unique traditional house type of North Cyprus. As seen from the photograph, the arcs are a common feature found in traditional North Cyprus buildings.

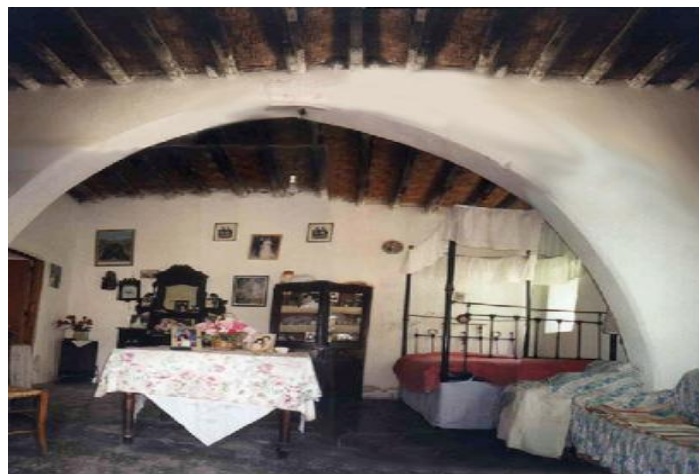
Figure 3.22: View from the interior of a traditional North Cyprus house.  
(Gunce et al., 2007)

Figure 3.22 shows a typical interior view of a traditional North Cyprus architecture, constructed using locally sourced building materials.

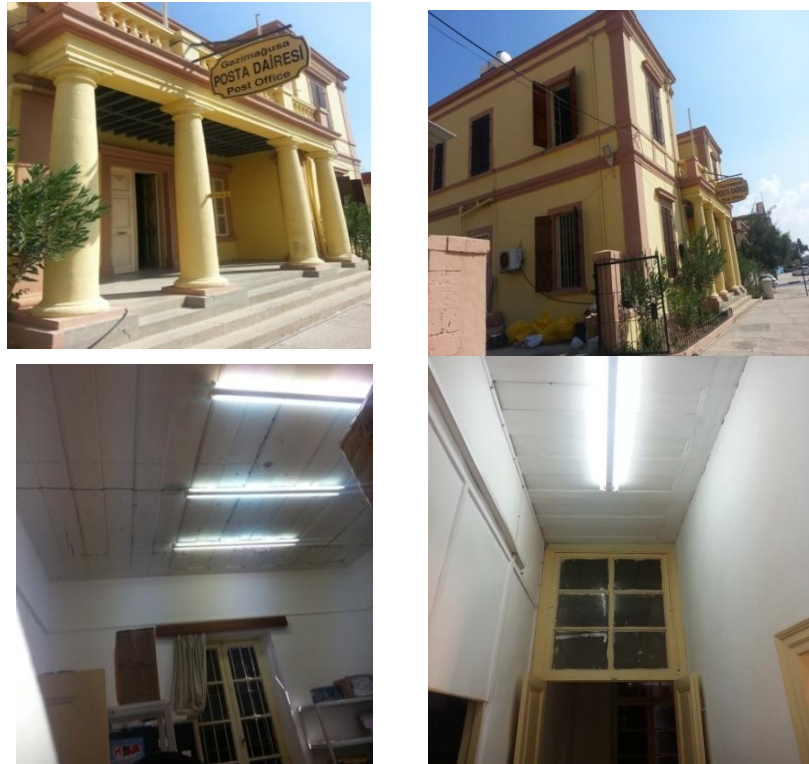
Figure 3.25: Photographs showing the Colonial Columns, Wooden Windows and ceilings from Colonial Period Post Office Famagusta, North Cyprus. (Aurthor, 2014)

Figure 3.25 above shows a Colonial Post Office building at Famagusta North Cyprus. As seen from the photographs, the character of the building from Colonial time is still in place, the upper floor was made using wood. The wooden doors and windows from Colonial time are still in good condition. The need to establish a Post Office in North Cyprus by the Colonials was however due to the need to bridge the communication gap, the Colonials working in North Cyprus needed to communicate with their fellow counterparts back in Britain.

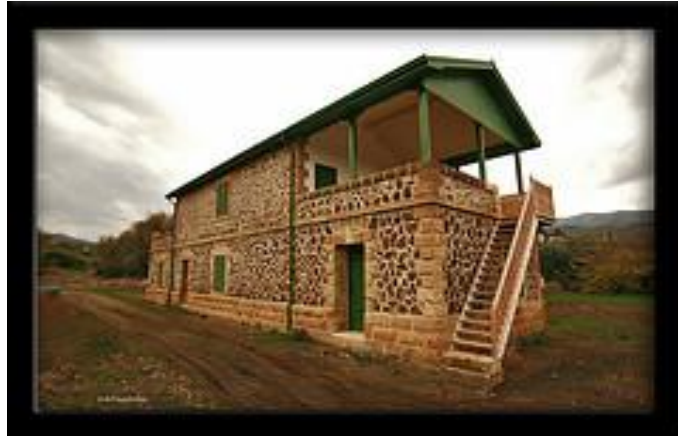
Figure 3.26: Restored Colonial railway building in Evrychou Nicosia, Cyprus. (URL 18)

Figure 3.26 Shows a Colonial era railway building in Cyprus. From the photograph, the walls are built using stones, a common phenomenon of the architecture during this period.

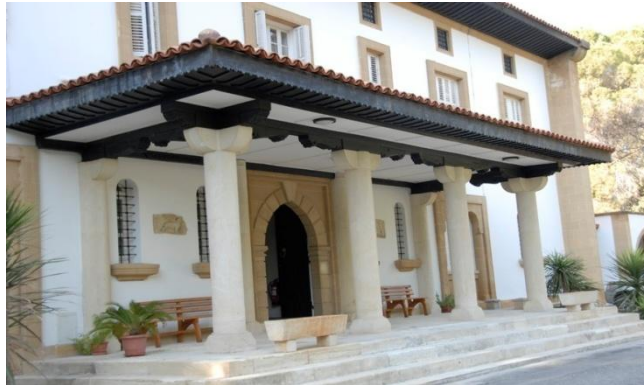
Figure 3.28: British high Commissioners Residence Nicosia, built 1933.  
(URL 20)

Figure 3.28 shows a typical residential building built by the Colonials at Nicosia Cyprus. As seen from the photograph, the building is still in place. Wood which is a major material used by the British in constructing their buildings during this period is used in this building.

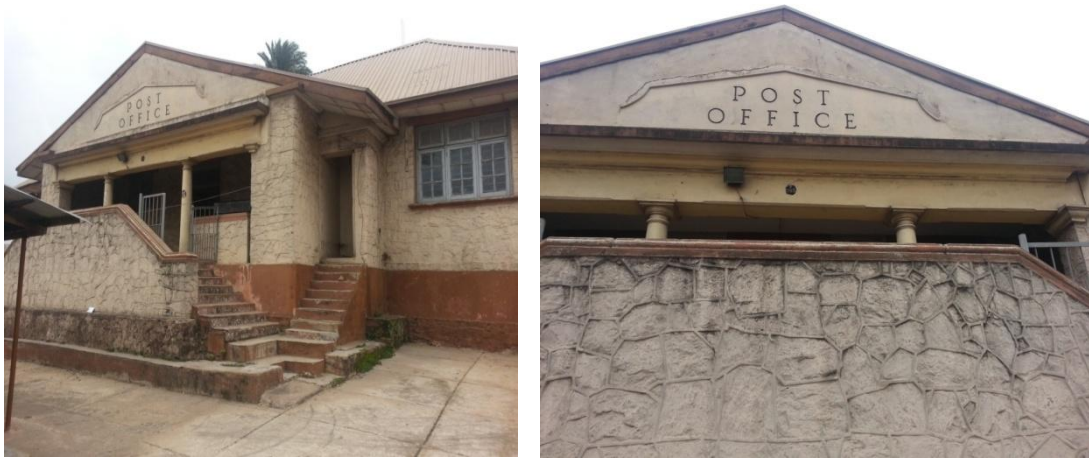
Figure 4.1: Photograph showing the approach view of Colonial Post Office Mapo, Nigeria. (Author, 2014)

The British Colonial Post Office building Mapo is the first British Colonial Post Office building in Nigeria dating back to 1898. It is situated with other buildings from historic times like the Colonial law Court building, Mapo hall and the Olu Ibadans palace (traditional ruler). Figure 4.1 shows different views from the exterior of the Colonial Post Office building at Mapo Ibadan Nigeria. From the photographs as seen, the Colonial style Post Office building possessing British Colonial style of architecture and it is still in perfect condition. Also from the photo, elements which are synonymous to Colonial style architecture are seen like the wooden windows, the column and finishing on the wall surface.

The Post Office building since its establishment in 1898, over a hundred years still stands in good condition, this is credited to the qualitative construction technique employed by the British in constructing the building. Till present, no major structural deformation is evident on the buildings frame. From the Information sourced during an interview with the Post Master reveals that no major maintenance work has been carried out on the building since it was constructed.

As seen from the photos and plan, the Colonial Post Office building in Mapo area of Ibadan Oyo state Nigeria, the wooden historic ceiling used in the interior of the building is still in good condition. The historic Post Office counter is also still standing. The historic Doric columns typical of British Colonial buildings are seen employed in the building as seen from the photos. The stone like patterns on the exterior walls to the building should be preserved even with the new use of the building. The Post Office mail boxes seen from the photos should also be conserved and retained with the new re-functioning idea of the building, as it is the most important fixture of the building which specifies the original use of the building even within the new function of the building.

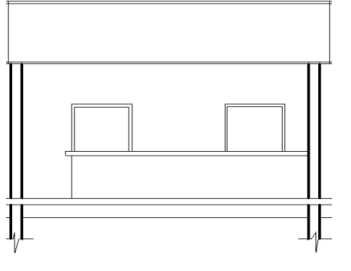
Sectional view showing the colonial Post Office counter with wooden openings

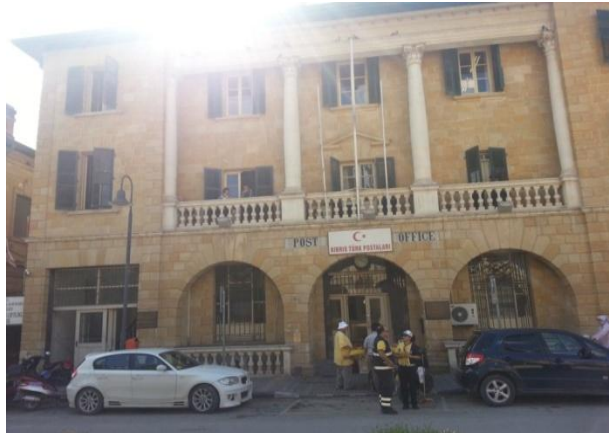
Figure 4.5: Photograph showing the approach view of Colonial Post Office building Nicosia, North Cyprus. (Author, 2014)

Figure 4.5 Shows the approach view to the Colonial Post Office building at Nicosia North Cyprus. From the photograph, the Colonial era style columns, wooden windows and Colonial style arch are seen on the Post Office building. The plans for the Post Office building were gotten from drawings taken from Ministry of *Bayindirlik ve Ulastirma Bakanligi, Planlama ve Insaat Dairesi-2002* archives and redrawn by the author in order to achieve a proper architectural analysis of the building. The plans have been used in Figure 4.6, Table 4.2, Table 4.3, Table 4.4 and Table 4.5 respectively.

The space organisation on the different levels of the Post Office building is done providing adequate circulation space for different activities on different floors (Figure 4.6). The size of openings in the building are seen to vary from room to room, depending on the requirement. Inspection of the building shows the building to be in good condition structurally with no deformation or cracks witnessed. The openings are made using wood which is a typical material used during the British Colonial period. The Post Office building has an hipped roof and is covered with french style terra cotta roofing tiles. The columns on the buildings facade are the Corinthian type Columns as seen from Figure 4.5 and Figure 4.8.

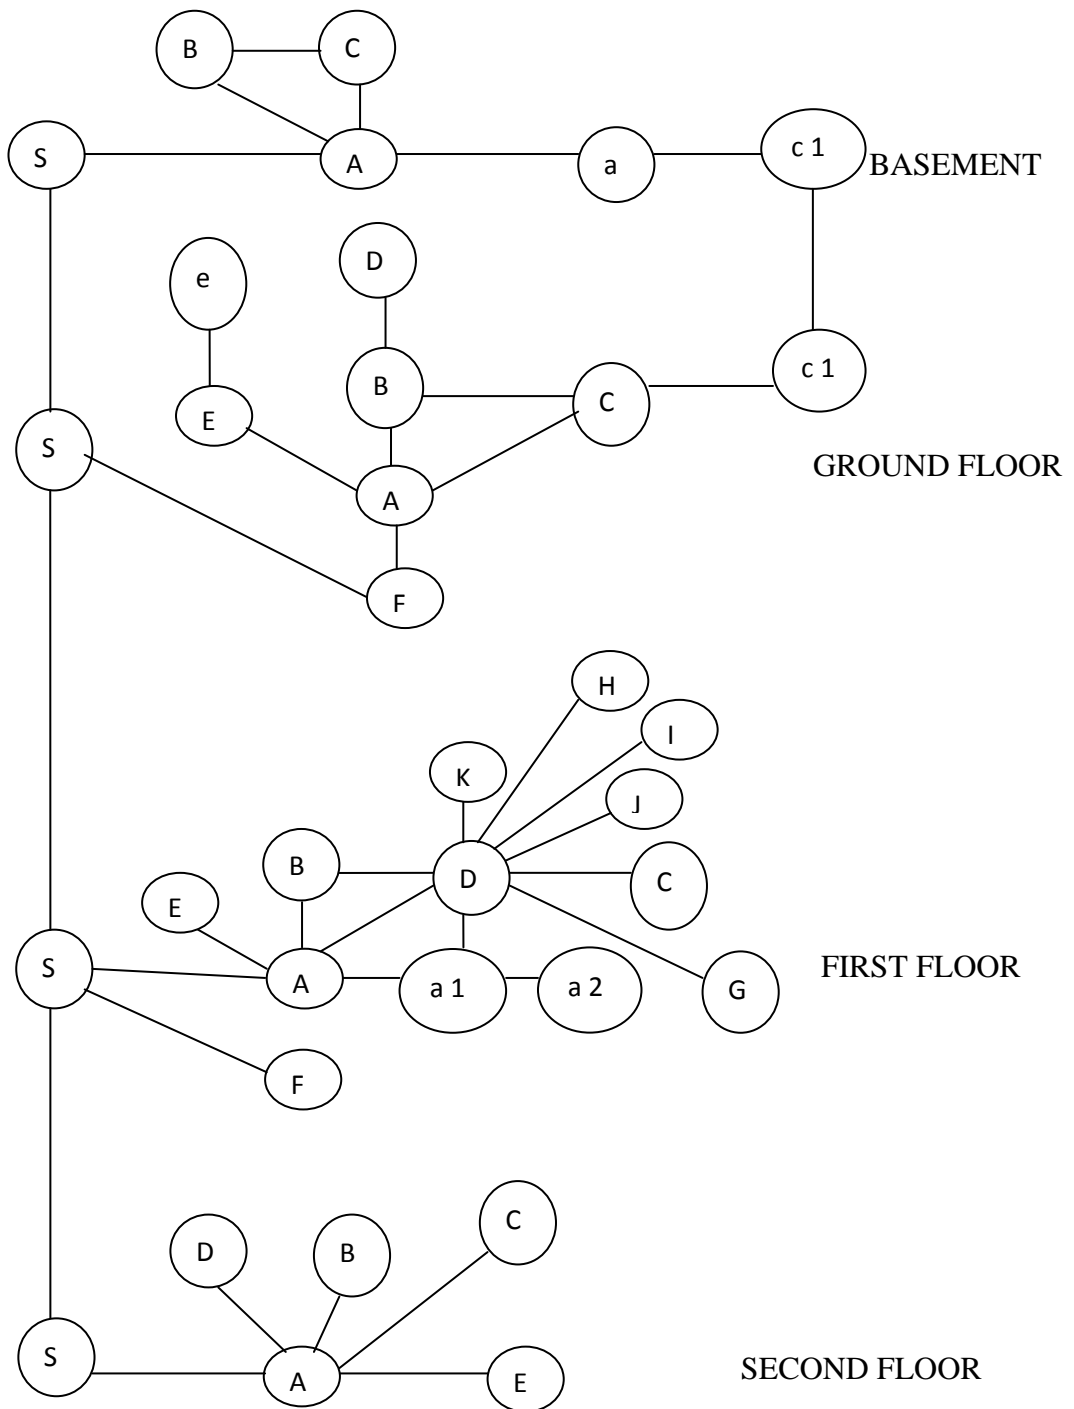
Bubble diagram showing the connectivity diagram within the indoor spaces of the Colonial Post Office building Nicosia, North Cyprus.

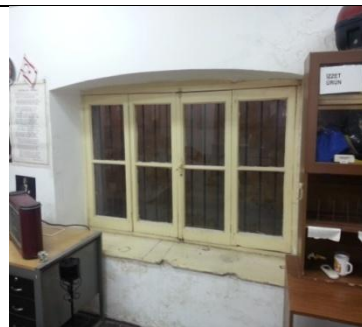
Colonial window from basement of Post Office building

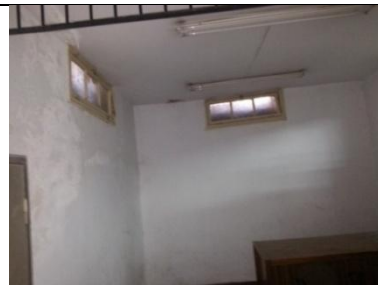
High level windows used in the basement floor of the Colonial Post Office Nicosia

As seen from the Photographs, different views from the basement floor of the Colonial Post Office building. The original openings (doors and windows) are still present. Also the original wooden floor is still in place within the basement floor. The past lifestyle is still felt within this space due to the presence of all these historic fixtures within the basement floor. The historic spiral stair which leads to the basement from the ground floor is still in place and in good condition as seen from the photographs. The skylight fixed on the roof to the basement floor from the ground floor helps allow light into the basement thus helping in illuminating the basement.

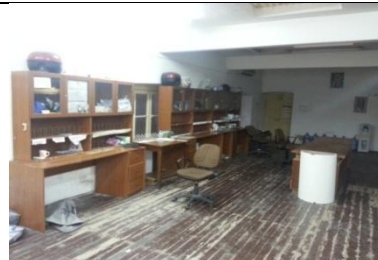
Photo showing wooden floor in basement

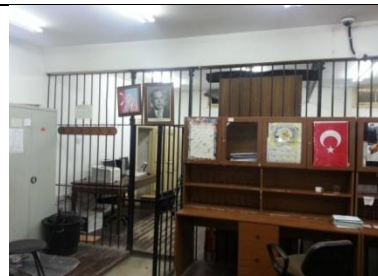
Iron bars used to demarcate a section of the basement floor

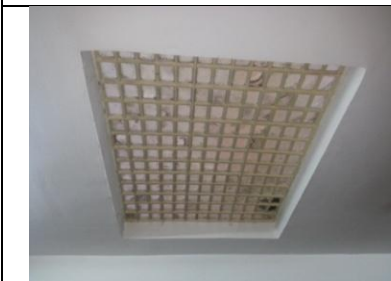
Skylight from basement floor to illuminate the basement

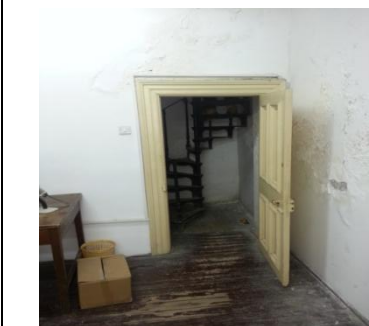
Door leading to the ground floor from the basement floor through the spiral stair case

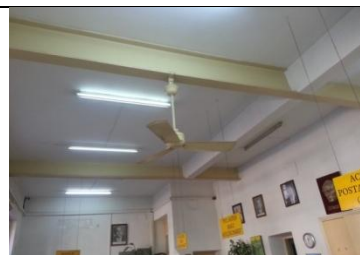
View showing the wooden upper floor been supported by beams

The wooden historic main entrance to the building as seen from the photographs which is still in good condition should be preserved. The iron beams and columns used to support the upper wooden floor are seen clearly from the sorting room area and the ceiling to the main Colonial Post Office hall Nicosia.

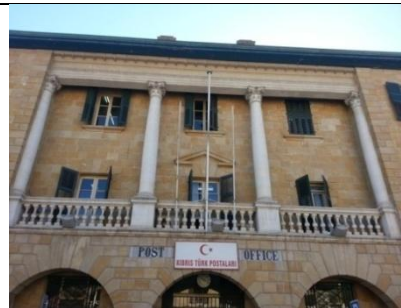
Photo showing Tuscan columns synonymous to British Colonial Period.

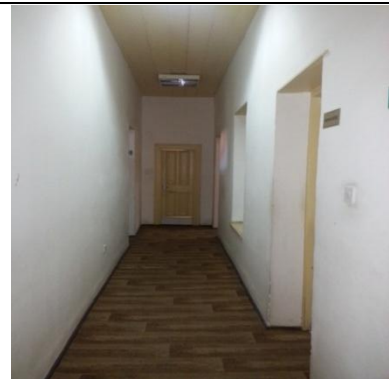
View showing the interior of first floor with carpet used to cover the original wooden floor

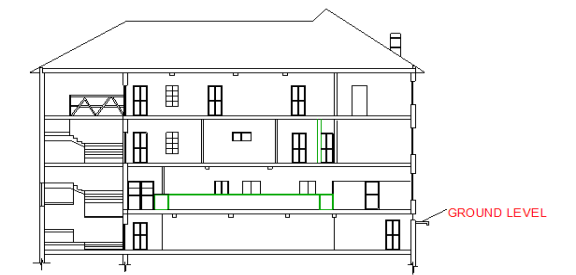
**SECTION Z-Z**

SECTIONAL VIEW OF COLONIAL POST OFFICE NICOSIA SHOWING BASEMENT GROUND, FIRST AND SECOND FLOORS

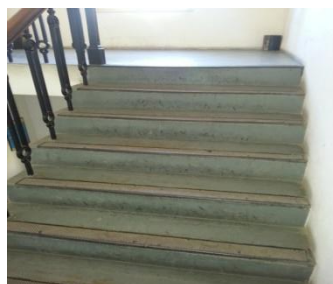
Cemented stair case area leading to the second floor from first floor

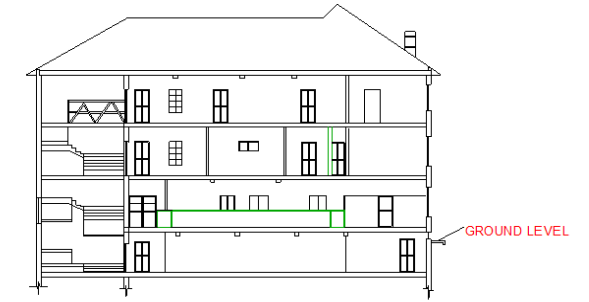
**SECTION Z-Z**

SECTIONAL VIEW OF COLONIAL POST OFFICE NICOSIA SHOWING BASEMENT GROUND, FIRST AND SECOND FLOORS

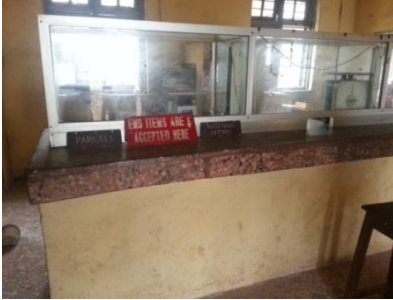
<p>The Counter in the main postal hall of the Post Office should be retained in the re-functioning process so as to show the traits of the building being a Post Office building.</p>
Historic columns

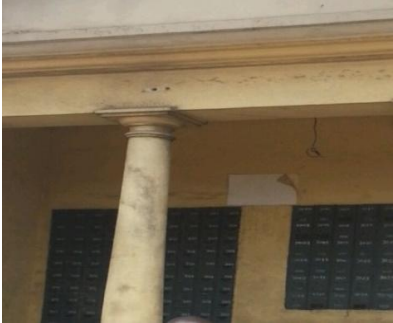
<p>The Tuscan type Colonial columns found in the building should as much as possible be preserved, this is because these columns serve as a symbol of the British myth during the Colonial Periods.</p>
Historic Wooden Ceiling

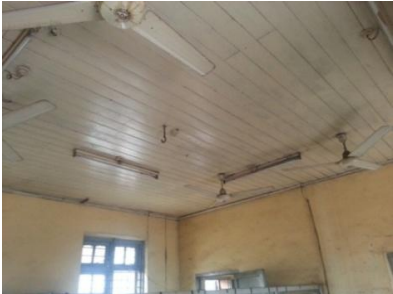
<p>The Colonial wooden ceilings should not be replaced, they should be retained even with the buildings new function so as to show traits of the past.</p>
Historic Post Office mail boxes

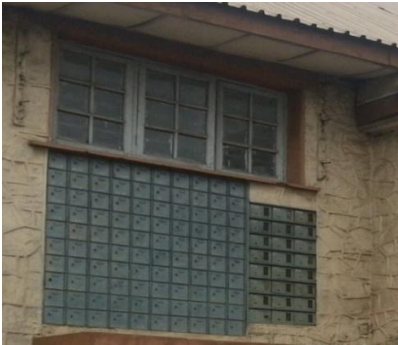
<p>The historic Post Office mail boxes should be preserved and kept even with the new function of the building, these give the building a feeling of its original use even with the new function.</p>

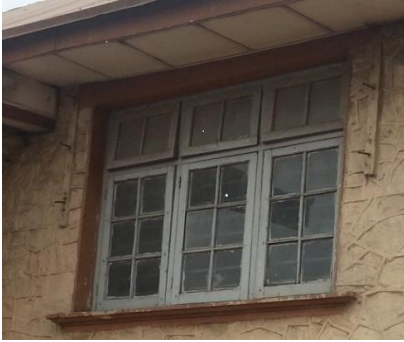
<p>The historic Colonial style wooden windows present in the Post Office building should not be replaced, they should be maintained even with the buildings new use. We need arises for maintenance of the windows, it should be done with outmost care.</p>
<p>Walls</p>

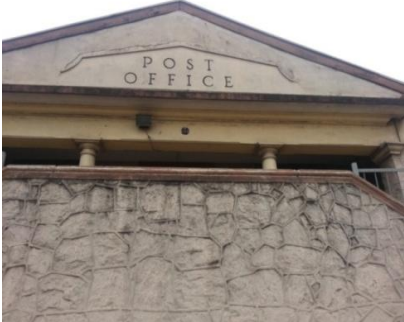
<p>The wall patterns on the exterior of the Post Office building should not be altered. They should be maintained so as to give the building the historic sense. Also, the inscription written on the buildings face should be preserved even within the buildings new use.</p>

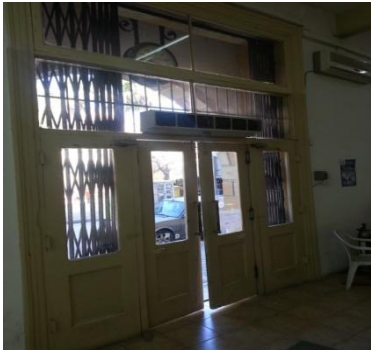
<p>The historic wooden doors found at the buildings entrance and within the interior spaces of the Post Office Building should be maintained even with the buildings new function.</p>
<p>Historic Columns</p>

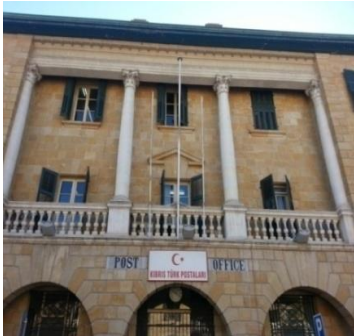
<p>The Corinthian type Colonial columns with classical cornices found in the Post Office building should as much as possible be preserved, this is because these columns serve as a symbol of the British myth during the Colonial Periods in different countries of the world, North Cyprus inclusive. Also the decorations on the wall surface seen from the buildings approach should be preserved.</p>
<p>Historic Wooden Floor</p>	 	<p>The wooden floor used in the Post Office building should be maintained, routine maintenance should be carried out on the floor so as to keep it in perfect conditions. New floor material tiles, was introduced to the floor on the ground floor, though it is an entirely different material it should be preserved since its already in place.</p>

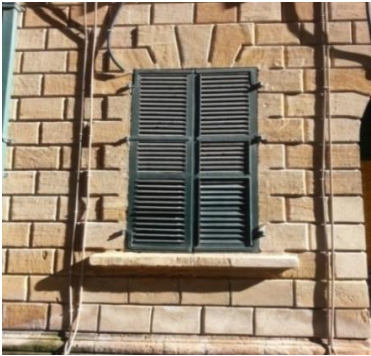
<p>The historic Colonial style wooden windows present in the Post Office building should not be replaced, they should be maintained even with the buildings new use. Were need arises for maintenance of the windows, it should be done with outmost care so as not to damage the historic fabric of the heritage building.</p>

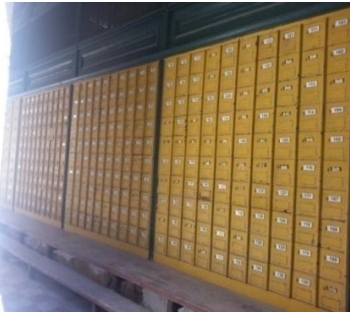
<p>The historic Post Office mail boxes should be preserved and kept even with the new function of the building, these helps gives the building a feeling of its original use of being a Post Office even with the new function.</p>
<p>Walls</p>

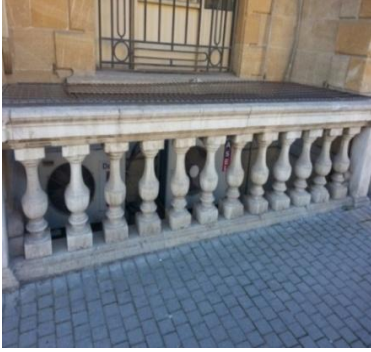
<p>The balusters in front of the Post Office, on the facade should be preserved and retained within the new use of the building.</p>

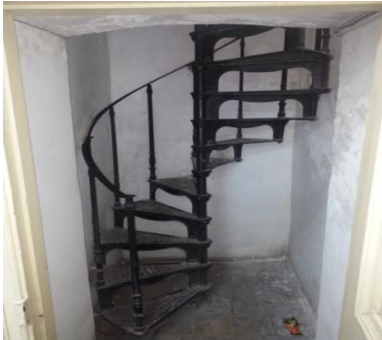
<p>Iron Spiral Stair leading to Basement Floor</p>

<p>The Spiral Stair which leads to the basement floor from the ground floor should also not be altered and the new re-functioning should accommodate.</p>

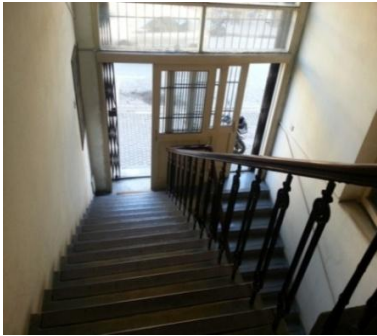
<p>Iron Stair Case</p>

<p>The historic iron stair case present in the building leading to the different floor levels should be preserved and retained within the buildings new use.</p>
<p>Post Office Counter on Ground Floor</p>

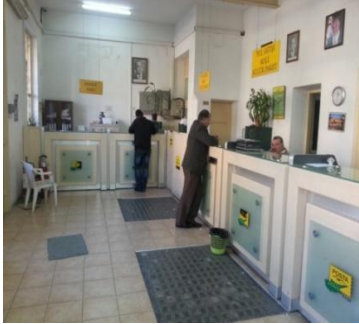
<p>The Counter in the main postal hall of the Post Office should be retained in the re-functioning process so as to show the traits of the building being a Post Office.</p>
