## ABSTRACT

The purpose of this study is to investigate lack of safety in the event of earthquake occurrence due to interior modification in the buildings during their life cycle.

**Keywords:** Earthquake Codes, Irregular Building, Interior Modification, Earthquake Architecture

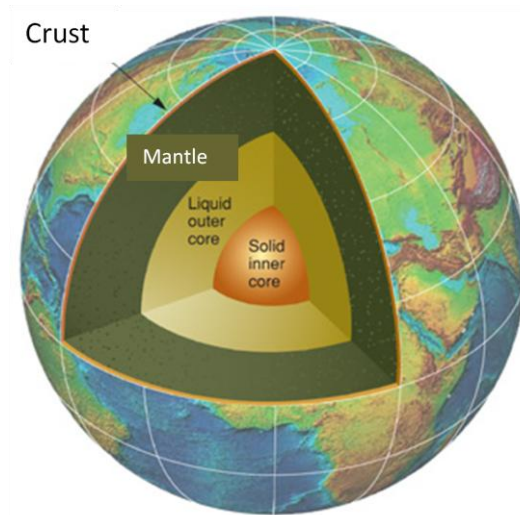
Figure 2.1. Earth Section ([www.nersc.gov](http://www.nersc.gov))

Figure 2.1 shows: the earth is composed of different parts with different proportions. These are in the order from inner part to outer part: solid inner core with thickness of (radius ~ 1290km), liquid outer core with thickness of (radius ~ 2200km), mantle, extending from a depth of about 30km below with thickness of (radius ~ 2900km) and the crust or lithosphere with thickness of (radius ~ 5 to 40 km) and, the outer rock layer of the earth with thickness of 25-65 km (Murty, 2004).

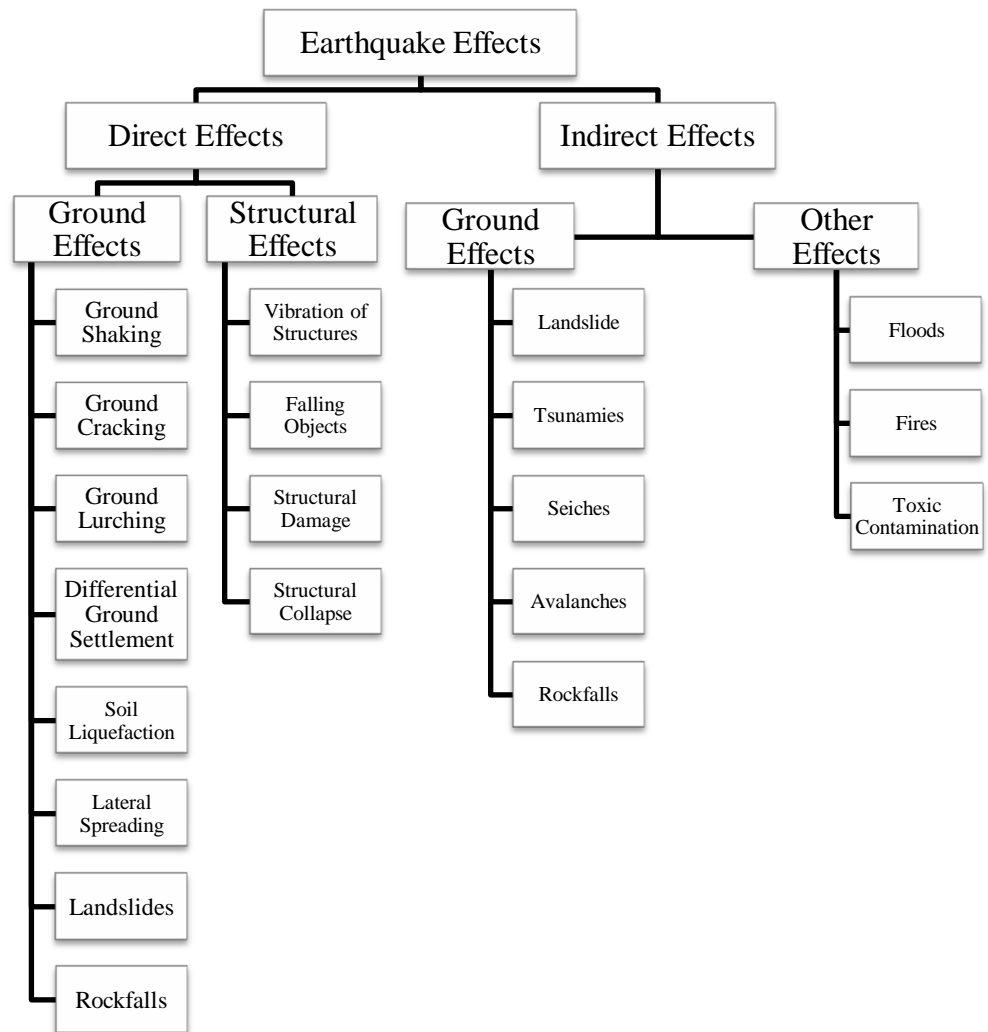
Figure 2.19. Direct and Indirect Earthquake Effects (Elnashai & Sarna, 2008)

On the other hand, the reasons for losses and degree of damage is largely contingent to the type of constructions and population density present in that region. Elnashai & Sarna, (2008) also mentioned that “Earthquakes impact a substantial toll on all aspects in the societal systems, and might impose more than a few direct or indirect effects” (Elnashai & Sarna, 2008) as shown in Figure 2.19.

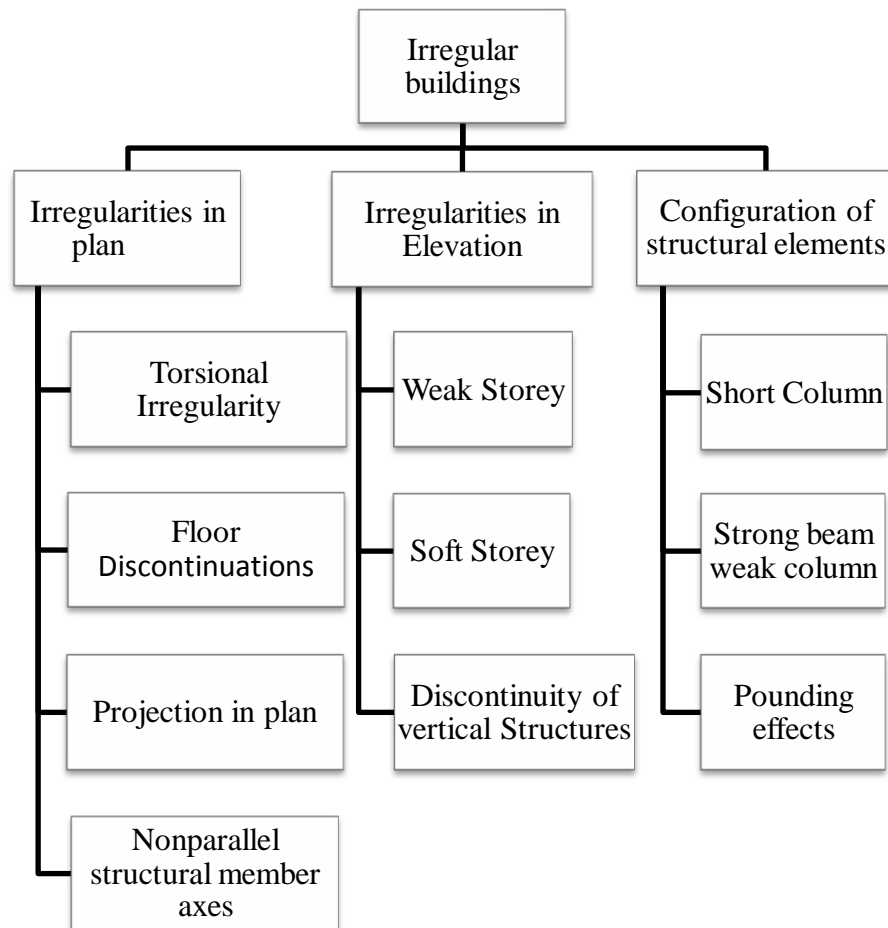
Figure 3.1. Structural Irregularities According to 2007 Turkish Earthquake Code.

There are many kinds of structural irregularities which are initiated during the architectural design stage. Tezcan and Cenk, (2001) states that the irregularities of buildings might include the following; plan of buildings not appropriately designed and vertical direction, disjointedness in mass and rigidity distribution, not paying attention to conformation of structural elements on serial axis, not considering distinct height between floors, implementation of short pillars and pounding effects” (Tezcan and Cenk, 2001).

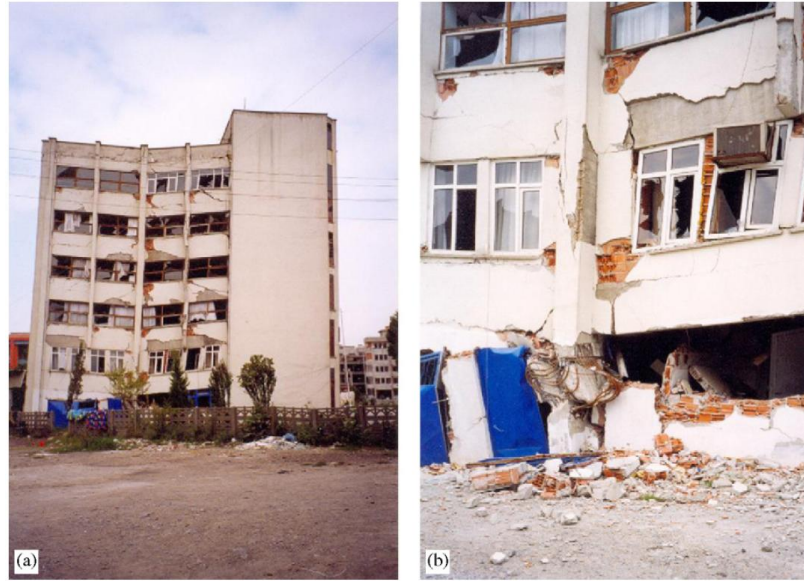
In agreement to Arnold, (2001), as well as Dimova and Alashki, (2003), another source for torsion is unequal distribution of stiffness along the perimeter of building which causes uneven resistance and in turn torsional moments. Beachfront apartments, for instance, are buildings that were designed with open facades, with orientation facing the beach side, which serves as a good illustration for unequal spreading of the strength and rigidity, leading to torsional moments. Other instances of such structures or buildings, are “bank halls, shops, including department stores as well” (İnan and Korkmaz 2011).

Figure 3.5. A Building Damaged due to Torsion Eccentricity (Özmen and İ.Ünay, 2007)

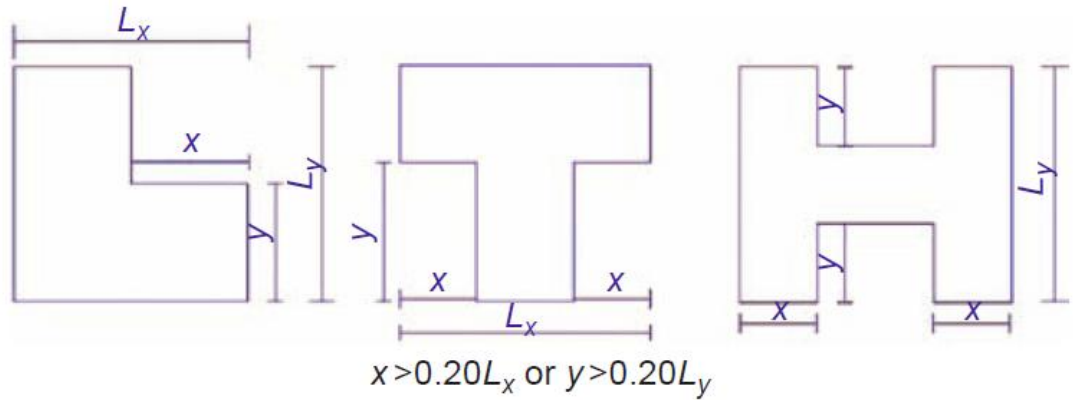
Figure 3.10. Projections in Plan (İnan and Korkmaz 2011)

The earthquake code of Turkey for the overhangs in plan irregularity is vividly described as when the “overhangs outside the re-entrant angles or corners in both of the two major directions in plan surpass the overall plan sizes of the building by greater than twenty percent in the considered individual dimensions, as schematically outlined in Figure 3.10.”.

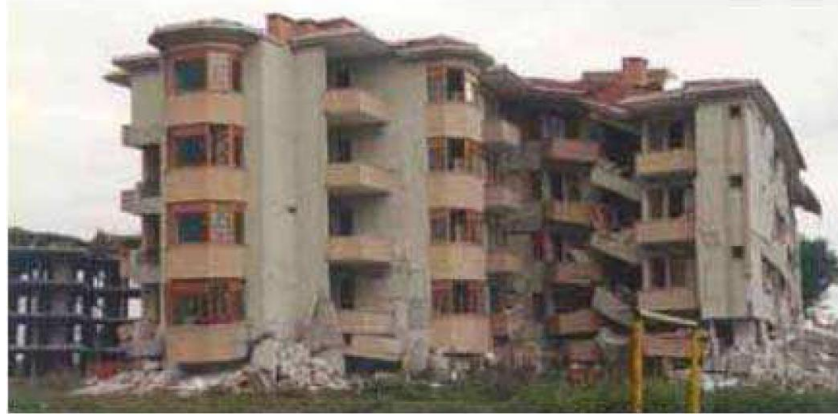
Figure 3.12. Illustration of a Building that was Ruined after Marmara Earthquake, Attributed to Irregularities in Plan (Balyemez and Berköz, 2005)

Özmen and Ünay (2007) declare that in terms of necessary projections, the structure ought to be disjointed into a number of sections with structural expansion joints, as show is Figure 3.11. On the other hand, Figure 3.12 shows a building that was ruined after Marmara earthquake, and is attributed to irregularities in plan.

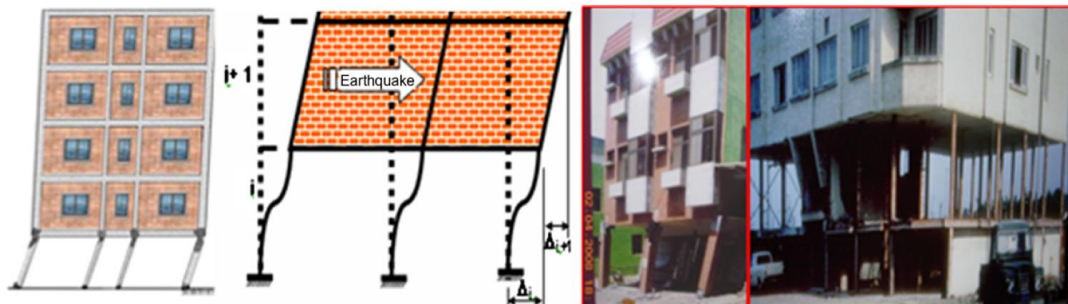
Figure 3.15. Behavior of Soft-Storey During Earthquake (Kirac, Dogan and Ozbasaran 2011)

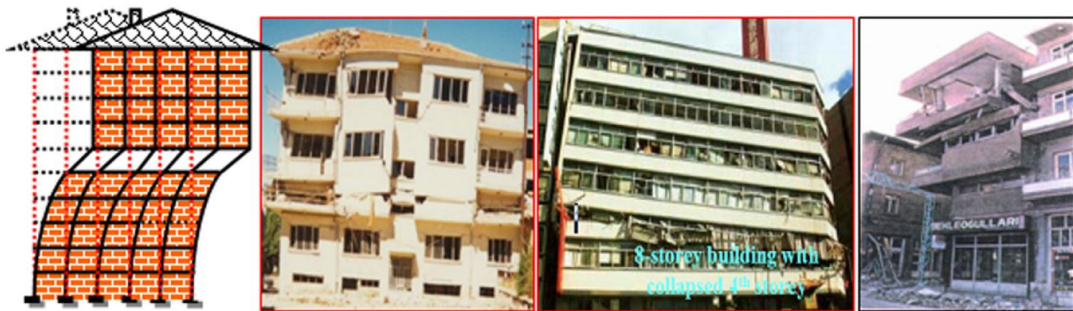
Figure 3.16. Failure of Middle Floors under Earthquake Loads (Doğan 1986)

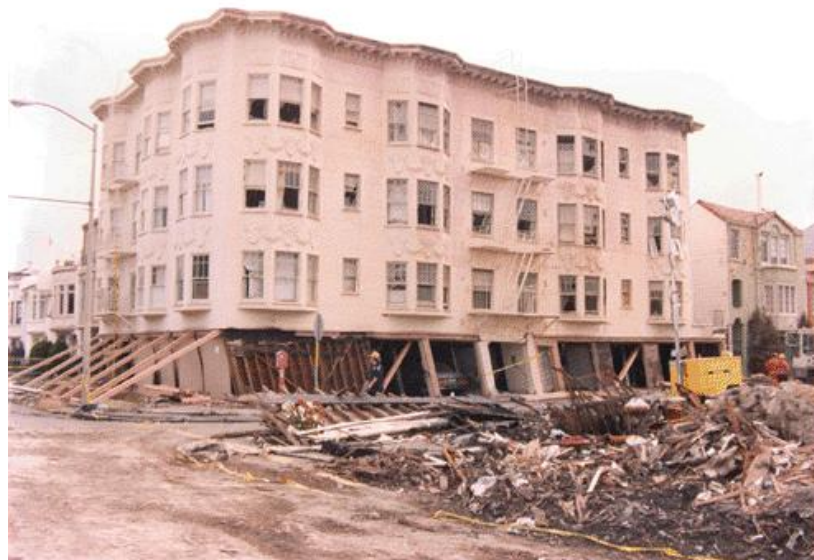
Figure 3.19. Collapse due to Soft or Weak Storey (Tolleson, 2010)

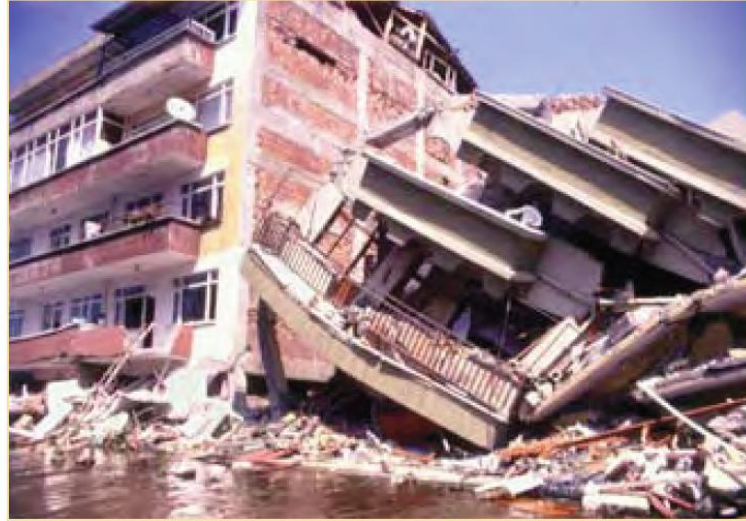
Figure 3.25. Illustration of the Destruction Triggered by Weak Column-Strong Beam Structure (Gulkan et al. 2002)

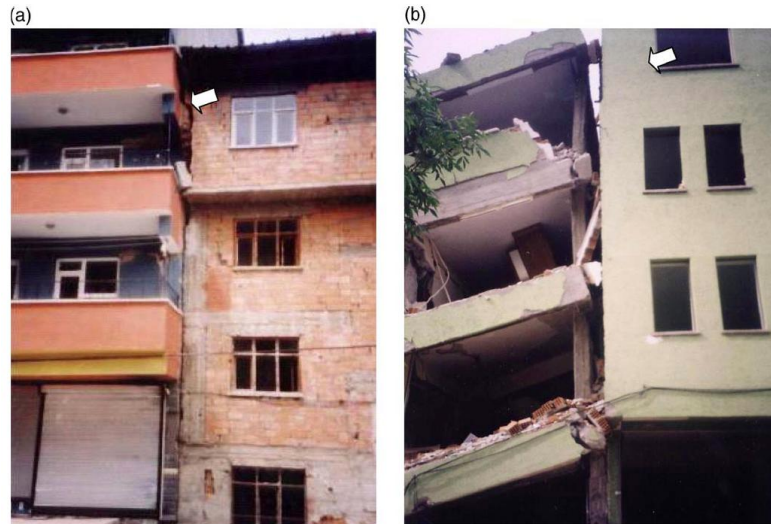
Figure 3.27. Hammering Effect for Adjacent Building (Doğangün, 2004)

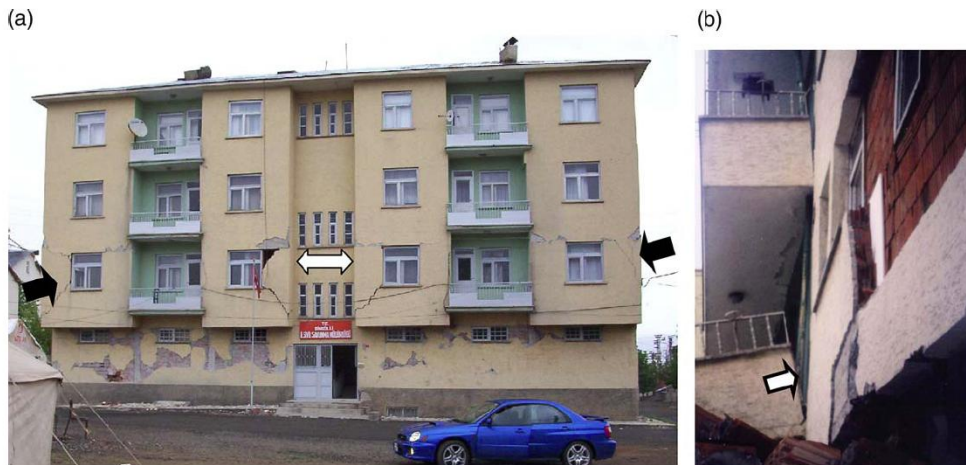
Figure 3.34. Heavy Cantilevers and Balconies (Doğangün, 2004)

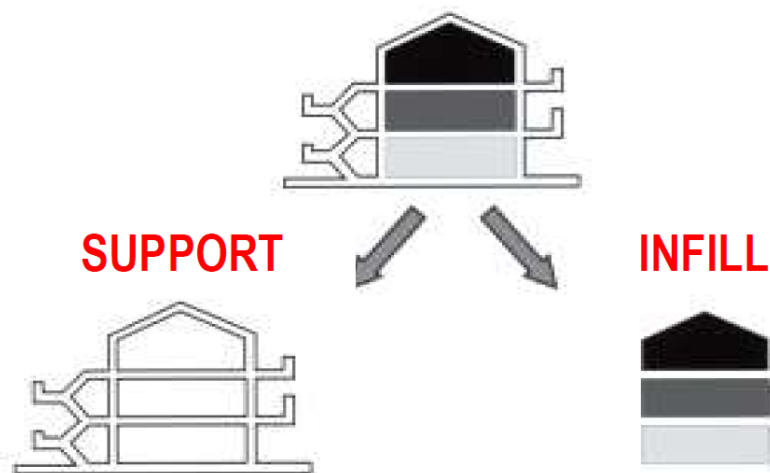
Figure 4.2. “Support” Level-“Infill” Level (Kamo, 2000)

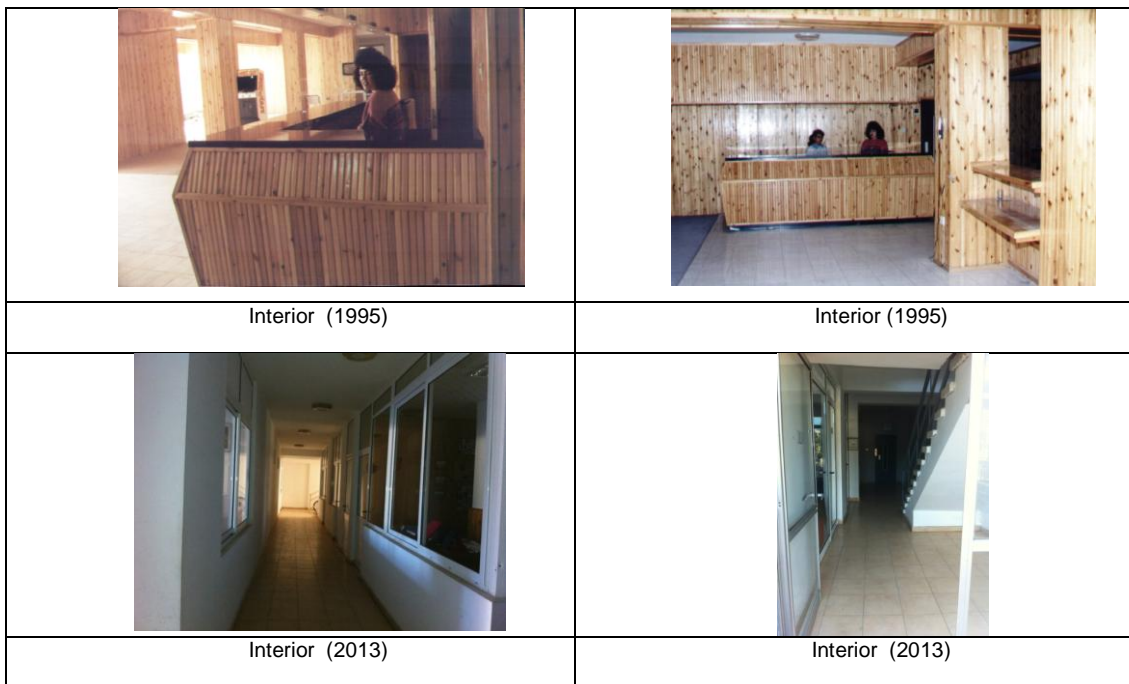
Figure 5.1. Interior of the Building in 1995 and 2013

After that time, many small modifications were done to the buildings and the existing situation of the building is now far from its initial architectural concept and engineering detailing (Figure 5.1). In 2010, the last modification, which totally

changed the elevation of the building, was done. The ground floor of the building was divided into different parts. A restaurant and a store were added to it.

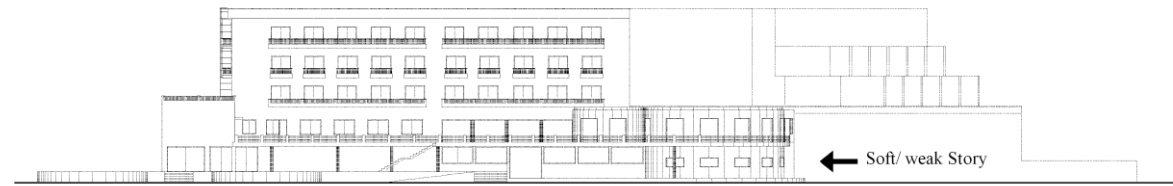
EAST ELEVATION-RIGHT WING

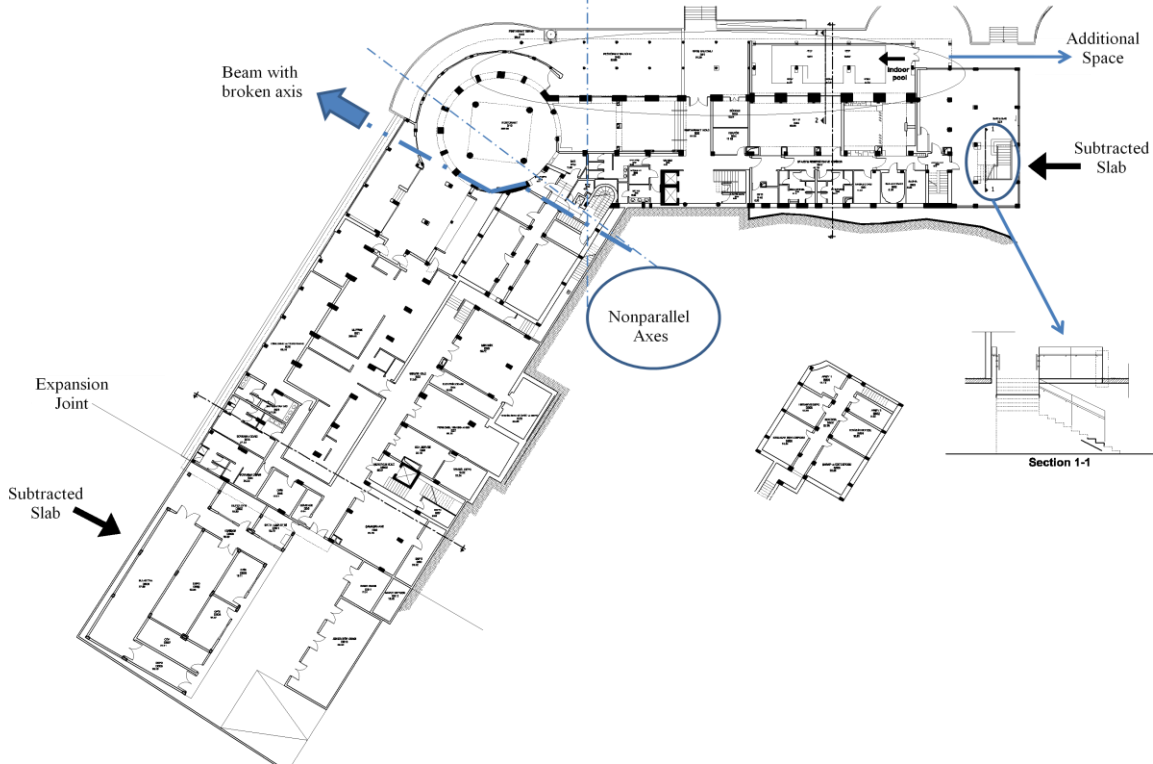
Type of problems:  
Beam intersecting without vertical supports.  
Beam and frames with broken axis.  
Irregular configuration of columns.  
Floor Discontinuation

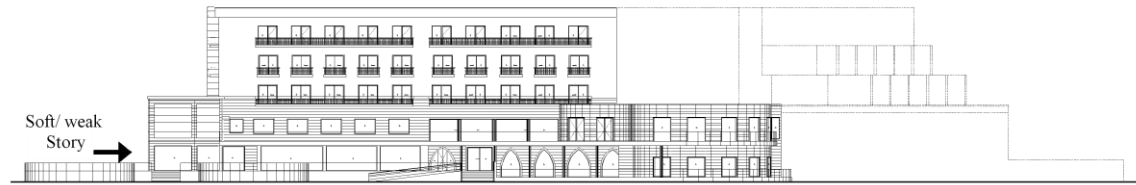
EAST ELEVATION-RIGHT WING

Type of problems:  
There is not any specific problems on this floor .  
Heavy overhang and the short column problem has been solved

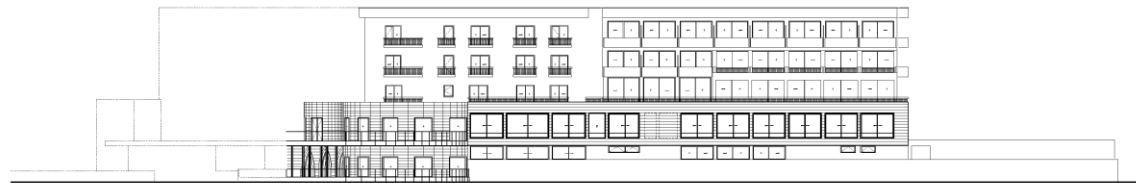
WEST ELEVATION- LEFT WING

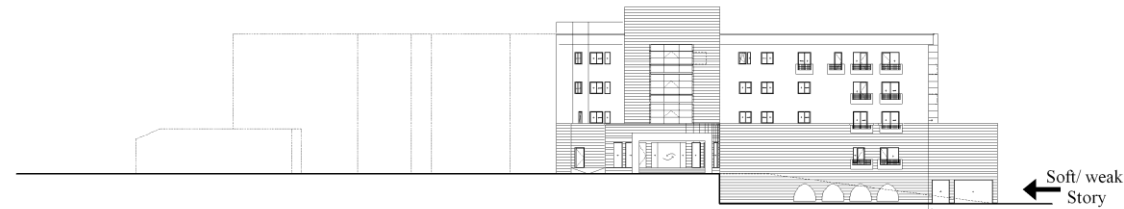
SOUTH ELEVATION- LEFT WING

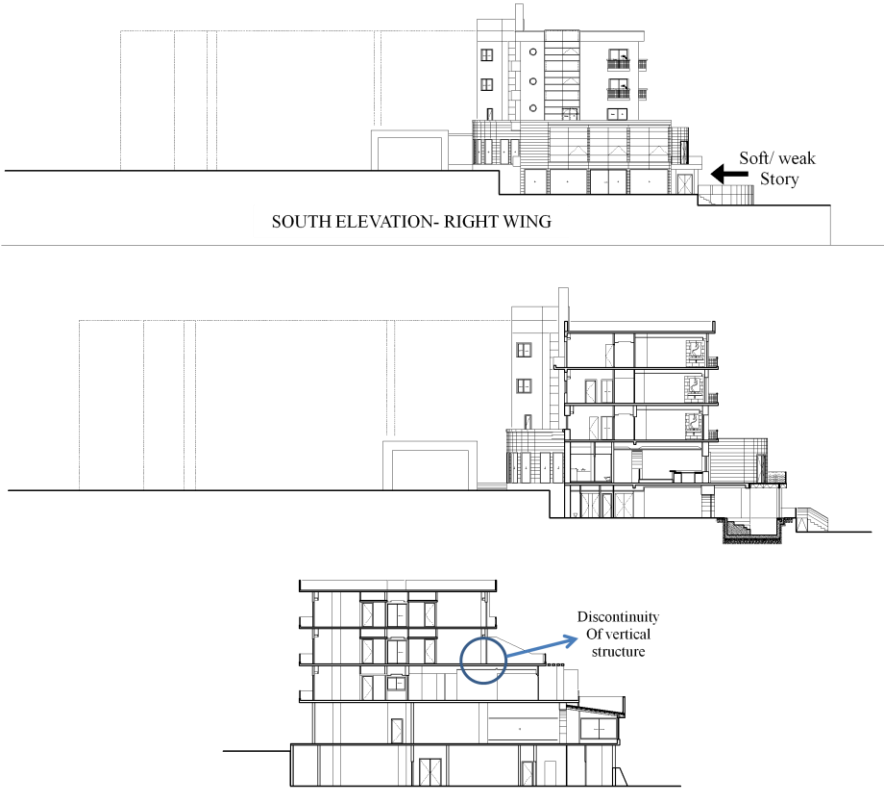
Type of problems:  
Discontinuity of vertical Structure  
Soft/Waek Story
