**Assessment of Changes in Values of
Cultural Heritage Buildings due to Adaptive Reuse
Works in Walled city of Nicosia**

Master of Science
in
Urban Design

Eastern Mediterranean University
December 2019
Gazimağusa, North Cyprus

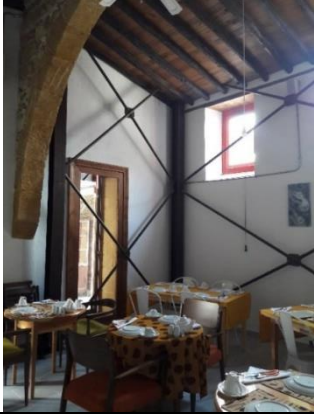
Table 3.6: Visuals of structure for case study 1.

- ii. Roof: With the adaptive reuse project, the roof character of the cultural heritage building was preserved, but the roof materials were renewed due to the deterioration of the roof material. In addition, the wooden rafters on the ceiling were preserved and the missing materials were completed according to the original. According to these changes, the authenticity of the roof of this building has changed moderately.

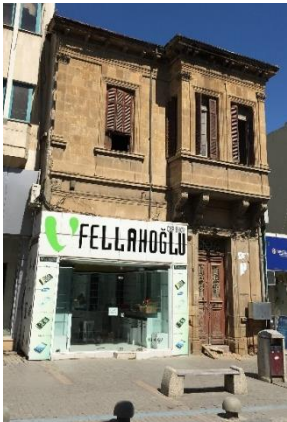
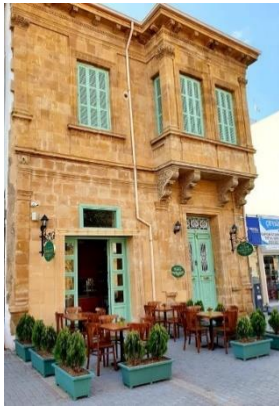
Table 3.12: Visuals of facade organization for case study 2.

- Mass and design decisions: With the applied restoration work, inappropriate additions that were previously applied to a part of the façade were removed, gaps that opened in the façade due to the previous restoration were completed

and the deteriorated parts were restored. With the adaptive reuse project, the bay windows, stone brackets, wooden works that constitute the façade character of this mansion building have been preserved and some missing shutters have been repaired. The entrance door has been preserved and a new section has been added to the café section to the left of the entrance. According to these statements, these arrangements massively moderated the 'authenticity' of this structure.

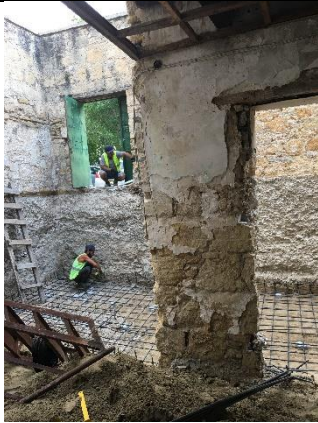
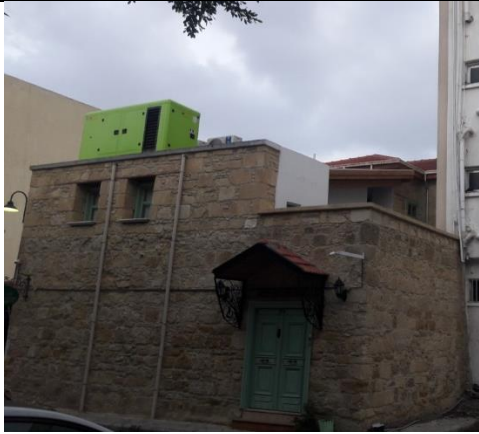
Table 3.14: Visuals of structure for case study 2

- i. **Structure:** With the adaptive reuse project, the the original structure of the front part of this mansion was preserved and the arches that were covered in the previous restoration work were revealed. However, in place of the ruined baths at the rear of this building, rooms were added using the modern structure. This new building was built into the existing walls and the façade was covered with stone material. In addition, some of the demolished walls in the back of the building were rebuilt with plasterboard walls. Due to these changes, the structural specificity of this building has changed moderately.

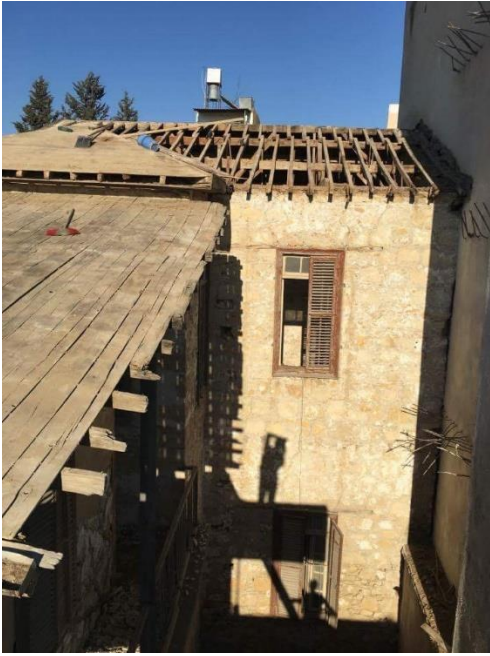
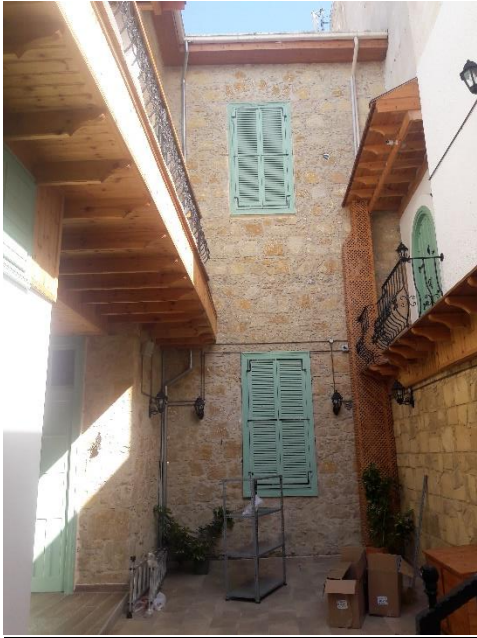
Table 3.15: Visuals of roof for case study 2

- ii. **Roof:** Since some parts of the roof were destroyed before adaptive reuse, the roof material was changed, the wooden sections were preserved in the good

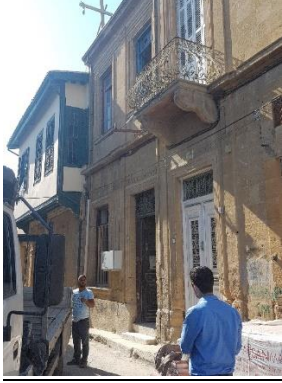
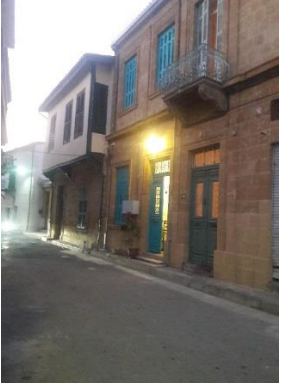
Table 3.23: Visuals of roof for case study 3.

- i. Roof: With the adaptive reuse project, the character of the roof of this building has not changed and its authenticity has been preserved.
- ii. Material: With the adaptive reuse project, the materials of this building were preserved and damaged joinery, windows and doors have been repaired. The iron work in this building as been maintained and painted. In this building, only the wooden doors of the wet spaces have been replaced. According to these changes, the authenticity of this building in terms of material has changed slightly.

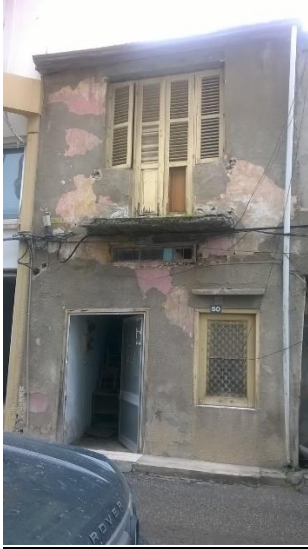
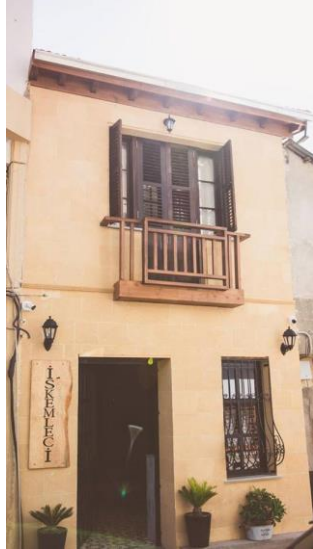
Table 3.28: Visuals of facade organization for case study 4.

- Mass and design decisions: Although it is not a very important feature in the character of the façade of the historical residential building, different designs referring to the same materials as the woodwork, shutters, windows and entrance door of the original have been used. When we compare the status of this building before and after its transformation, it is observed that the authenticity of the facade moderately changed.

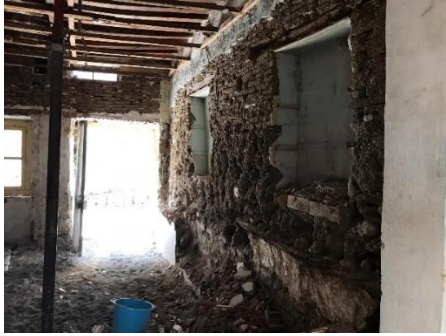
Table 3.31: Visuals of roof case study 4.

- iii. Roof: The roof materials of this residential building had deteriorated, so the roof materials have been replaced. In addition, new straw material was used on the ceiling of this building. Due to these changes, the authenticity of the roof in this structure has moderately changed.

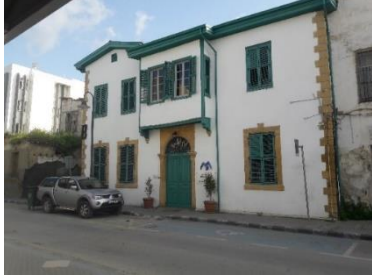
Table 3.36: Visuals of facade organization case study 5.

- Mass and design decisions: Before to the adaptive reuse project, this building has become obsolete due to the vacant use of the building and its façade has been restored. The cumba and wooden works on the façade are preserved according to their original condition and retained their original authenticity.

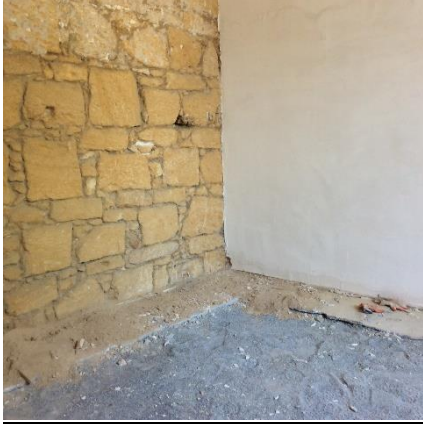
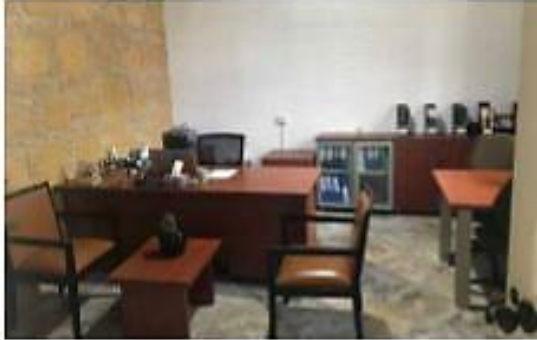
Table 3.38: Visuals of structure case study 5.

- Structure: The structural system of this building did not change. According to the findings, cracks were formed in the structure and it was strengthened due to the detection of collapse.

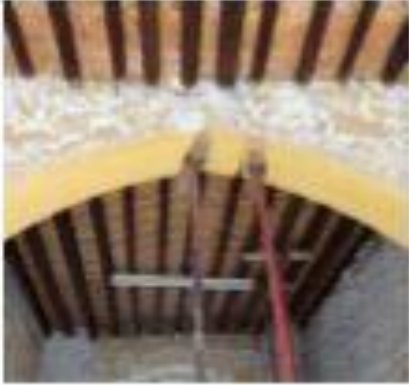
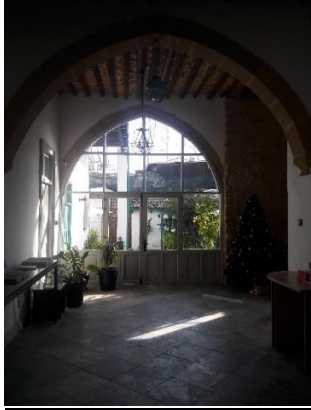
Table 3.39: Visuals of roof for case study 5.

- ii. Roof: This structure has not changed as the roof has not been degraded and authenticity is preserved as in the original state.

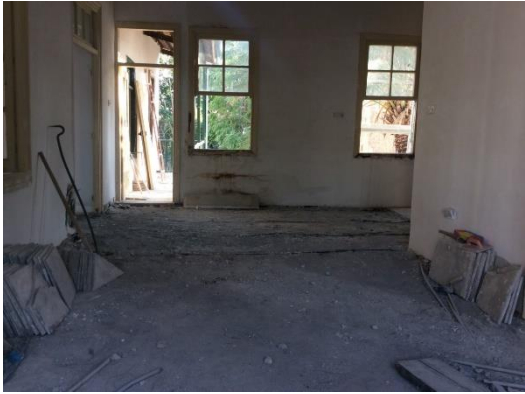
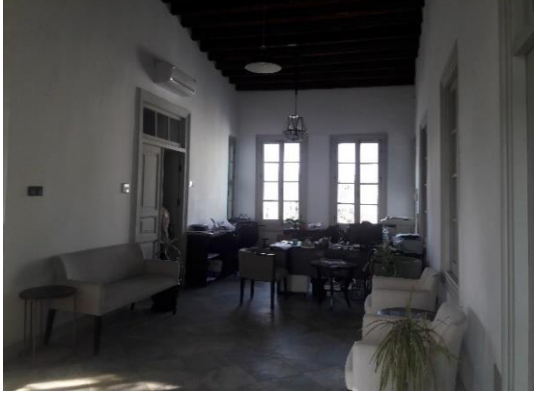
Table 3.40: Visuals of material for case study 5.

- iii. Material: Original materials were used or repaired. For materials in poor condition, materials suitable for the original were used. Therefore, few changes are observed in authenticity of the buildings.

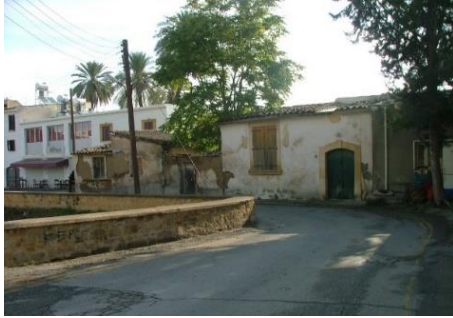
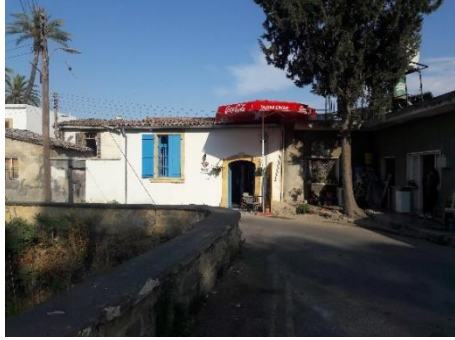
Table 3.44: Visuals of facade organization for case study 6.

- Mass and design decisions: With this adaptive reuse project, the damages on this façade was repaired, the timber and iron work on the façade was restored and the authenticity of the façade of this cultural heritage building was preserved.
- Use and function decisions: With the adaptive reuse project, the plan layout of this building was preserved and only wet spaces and wooden stairs were added together with a mezzanine floor. Since there is no change in plan organization, the plan specificity of this structure has slightly changed.

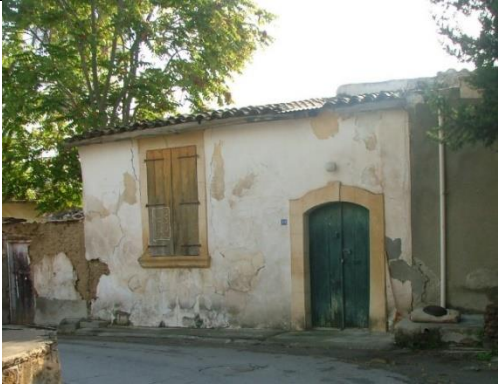
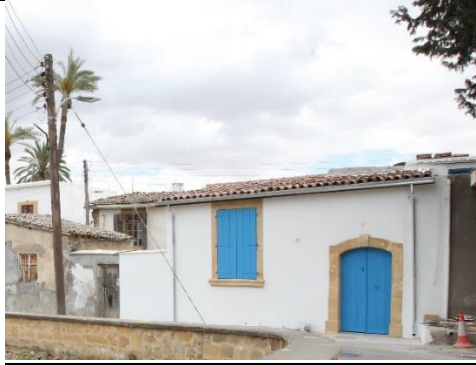
Table 3. 47: Visuals of roof for case study 6.

- ii. Roof: In this cultural heritage building, the authenticity of the building has been preserved without making any changes to the roof character.

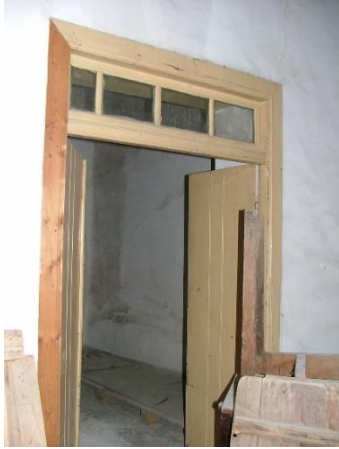
Table 3.48: Visuals of material for case study 6.

- iii. Material: With the Adaptive reuse project, the materials that make up the character of this structure have been repaired and preserved. In this building, a wooden staircase and a wooden mezzanine floor were added to create a rest area. In addition, as this residential building turned into a cafe, only the ceramics in the entrance hall and kitchen were replaced. Due to this change, the material specificity of the structure has moderately changed.

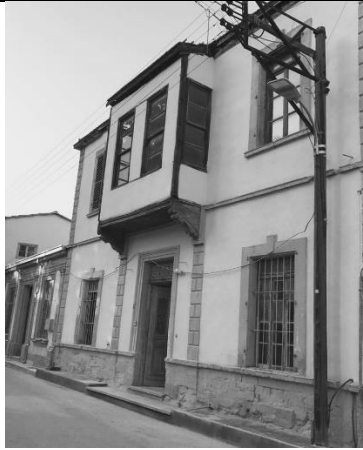
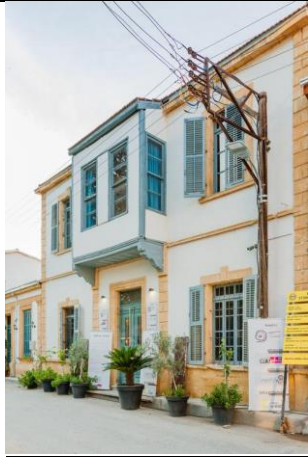
DOCUMENTATION and DESCRIPTION	
Visuals of Facade Organization	
Before Restoration Project	After Adaptive Reuse Work

- Mass and design decisions: After the adaptive reuse, the architectural characters that form the façade of this building have been preserved with historical importance. In addition, this building was not in use before this transformation and it was in poor physical condition. Therefore, the wooden works on the façade were repaired and the yellow stones and the cumba that played an important role in its identity were restored. When this adaptive reuse project is

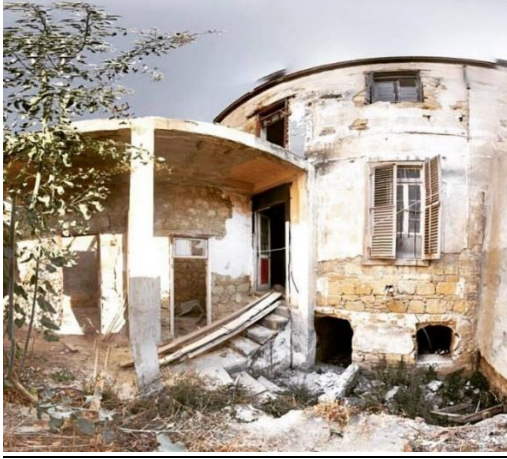
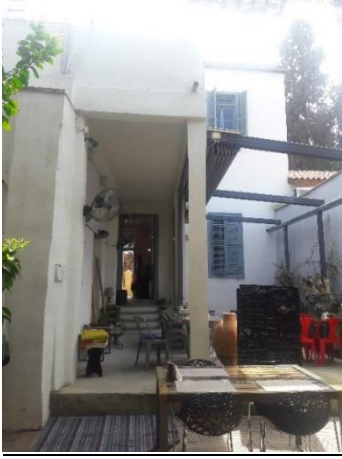
Table 3.54: Visuals of structure case study 7.

DOCUMENTATION and DESCRIPTION	
Visuals of Architectural Elements Structure	
Before Restoration Project	After Adaptive Reuse Work

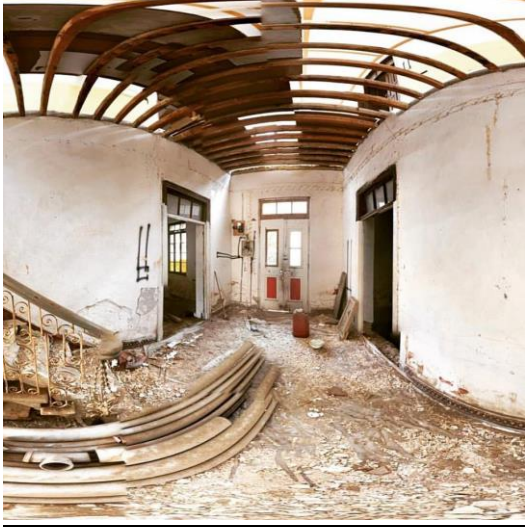
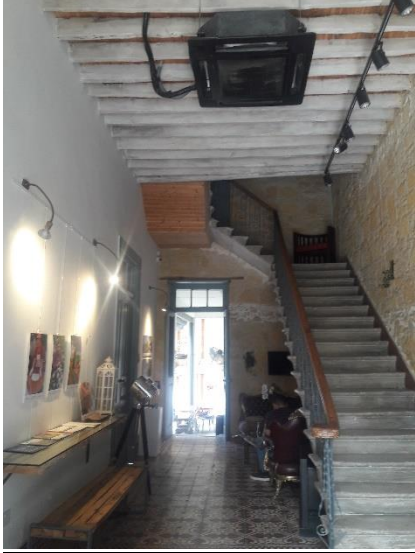
Table 3.55: Visuals of roof for case study 7.

- ii. Roof: Some parts of the roof of this building were demolished due to collapsing and contemporary additions were obtained by using wooden and concrete rafters on the ceilings. The wooden roof system and wicker ceiling applied to the destroyed parts in order to create space in the inner garden added a distinct aesthetic to the building. In addition, the steel pergola, which is designated as the structure, is used with the contemporary roof system that can be opened and closed in the restaurant and cafe areas of the garden. Although the additions added to the roof in this building and the construction of ceilings with new materials moderately ‘authenticity’, the new roof systems applied in the garden of this building added a distinct character to this building.

DOCUMENTATION and DESCRIPTION	
Analysis of Architectural Elements	
Roof	
Before Restoration Project	After Adaptive Reuse Work

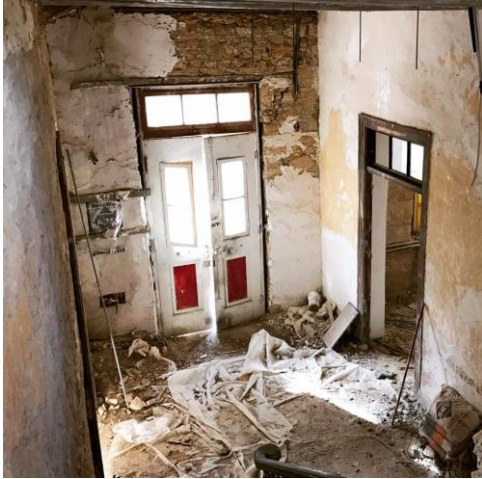
Table 3.56: Visuals of material case study 7.

- iii. Material: The main staircase material which is Cyprus marble, some part of ground floor marble found in this structure was preserved, damaged doors, windows and shutters were repaired and missing parts were completed. Glass doors were added to the entrance door of the building, and today's materials were reflected with using concrete in the ceilings. In addition, wooden material was used to complete the missing ceiling sections and reinforce the stairs. Depending on these expressions, it is observed that the material specificity changes moderately.

DOCUMENTATION and DESCRIPTION	
Visuals of Architectural Elements Material	
Before Restoration Project	After Adaptive Reuse Work

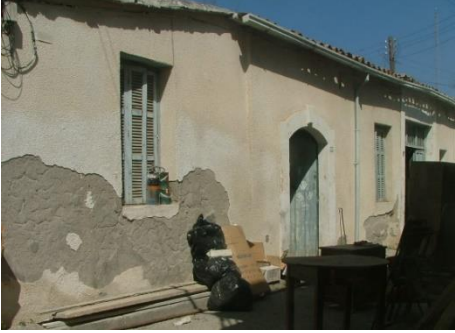
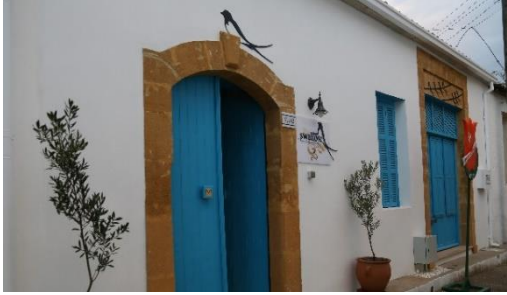
Table 3.60: Visuals of facade organization for case study 8.

DOCUMENTATION and DESCRIPTION	
Visuals of Facade Organization	
Before Restoration Project	After Adaptive Reuse Work

- Mass and design decisions: When we evaluate the facade of this building; it can be observed that only one non-original window was covered and other characteristics of the façade were preserved. In addition, the wooden joinery, shutters and entrance door, which were in poor condition, were repaired. Since the cultural heritage building was restored according to the original, this building's authenticity did not deteriorate regarding mass and design.

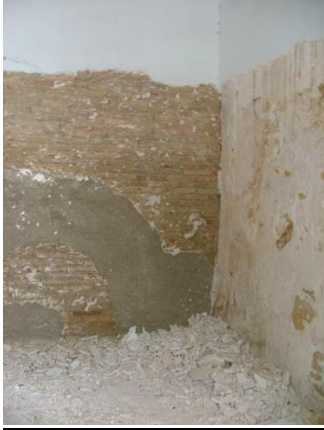
Table 3.62: Visuals of structure for case study 8.

DOCUMENTATION and DESCRIPTION	
Visuals of Architectural Elements	
Structure	
Before Restoration Project	After Adaptive Reuse Work

- i. Structure: In this cultural heritage building, the structural originality of the building was preserved just by consolidation of the structure.

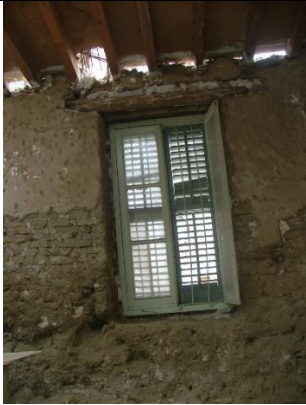
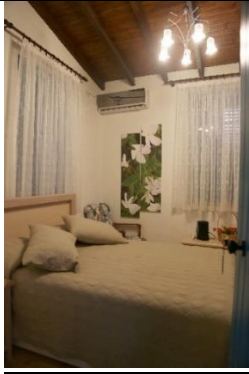
Table 3.63: Visuals of roof for case study 8.

DOCUMENTATION and DESCRIPTION	
Visuals of Architectural Elements	
Roof	
Before Restoration Project	After Adaptive Reuse Work

- ii. Roof: In this adaptive reuse project, only the material was changed due to the deterioration of the roof. In addition, the inappropriate attachment at the back was removed and the original room and roof were added to the original building. Based on these statements, the authenticity of the building has moderately changed.

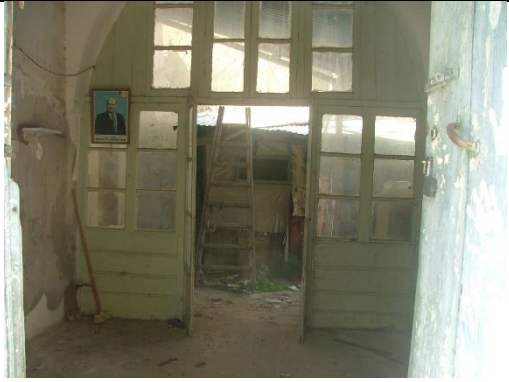
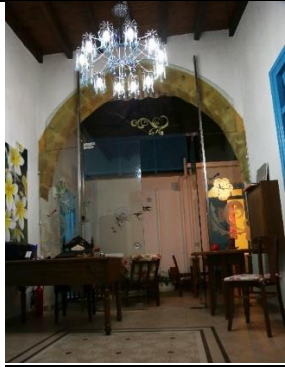
Table 3.64: Visuals of material for case study 8.

DOCUMENTATION and DESCRIPTION	
Visuals of Architectural Elements	
Material	
Before Restoration Project	After Adaptive Reuse Work

- iii. Material: In this cultural heritage building, the original materials were preserved, damaged woodwork and joinery were repaired. Due to the aging of the roof material, some parts of the roof were repaired in accordance with the original. Based on these statements, the material and substance specificity of the structure has moderately changed.
