**Conservation of Historic Khans through Adaptive  
Re-Use in the Walled-City of North Nicosia: A  
Comparative Analysis Based on the Concepts of  
Authenticity and Integrity**

Master of Science  
in  
Interior Architecture

Eastern Mediterranean University  
September 2018  
Gazimağusa, North Cyprus

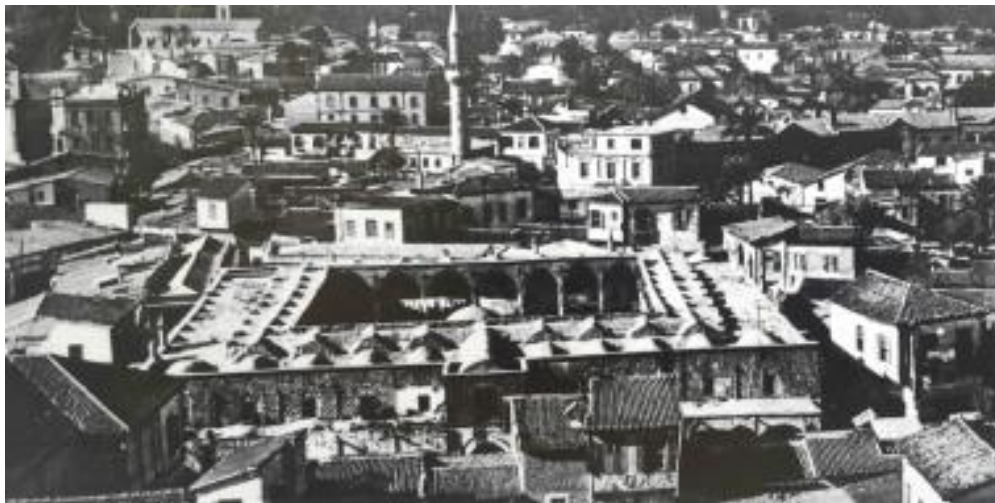
Figure 3.4: The Büyük Han, Walled-City in Nicosia. (Altan and Özsoy, 2017).

The Büyük Han, which is the most well-known historical building in North Cyprus, and a landmark amongst the most vital historical buildings that acquired from the Ottoman period. The Büyük Han has two floors and a more or less square shape; its dimensions are 50.67 m by 45.25 m. There is a large inner courtyard which is surrounded by the rooms that have colonnades with cross vaults in front. There are

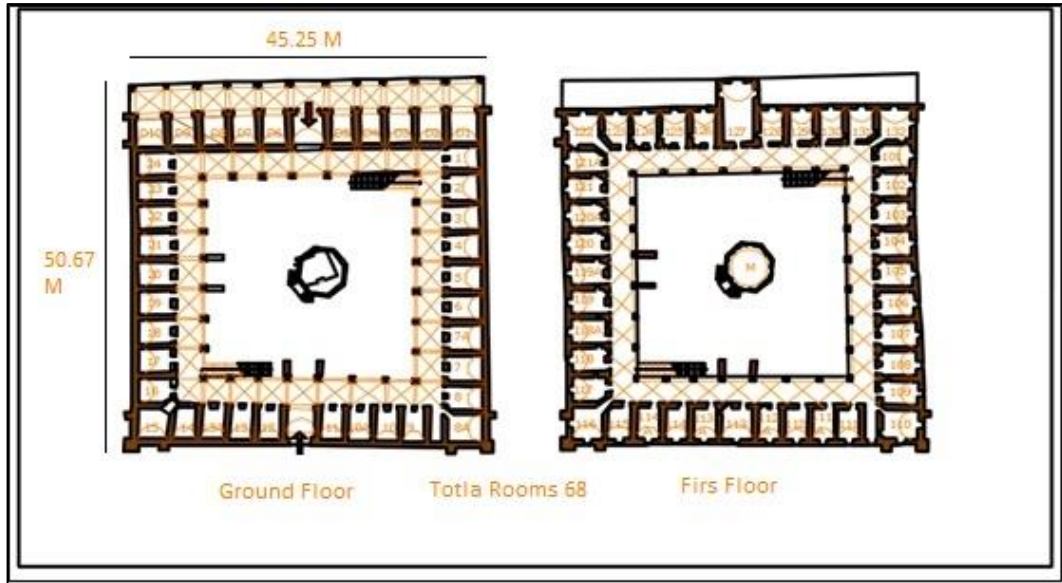
Figure 3.5: Ground and 1<sup>st</sup> Floor Plans of the Büyük Han.

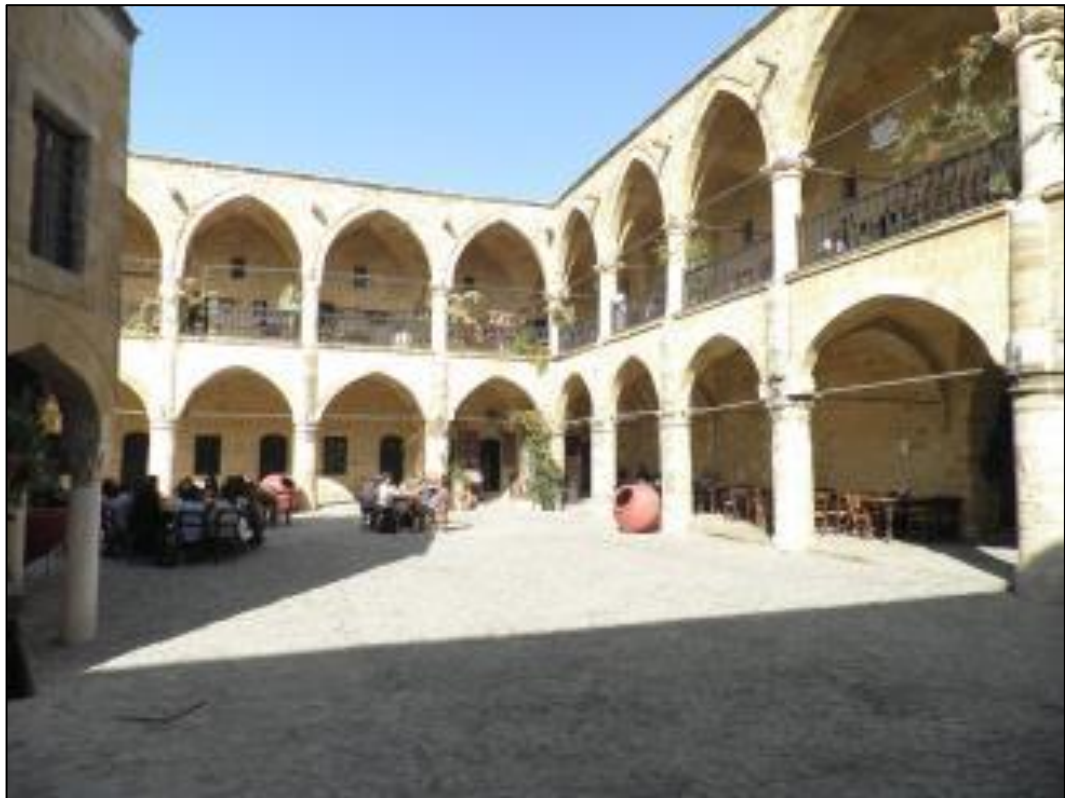
Figure 3.9: The Büyük Han in Walled-City of Nicosia, View from the Courtyard in (URL2).

In 2002, there have been radical modifications in function of this Khan and it was re-opened. For example, holding shows and concerts on the internal patio (courtyard) and ground floor rooms, which previously were used to keep passenger's animals. At the same time change the places where people utilized for the stay and

accommodated in the night with craftsmanship studios. The change of the building, physically and functionally, has influenced the Büyük Han to be something beyond a normal historical building with a high historical value and transformed it into a landmark of the city and destination of tourists, while representing an important cultural and social figure, which brings a new life.

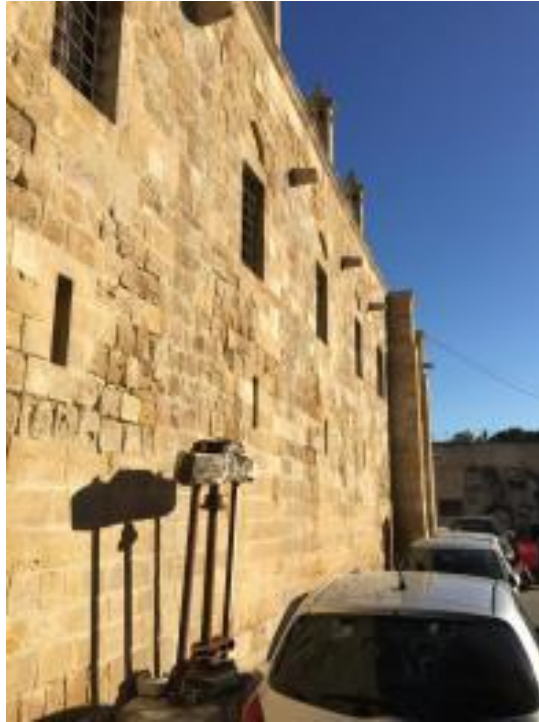
a- Ornaments & floors: Damaged elements with more than 60% were majority replaced by stones from the same types, See Figure 3.10. Hence the authenticity was preserved as per International standards. See Table 2.3

Figure 3.10: Büyük Han outer walls. (Author, 2017)

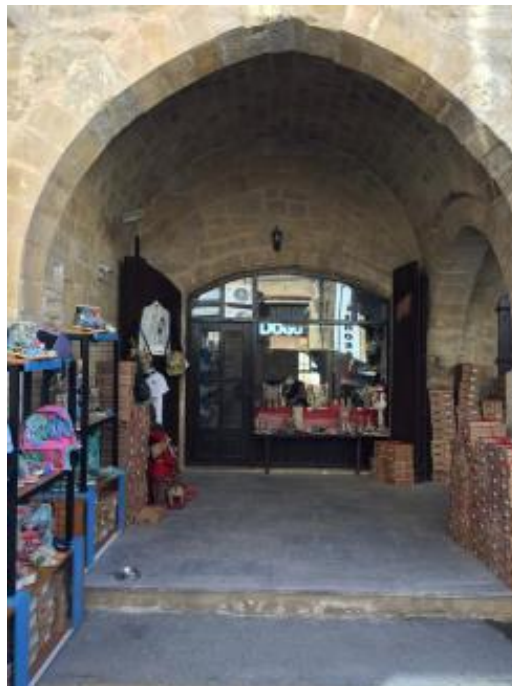
b- Openings: Restoration of the glasses by using different materials but restoring the colors and shapes as seen in Figure 3.11, indicates that the authenticity was not preserved totally, as per International standards. See Table 2.3

Figure 3.11: Reflected (not original) glasses in Büyük Han. (Author, 2017)

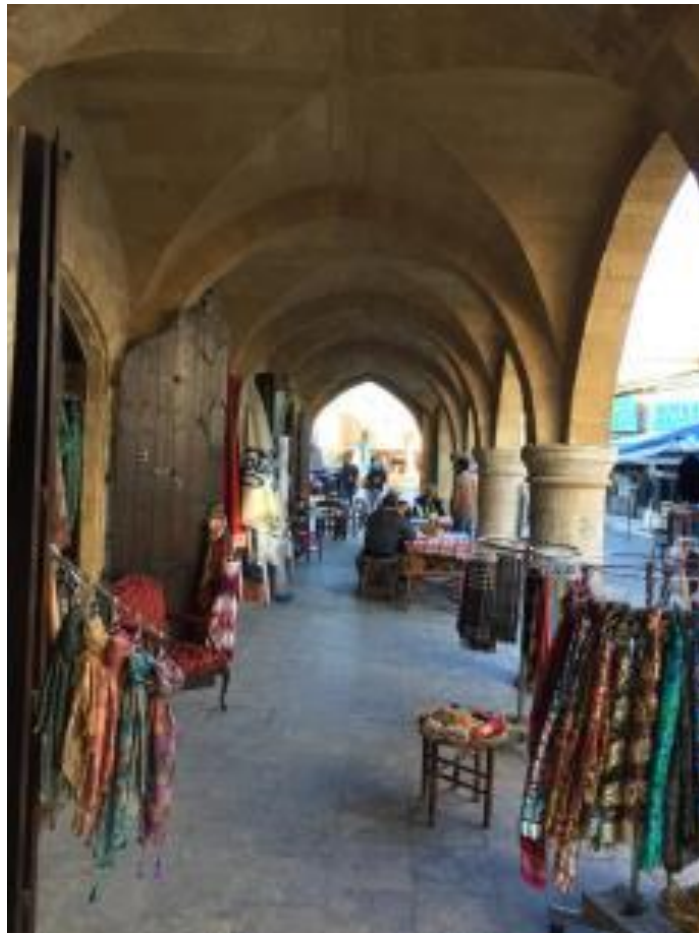
c- Building Structure: The original material of the building structure of the roof and walls has been preserved as much as possible. Only those elements that could not be repaired have been replaced by new material as see Figure 3.12. Thus, the authenticity can be considered as preserved, as per International standards. See Table 2.3

Figure 3.12: Original arcades of Büyük Han. (Author, 2017)

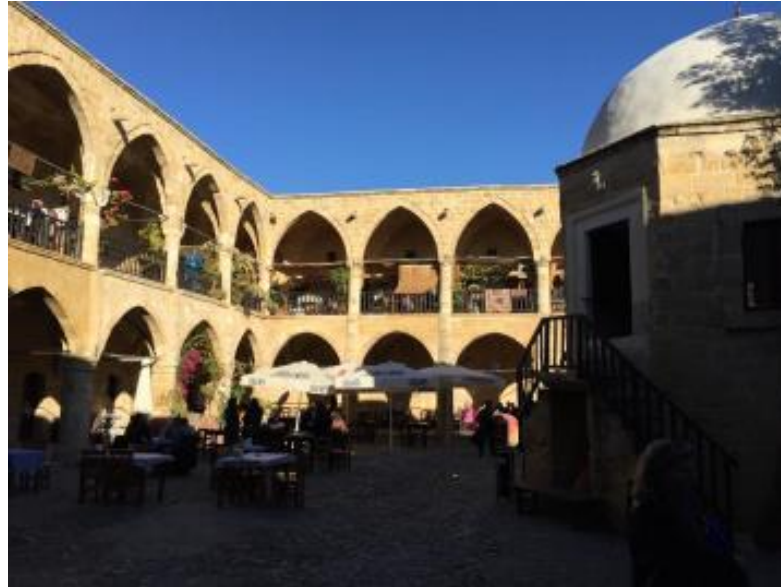
a- Building Form: The form of the building had no change in its shape and restored as original, as see Figure 3.13. Although there is a new extension added to the inn's courtyard, the original form and the new extension could be differentiated . Means the authenticity is mostly preserved, as per International standards. See Table 2.3.

Figure 3.13: Courtyard of the Büyük Han. (Author, 2017)

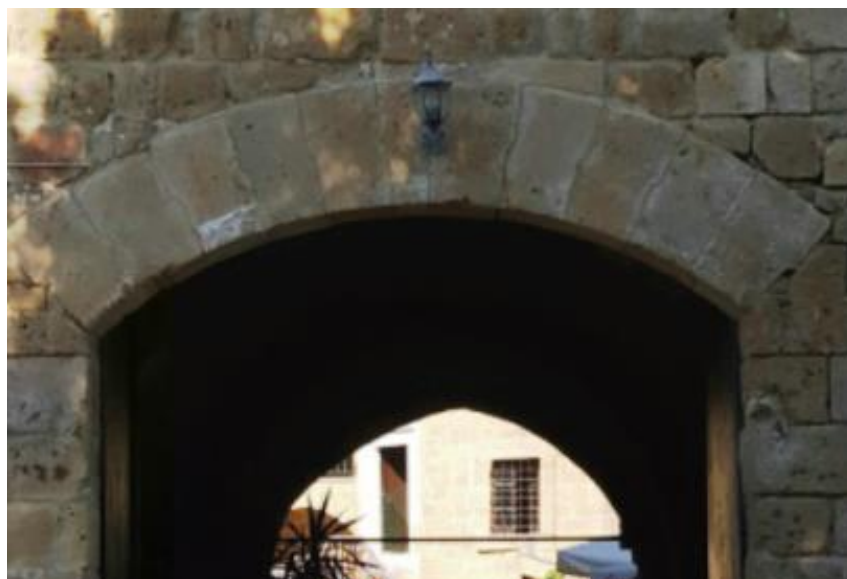
b- Lighting: All lighting system has been changed with new ones and no original shape of the lighting system, as seen in Figure 3.14. Despite the adaptive re-use should include acceptable change for the purpose of adapting adequate lifestyle, but that could be carried out with respecting to the original outer shapes but new technologies involvement, and original location of lighting places. Thus, then that address of losing of authenticity, as per International standards. See Table 2.3.

Figure 3.14: Lights and lighting system in Büyük Han. (Author, 2017)

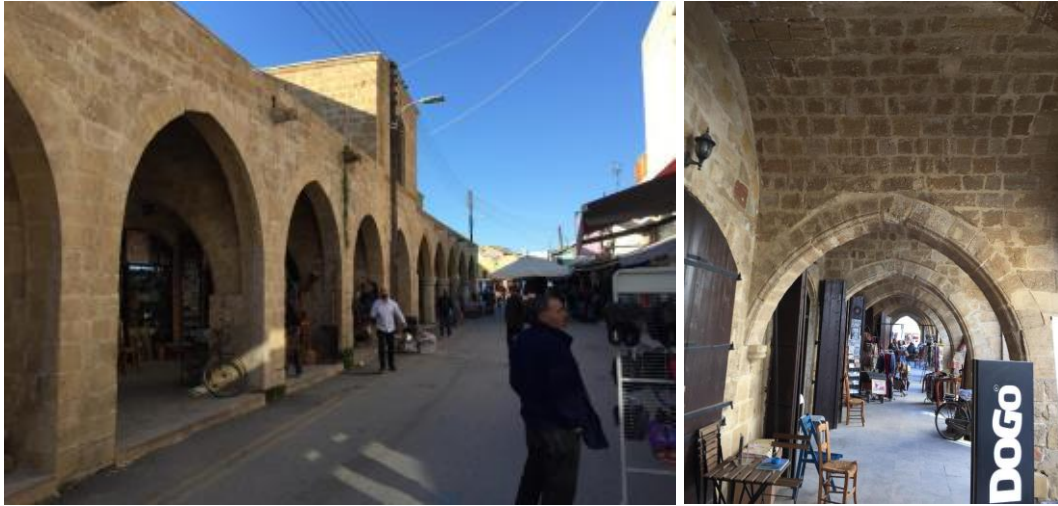
c- Advertising titles: No advertising signs are allowed to be attached parallel to the façades, as seen in Figure 3.15, thereby; the authenticity is preserved, according to the International standards. See Table 2.3.

Figure 3.15: Shops of Büyük Han without advertising or titles. (Author, 2017)

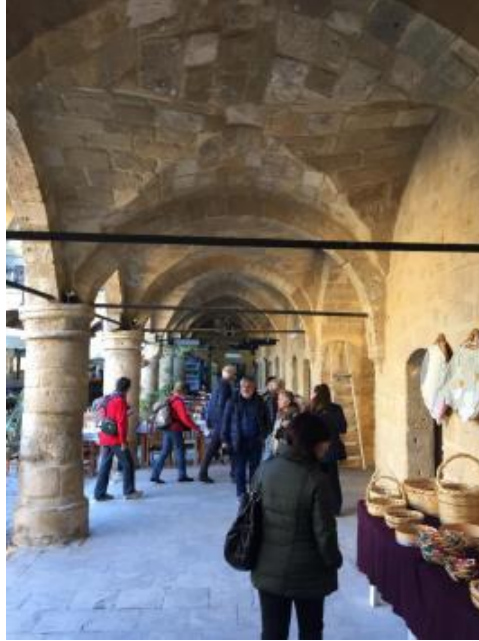
Figure 3.16: Shops and entertainment places inside Büyük Han. (Author, 2017)

b- Nowadays: The urban centre for the tourists to spend good time consists of restaurants, cafes, arts and craft shops, etc. This refers that authenticity is preserved within this parameter, means authenticity is repeats, according to the International standards, because the shops containing goods that relatively similar to the original goods that were used by old shops, as seen in Table 2.3. See Figure 3.16.

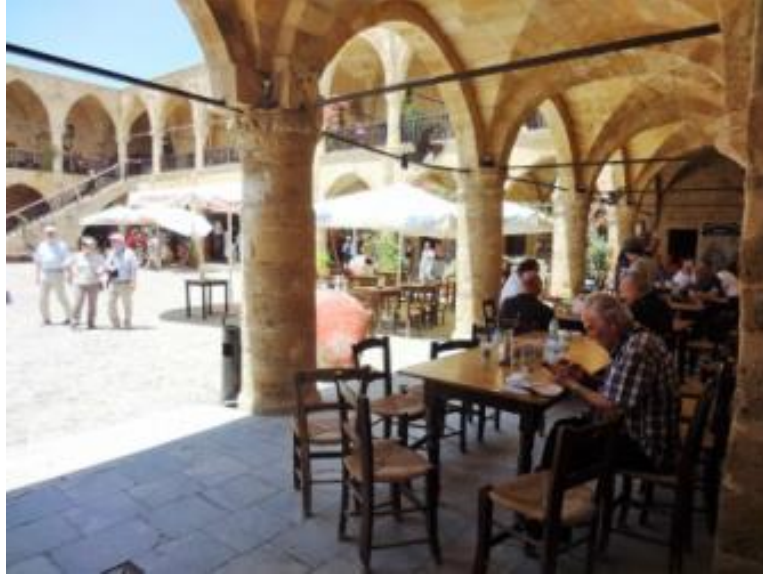
4. Function and Use: The varied functions were changed to ensure the commercial exploitation of the building, which indicates that the authenticity is not preserved, according to the International standards as seen in Table 2.3. Where, the function changed to be cafe, restaurants, and souvenir shops. See Figure 3.17. Functions surrounding the Büyük Han has been changed to commercial functions where majority of them consists of retail shops.

Figure 3.17: Adaptive Re-Use in Büyük Han. (Author, 2017)

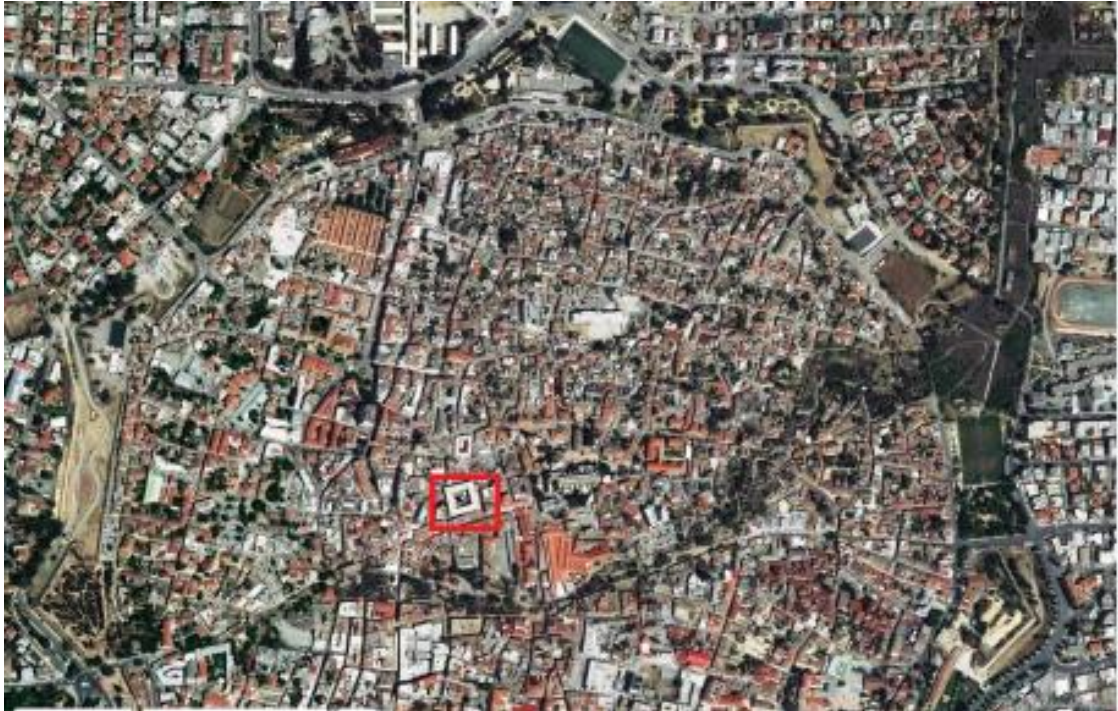
Figure 3.18: Location of Büyük Han inside Walled-City of Nicosia. (Based on Google Map in 2017)

5. Location and setting: Well integrated in the historic urban fabric, which indicated authentic value has been preserved, according to the International standards as seen in Table 2.3. One of the most striking differences between the Büyük Han and the Kumarcılar Hanı is that the former has two gates and therefore can be used by users as a transition space, where people can pass through the building, whereas, the Kumarcılar Hanı has only one gate and therefore it becomes a dead end. See Figure 3.18.

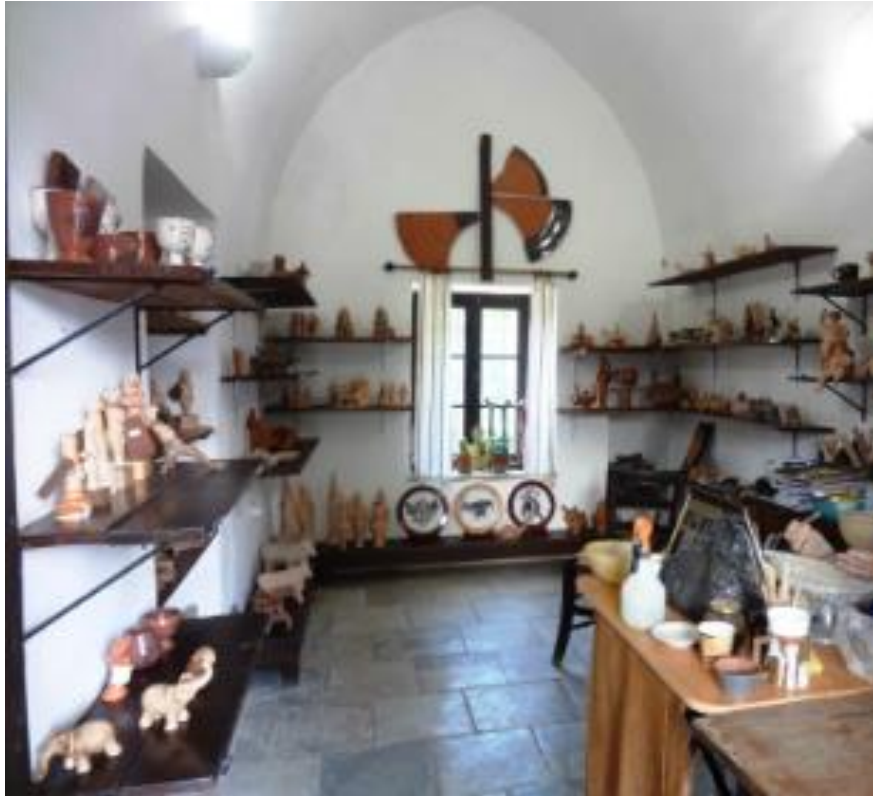
Figure 3.19: The type of display in some shops inside the Büyük Han. (Author, 2017)

b- Quality of Sold merchandize: Traditional goods, some of them are specifically representing an old Walled-City of Nicosia. However, some are brought from Turkey, but they connect the visitors to the past and history of the place. This means, authenticity have been preserved, according to the International Standards. See Figure 3.19.

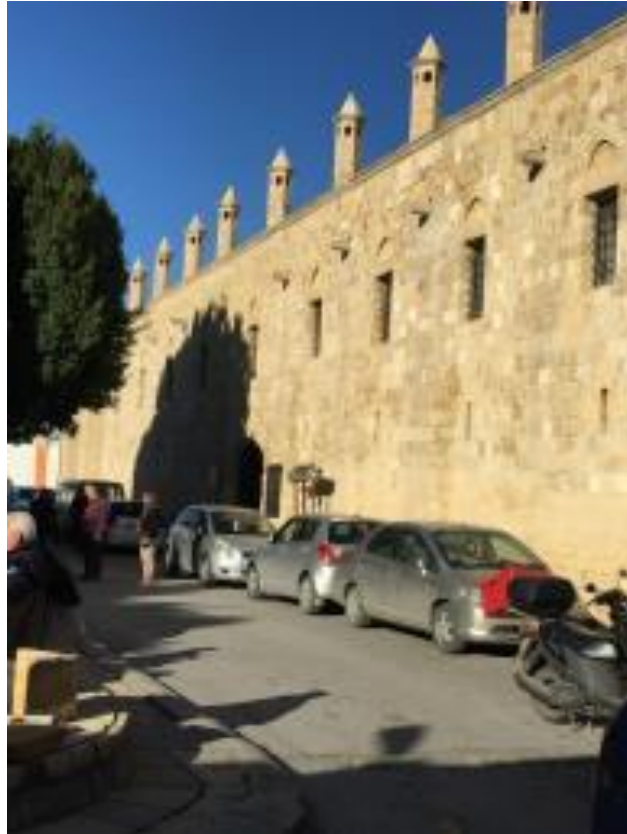
Figure 3.20: Outside of the Büyük Han at the present. (Author, 2017)

2. Wholeness: The Büyük Han, consist of the full scale conserved architectural elements, including the exterior walls, windows, rooms, toilets located at the corner-towers, chimneys, arcades, central courtyard, porticos. In addition to space

organization as original. Thus, integrity has been preserved, according to the International standards, as seen in Table 2.3. See Figure 3.20.

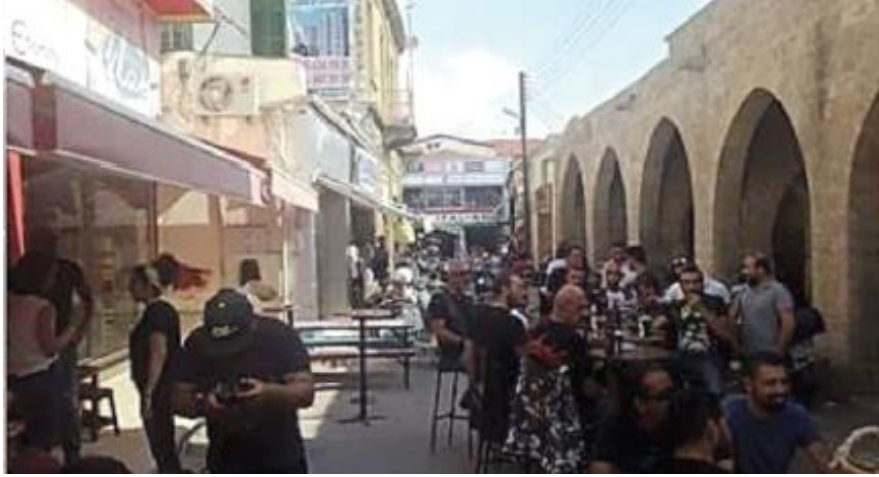
3. Honesty: the original elements of the building which easy to be identified from outside on the historical building, has been partially preserved, and not completely, due to new function for the shops that have been located surrounding the inn in next periods. Hence, the integrity was partially preserved, according to the International standards, as seen in Table 2.3. See Figure 3.21.

Figure 3.21: New buildings surrounding the Büyük Han. (Author, 2017)

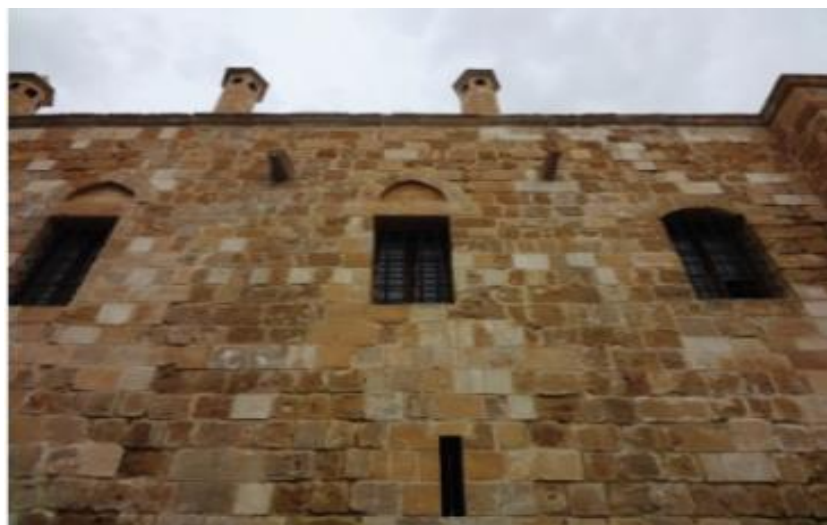
5. Structural integrity: despite there was damaged elements from the historical building and some element reconstructed but in general the conservation had been achieved in such way that kept the integrity of this building preserved, according to the International standards, as seen in Table 2.3. See Figure 3.22.

Figure 3.22: Büyük Han-North Elevation showing octagonal chimneys on the roof of the building. (Author, 2017)

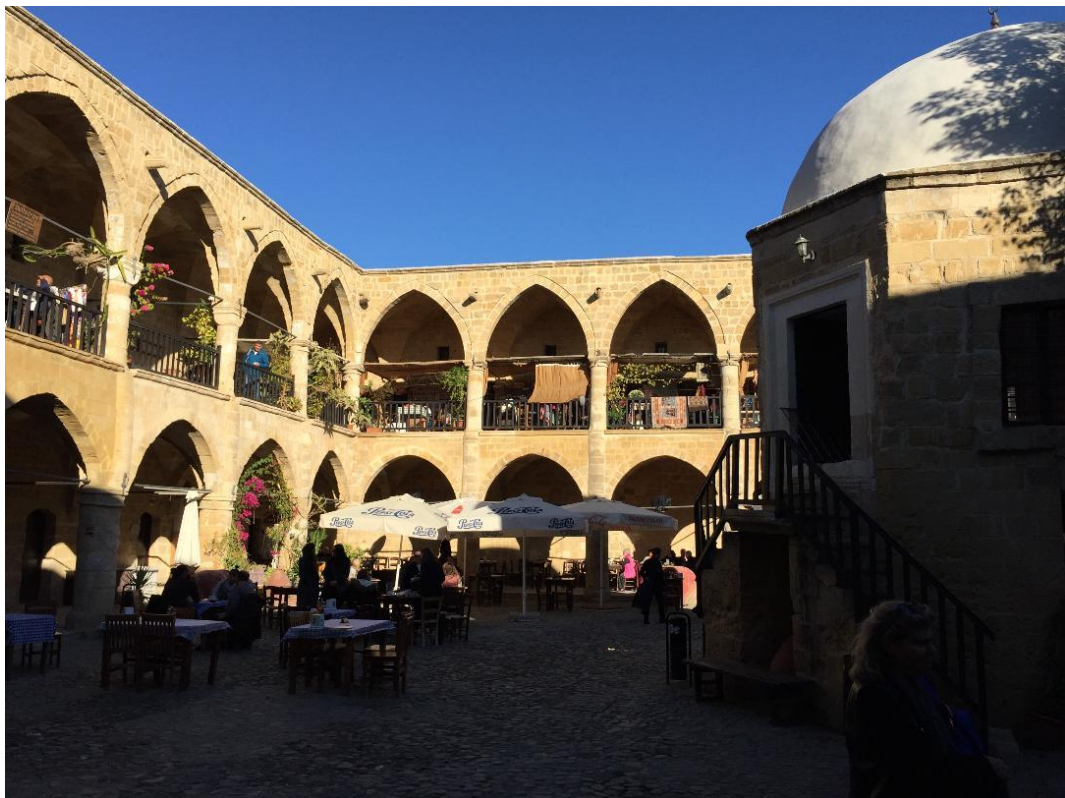
Figure 3.23: Büyük Han-Courtyard. (Author, 2017)

6. Visual integrity: the aesthetic value presented in the building through conserving the originality in the materials, designs, in order to keep the aesthetic value of the Inn, according to the International standards, as seen in Table 2.3. Although some additional wooden element had been added like extension in courtyard, but it is movable and not affecting the original historical building. Thus, the visual integrity has not been fully preserved, but it was successful. See Figure 3.23.

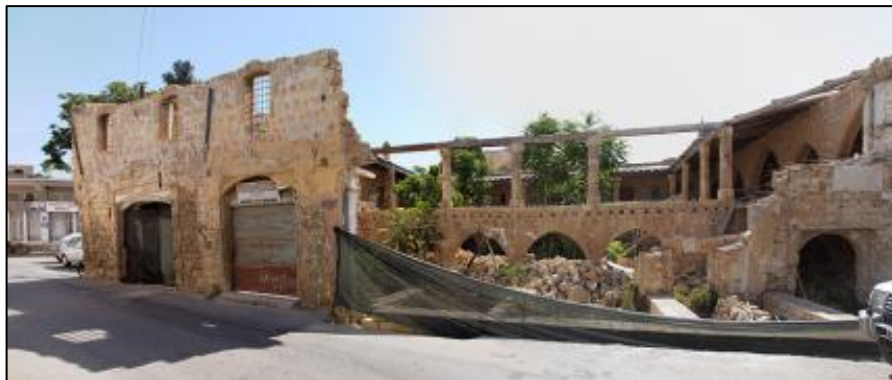
Since then, the Kumarcılar Hanı has faced a dilapidating state and threatened to collapse. See Figure 3.31.

Figure 3.31: Kumarcılar Hanı, in 2008. (URL5).

c- Building Structure: The original material of the building structure of the roof and walls has been preserved as much as possible. Many parts of the building structure were lost, as shown in Figure 3.31 above, those elements have been replaced by new material, and therefore, the authenticity has been preserved but not completely. The original structure which is a load-bearing system has been conserved in the same way together with vaults and arches.

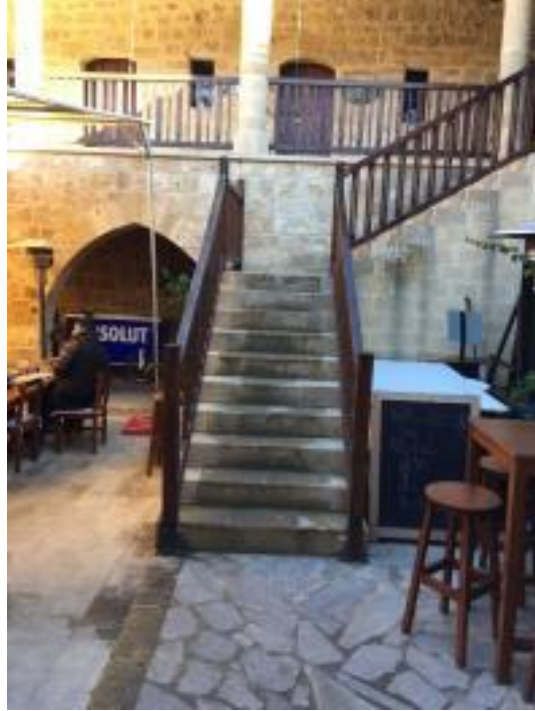
a- Ornaments & floors: Damaged elements were replaced by stones from the same types. Although, the amount of replaced stones is too much, and the way of cutting stones was not the same original way, and texture relatively different in some parts from original one, new additions are generally harmonized. Thus, the authenticity was preserved, according to the International standards, as seen in Table 2.3. See Figure 3.32.

Figure 3.32: Stones and Ornaments of Kumarcılar Hanı. (Author, 2017)

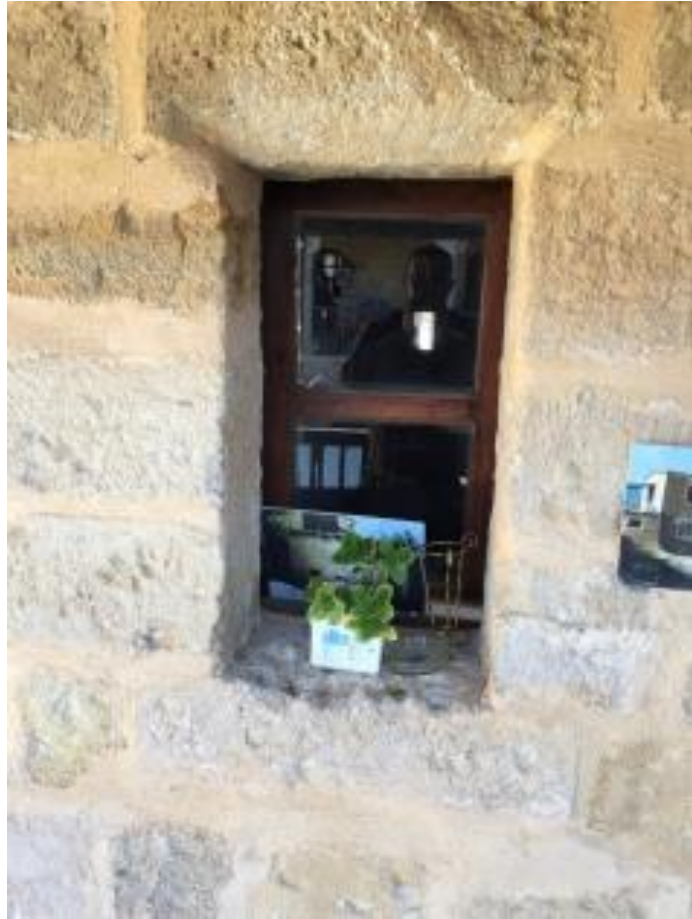
b- Openings: the glasses changed by using different materials with restoring the original colors and shapes, which indicates that the authenticity was not preserved completely, according to the International standards, as seen in Table 2.3. See Figure 3.33.

Figure 3.33: New Glass material employed (reflective). (Author, 2017)

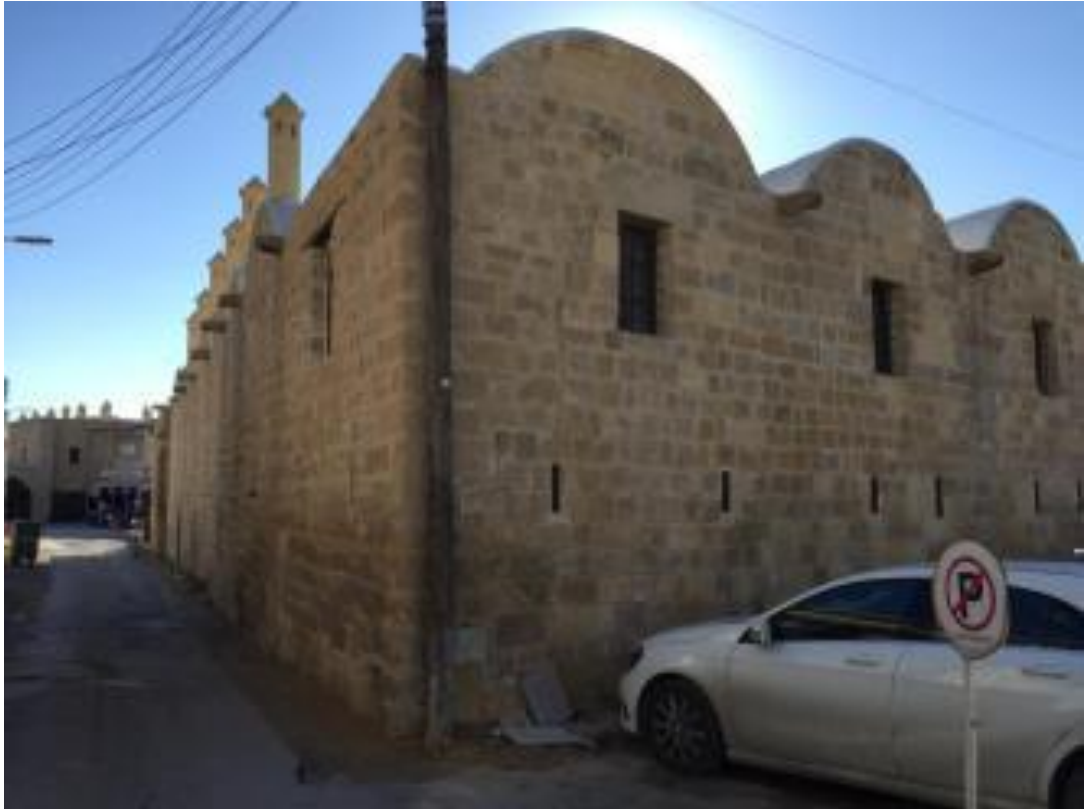
a- Building Form: The form of the building restored as original, and the authenticity has been preserved, according to the International standards, as seen in Table 2.3. See Figure 3.34.

Figure 3.34: Form of Kumarcılar Hanı, after conservation. (Author, 2017)

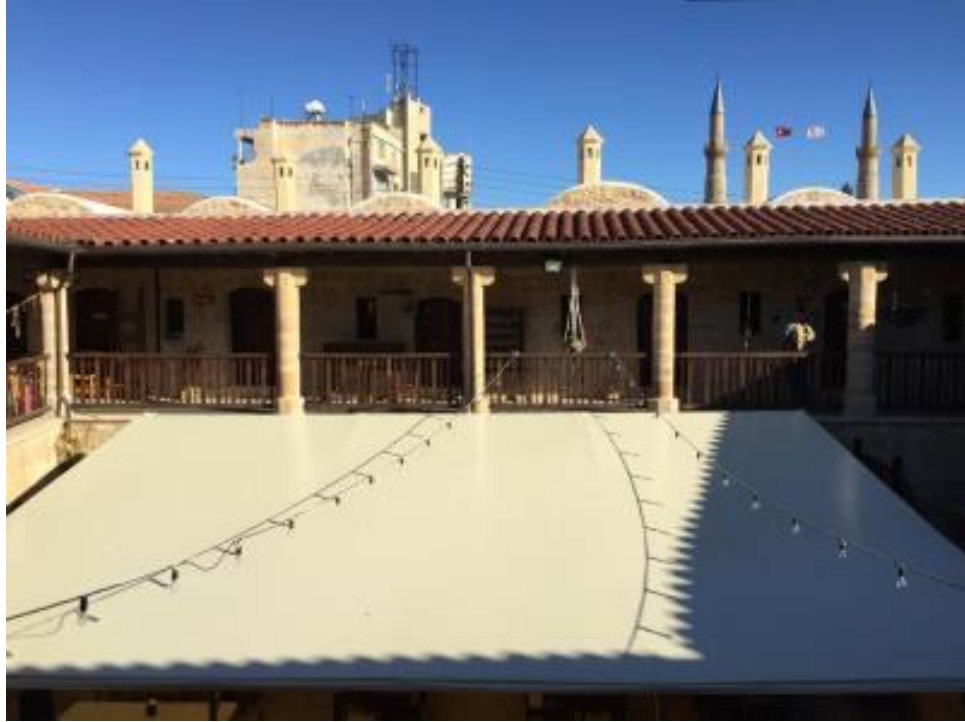
Figure 3.35: Lighting system after the conservation of the Kumarcılar Hanı. (Author, 2017)

b- Lighting: lighting system has been changed with new lighting system, where the original lighting position and luminous lux was different than existing ones, then that address of loosing of authenticity, according to the International standards, as seen in Table 2.3. See Figure 3.35.

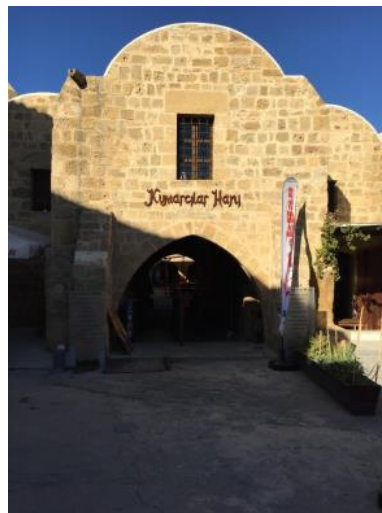
Figure 3.36: Outer walls of Kumarcılar Hanı, showing the entrance facade. (Author, 2017)

c- Advertising titles: No advertising signs are attached to the façades (except at the entrance gate), thus, the authenticity has preserved, according to the International standards, as seen in Table 2.3. See Figure 3.36 that shows the words of title not directly touching the façade of the building.

Third parameter is ‘signboards ; the observation and assessment of the Büyük Han building demonstrated that no signboards are allowed to be attached to the façades, thereby, the authenticity is preserved, and the same condition have been found for *Kumarcılar Hanı*. (See Table 4.1, ‘Form & Design- Advertising titles’).

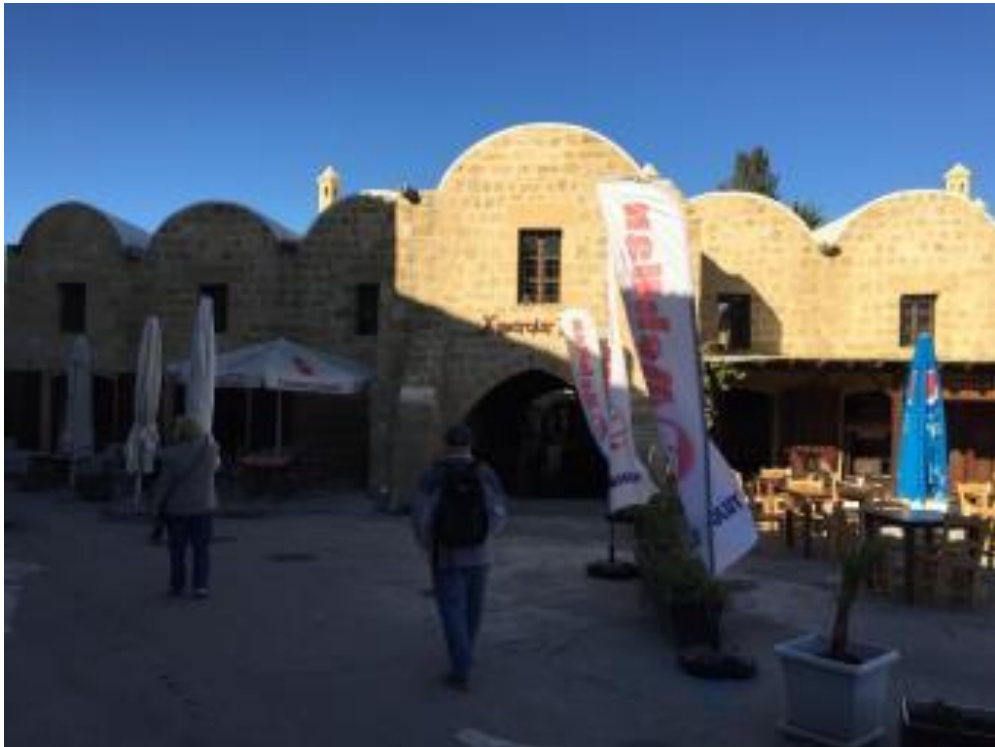
Figure 3.37: Places for tourism and entertainments in Kumarcılar Hanı. (Author, 2017)

b- Nowadays: during the implementation of the conservation project, old building technologies of the load-bearing system has been transferred to today's knowledge.

See Figure 3.37.

4. Function and Use: the same condition as what happened in Büyük Han; the functions were changed to ensure the commercial exploitation of the building, hence, the authenticity is not preserved, according to the International standards, as seen in table 2.3. See Figure 3.37. The urban center for the tourists to spend good time

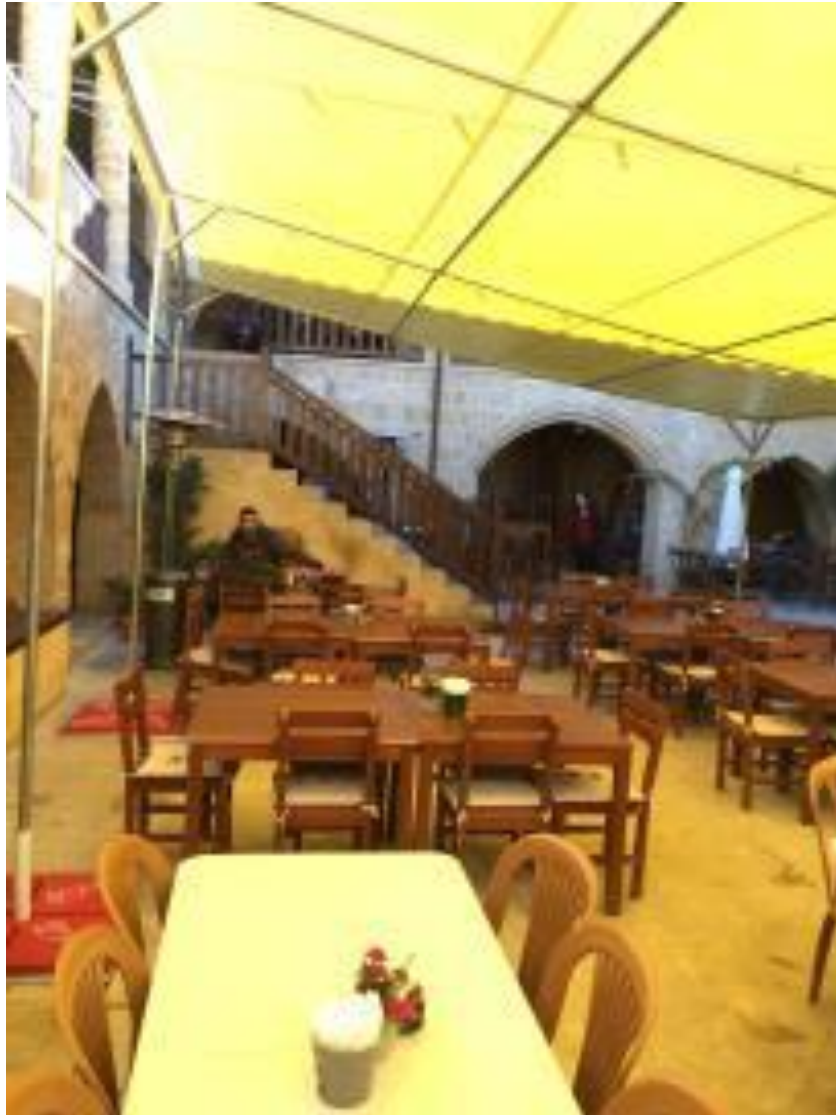
Figure 3.38: Adaptive Re-Use, and changing the original function of Kumarcılar Hanı. By (Author, 2017)

consists of restaurants, cafes, souvenir shops, and partially the traditional goods are selling there which are similar to original goods that were selling. Therefore, authenticity is preserved, according to the International standards, as seen Table 2.3. See Figure 3.38.

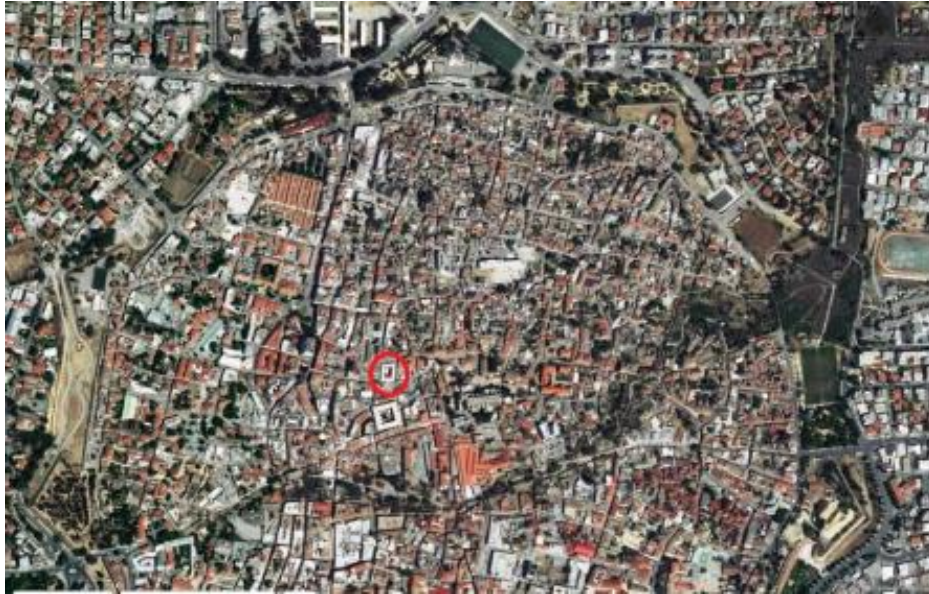
Figure 3.39: Location of the Kumarcılar Hanı inside The Walled-City in Nicosia. (Based on Google Map in 2017)

5. Location and setting: the Building is well integrated in the urban context, which preserve that authentic value, according to the International standard, as seen in Table 2.3. See Figure 3.39.

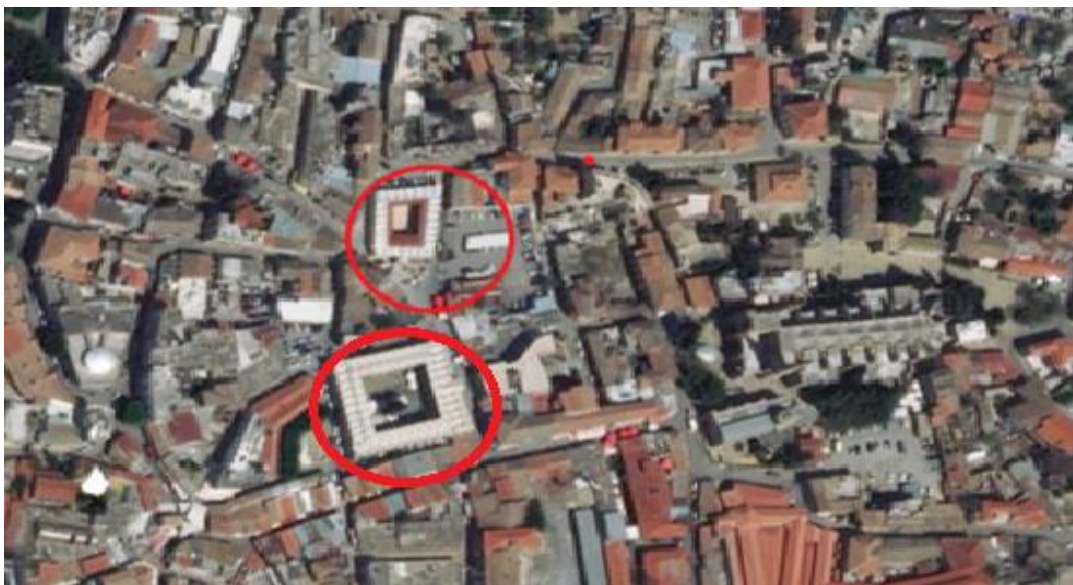
Figure 3.40: The different in size between Kumarcılar Hanı' (Surrounded by Red Circle), and Büyük Han (Squared building below). (Based on Google Map in 2017)

a- Scale: The scale of the historical building is small relatively if compare with the Büyük Han, as shown in Figure 3.40, and stores remained as they were that means the authentic value has been partially preserved according to the International standards. See Table 2.3.

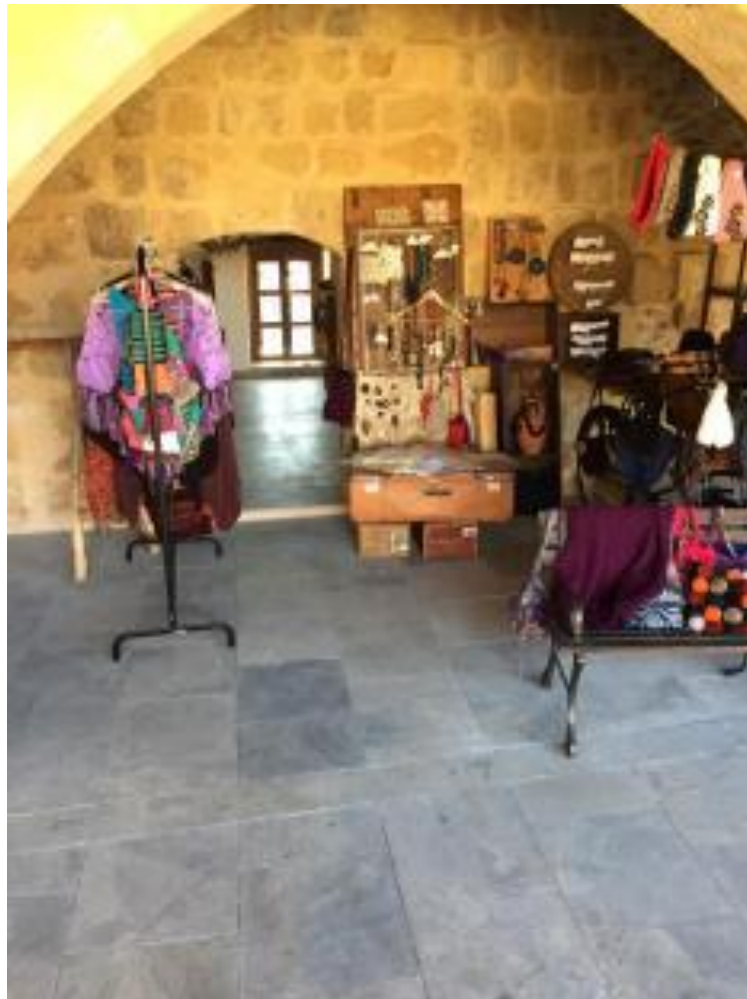
Figure 3.41: Traditional goods, in Kumarcılar Hanı. ( Author, 2017)

b- Quality of Sold merchandize: Cypriot traditional goods, and other goods that brought from Turkey, about history of the place and the country, as what is made in Büyük Han but with smaller scale based on the size of the Kumarcılar Hanı which is smaller than Büyük Han, to give the spirit of past to the visitors. However, authenticity has been preserved as well, according to the International standards, as seen in Table 2.3. See Figure 3.41.

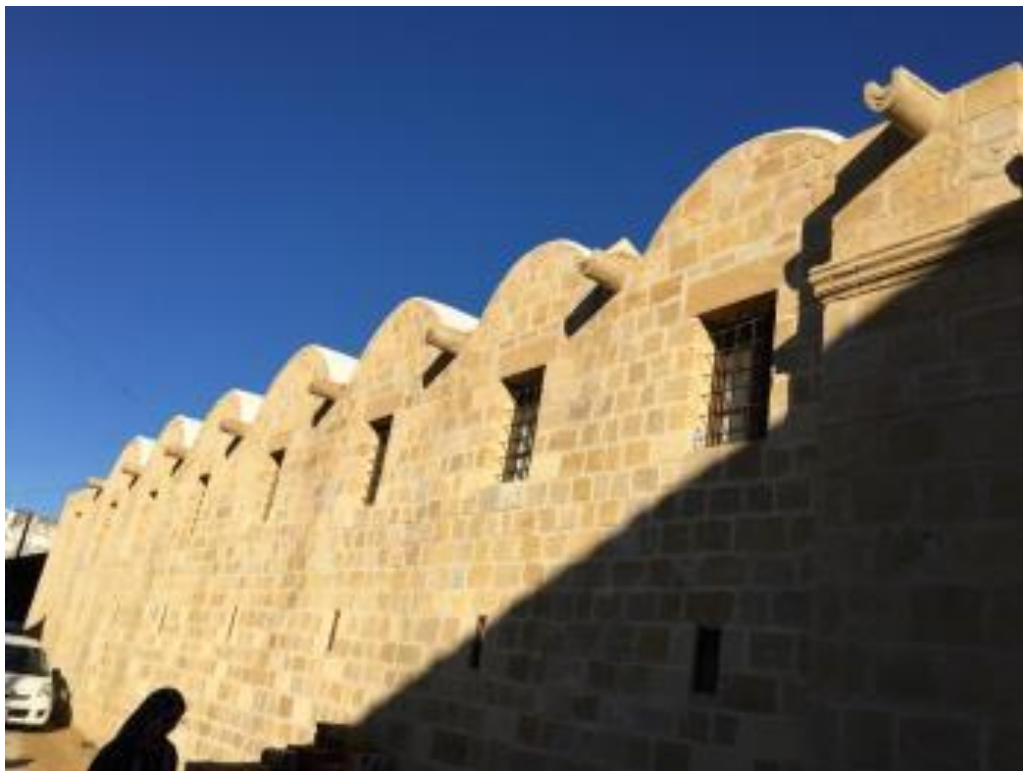
Figure 3.42: Conserving architectural elements in Kumarcılar Hanı. (Author, 2017)

2. Wholeness: the Kumarcılar Hanı, consist of conserved architectural elements, including the majority of the architectural elements, such as exterior walls, windows, and total rooms partially re-built as original. Therefore, integrity has been preserved, according to the International standards, as seen Table 2.3. See Figure 3.42.

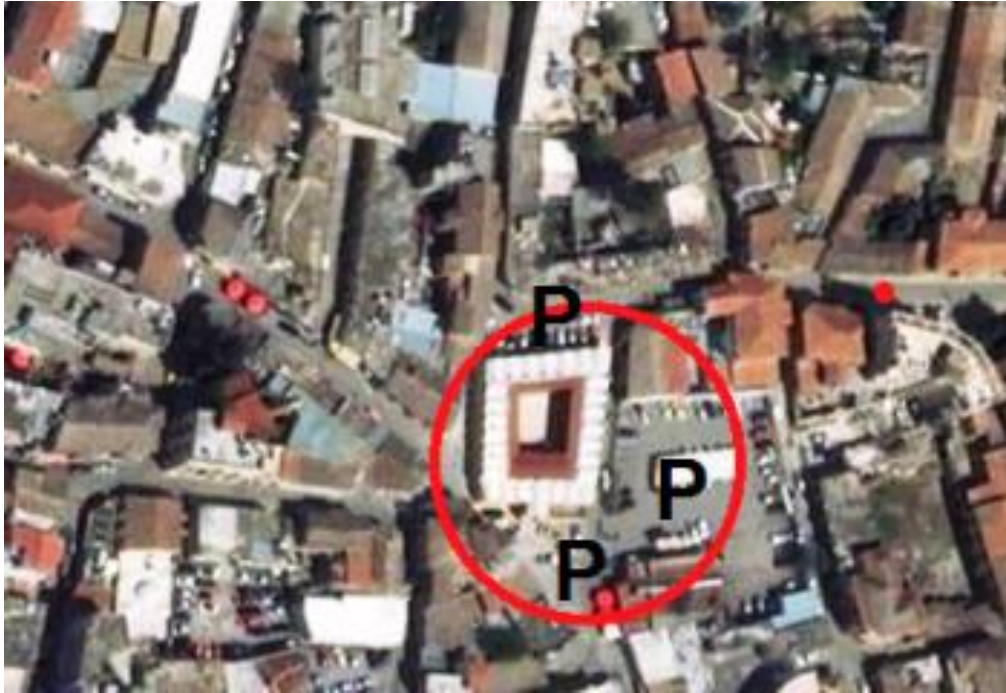
Figure 3.43: Kumarcılar Hanı surrounded with Car Parks. (Based on Google Map in 2017)

3. Honesty: it refers to the original elements of the building and the adverse effect of surrounded development on the historical building, which has been preserved partially, because of new activities, like car parking, some new shops that have been

built surrounding the Inn in following periods. Therefore, the integrity was partially preserved, according to the International standards, as seen Table 2.3. See Figure 3.43.

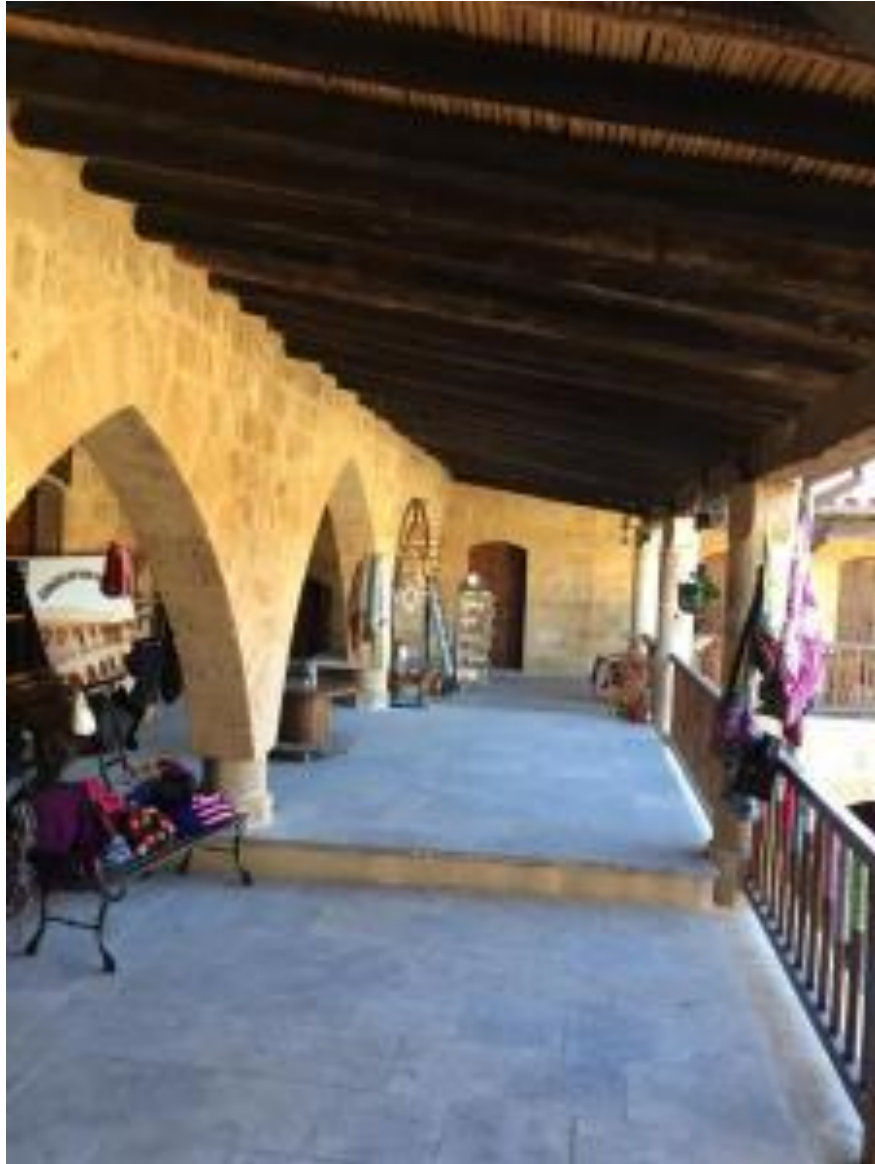
5. Structural integrity: There were damaged structural elements from the historical building of Kumarcılar Hanı more than what was in Büyük Han. But, in general the preservation had been achieved in proper way to keep the integrity of this building preserved, according to the International standards, as seen in Table 2.3. See Figure 3.44.

Figure 3.44: Conserved structure in Kumarcılar Hanı . (Author, 2017)
