**Conservation of Historic Khans through Adaptive  
Re-Use in the Walled-City of North Nicosia: A  
Comparative Analysis Based on the Concepts of  
Authenticity and Integrity**

Master of Science  
in  
Interior Architecture

Eastern Mediterranean University  
September 2018  
Gazimağusa, North Cyprus

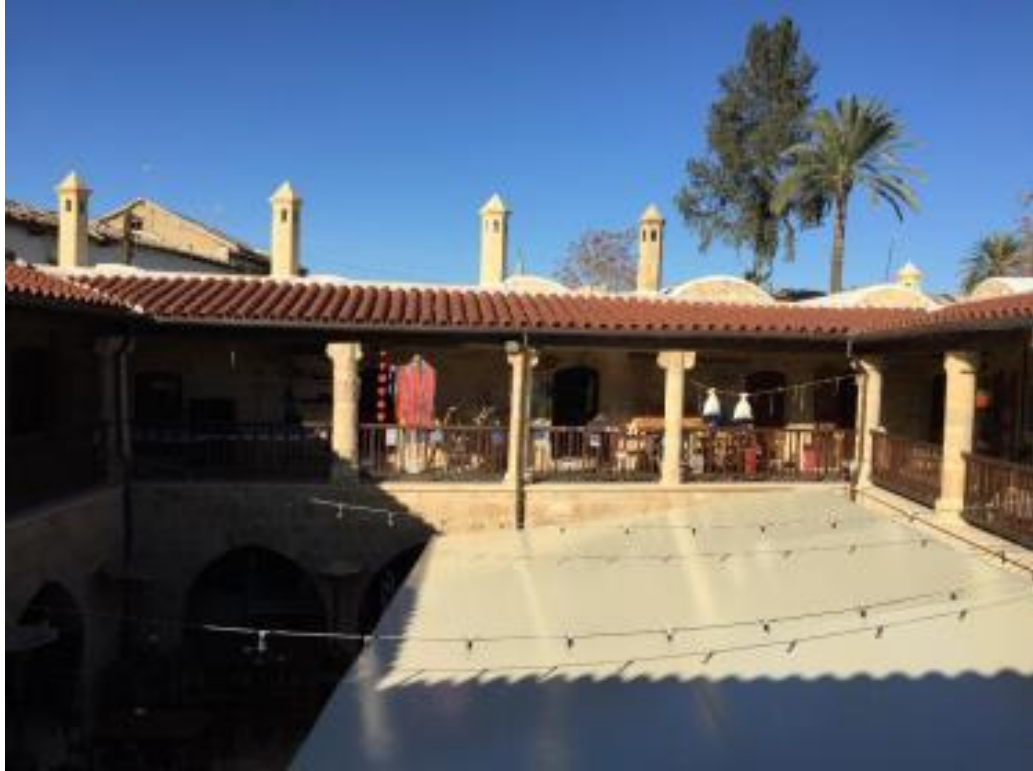
Figure 3.45: Conserved Kumarcılar Hanı, with its aesthetic value conservation. (Author, 2017).

6. Visual Integrity: In Kumarcılar Hanı the aesthetic value presented within the original historical building by conserving process, to do not lose the aesthetic value of the Inn. Hence, the integrity has been preserved, according to the International standards, as seen in Table 2.3. See Figure 3.45.
