The Deterioration of Concrete in Wastewater Treatment Plants

Master of Science
in
Civil Engineering

Eastern Mediterranean University
July 2013
Gazimağusa, North Cyprus

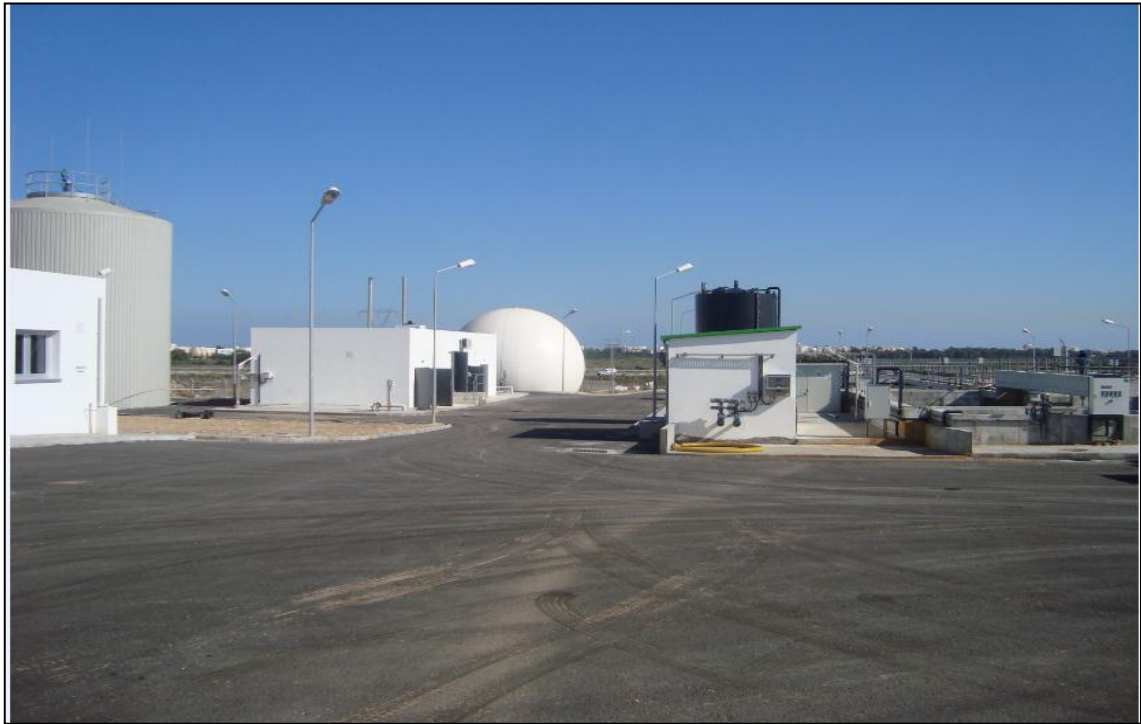
Figure 3.2: Unit Treatment Tanks of Gazimağusa WWTP

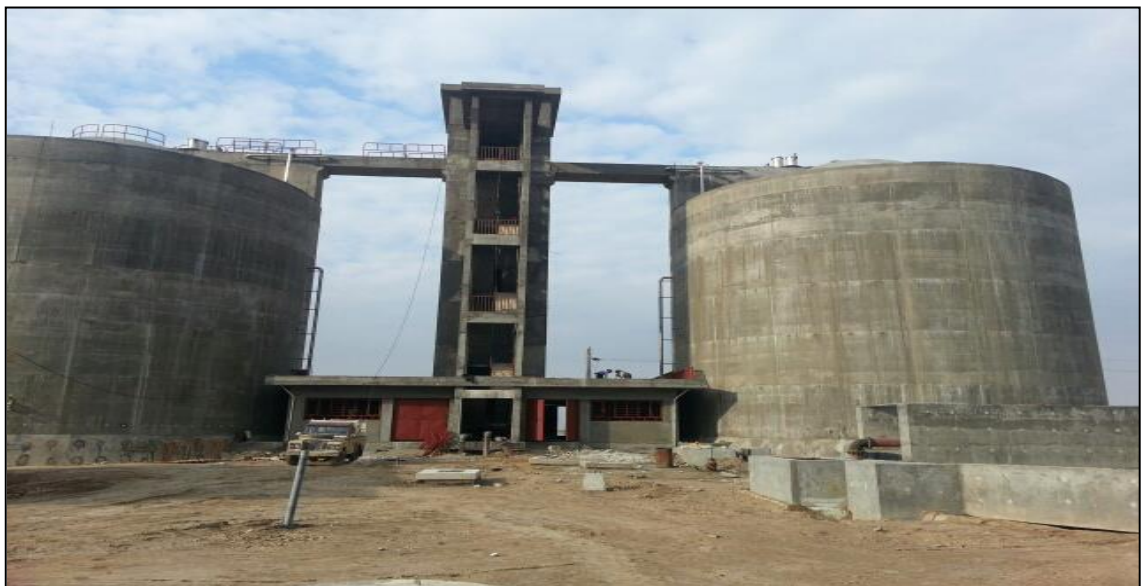
Baquba-Iraq WWTP is an Iraqi project in the middle of Iraq. This plant serves 250,000 people. The project was designed by the Germany Company in 1979; however the construction started in 2008 due to the war.

Figure 3.4: Digester Tank in Baquba-Iraq WWTP

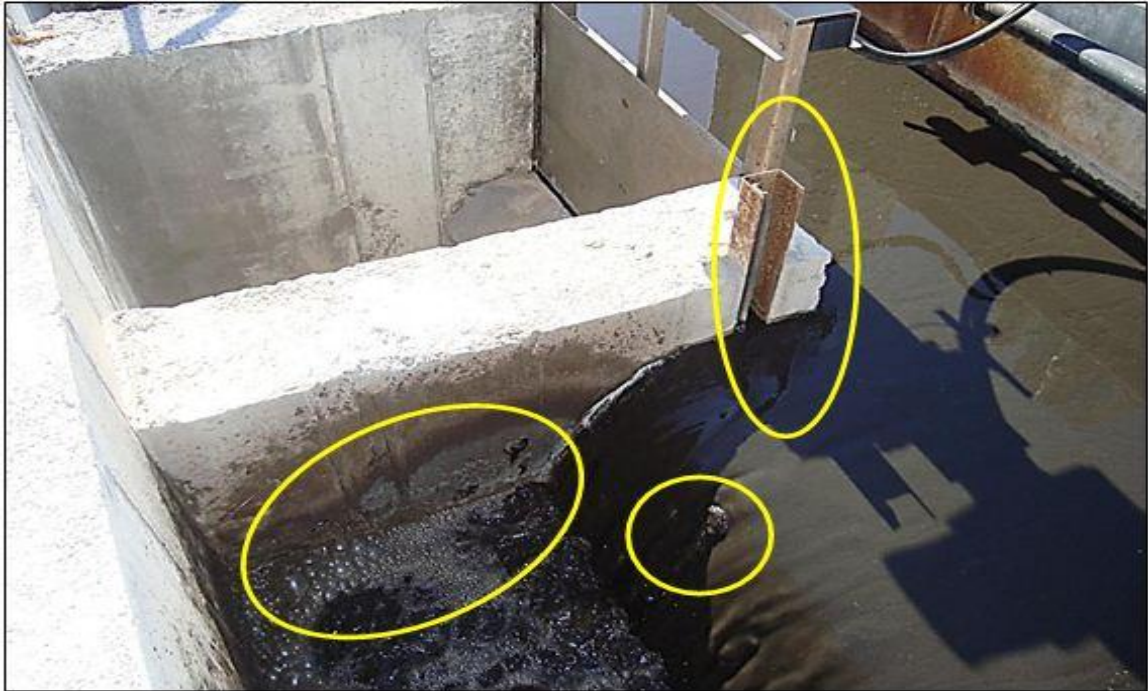
Figure 4.1 and 4.2 shows the initiation of corrosion in the stop logs and pipes which are produced by iron. In order to protect these parts from corrosion, they should be isolated by using epoxy or such like materials. On the other hand, as it can be observed from Figure 4.1, concrete surface is not smooth due to the existing small holes and pores. This may increase the rate of penetration of the wastewater into the concrete. In Figure 4.3 shows the poor workmanship, where the nails are kept inside the concrete. Since the H_2S gas is very effective in this area after a few years of time, the concrete will deteriorate and the steel bars will suffer from corrosion.

Figure 4.1: Bump Concrete and Rusting of the Steel.

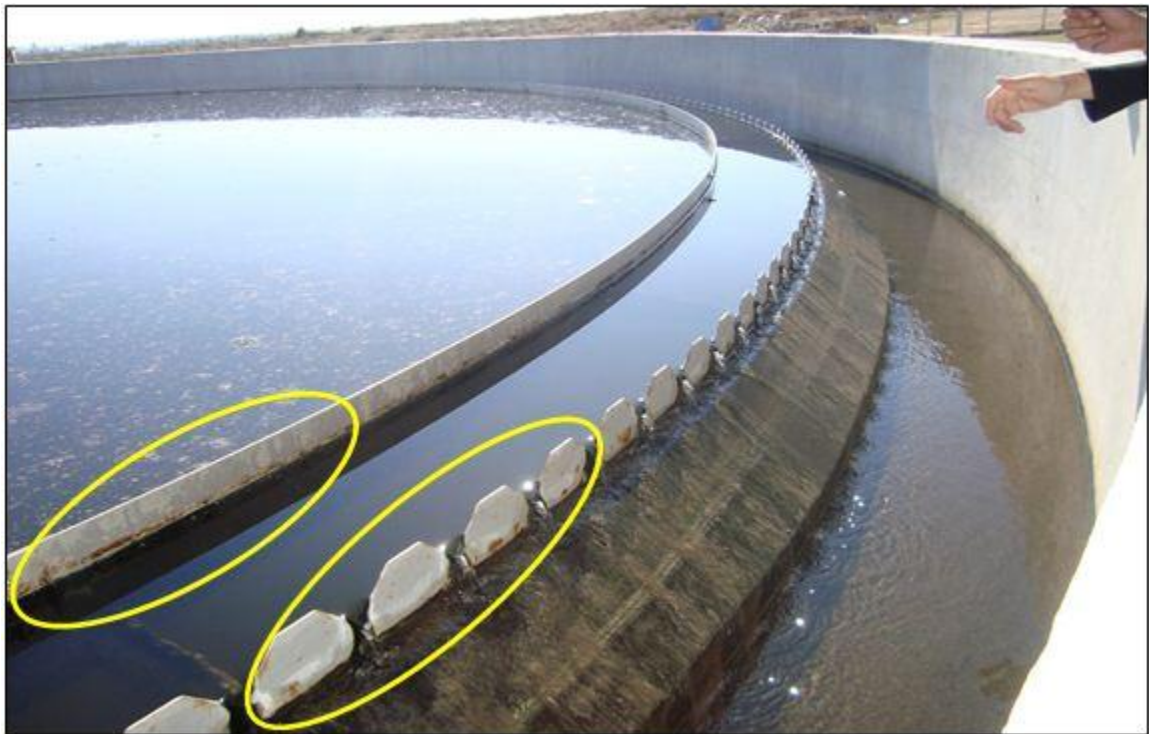
Figure 4.2: Rust Layer on the Secondary Tank

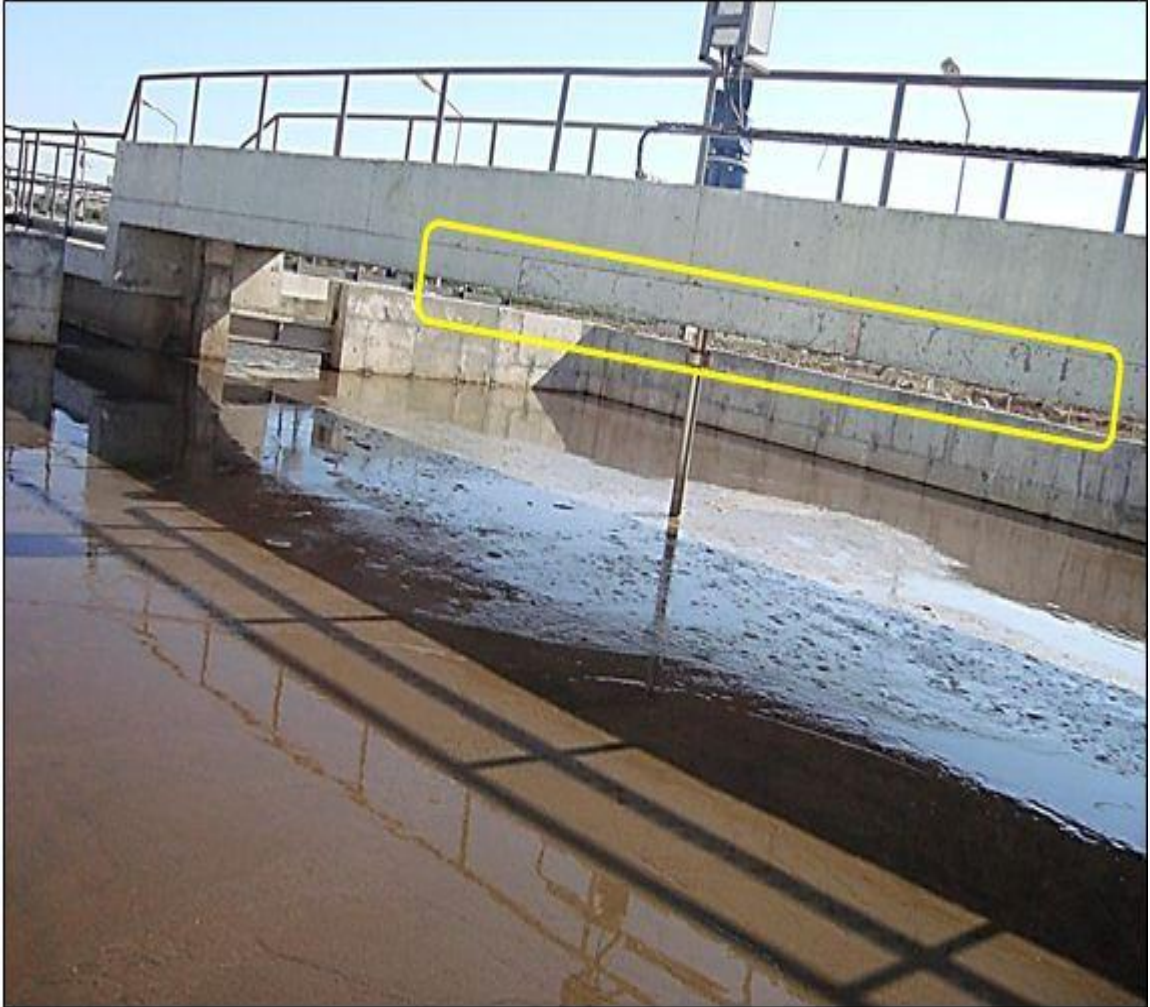
Figure 4.3: Workmanship Problems

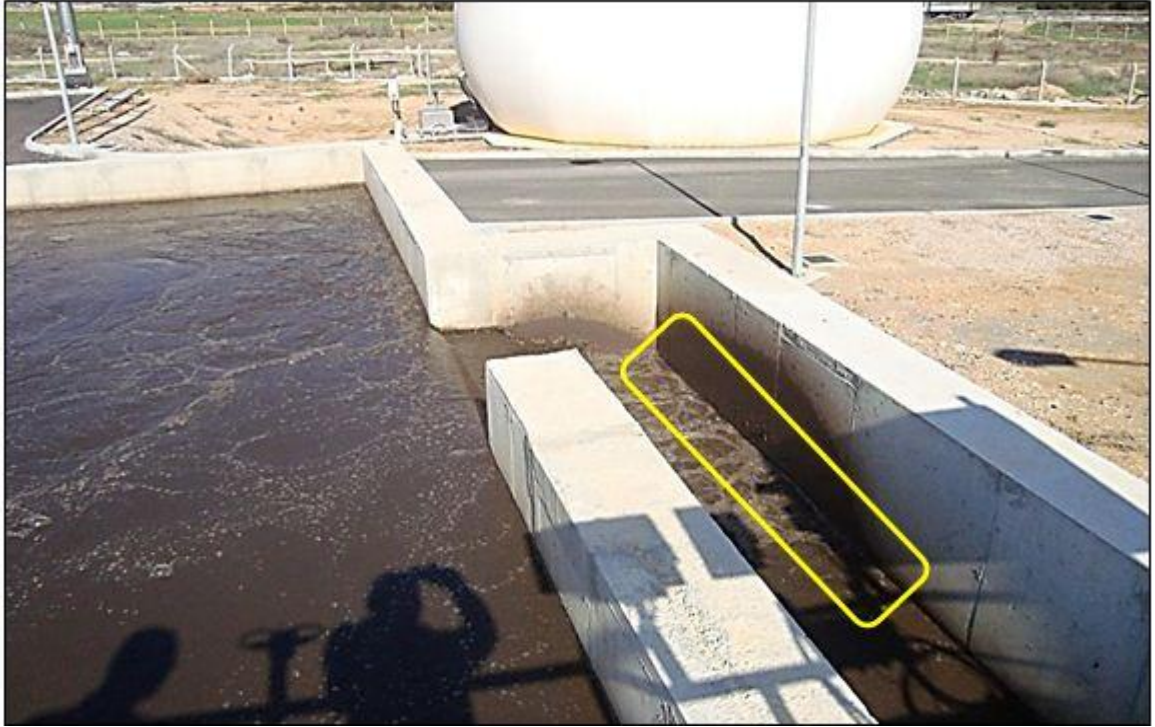
Microbiological problems have the greatest effect on concrete deterioration especially in wastewater treatment plants. The effect of micro-organism can be observed in the main lagoon which is the first unit for the wastewater treatment process. In these sewer systems, the bacteria create a sulphur cycle, which can lead to the formation of sulphuric acid. The formation of this sulphuric acid is the main cause for the further expansion of the corrosion of steel bars process (Figure 4.4 and 4.5).

Figure 4.4: The Effect of Microorganism on Concrete Surface in Main Lagoon

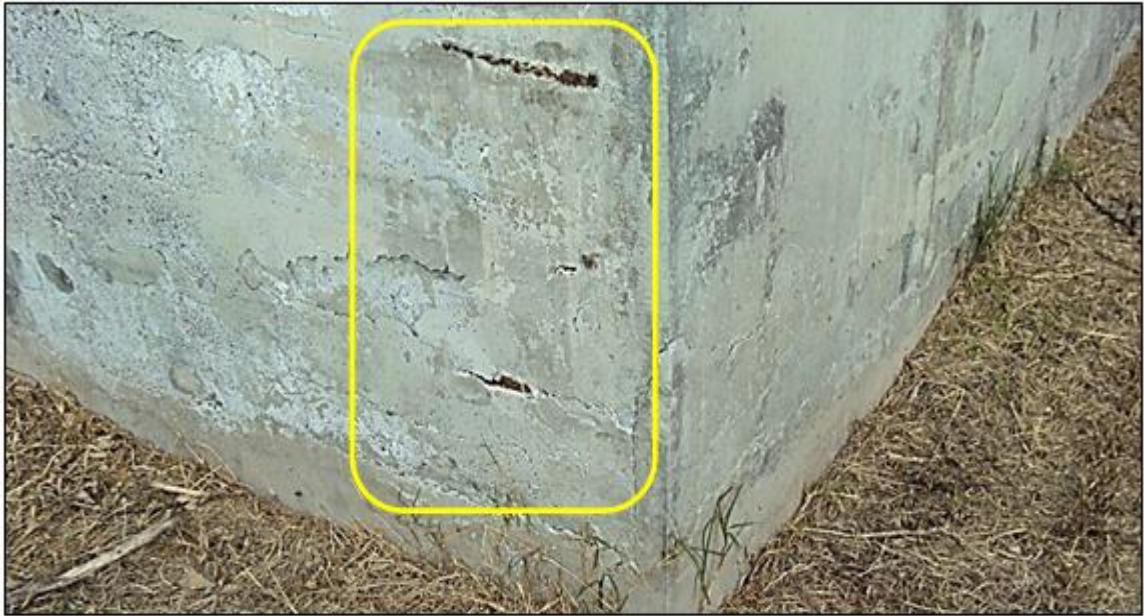
The thickness of the concrete cover is one of the main factor that affect the rate of penetration of chloride ions, and the incursion of carbon dioxide into the concrete to reach the level of the steel bar. When the thickness of the concrete cover is adequate, chlorides and carbon dioxide takes more time to reach to the surface of the steel bar. As it can be displayed in Figure 4.8, the cover thickness of the concrete is very small and therefore corroded within the past fifteen years.

Figure 4.8: Cover Problem at the EMU Campus WWTP.

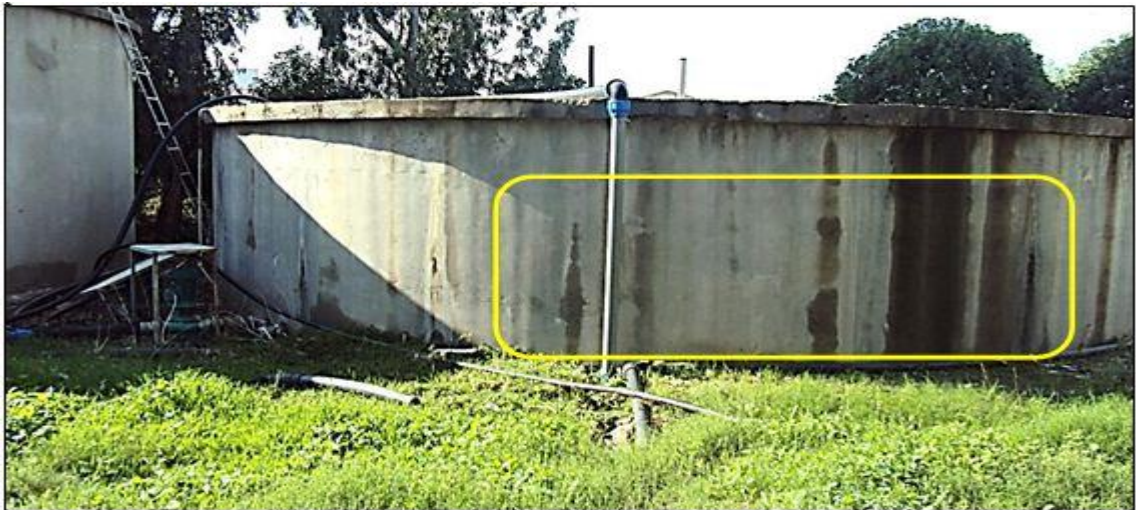
Permeability of concrete is one of the most important factor that must be taken into account during the design and implementation stages of a durable concrete. EMU campus WWTP concrete is very permeable to water and gas. This situation accelerated the corrosion of steel bars process as shown in the figure below.

Figure 4.9: Permeability Problem at the EMU Campus WWTP.

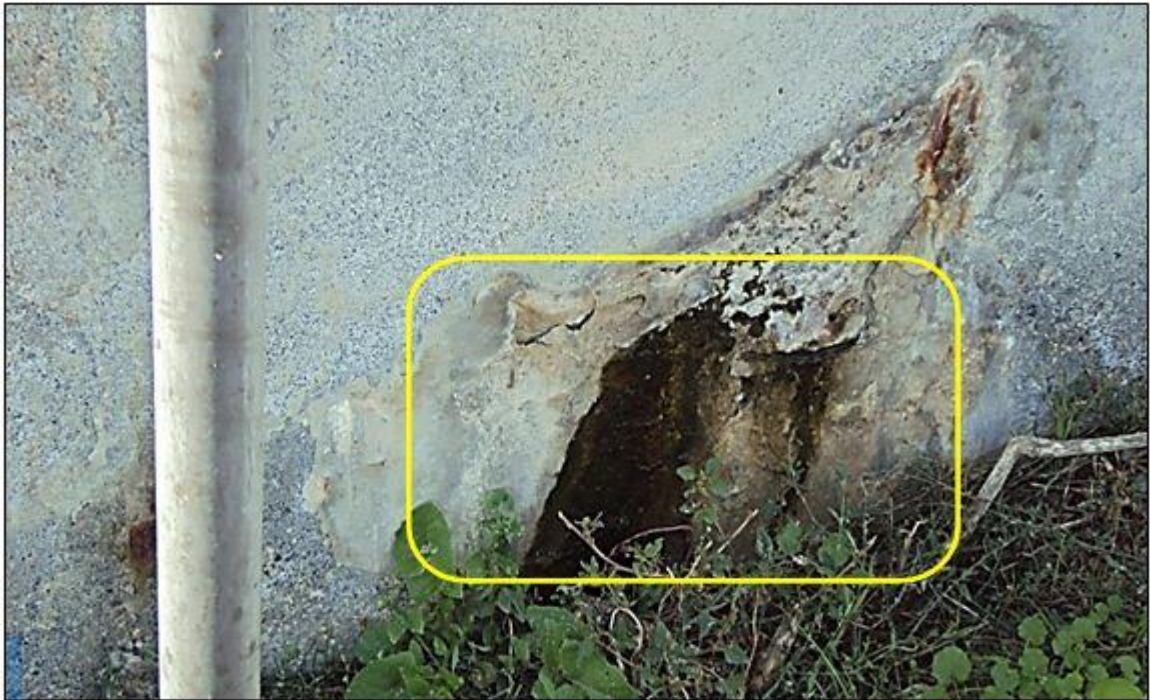
This is the most common type of problem that occurs when the water contains dissolved sulphate due to bacteria and penetrates into the concrete. This reaction leads to changes in the composition and microstructure of the concrete. These changes commonly include; extensive cracking due to expansion, loss of bond between the cement paste and its aggregates, alteration of paste composition. The effect of these

changes is the overall loss of concrete strength and durability. These changes can be seen in Figures 4.11 and 4.12.

Figure 4.11: Sulphate Problem in the EMU Campus WWTP

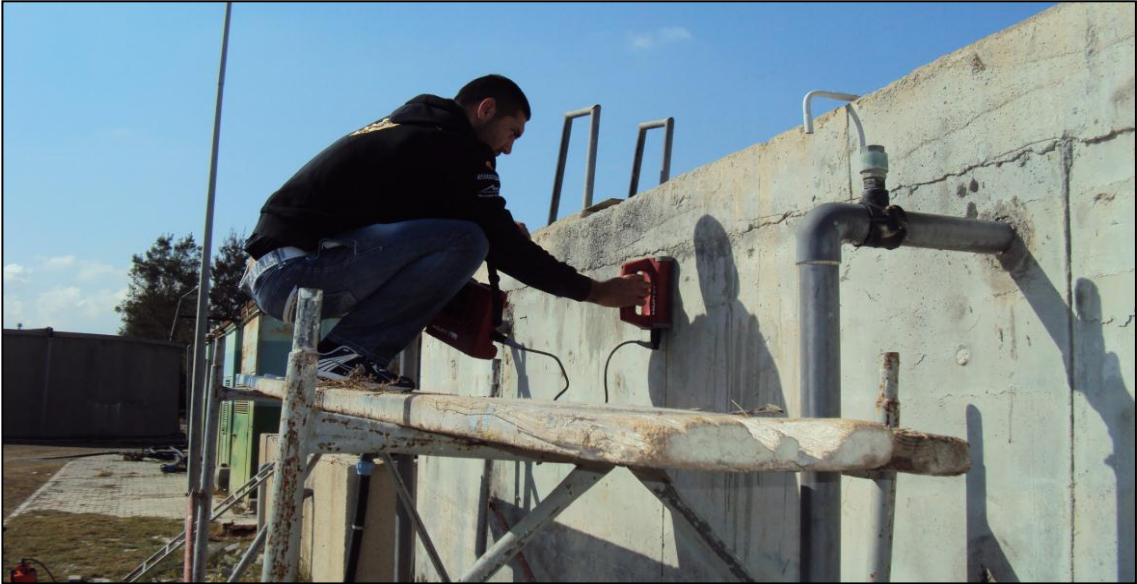
According to ASTM C42/C42M-13 named as "Standard Test Method for Obtaining and Testing Drilled Cores and Sawed Beams of Concrete", eight core samples were taken from two units of the EMU campus wastewater treatment plant. To determine the actual compressive strength a total of five core samples were taken either from unit-1 or unit-2. On the other hand, three more core samples were taken only from unit-1 for

Figure 5.1: Determination of Core Sample Location

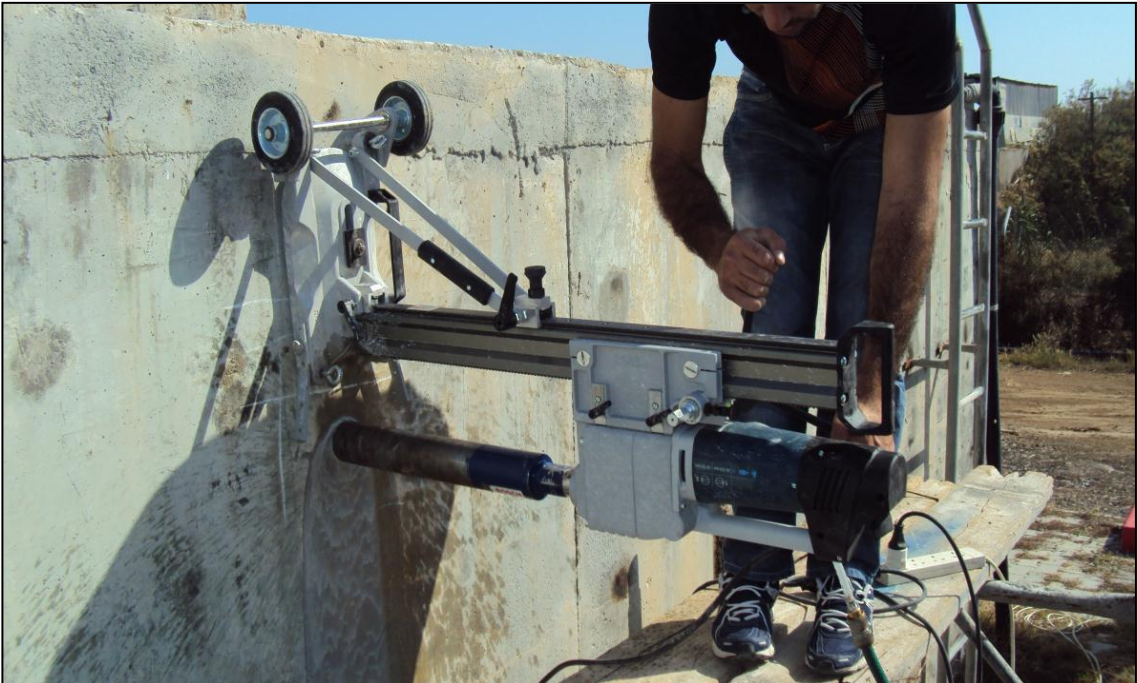
Figure 5.2: Sampling Core Operation

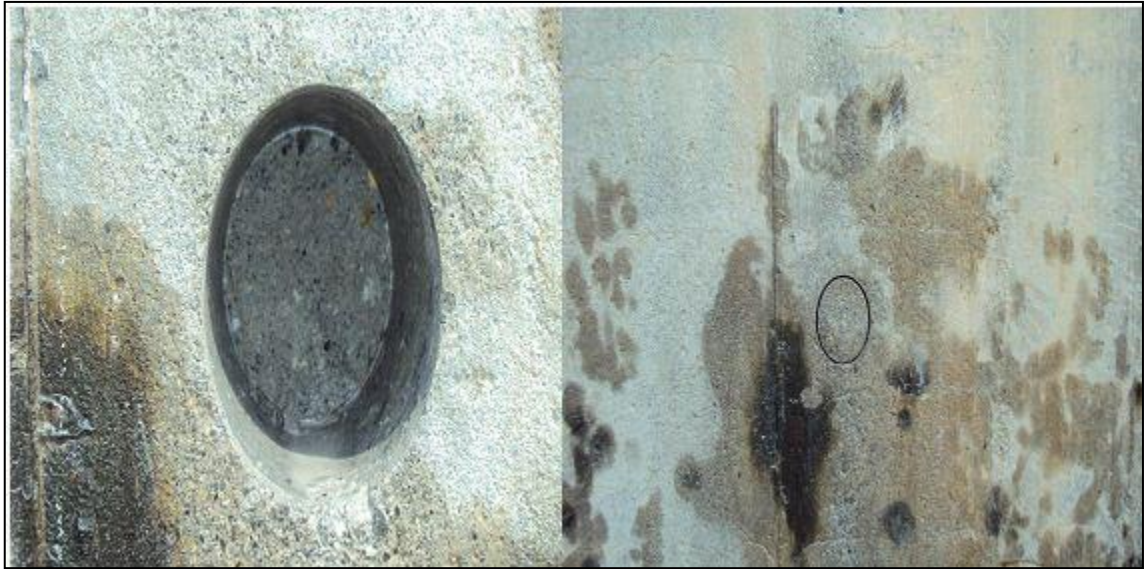
Figure 5.3: Sample Core Drilled

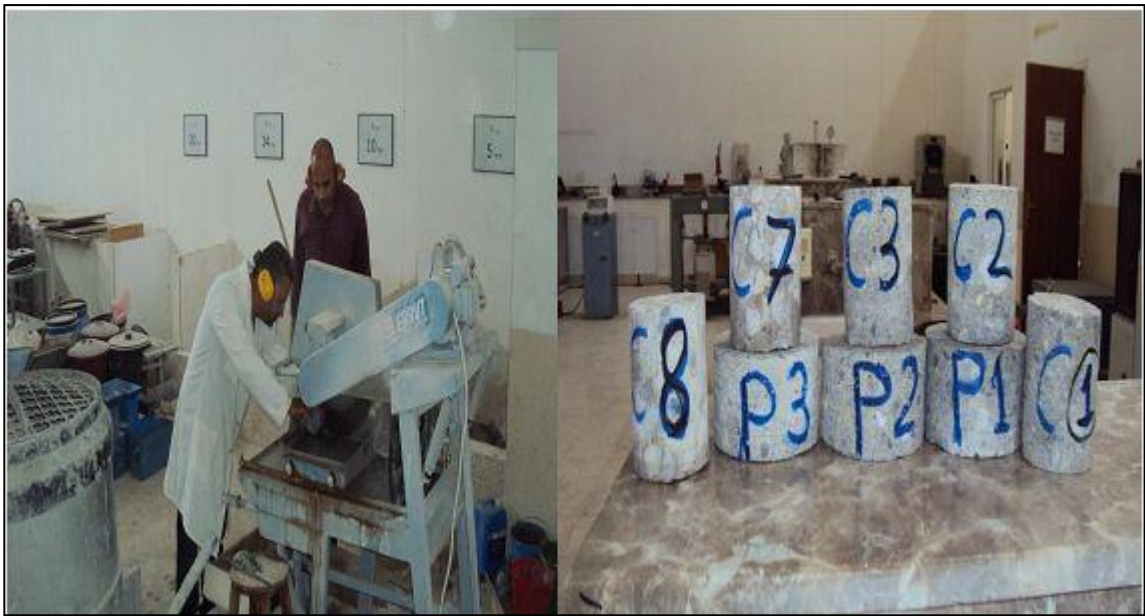
Figure 5.4: Sampled Core Cutting Process for Test.

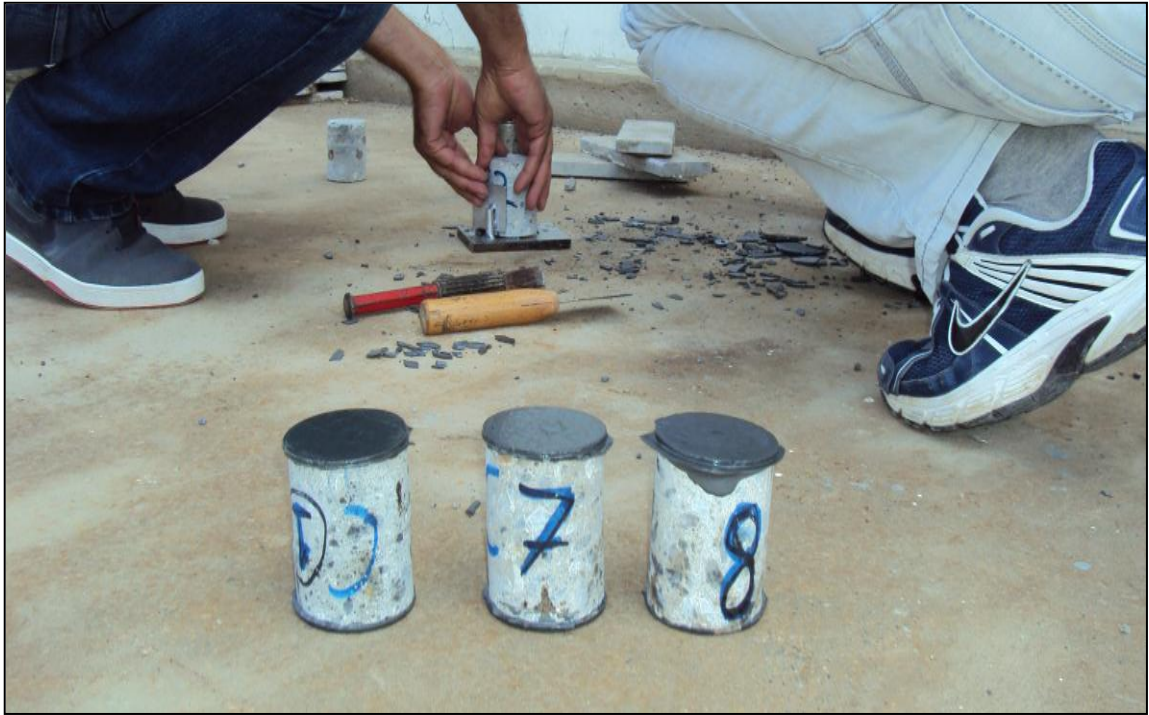
After finishing the cutting process as shown in Figure 5.5, the capping operations were done for the five samples to prepare them for the compressive strength test. After the capping process, the concrete specimens were cured for two days in a water tank as shown in Figure 5.6.

Figure 5.5: Capping Specimens

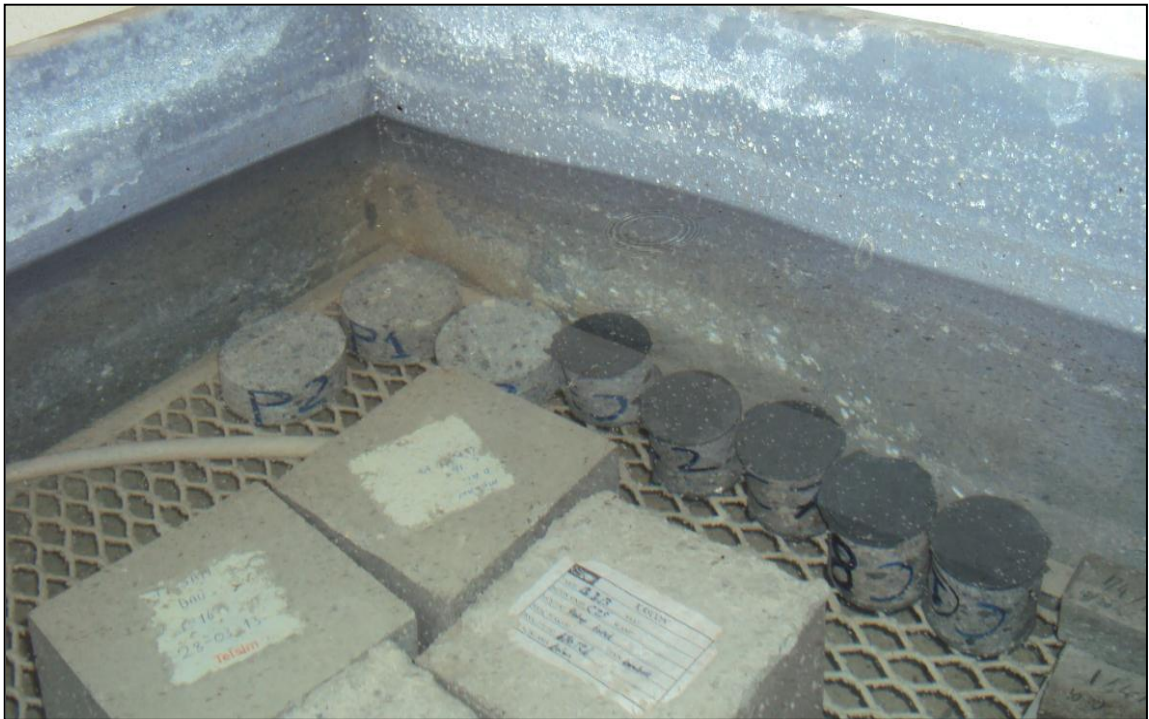
Figure 5.6: Curing Process of Specimens

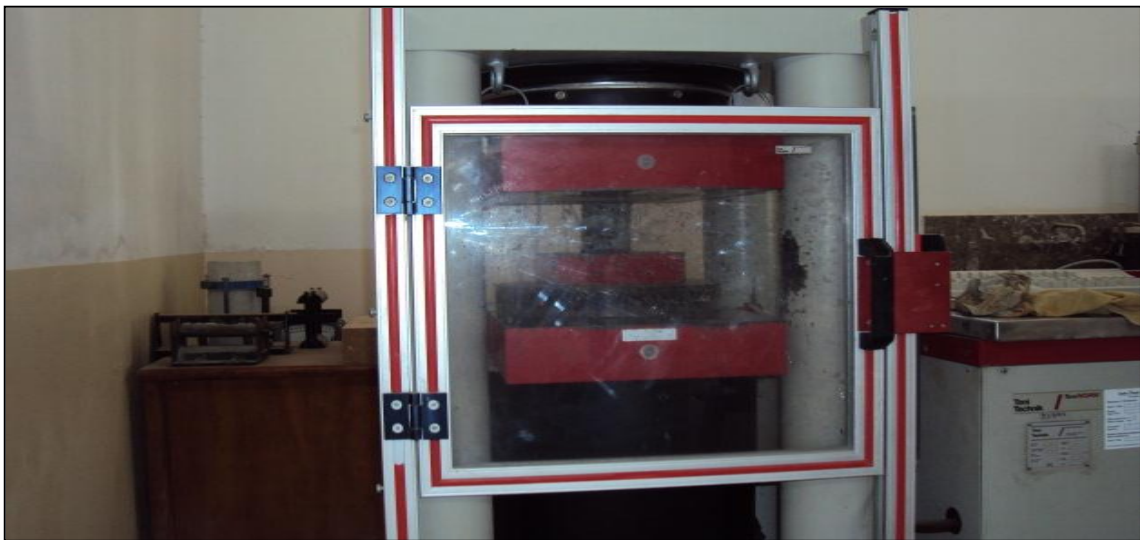
Figure 5.7: Compressive Strength Tests

According to the TS-EN 206.1 standard given in Table 3.5; the actual compressive strength test result of unit-1, with an average value of 24.4 MPa, corresponds to C20 type concrete. However, according to the average value obtained for unit-2, which is 46.83 MPa, corresponds to C40 type concrete.

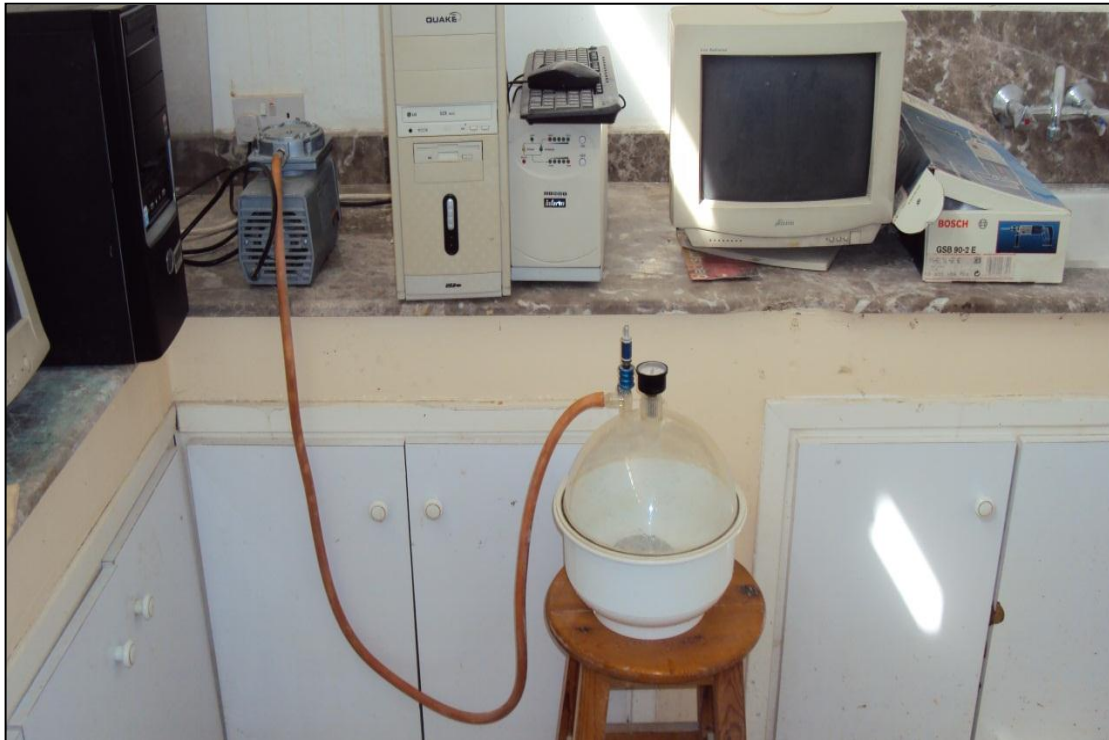
For this research, the permeability tests were carried out on three samples taken from unit-1. The test was implemented according to ASTM C1202. The vacuuming process of these samples, before testing, is shown in Figure 5.8.

Figure 5.8: Vacuuming Apparatus

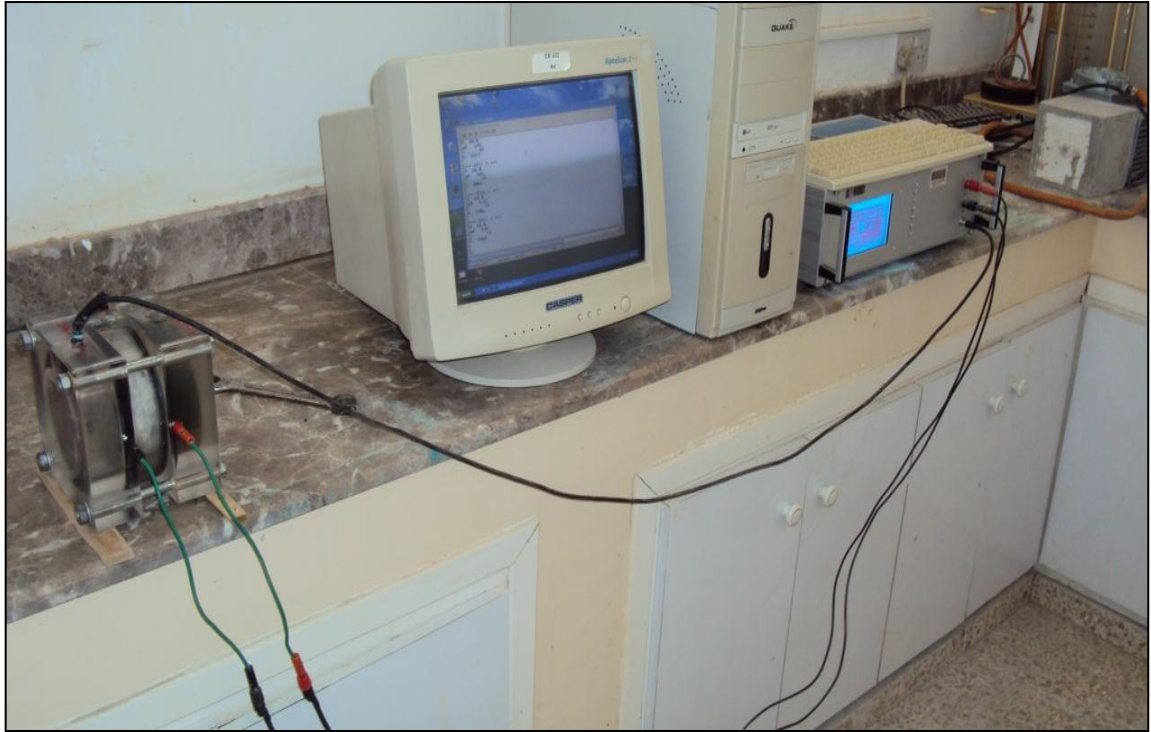
After installing the machine, the test was launched to find the change (coulombs) passing through the specimen. Readings were taken every five minutes as disclosed in appendix 5.

Figure 5.9: Recording of Permeability Values

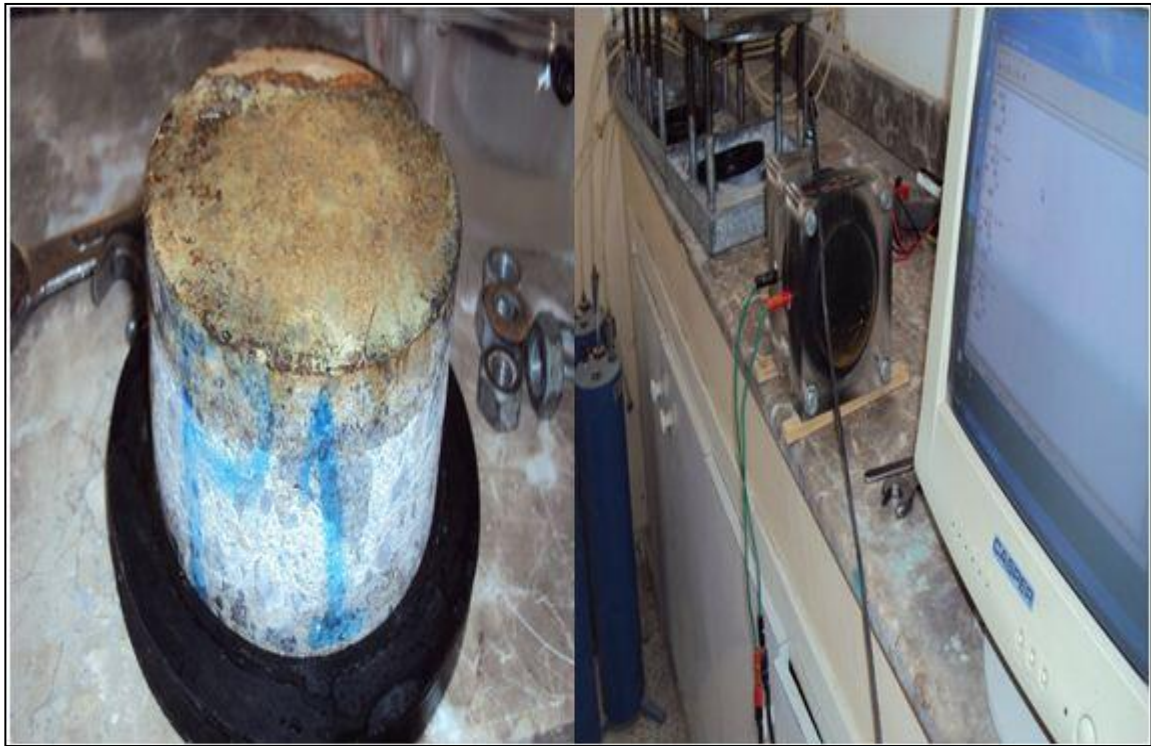
Figure 5.10: High Permeable Concrete

As it can be observed in Table 5.2, all values recorded from the three samples of unit-1 are greater than 4,000. This means that the concrete of unit-1 is highly permeable.

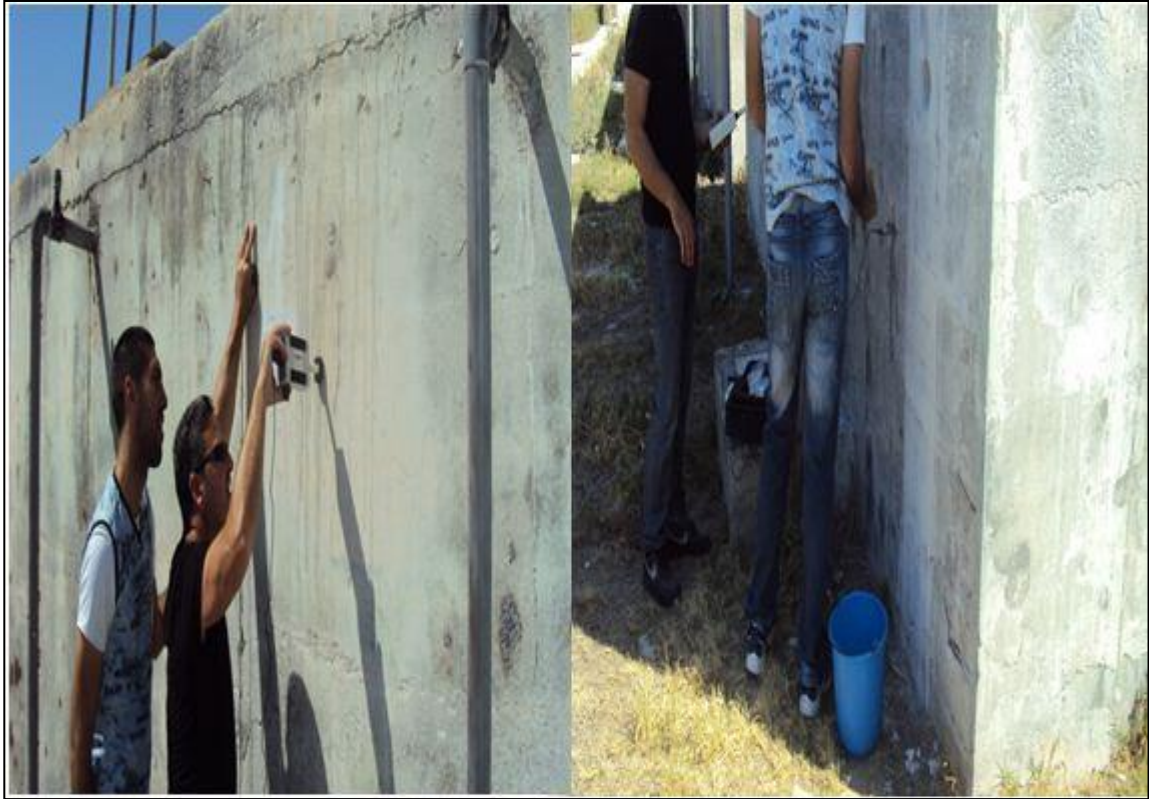
According to ASTM C876-80, the measurements for the potential corrosion were carried out by drawing a grid with 10*10 cm dimension as shown in Figures 5.11 and 5.12. The area of corrosion and their percentage can be obtained using this method. This test was applied to two different points of unit-1. One reading is taken from the top of the concrete wall and the other reading is taken from the bottom which is in direct contact with the wastewater.

Figure 5.13: Potential Corrosion Measurement Process.

If the test results are compared; an extreme difference exists between the corrosion percentage results for the reinforcement steel bars of the concrete which are in direct contact with the wastewater than the corrosion reading taken from the top of the wall. The corrosion result for the first case is 95%, while for the others, which are not in direct contact with the wastewater, it is only 5%.
