Roof Defects in North Cyprus

Submitted to the
Institute of Graduate Studies and Research
in partial fulfillment of the requirements for the Degree of

Master of Science
in
Architecture

Eastern Mediterranean University
February 2015
Gazimağusa, North Cyprus

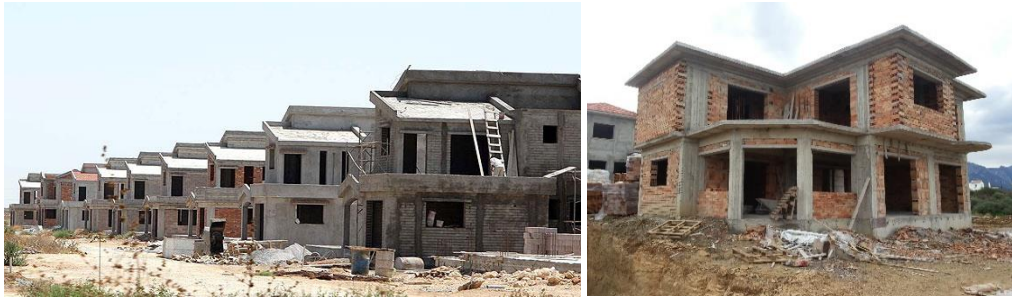
Figure 39 and 40. Construction in North Cyprus (URL 2, 3)

After 1985 applying insulations became more popular and construction began to cost more. Contemporary roofs are generally flat, with 15 cm thickness. Reinforced structures are common, most of the roofs are built without any thermal insulations. This type of construction is cheap, however; results in great problems. This technique is similar in all cities in North Cyprus and is often applied because it requires no special skills (Florides et al., 2001). [Figure 39, 40]

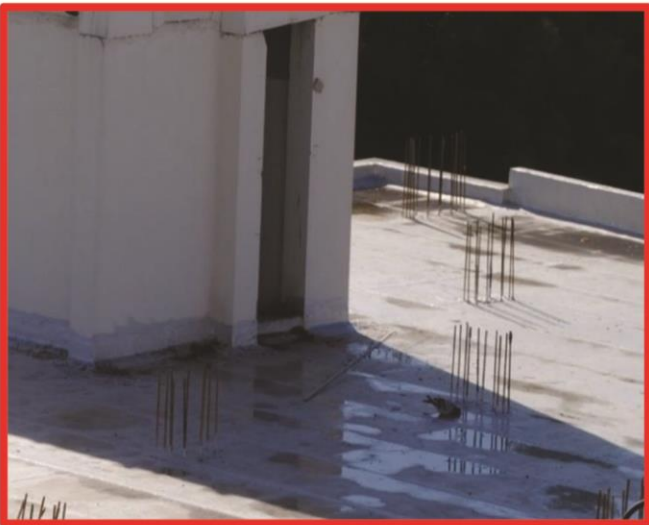
Flat Roof	Common Roof Defects and Suggestions for Flat Roofs in North Cyprus			
<p>Problem: Ponding</p>	<p>Reason of Problem</p>	<p>Suggestion 1 (waterproofing above insulation)</p>	<p>Suggestion 2 (with impermeable concrete)</p>	<p>Suggestion 3 (for vehicular traffic)</p>

<p>Reason: Lack of proper leveling and sloping</p>

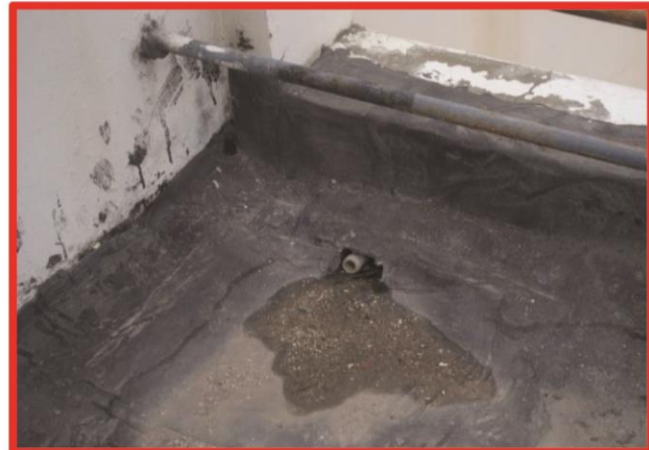
<p>Problem: Lack of cover for drains</p>	<p>Reason of Problem</p>	<p>Suggestion 1 (waterproofing above insulation)</p>	<p>Suggestion 2 (for foot traffic)</p>

<p>Reason: Lack of cover for drains results in blocked pipes and improper drainage</p>

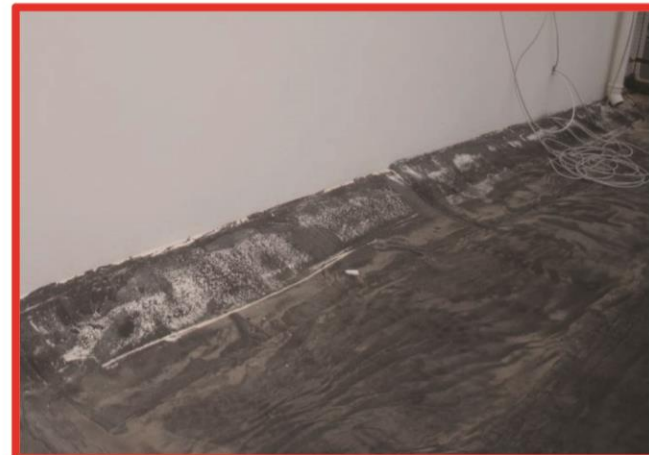
<p>Problem: Improper roof and wall joint</p>	<p>Reason of Problem</p>	<p>Suggestion 1 (waterproofing above insulation)</p>	<p>Suggestion 2 (for foot traffic)</p>	<p>Suggestion 3 (for vehicular traffic)</p>

<p>Reason: Lack of proper design details results in construction without knowledge</p>

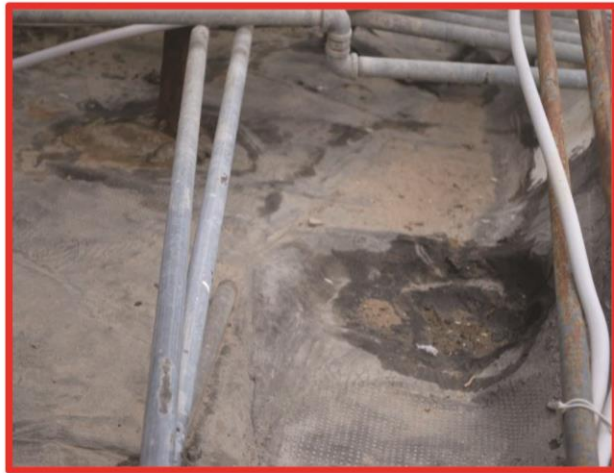
Flat Roof		Common Roof Defects and Suggestions for Flat Roofs in North Cyprus		
<p>Problem: Improper slope to the drain</p>

<p>Reason of Problem</p> <p>Reason: Improper slope to the drains causes improper drainage</p>

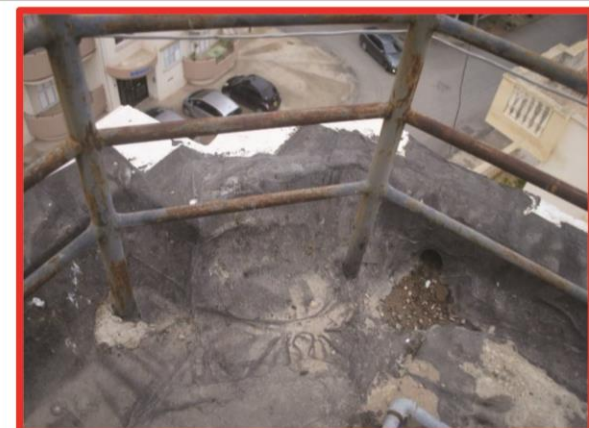
<p>Problem: Improper joint between roof and parapet wall</p>

<p>Reason of Problem</p> <p>Reason: Improper detailing causes ridging and cockling in the joint of roof to the parapet</p>

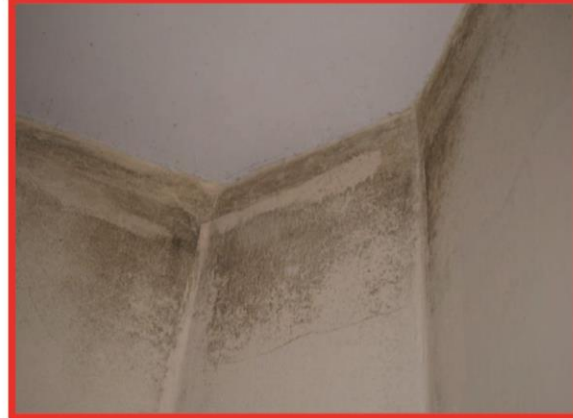
<p>Problem: Lack of thermal insulation</p>

<p>Reason of Problem</p> <p>Reason: Lack of thermal insulation causes condensation and mold growth under roof</p>

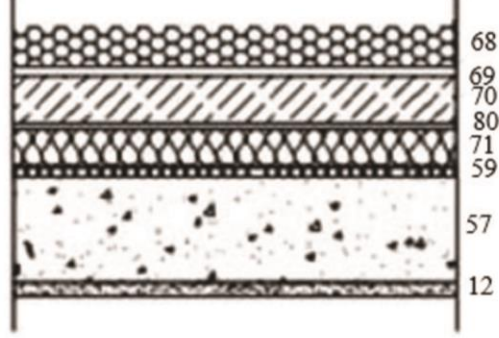
<p>Suggestion 2 (Proper detail for thermal comfort)</p>

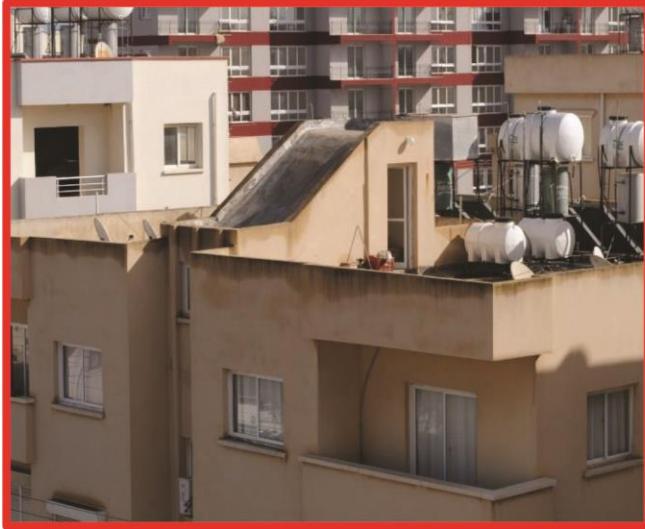
Flat Roof		Common Roof Defects and Suggestions for Flat Roofs in North Cyprus		
<p>Problem: Lack of coping</p>

<p>Reason of Problem</p> <p>Reason:</p> <p>Lack of coping causes water penetration to the external walls</p>

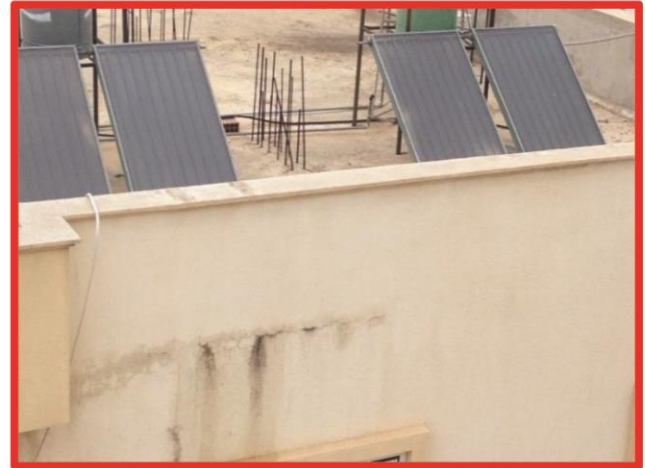
<p>Problem: Improper wall to roof joints</p>

<p>Reason of Problem</p> <p>Reason:</p> <p>Poor wall to roof joining detail</p>

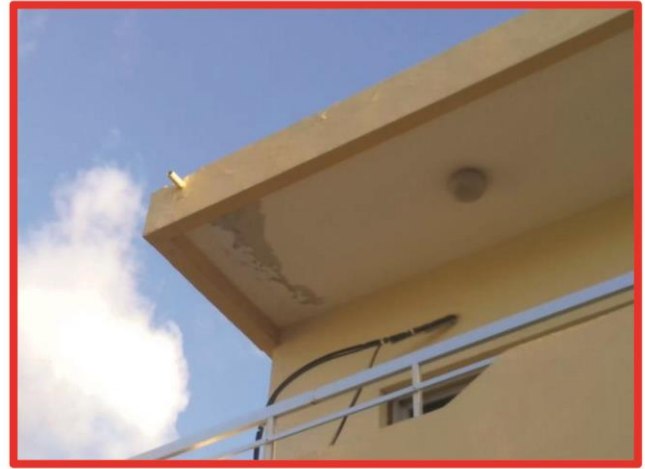
<p>Problem: Improper drainage</p>

<p>Reason of Problem</p> <p>Reason:</p> <p>Improper drain pipes</p>

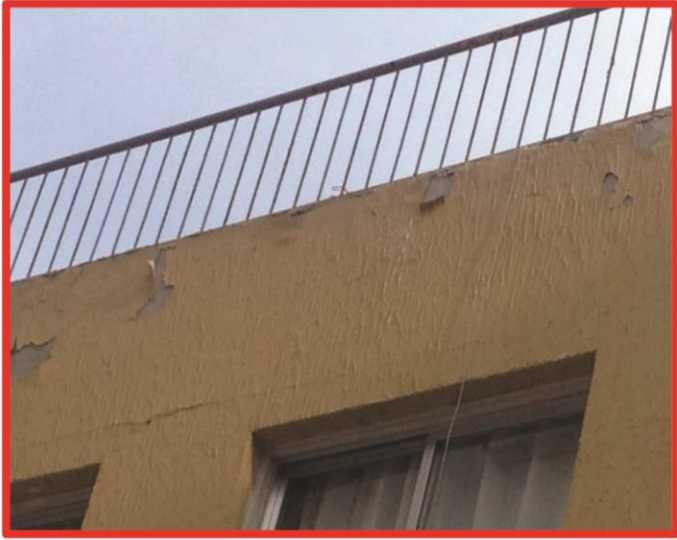
Flat Roof		Common Roof Defects and Suggestions for Flat Roofs in North Cyprus		
<p>Problem: Lack of coping</p>

<p>Reason of Problem</p> <p>Reason: Improper coping causes water penetration</p>

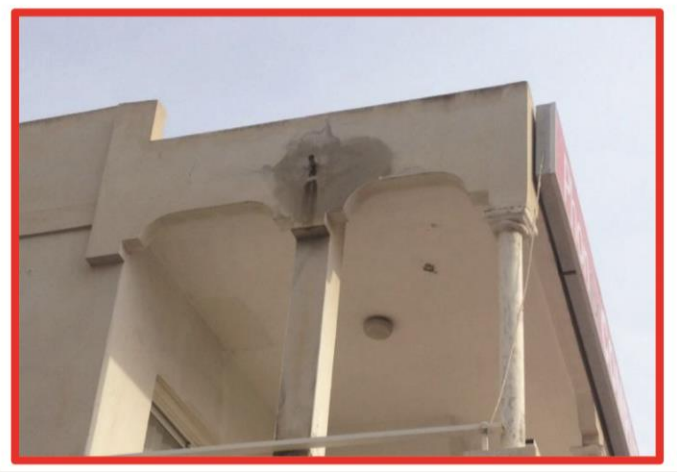
<p>Problem: Improper drainage</p>

<p>Reason of Problem</p> <p>Reason: The rainwater drips over external walls</p>

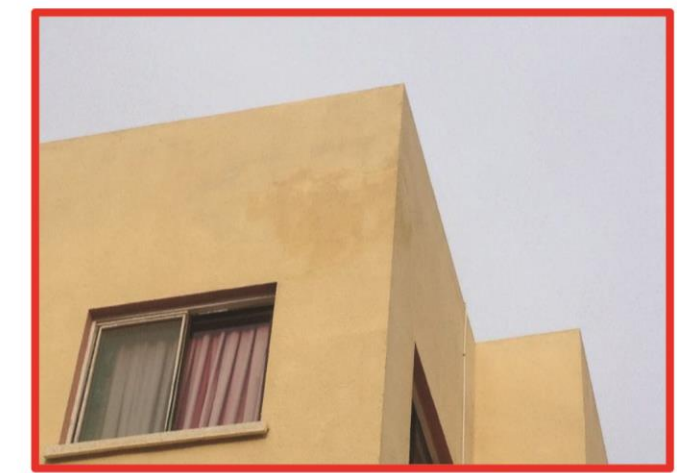
<p>Problem: Water stains on parapet</p>

<p>Reason of Problem</p> <p>Reason: Water stains are demonstrating water penetration</p>

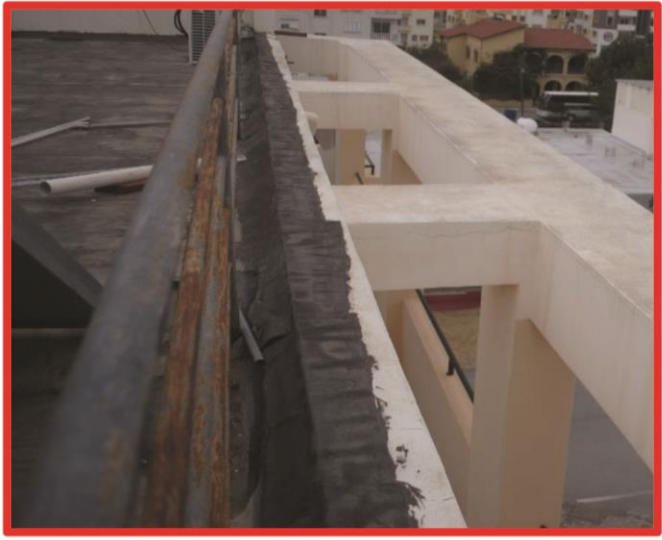
Flat Roof	Common Roof Defects and Suggestions for Flat Roofs in North Cyprus			
<p>Problem: Poor coping</p>

<p>Reason of Problem</p> <p>Reason:</p> <p>Improper waterproofing of parapet wall</p>

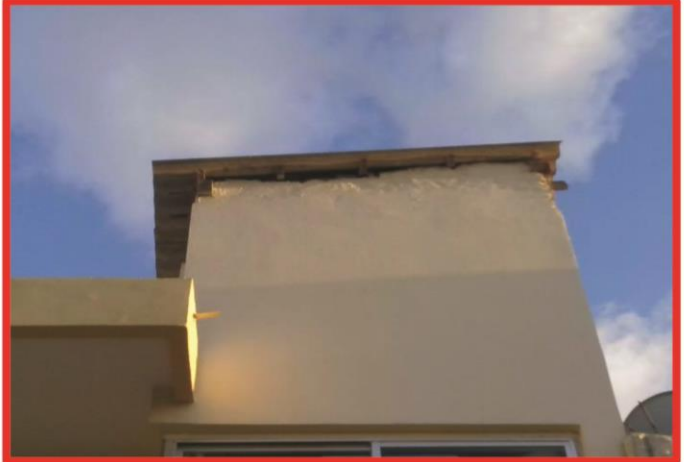
<p>Problem: Improper connection between roof and wall</p>

<p>Reason of Problem</p> <p>Reason:</p> <p>Improper overhanging roof detail</p>

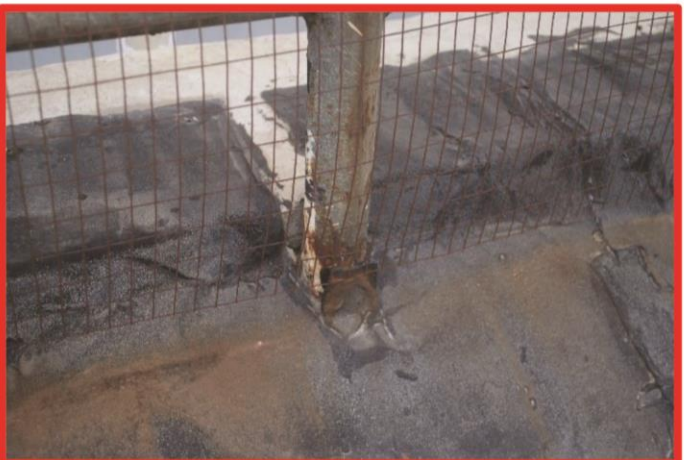
<p>Problem: Improper joint</p>

<p>Reason of Problem</p> <p>Reason:</p> <p>Improper joints between roof and other elements</p>

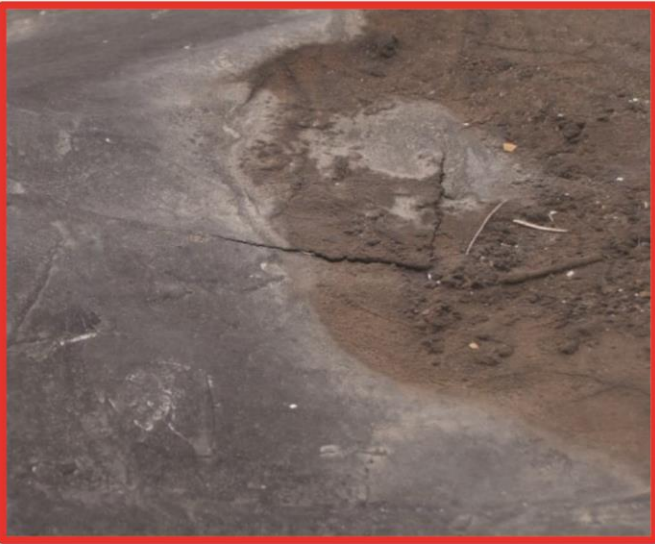
<p>Reason:</p> <p>Improper workmanship results in splits on the roofing membrane of flat roofs</p> <p>The construction workers should be informed to build properly</p>

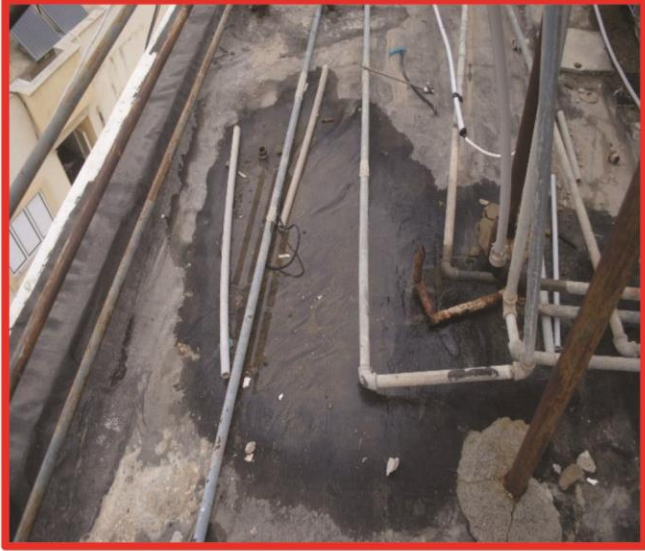
<p>Reason:</p> <p>Placing various elements over roof blocks the rainwater falls and causes ponding</p> <p>The surface of roof should be free of additional elements</p>

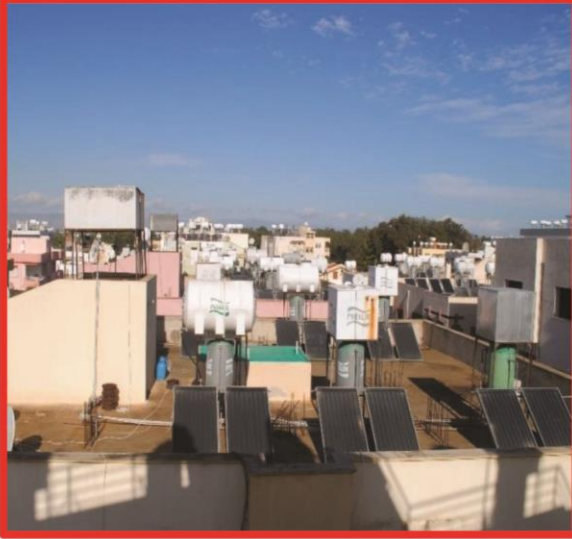
<p>Reason:</p> <p>Placing various elements over roof affects the appearance negatively</p> <p>The roof surface should become clear of additional elements</p>
Problem: Lap or joint failure	Reason and Suggestions of Problem	Problem: Improper roofing	Reason and Suggestions of Problem	Problem: Ridging and cockles on roofing membrane	Reason and Suggestions of Problem

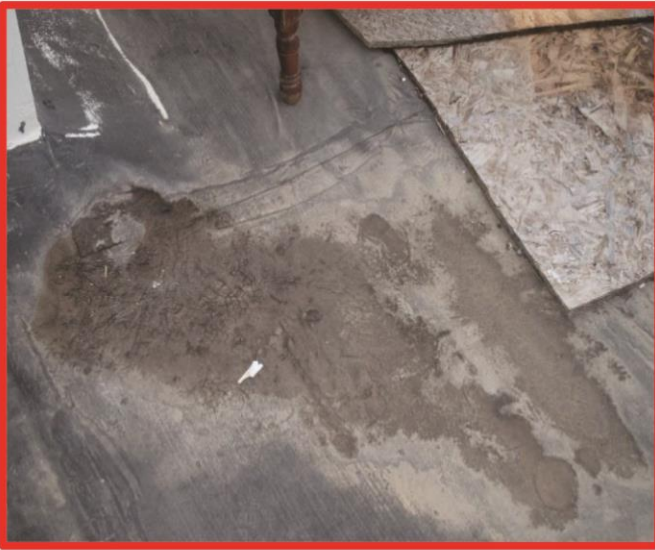
<p>Reason:</p> <p>Improper lap between roofing layers</p> <p>The construction workers should be informed to build properly</p>

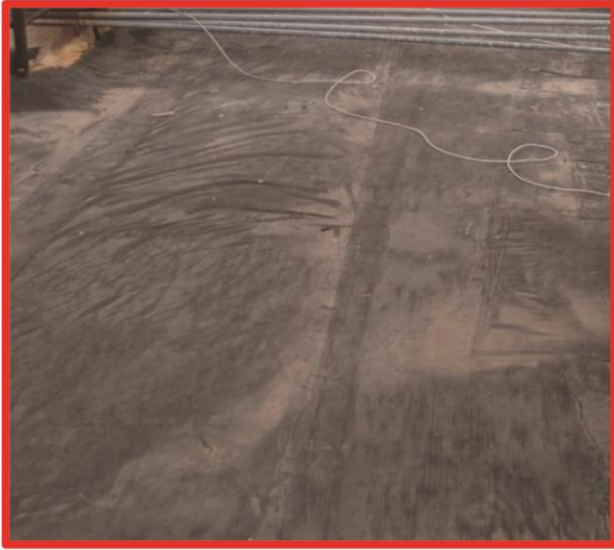
<p>Reason:</p> <p>Improper roofing layers</p> <p>The construction workers should be informed to build properly</p>

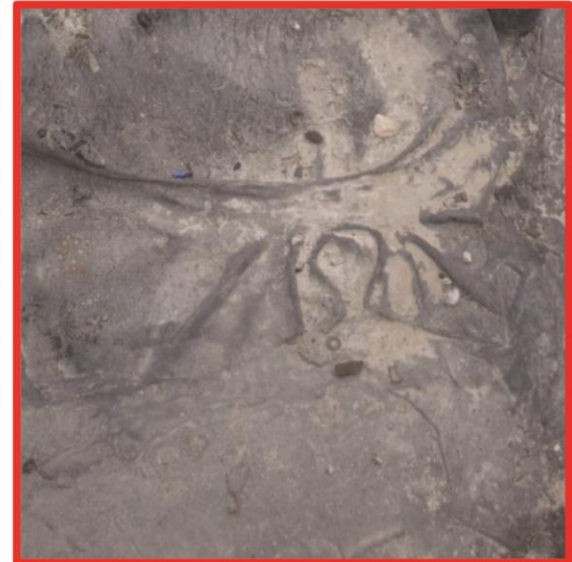
<p>Reason:</p> <p>Ridging and cockles over roofing membrane affects its performance</p> <p>The construction workers should be informed to build properly</p>

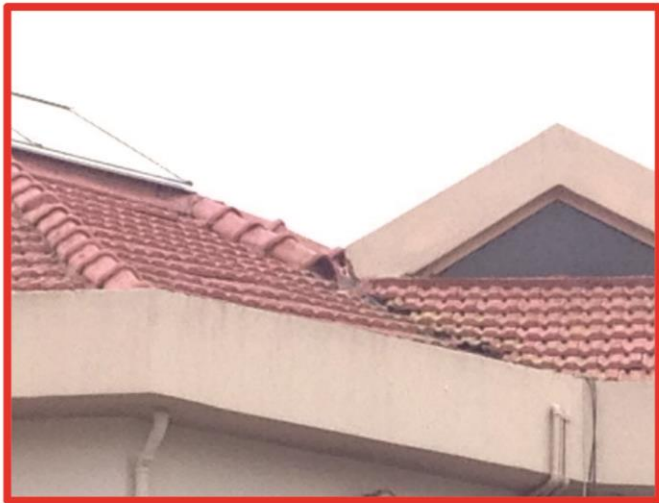
Reason: broken tiles and improper roof detailing ➔

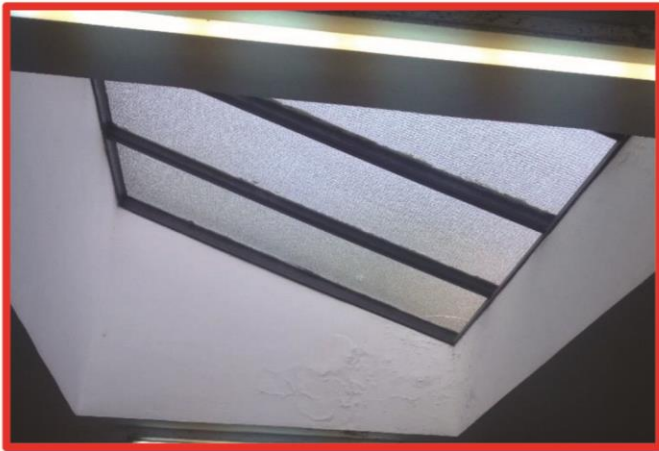
Problem: Water penetration, improper flashing	Reason of Problem	Suggestion 1 (waterproofing above insulation)		Suggestion 2 (roof detail for thermal satisfaction)

Reason: Water penetration as a result of improper roof window detail ➔

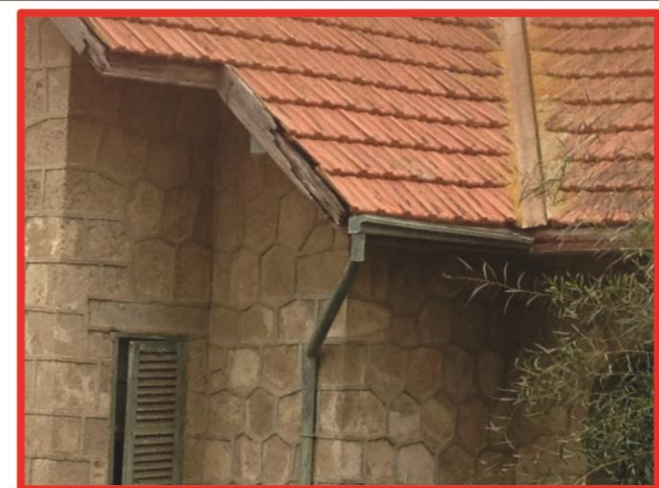
Reason: Poor valley detail ➔

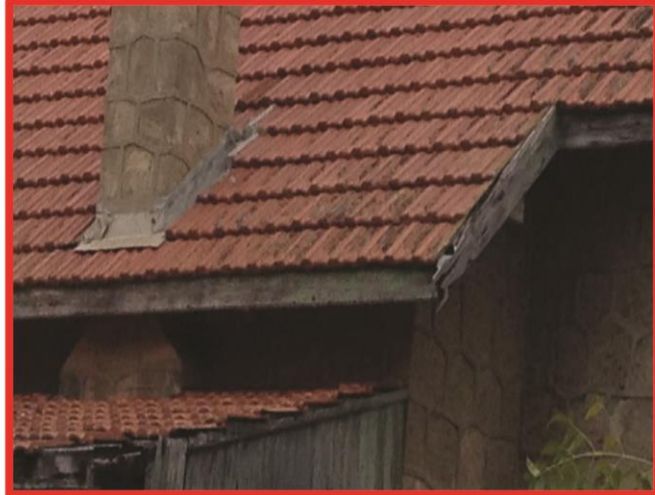
Reason: Lack of gutter ➔

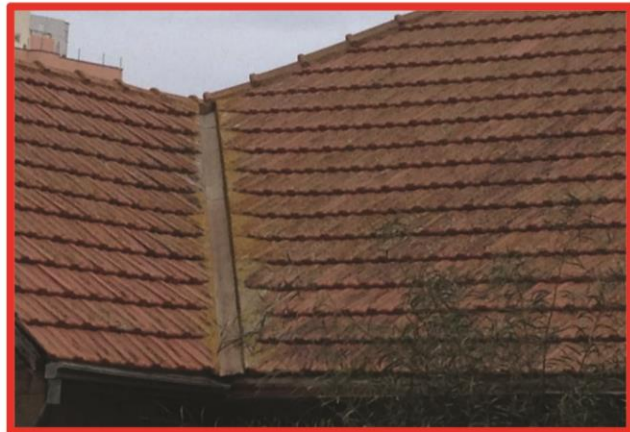
Reason: Improper valley detail ➔

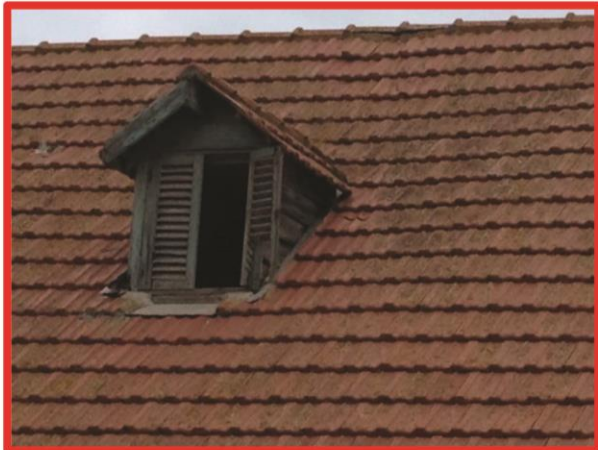
Problem: Poor dormer detail	Reason of Problem	Suggestion 1 (Profiled clay and concrete tiles: Roof covering with roofing felt underneath)	Suggestion 2 (Profiled clay and concrete tiles: Roof covering with secondary waterproofing layer underneath)	Suggestion 3 (Metal profiled sheeting: Ventilated roof covering, roofing felt on thermal insulation, loadbearing skin acting as vapor barrier)

Reason: Improper roof to dormer connection ➔

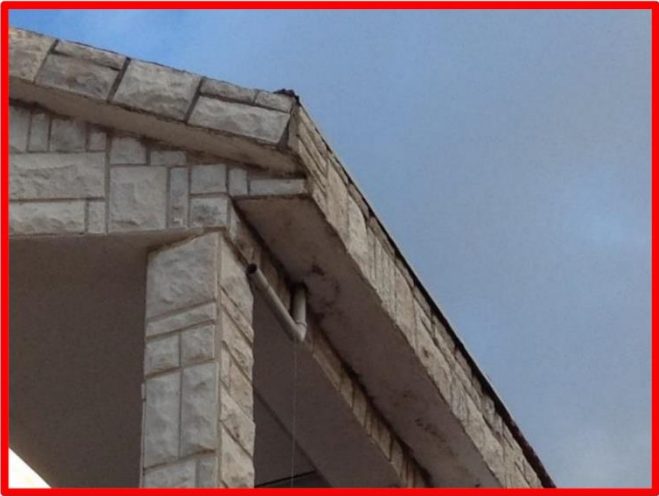
Reason: Rainwater drips over external walls ➔

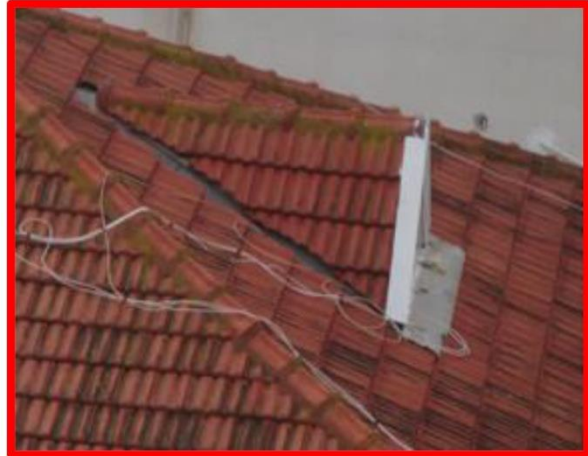
Reason: Improper roof to dormer connection ➔

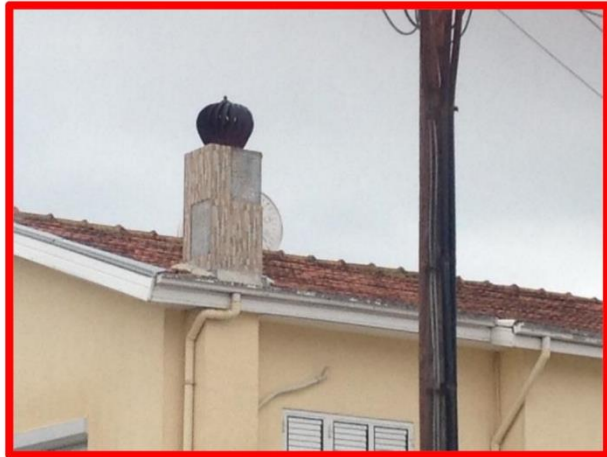
Problem: Poor chimney connection	Reason of Problem	Suggestion 1 (Profiled clay and concrete tiles: Roof covering with roofing felt underneath)	Suggestion 2 (roof detail for thermal satisfaction)

Reason: Improper penetration detail ➔

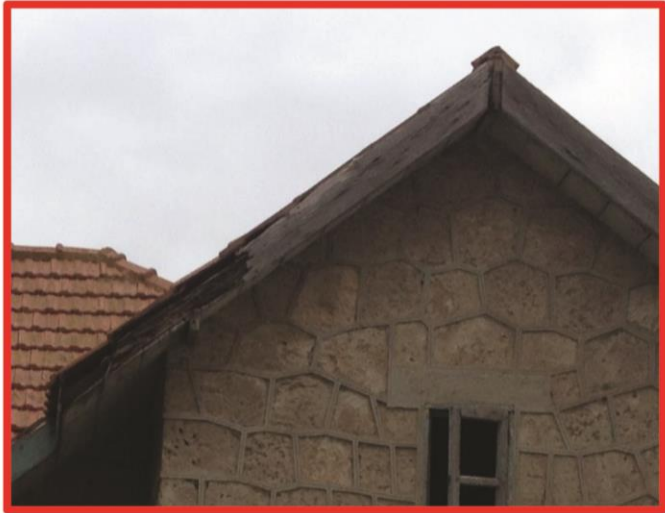
<p>Reason of Problem</p> <p>Reason: Improper ridge detail</p>

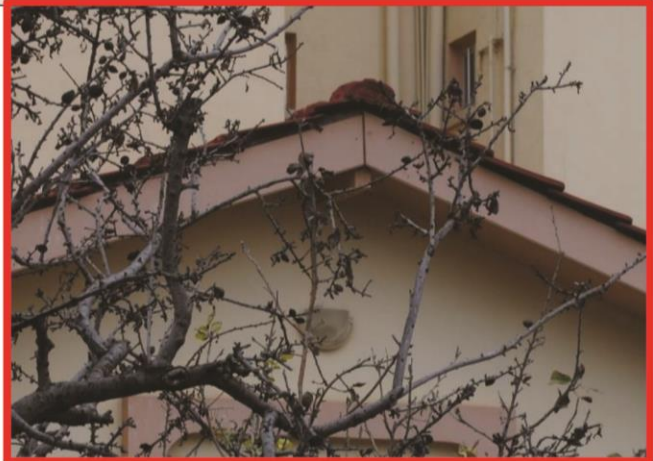
<p>Problem: Poor ridge detail</p>

<p>Reason of Problem</p> <p>Reason: Improper ridge detail</p>

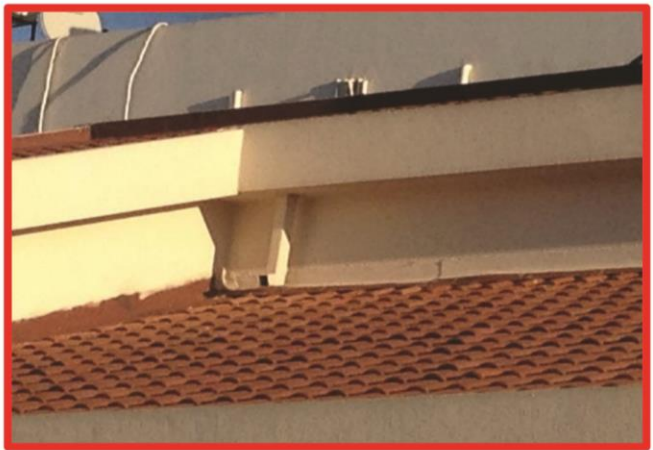
<p>Problem: Poor drainage</p>

<p>Reason of Problem</p> <p>Reason: Rainwater is not drained from each level of roof independently</p>

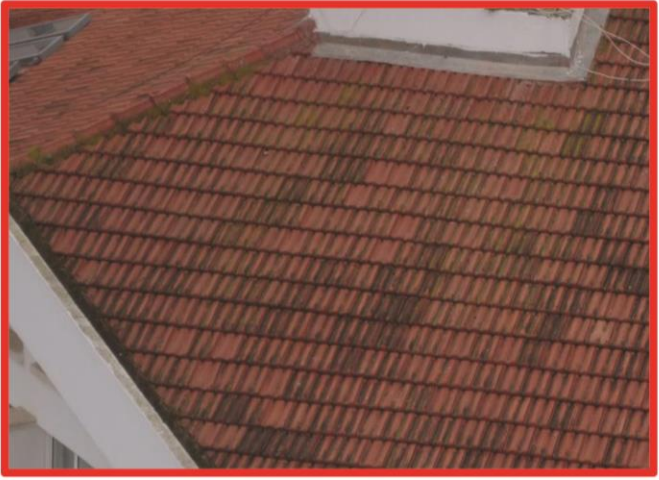
<p>Reason:</p> <p>Vegetation and algae grow over the roof tiles</p> <p>Roof tiles should be cleaned</p>

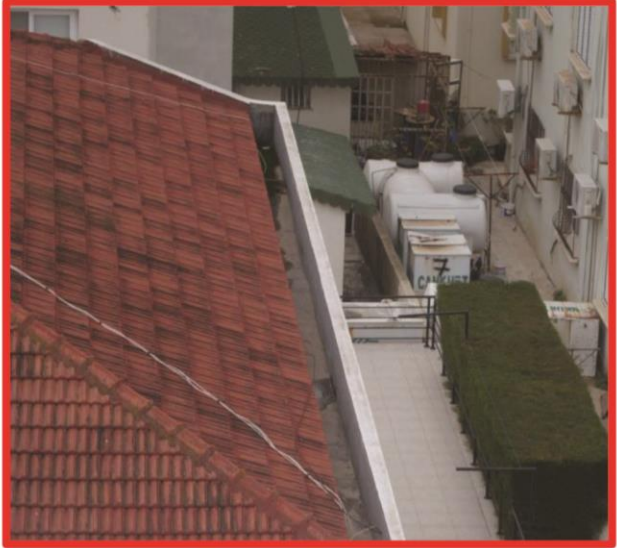
<p>Reason:</p> <p>Blocked gutter causes improper drainage</p> <p>Gutters should be cleaned</p>

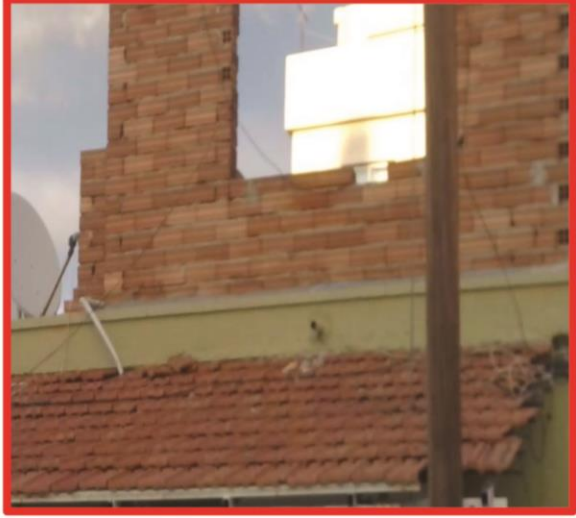
<p>Reason:</p> <p>Slipped and lost roof tiles as a result of poor workmanship and maintenance</p> <p>Tiles should be modified</p>
Problem: Slipped roof tiles	Reason and Suggestions of Problem	Problem: Placing various elements over roof	Reason and Suggestions of Problem	Problem: Mold on tiles	Reason and Suggestions of Problem

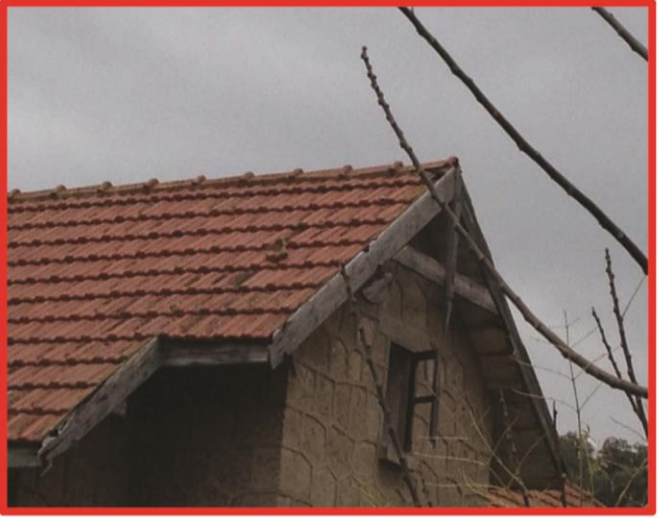
<p>Reason:</p> <p>Slipped and lost roof tiles as a result of poor workmanship and maintenance</p> <p>Tiles should be modified</p>

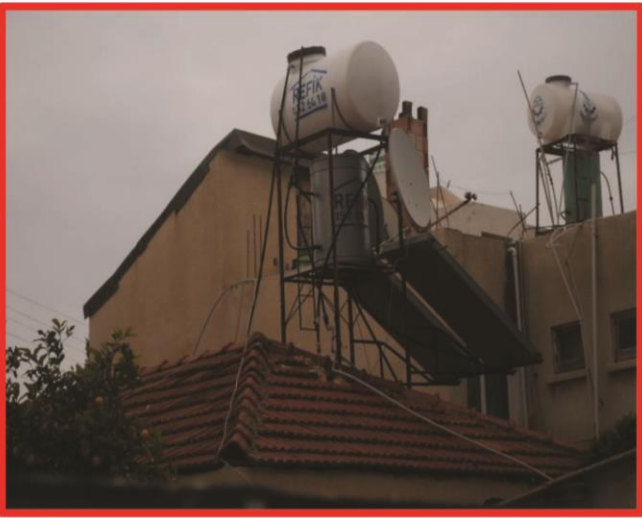
<p>Reason:</p> <p>Placing various elements over roof affects the appearance and punches tiles</p> <p>The roof surface should be free from additional elements</p>

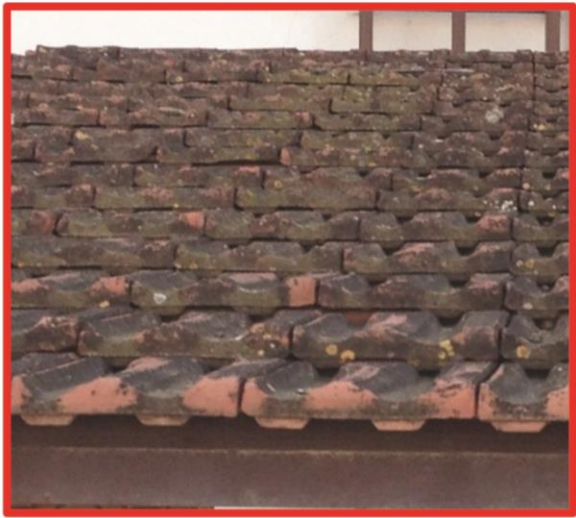
<p>Reason:</p> <p>Mold growth over tiles as a result of high humidity and lack of proper maintenance</p> <p>Roof tiles should be cleaned</p>
