Analysis of Occupational Construction Accidents in North Cyprus

Master of Science
in
Civil Engineering

Eastern Mediterranean University
February 2014
Gazimağusa, North Cyprus

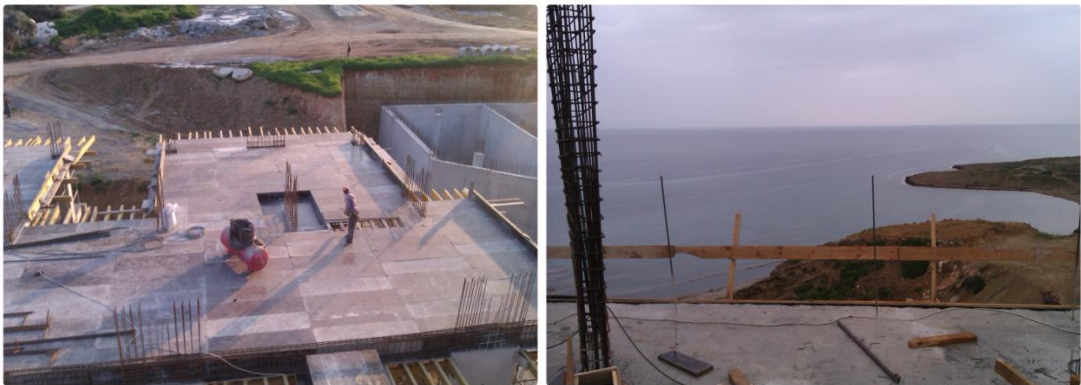
Figure 5.4. Guardrails in LPH project

A guardrail system is a “barrier erected to prevent employees from falling to lower levels”. Guardrail systems are vital for those workers who have to work on elevations of 6 feet (1.8 m) or more above ground level. OSHA regulated guardrails to be constructed from 2 inches (5 cm) x 4 inches (15 cm) lumbers and can range between 39 inches (1 m) and 45 inches (1.14 m) above the working level [41]. Guardrails can be established with different methods such as counterweighing, mounting on the roof as joists, or attaching to the wall or roof of the building. A sample of guardrails for floors and staircases in the case study can be viewed in Figures 5.4, 5.6, 5.7 and 5.8.

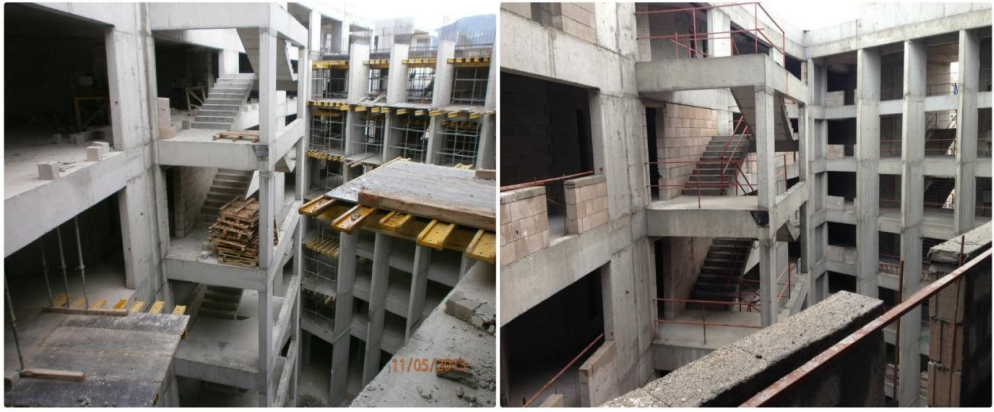
Figure 5.5 Guardrails in staircases (1)

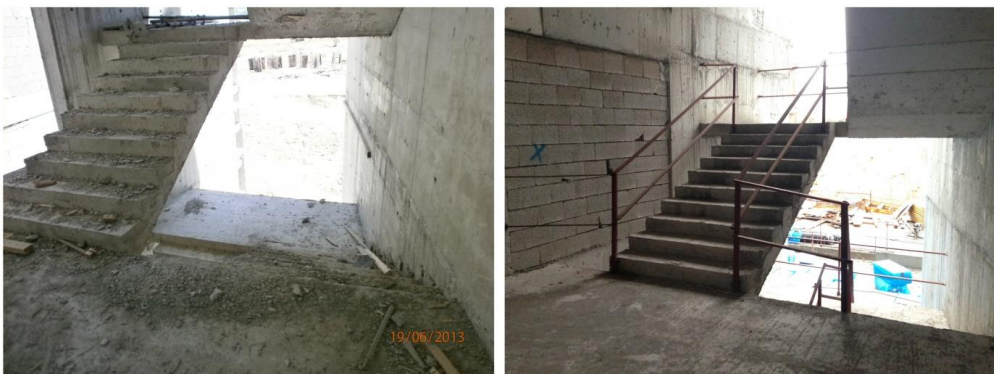
Figure 5.6. Guardrails in staircases (2)

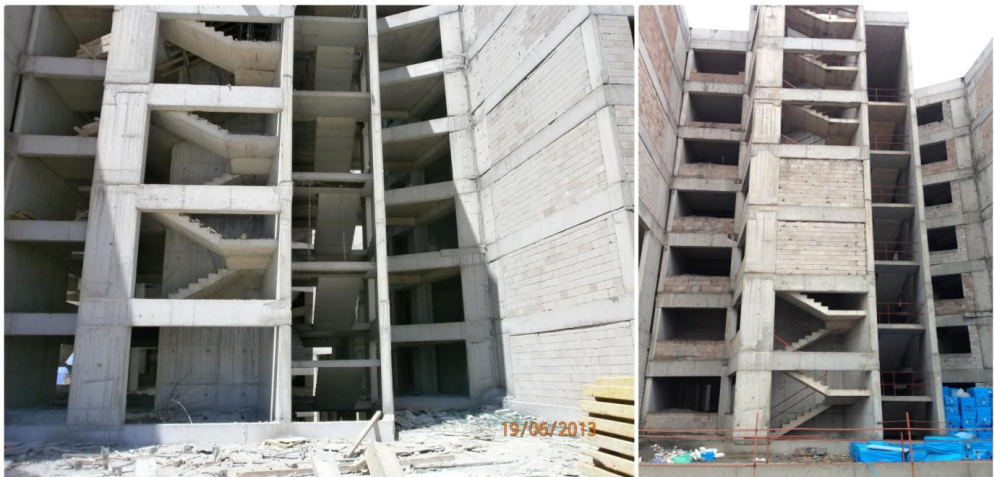
Figure 5.7. Guardrails in staircases (3)

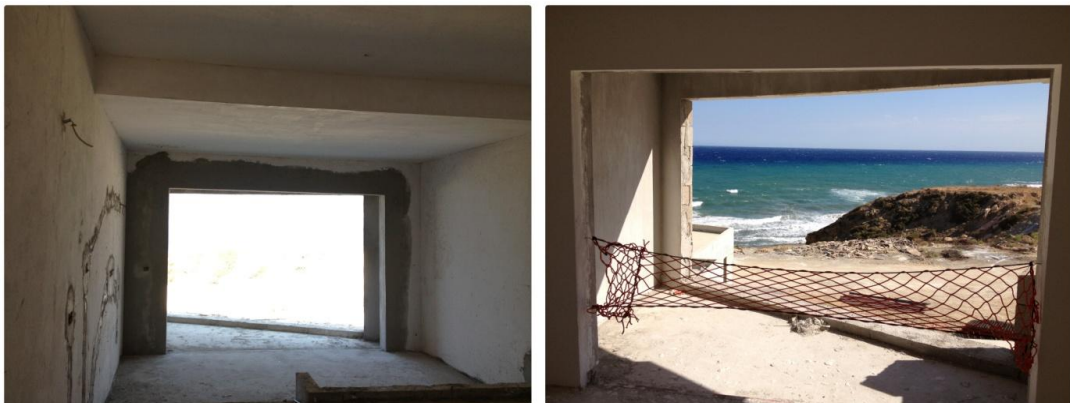
“A safety net system is a meshed netted structure located under the surface where employees are working which prevents them from making contact with the surfaces at lower levels during a fall. Net system can be used when working on high elevations, the systems should be installed no more than 9.1 m (30 ft) below the working surface and should have sufficient clearance to avoid contact with surfaces at lower levels on lower elevations. Mesh sizes are limited to 15 cm (6 in) by 15 cm (6 in) and should be properly secured to prevent enlargement of mesh openings during a fall [41]”. Figures 5.8 and 5.9 show a net system fall protection in the case study.

Figure 5.8. Safety net system in LPH project (1)

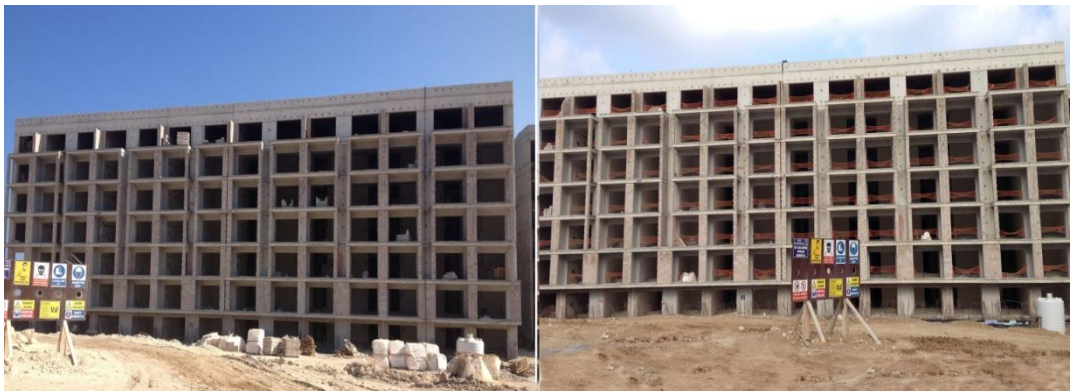
Figure 5.9. Safety net system in LPH project (2)

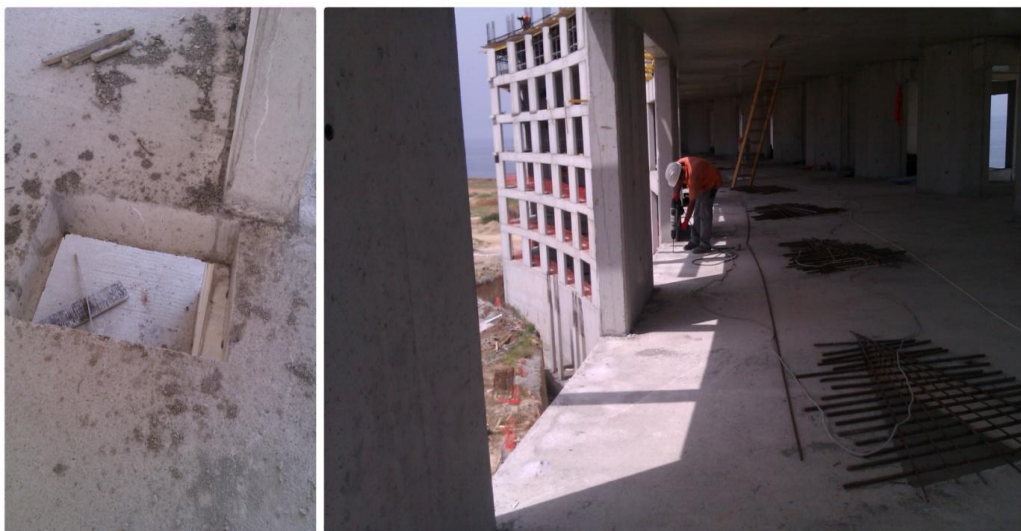
Since a considerable amount of falls occur through openings in floors, it is important to provide procedures to prevent those types of falls by properly covering floor openings [41]. Figure 5.12 depicts that the worker is covering the floor opening.

Figure 5.12. Floor covers for openings

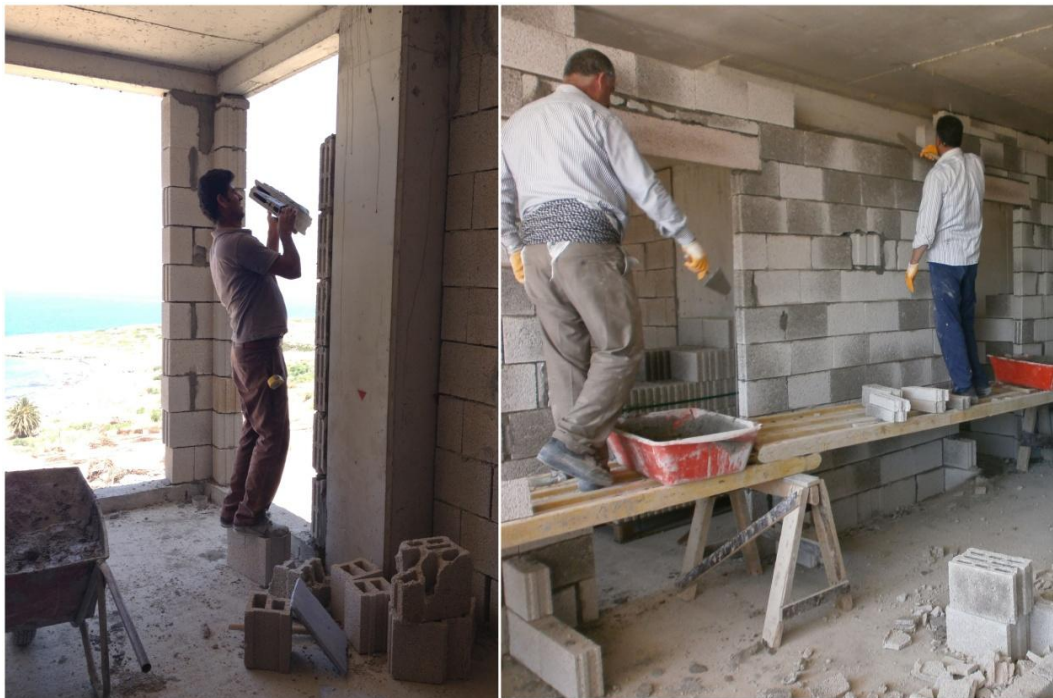
Figure 5.13 shows the appropriate and inappropriate form of using equipment for reaching higher height points of a wall. Using equipment on which the worker does not have any balance, is extremely dangerous.

Figure 5.13. Work at height level

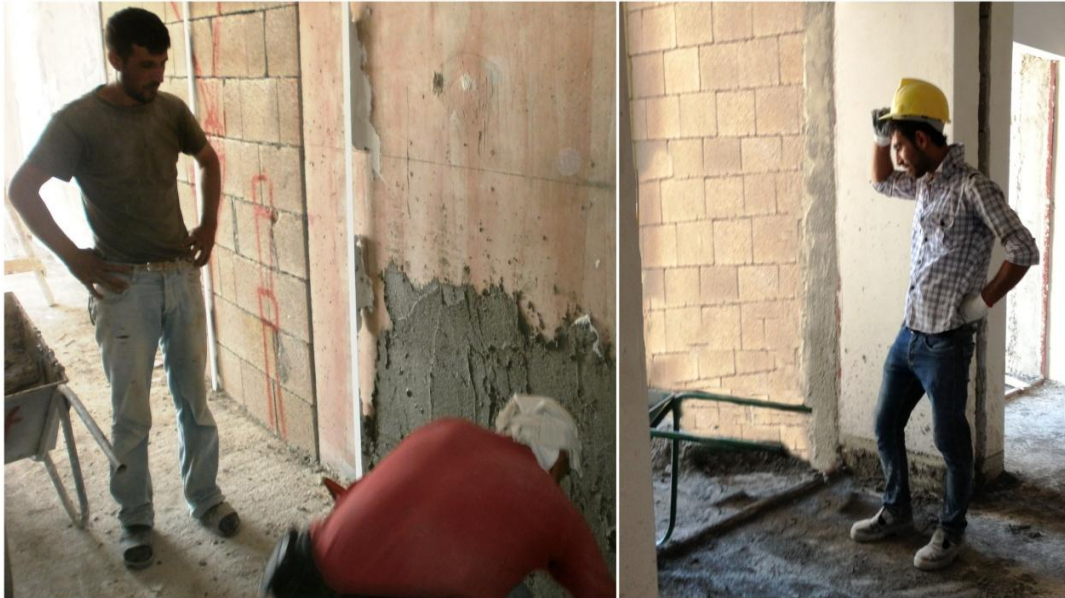
ignorance of wearing safety work gear like stepping on nails. Using appropriate shoes can also prevent from electrocuting (Figures 5.16 and 5.17).

Figure 5.16. Hard hat and work shoes

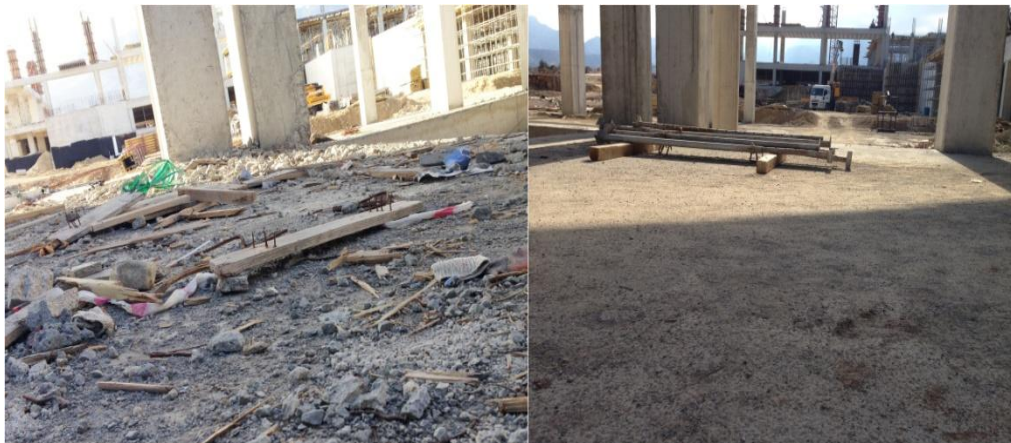
Figure 5.17. Nail and sharp object

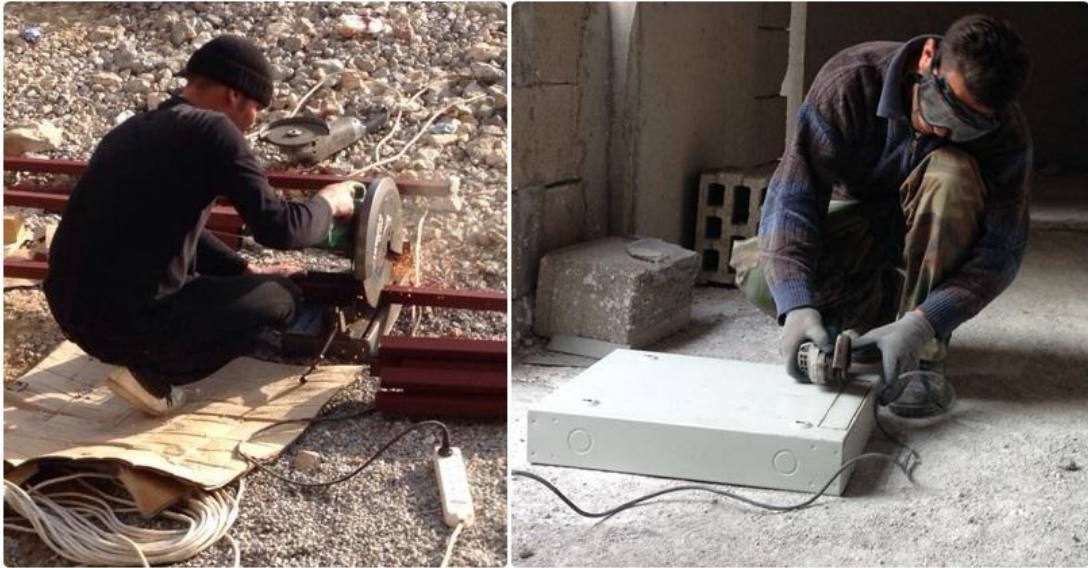
Figures 5.18 and 5.19 show the usage and lack of work gloves and protective glasses in the LPH for the workers. Using masks and ear muffs can also help prevent them harm.

Figure 5.18. Work glasses

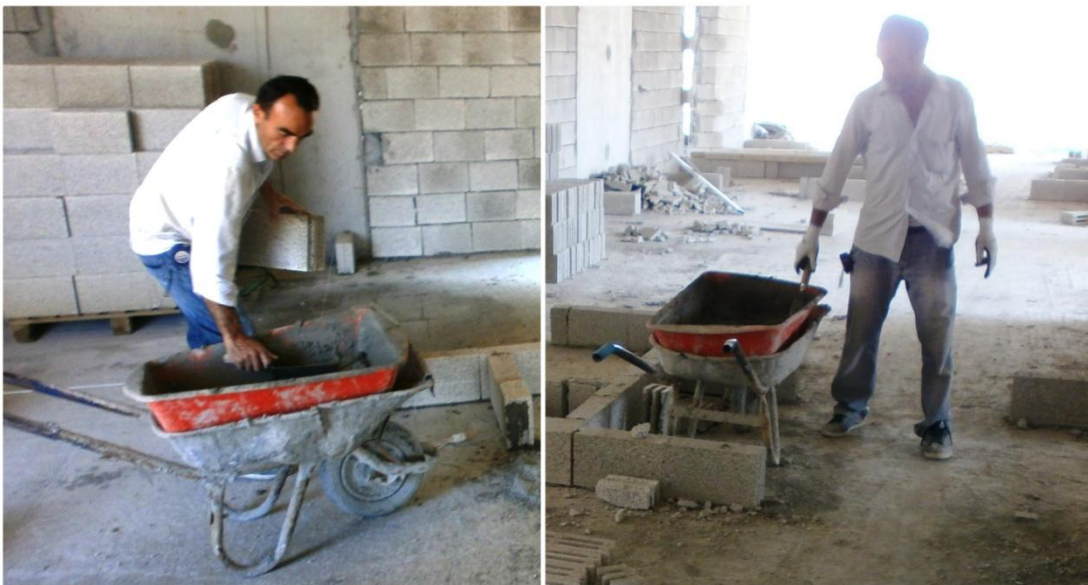
Figure 5.19. Work gloves
