The conservation of traditional olive oil mills in Cyprus

Hülya Yüceer, Beser Oktay Vehbi & Yonca Hürol

ABSTRACT

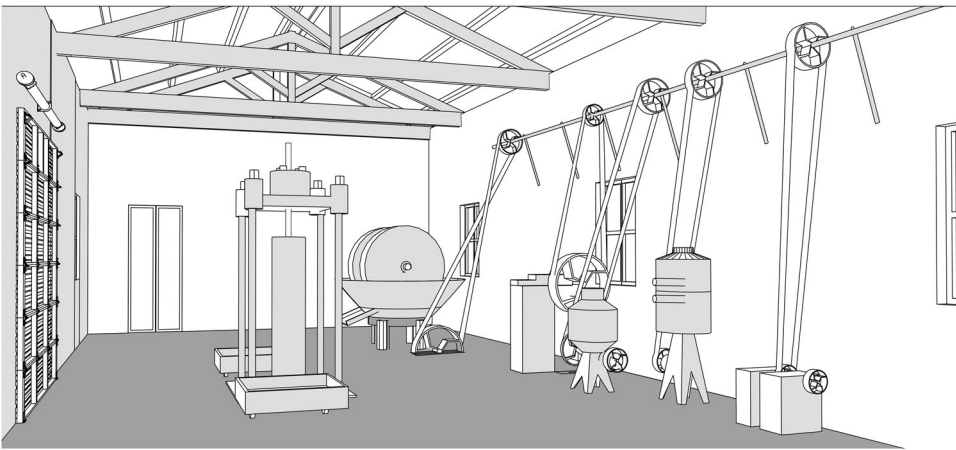
Figure 9. Machinery types in Type C mills – Sipahi (Aytrias)

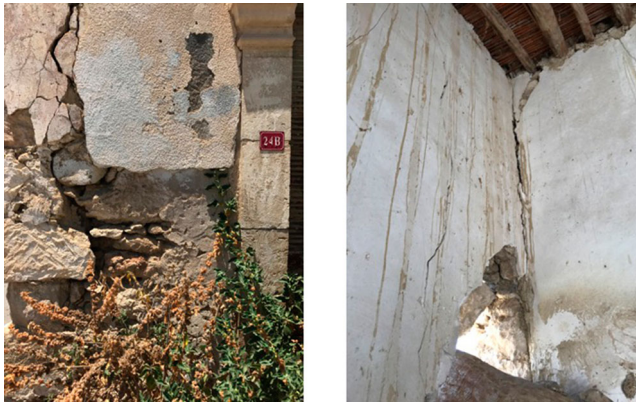
Four of these adobe buildings have large vertical cracks on their walls, whilst three of them have diagonal cracks. Figure 10 shows a large vertical crack and a large diagonal crack in Büyükkonuk 1 olive mill. There are thin vertical and diagonal cracks in all adobe olive mills. Holes are opened in the walls of Yenierenköy olive mill for the purpose of putting mechanical equipment pipes into the building. However, these holes did not affect the structure.

Figure 10. A vertical and a diagonal crack in the walls of Büyükkonuk1 olive mill.

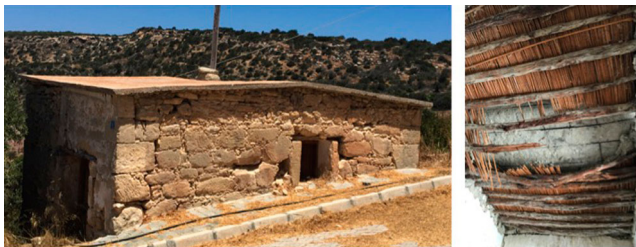
roofs. Metal roofs give harm to the originality of these structures, however the concrete roofs are heavy and they cause the collapse of these buildings in long term.

Figure 11. Concrete roof over Esenköy and Büyükkonuk 1 olive mills.

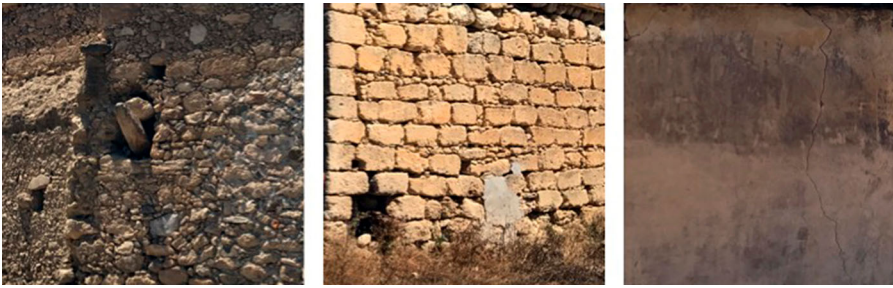
There are collapsed parts in 5 out of 12 stone olive mills. There are large vertical cracks in the walls of 3/12 of the stone mills. There are large diagonal cracks in the walls of 2/12 of the mills. Holes have been opened in the walls of 2/12 of the mills. There are also thin vertical and diagonal cracks in all mills. **Figure 12** shows a collapsed part in the walls of the Büyükkonuk 1 mill, a large vertical crack in a wall of the Boltaşlı mill and a large diagonal crack in a wall of the Taşlıca mill. 2/13 of the damage in the stone olive mills was due to slope.

Figure 12. (a) A collapsed part in the walls of the Büyükkonuk 1 mill, (b) a large vertical crack in a wall of the Boltaşlı mill, and (c) a large diagonal crack in a wall of the Taşlıca mill.

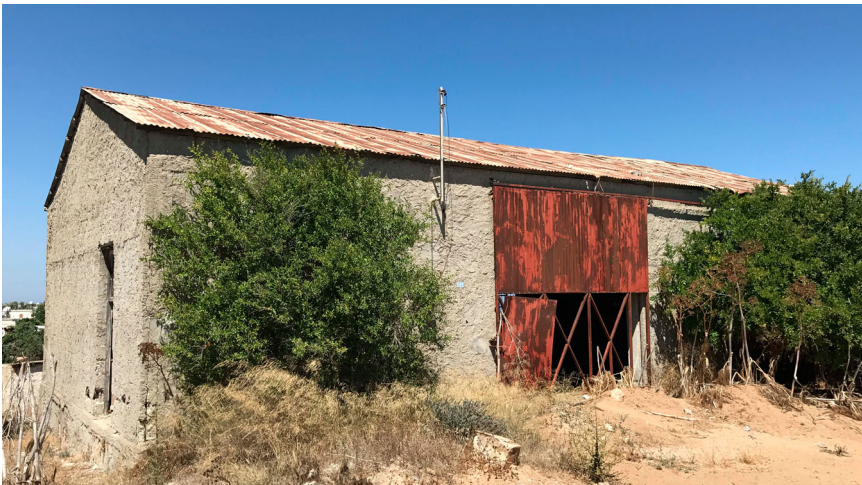
Numerous defective repairs were noticed including: inadequate new roofs, RC buttresses, steel I beams, cement plaster, and the closing/opening some openings (Figure 13). Inappropriate repairs like the extensive application of incompatible, impermeable materials, especially cement and RC buttresses and concrete post and beam and slab additions, over the years have significantly and irreversibly damaged the historic fabric both structurally and aesthetically (Figure 14). As a result, the decay of these structures increased and this requires major repairs (consolidation of stone, replacement of adobe and mortar and reintegration of missing elements-doors-windows, etc.).

Figure 13. A new door opened on the front façade of Yenierenköy.

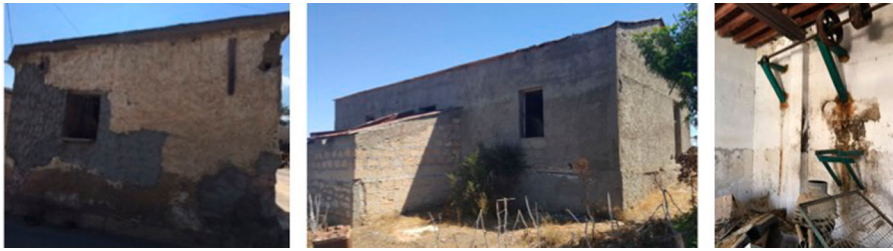
There are incompatible interventions such as cement mortar and plastering the cracks repair, which did not stop them from widening. The buildings have also been plastered in some parts, and most of the plaster has vertical cracks in it. In some adobe buildings, wrong plaster material was used (Ergazi 1 and 2), which might cause deterioration of adobe as an organic material in long term. Adobe walls should have earth-based plaster. However, there were cement or gypsum-based plaster in some adobe olive mills. Climatic factors such as wind, sun and rain have led to severe damage to the adobe, stone and brick materials and jointing. These unwanted openings allowed rain water to enter, which has caused further damage.

Figure 14. (a) Inappropriate interventions – cement plastering, (b) additional spaces next to the mill, and (c) addition of RC buttresses.

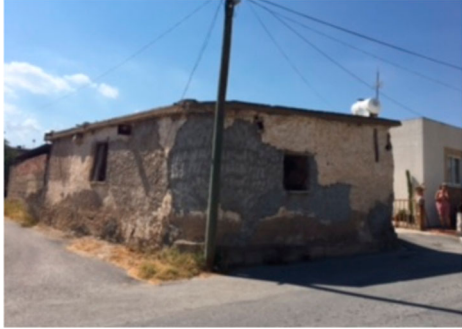
Building name	Wall and slab structure	Alterations	Wrong decisions	Damage in structure	Level of damage	Conservation proposal
Ergazi1

Wall: Adobe masonry Slab: Timber and steel beams, metal sheet, concrete roof	Metal sheet, concrete roof Bad plastering	Concrete roof	<ul style="list-style-type: none"> • 2.5 cm vertical crack at the corner • 45 degree thin crack at the other corner 	High damage	<ul style="list-style-type: none"> • Removal of plaster. • Wire-mesh and earth-based plaster application to all walls. • Addition of a timber frame should be considered to carry the roof and support the walls. • Design and reconstruction of the original roof cover.
Ergazi2

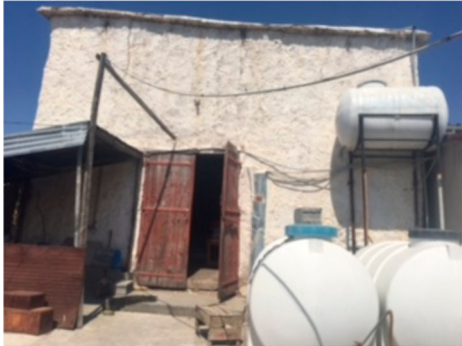
Wall: Adobe masonry + buttresses outside + buttresses added inside Slab: Steel beam + RC slab	<ul style="list-style-type: none"> • Buttresses added inside • Plastering -RC slab 	RC slab	<ul style="list-style-type: none"> • 1 cm vertical crack at corner • 2 cm vertical crack at the other corner due to slope 	High damage	<ul style="list-style-type: none"> • Slope should be considered to eliminate future damage. • Removal of plaster. • Application of wire-mesh and earth-based plaster application to all walls. • Addition of a timber frame should be considered to carry the roof and support the walls. • Design and reconstruction of the original roof cover.

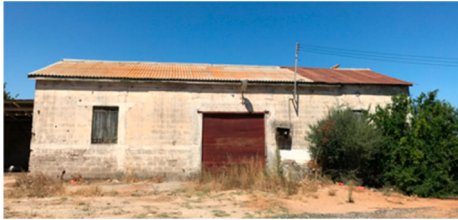
Building name	Wall and slab structure	Alterations	Wrong decisions	Damage in structure	Level of damage	Conservation proposal
Sipahi

Wall: Back wall is rubble stone, other walls are sea-sand brick, no interlocking at corner cut stones, RC vertical and horizontal tie-beams (not at corners) Slab: Timber truss + metal sheet	Metal sheet	<ul style="list-style-type: none"> • No interlocking at corners • No vertical tie-beams at corners 	<ul style="list-style-type: none"> • 2 cm vertical crack at the corner • Diagonal crack at the same corner because of slope, incorrect structure and addition of water storage 	High damage	<ul style="list-style-type: none"> • Slope and water storage should be considered to eliminate future damage. • Plaster should be removed. • Wire-mesh and cement-based plaster application to interior walls. • Addition of a steel frame should be considered to carry the roof and support the walls. • Stone parts should be balanced to avoid twisting. • Design and reconstruction of the original roof cover.

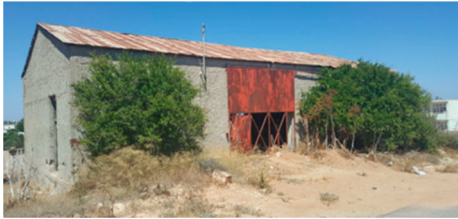
Yenierenkoy

Wall: Rubble stone back wall, sea-sand brick at other walls, RC vertical and horizontal tie-beams Slab: Timber truss + metal sheet	Added parts are connected with metal hooks. Metal sheet	-	<ul style="list-style-type: none"> • Holes opened for pipes • New large door opened • Vertical thin crack beside the vertical tie-beam • 45 degree crack because of slope 	Medium damage	<ul style="list-style-type: none"> • Slope should be considered to eliminate future damage. • Added parts should be removed. • Holes should be closed. • Plaster should be removed. • Wire-mesh and cement-based plaster application to interior walls. • The new door should be replaced with the original. • Stone parts should be balanced to avoid twisting. • Design and reconstruction of the original roof cover.

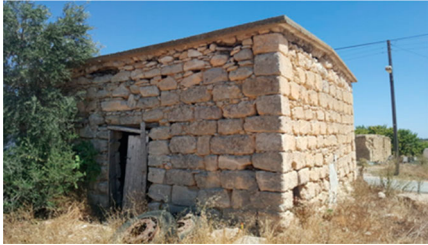
Building name	Wall and Slab structure	Alterations	Wrong decisions	Damage in structure	Level of damage	Conservation proposal
Boltaşlı

Wall: Stone masonry Slab: 1 pointed stone arch + RC slab	RC slab	RC slab	<ul style="list-style-type: none"> • Collapsed part • 8 cm vertical crack at one corner • 1 cm vertical crack at another corner 	High damage	<ul style="list-style-type: none"> • Partial reconstruction of the collapsed part. • Use of anchors containing steel bars and tendons. • Injection of puzolanic lime-based grout into the cracks, wire-mesh and plaster. application to the internal walls. • Addition of a steel frame should be considered to carry the roof and support the walls. • Design and reconstruction of the original roof cover.
Buyukkonuk1

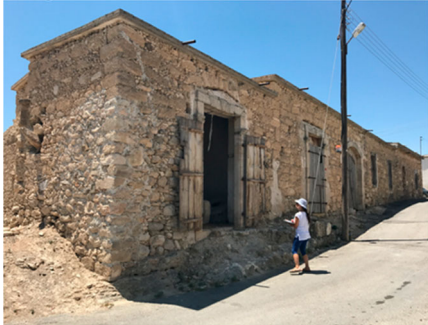
Wall: Stone masonry Slab: Pointed stone arches	<ul style="list-style-type: none"> • Roof system changed • Internal plastering 	–	<ul style="list-style-type: none"> • 2 cm crack between wall and arch • 45 degree 4 cm crack at the corner • 45 degree 2 cm crack at other corner • Collapsed parts 	High damage	<ul style="list-style-type: none"> • Partial reconstruction of the collapsed parts. • Anchors + steel bars + tendons for the vertical and diagonal cracks. • Injection of puzolanic lime-based grout into the cracks, wire-mesh and plaster application to the internal walls. • Addition of a steel frame should be considered to carry the roof and support the walls. • Design and reconstruction of the original roof cover.

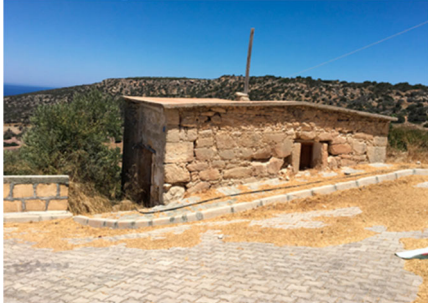
Building name	Wall and Slab structure	Alterations	Wrong decisions	Damage in structure	Level of damage	Conservation proposal
Esenköy

Wall: Stone masonry Slab: Timber beams	–	–	<ul style="list-style-type: none"> • Roof has a belly • 5 cm vertical crack at the corner due to slope • Collapsed parts 	High damage	<ul style="list-style-type: none"> • Slope should be considered to eliminate future damage. • Reconstruction of the collapsed parts. • Use of anchors containing steel bars and tendons. • Injection of puzolanic lime-based grout into the cracks, wire-mesh and plaster application to the internal walls. • Addition of a steel frame should be considered to carry the roof and support the walls. • Design and reconstruction of the original roof cover
Kumyalı

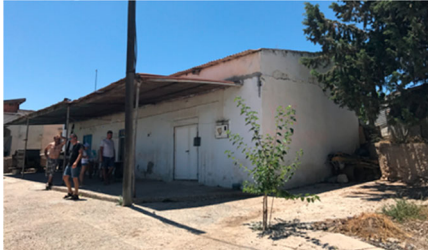
Wall: Stone masonry Slab: Timber beam + metal sheet	Plastered Metal sheet	–	No damage	<ul style="list-style-type: none"> • No damage • Lost character 	Not suggested

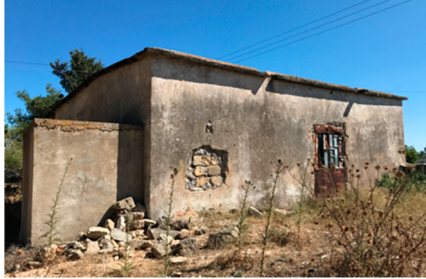
Taşlıca

Wall: Stone masonry
Slab: Multiple arches
Concrete on wicker +
mud

Badly
plastered
Concrete
roof

- Hole which caused 45 degree major crack
- Vertical cracks on plaster close to arches
- Corner is damaged
- 45 degree major crack at corner

High damage

- Plaster should be removed.
- Anchors + steel bars + tendons for vertical and diagonal cracks.
- Injection of puzolanic lime-based grout into the cracks, wire-mesh and plaster application to the internal walls.
- Reconstruction of the damaged part.
- Addition of a steel frame should be considered to carry the roof and support the walls.
- Design and reconstruction of the original roof cover.

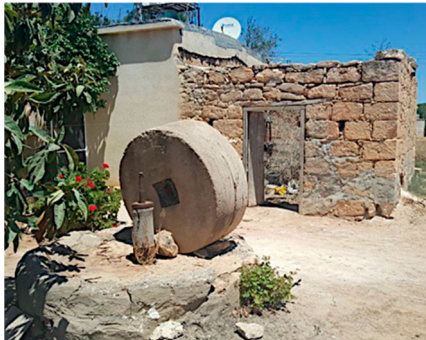
Yeşilköy

Wall: Stone masonry
Slab: Timber beams

Partial
plastering
inside

Medium
Damaged

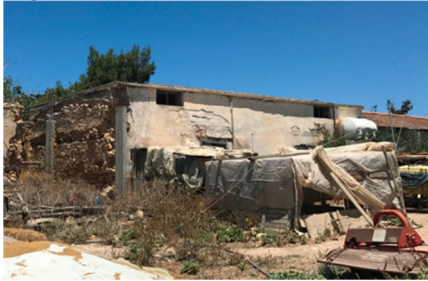
Building name	Wall and Slab structure	Alterations	Wrong decisions	Damage in structure	Level of damage	Conservation proposal
Ziyamet

<p>Wall: Stone masonry + RC columns + stone buttresses at front Slab: RC slab added</p>	<ul style="list-style-type: none"> • RC system added • Plastered 	RC system –	<ul style="list-style-type: none"> • Column has damages • Corner collapsed • 45 degree thin crack at corner 	High damage	<ul style="list-style-type: none"> • Removal of the damaged RC column. • Plaster should be removed. • Partial reconstruction of the collapsed part. • Injection of puzolanic lime-based grout into the cracks, wire-mesh and plaster application to the internal walls. • Addition of a steel frame should be considered to carry the roof and support the walls. • Design and reconstruction of the original roof and its cover.
