Hürol, Yonca; Wilkinson, Nicholas, (2005) "A Critique of Earthquake Policies of Northern Cyprus." *Proceedings of the Institution of Civil Engineering-Structure and Buildings*. 158(6) pp.355-369.

A CRITIQUE OF THE EARTHQUAKE POLICIES IN NORTHERN CYPRUS

Yonca Hürol, Nicholas Wilkinson

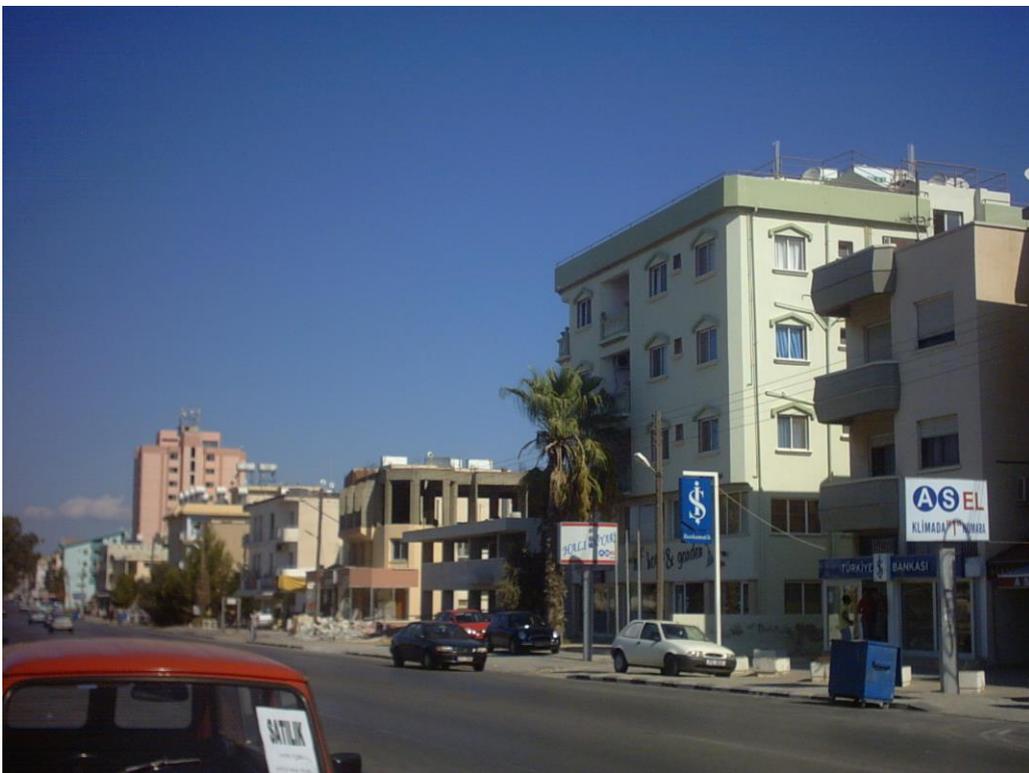
Figure 1. The commercial street in Famagusta: Salamis Road (Photo: by authors)

In order to show the relationship between these problems and architectural design, a comparative research study between a commercial and a residential street in the town of Famagusta in Northern Cyprus (Figure 1 and 2), has been prepared. This research demonstrates how frequently the problems of “soft storey” and “short column” occur, the relationship of each problem with the architectural design, and the most appropriate solution for each case, by considering the economic status of the owner. Only those buildings, less than 30 years old, are studied in both streets. Given this information, the buildings under examination were constructed solely by the citizens of Northern Cyprus, but not by the people in the southern part of the island. All the buildings have at least three levels including the ground floor level. They all have reinforced concrete frame structures with non-load bearing brick walls.

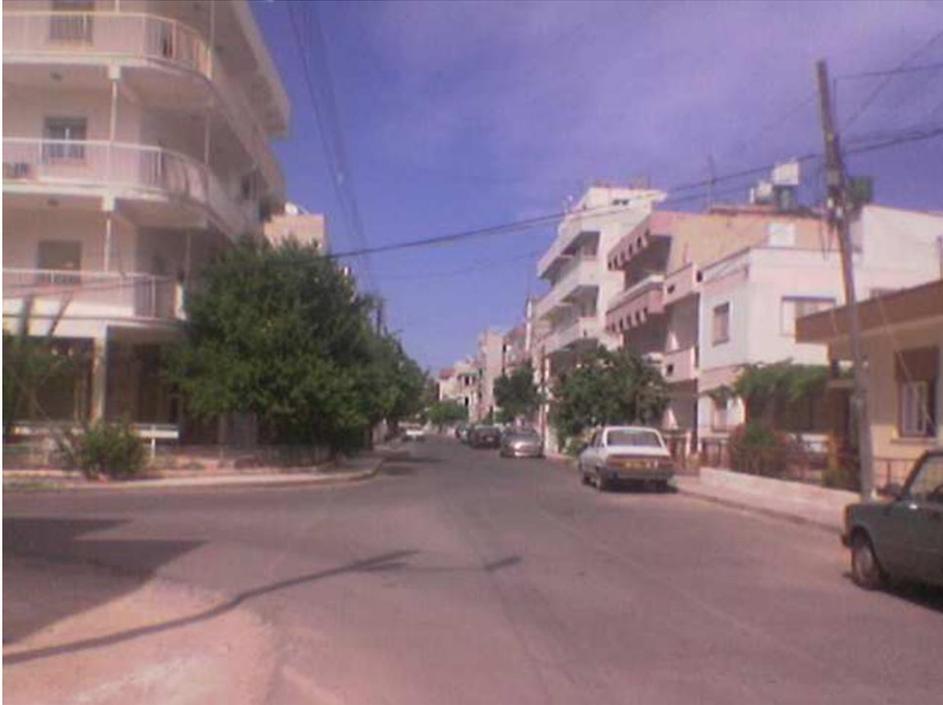
Figure 2. The residential street in Famagusta: 19th of May Street (Photo: by authors)

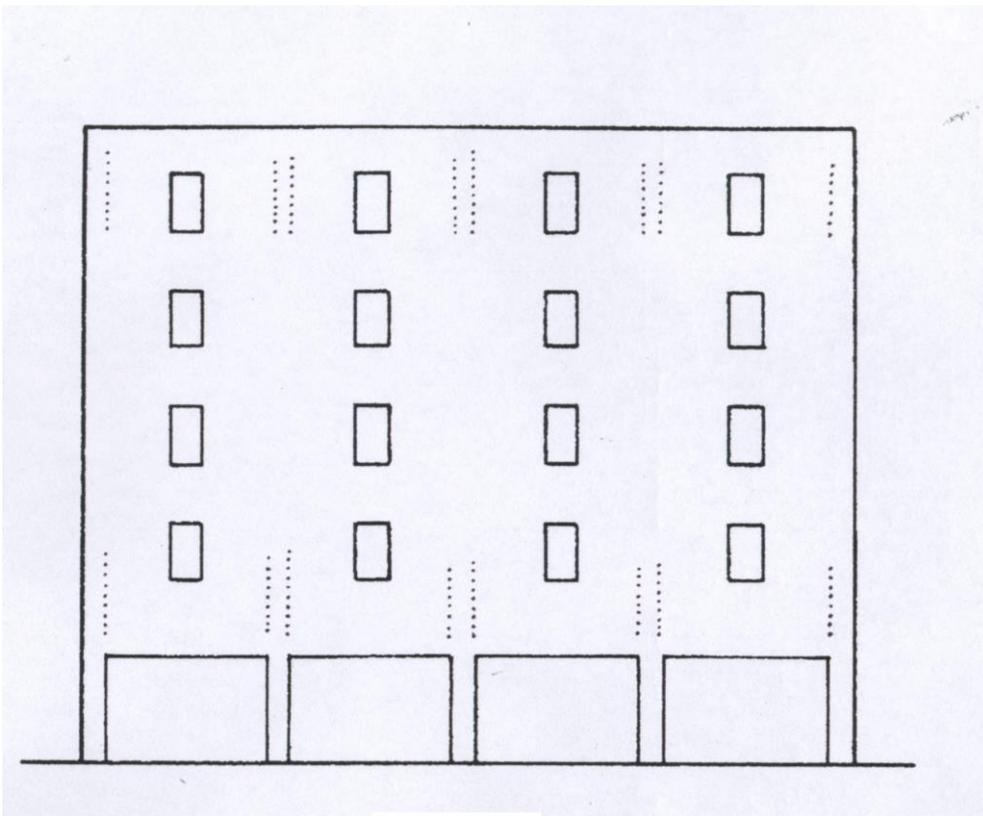
Figure 3. Graphical expression of the soft storey problem

Walls do not permit the upper storey columns to deflect. The rigid upper parts sway in the direction of the lateral load and cause the slender ground floor columns to receive an unpredicted excessive moment. This moment in the columns causes the collapse of the ground floor. *‘In principle it is advantageous to isolate a structure from excessive ground movements by some sort of spongy layer. It has been proposed that a basically stiff structure could be protected from short-period vibrations by making the bottom storey columns relatively flexible. Unfortunately, many modern buildings of this type have not performed well in*

The negative effects of non-load bearing infill walls on reinforced concrete frames can be analyzed under the headings of “soft storey” and “short column” problems. Ambrose and Vergun (1999) define the “soft storey” problem thus: *“In a multistorey structure, a storey level whose lateral stiffness is significantly less than that of storeys above it.....an abrupt change in total storey stiffness between adjacent levels, between different vertical levels”* (Figure 3)

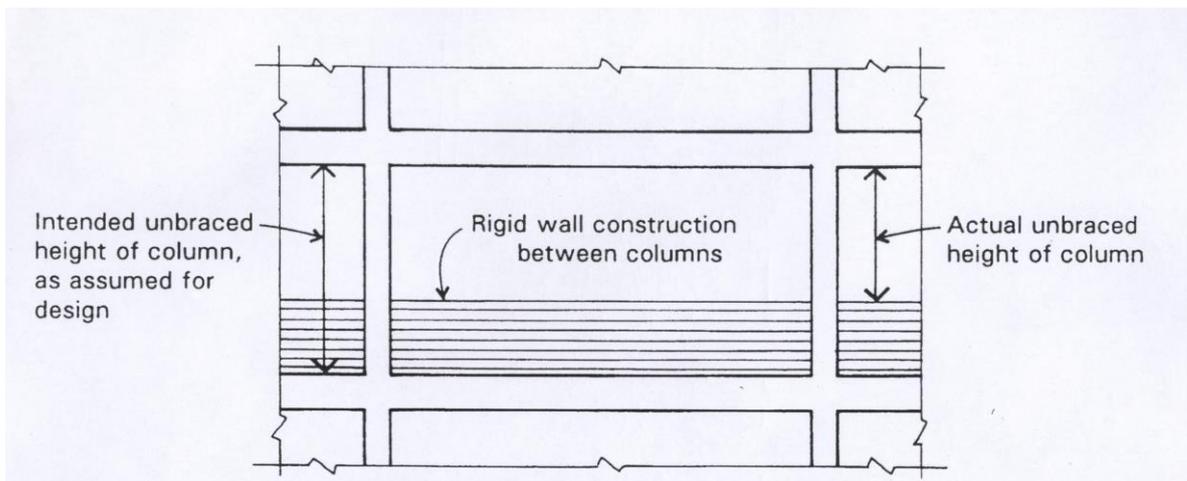
Figure 4. Graphical expression of the short column problem

The movement of the top part of the column is not restricted by the wall. However, the lower part is. The column can only bend through the height of the window. The whole shear is concentrated on that short length, and the amount of shear is increased. (Ministry of Public Works and Settlement, 1997) The increased level is unpredictable and the column collapses from shear instead of bending.

Key (1998) gives examples of “short column” and mentions that *“the constraining effect of masonry abutting the column makes it liable to fail in shear before it fails in bending; at the weak point opposite to the window opening...”* (Figure 4)

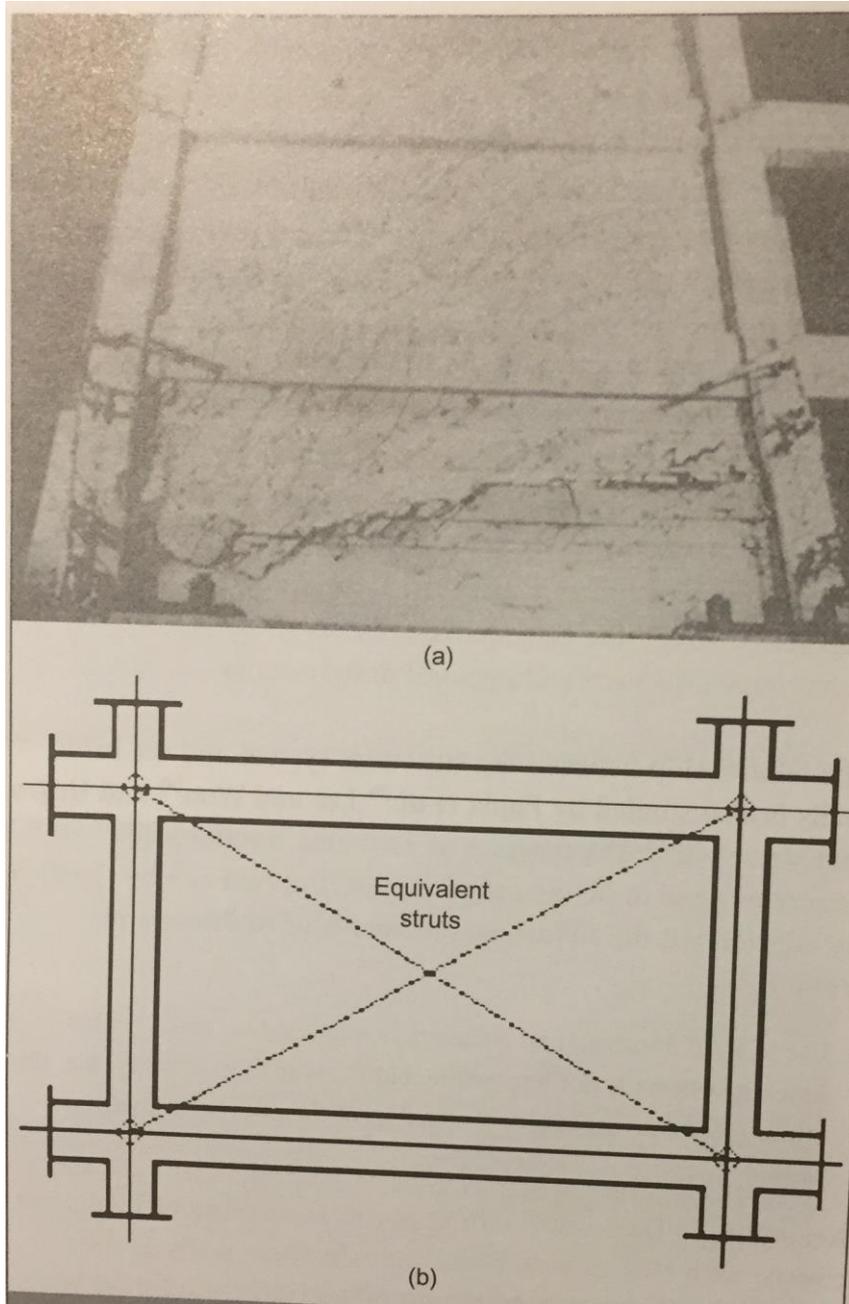
Figure 5. a. Development and crush of struts in an infill wall.
b. Analytical idealization of an infill wall as two equivalent struts.
(Klingner, 1980)

infill walls. (Freeman, Czarnecki, Honda, 1980) The laboratory experiments, which were carried out to determine the structural role of non-load bearing brick walls on reinforced concrete frames, also support these explanations. Under such conditions, the infill walls start forming struts. (Klingner, 1980) (Figure 5)

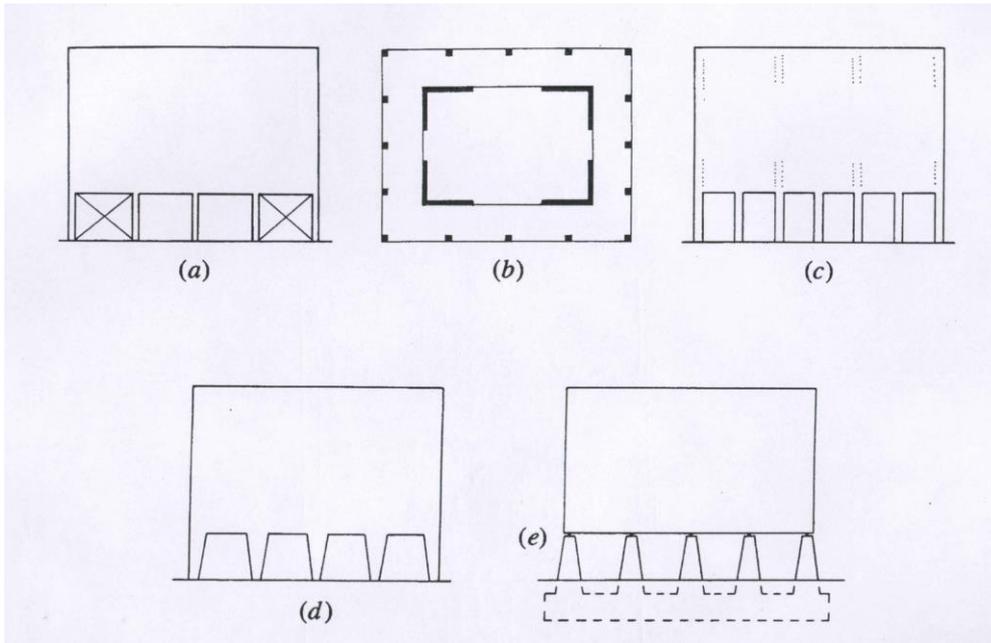
Figure 6. Floor design to combat soft storey formation. (Ambrose, Vergun, 1999)

4. Developing a rigid first storey as an upward extension of a heavy foundation structure. (Figure 6.e)
5. Increasing the number of ground floor columns. (Figure 6.c)

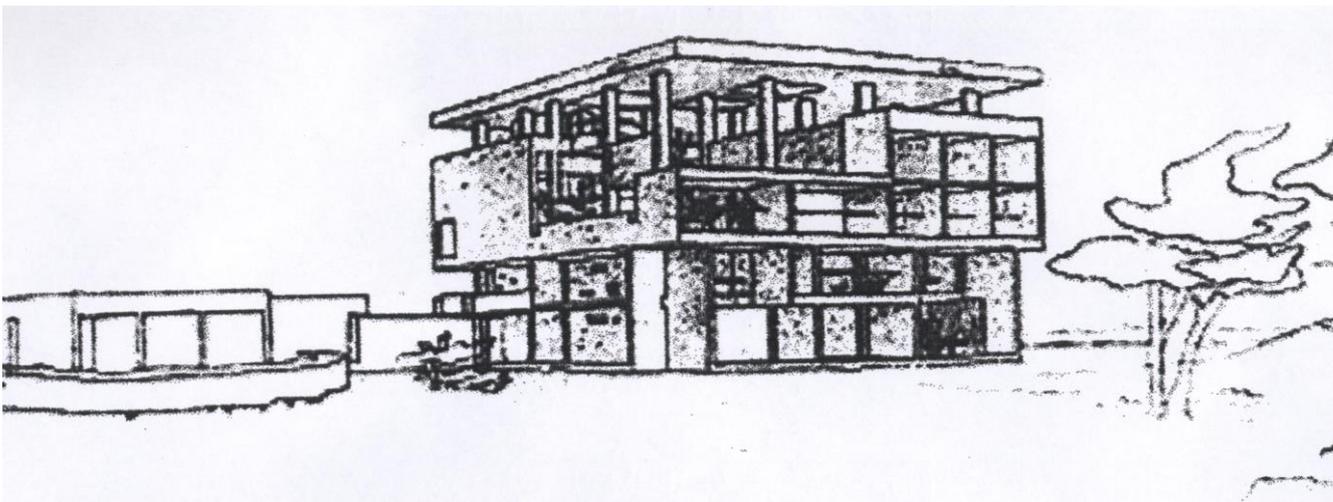
Figure 7. An example of the separation of the axis of nonstructure from the axis of structure.

7. In addition to these preliminary design solutions, one more suggestion can be added to them; that of separating the axis of non-load bearing walls from the axis of the structural frame, as in the designs of Le Corbusier, who has extensively used "strip windows" as well as "pilotis," which has set the precedent for the most frequent reasons for soft storey and short column formations currently. (Figure 7)

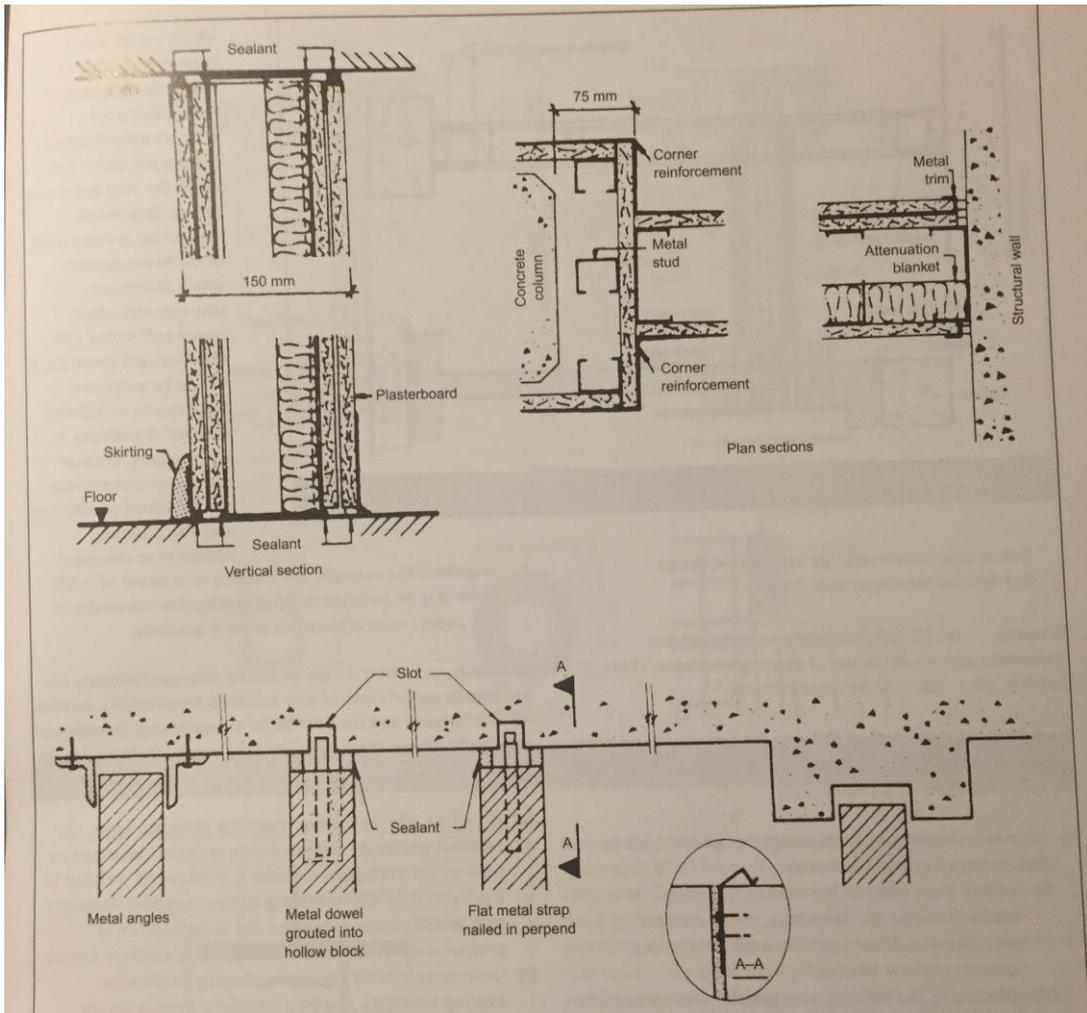
Figure 8. Integrating infill with structure. (Dowrick, 1990)

Seismic detailing of structure includes control joints, motion isolation joints, energy absorbing devices and base isolation of the buildings. Here, only the joint types between the infill walls and structure are explained, because only these can be direct solutions for soft storey and short column problems. Infill walls may be either integrated into the structure, or separated from it. Dowrick (1990) proposes integration, but only if the structural system is stiff because of the existence of shear walls. (Figure 8) Separation of infill from structure is necessary, only if the building structure is a flexible frame. (Figure 9)

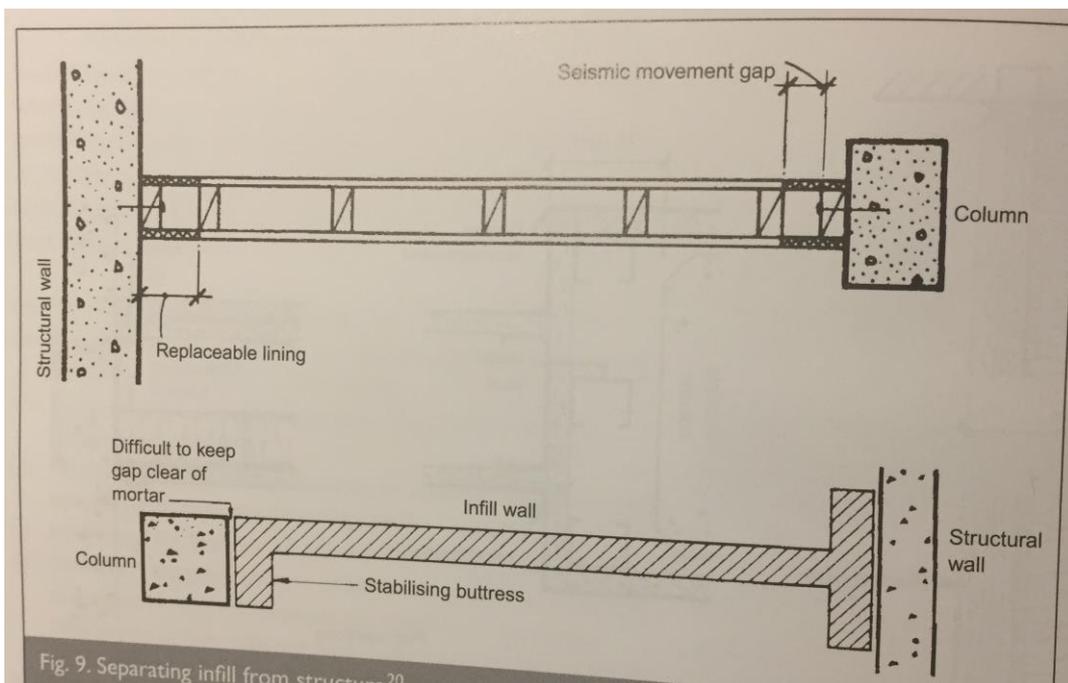
Figure 9. Separating infill from structure. (Dowrick, 1990)

The wall, which is separated from the structure has to be designed in such a way as to reduce any problems arising from its separation from the reinforced concrete frame. There must be 20 to 40 mm distance between the structure and the infill wall for structural purposes, and this requires care during construction. The stability of this independent infill wall against the out of plane forces, must also be realized. The material used between the structure and the wall is important for the purposes of adequate heat and sound insulation. ‘Seismic detailing’ is one of the solutions to the problem, which is proposed by Mexico City building code. (Paz, 1994)

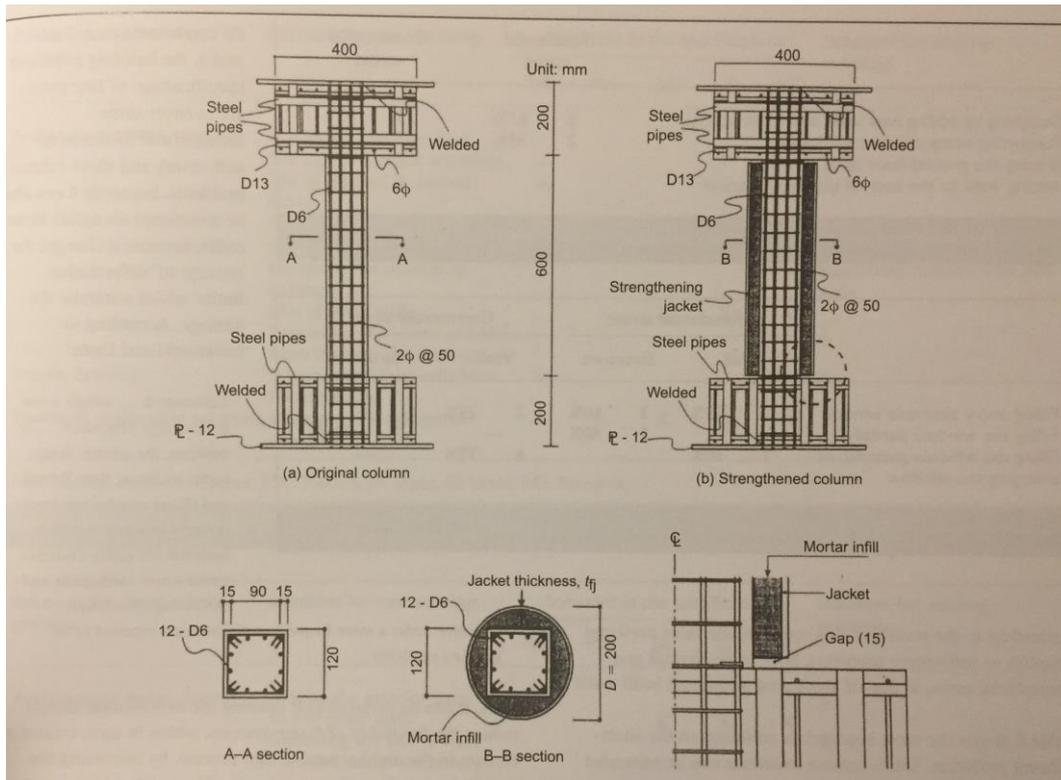
Figure 10. Strengthening of a column by using a ferrocement jacket. (Katsuki, Takiguchi, Abdullah, 2001)

Increasing the strength of the elements and joints by making them larger is another alternative. The use of jackets, strips, wraps, or plates, which are made of steel, carbon fibre, and ferrocement are examples of this. (see Ambrose, Vergun, 1999; Katsuki, Takiguchi, Abdullah, 2001; Sabnis et.al., 1996; Parra-Montesinos, Wight, 2001; Ghobarah, Galal, 2004; Martnezrueda, Elnashai, 1995) Figure 10 shows shear strengthening of reinforced concrete columns by using ferrocement jackets. Here, the jacket contains layers of wire mesh, which are put in a cement paste. Figure 11 shows the wrapping of those (reinforced concrete hybrid) column regions just above and below the steel beam with carbon fibre sheets.

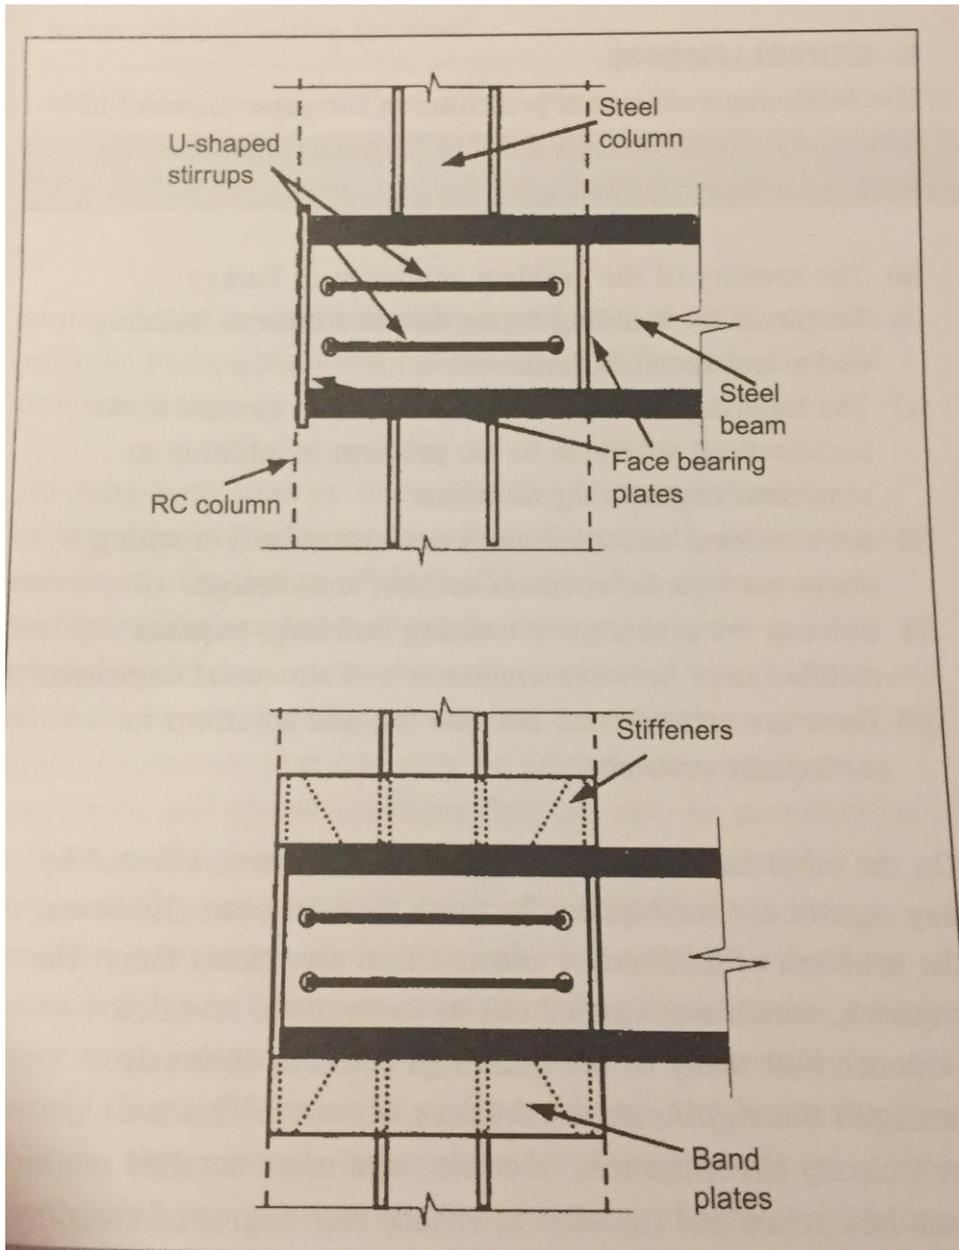
Figure 11. Wrapping RC hybrid column with carbon fibre sheets. (Parra-Montesinos, Wight, 2001)
