Hurol, Y., Yüceer, H., Basarır, H., (2014) "Ethical Guidelines for Structural Interventions to Small Scale Historic Stone Masonry Buildings." *Science and Engineering Ethics*. December 2015, Volume 21, Issue 6, pp 1447-1468.

Ethical Guidelines for Structural Interventions in Small-Scale Historic Stone Masonry Buildings

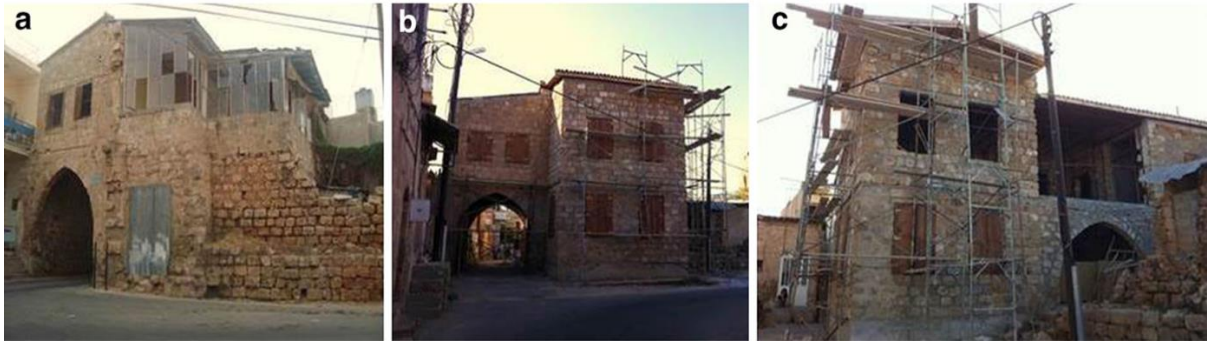
One important decision in the restoration of a historic building is the development of an approach for the missing parts. As stated in the Venice Charter's 9th article, conjecture should be avoided in any restoration work. Replacement of missing parts should be done in a way that can be distinguishable from the original parts so as to not cause falsification. With this in mind, the approach for the case building is considered inappropriate when comparing its actual state to its former one. As seen from the Fig. 6, the building had some missing and ruined parts, which were later replaced based on conjecture and are not easy to distinguish from the original parts.

Fig. 6. The state of the building before restoration (a) and after restoration (b, c) (Photos by)

Looking at the plan scheme and its reflection in the mass of the building's current state, during restoration work, the building was enlarged towards the south, occupying extra space on 28 Mehmet Celebi Street to provide larger rooms for the ground and first floors. The façade arrangement was also designed based on assumptions by looking at the façade order and elements of other neighbouring residential buildings. Other major interventions took place on the eastern part of the building facing a church. While the building had some traces indicating that it extended towards the east, with the restoration work, that part was also completely changed (Fig. 6c).

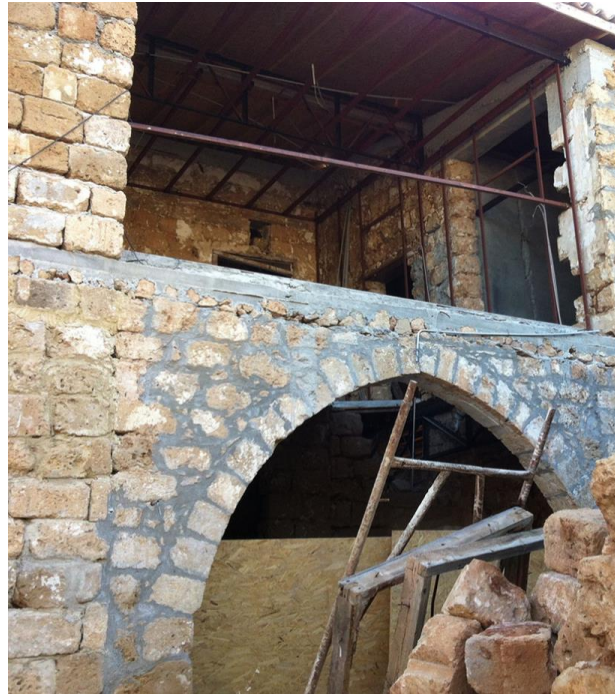
- Reinforced concrete foundations were added to the existing stone masonry,
- The timber horizontal tie-beams were replaced with reinforced concrete horizontal tie-beams,
- Reinforced concrete lintels were introduced on window and door openings,
- Cement mortar was used in the reconstruction of ruined parts to bind the local stone (Fig. 7)

Fig. 7. The uses of concrete beams and cement mortar for the restoration work (Photo by)

-As stated in the Nara Document on Authenticity (ICOMOS 1994), authenticity judgements may be linked to a variety of sources comprising materials, techniques and hence structure. In the case building, the use of different structural systems and materials may be necessary (but this should still be questioned), yet the way in which it is integrated with the historic fabric threatens its authenticity. In addition, the use of cement is also harmful for stone masonry because of its acidic content. Reinforced concrete can be used with this type of building only if white cement is used (Juhasova et al. 2008; Pieper 2002).

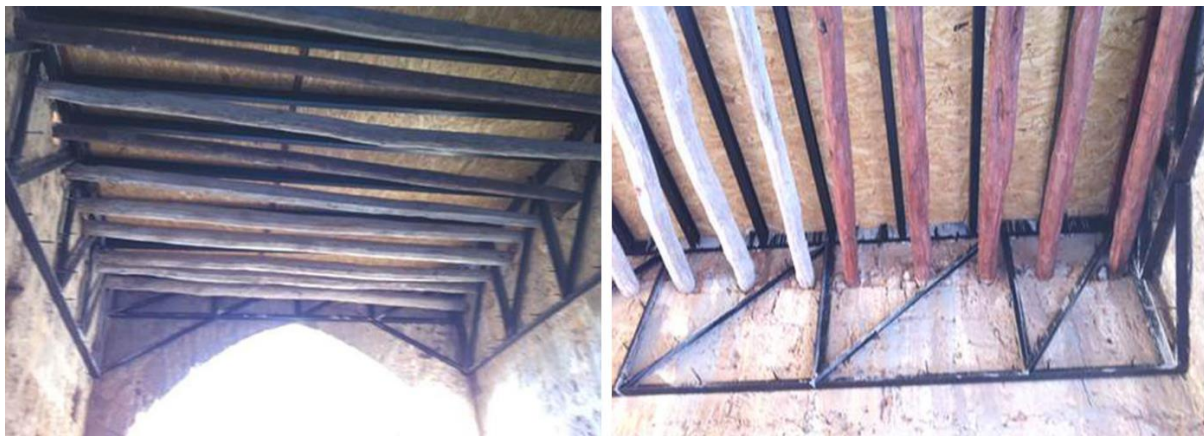
- Steel beams were added to carry the floors, and the timber beams were removed (Fig. 8),
- The steel beams were supported by steel trusses supported by the stone masonry wall,
- The timber floors were replaced with plywood panels, mainly *osb*- oriented strand board,
- The roof was replaced with a steel truss roof.

Fig. 8. Steel beams added during restoration work. (Photos by)

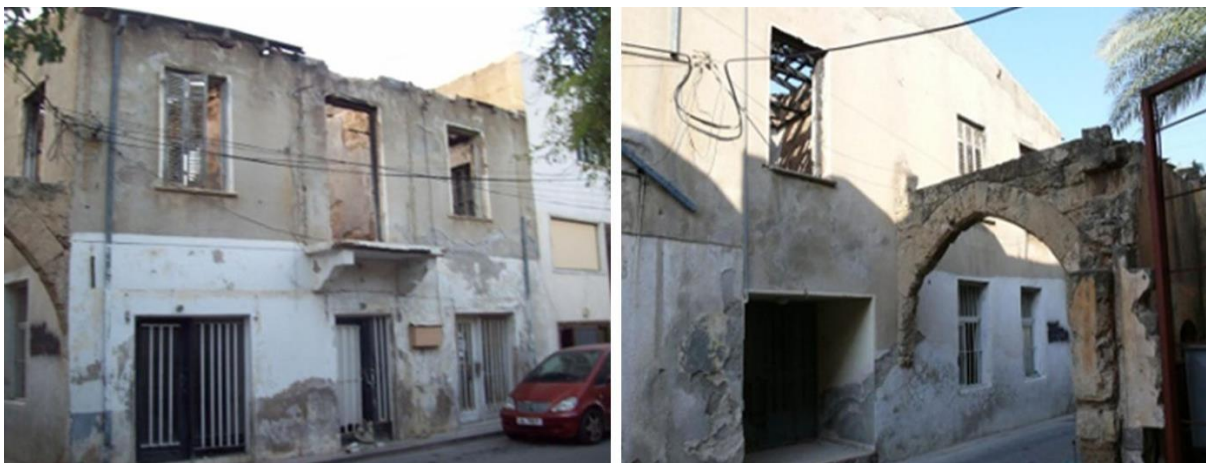
The case-study building above was a semi-ruined building before its restoration. However, there are intact and ruined buildings within conservation areas. Some buildings might require additional vertical supports and completely new floor and roof systems, as seen in Fig. 10. The ethical suggestion for making interventions in ruined buildings should be different than the suggestions for intact buildings.

Fig. 10. General view of a ruined building in walled city of Famagusta (Photos by)
