Application of Pavement Management Systems for the Nicosia Turkish Municipality Road Network

Master of Science
in
Civil Engineering

Eastern Mediterranean University
January 2019
Gazimağusa, North Cyprus

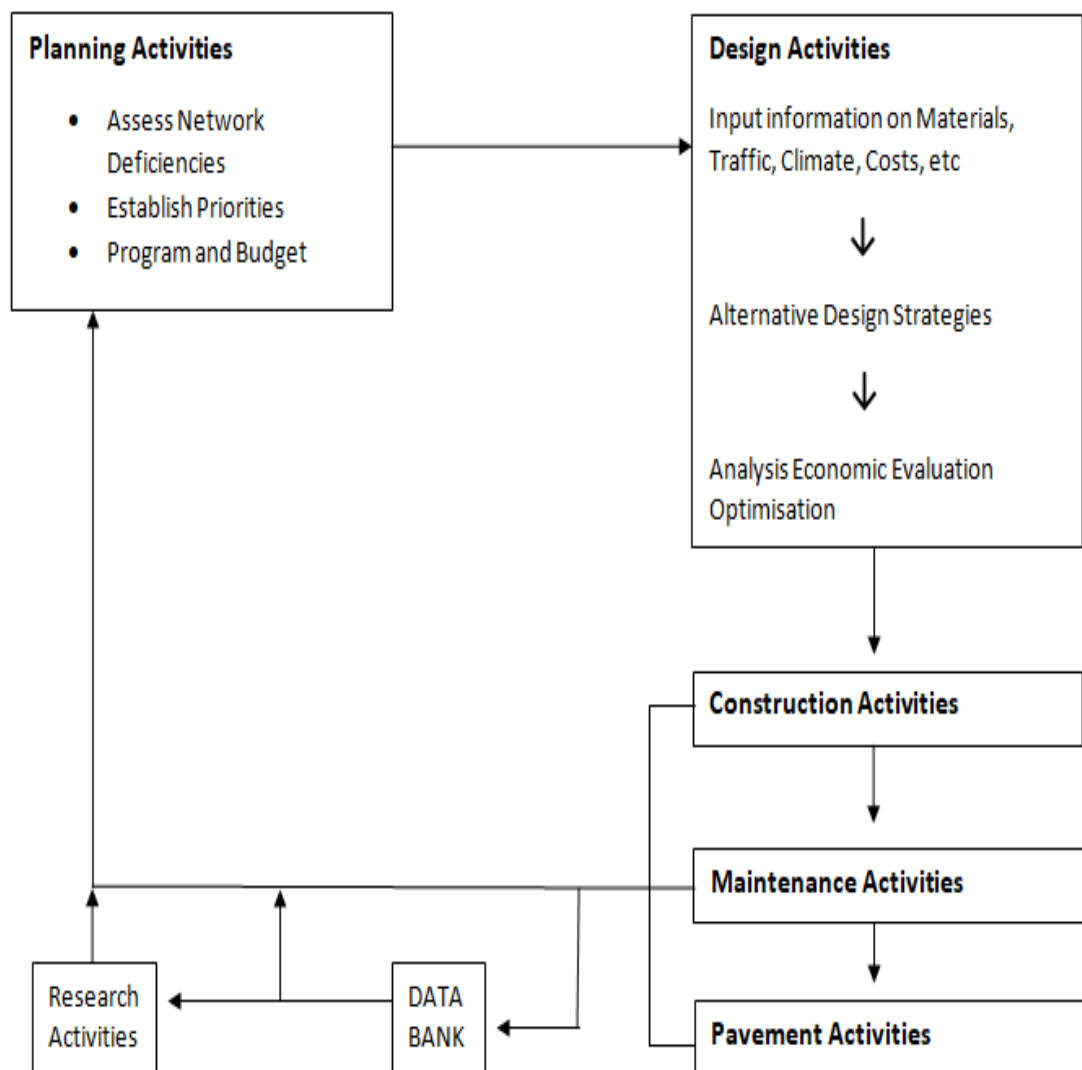
Figure 2: Basic Components of a Pavement Management System (Haas and Hudson, 1978)

PMSs have seven basic components that start with planning activities including assessing the deficiencies in the network, establishing priorities and programming and budgeting. Once an efficient program is established, the design activities can start. The traffic volume, climate and the materials to be used are a vital part of the design activities. The material to be used in PMS should be selected by taking the

climate into consideration. Alternative design strategies to be applied in any case of disparity should also be in-hand. Then, the economic evaluation should be optimised for the construction, maintenance and pavement activities. Once the activities are completed the new data should be entered into the system for further research. The basic components of a PMS, adapted from Haas and Hudson (1978) is shown in Figure 2 below.

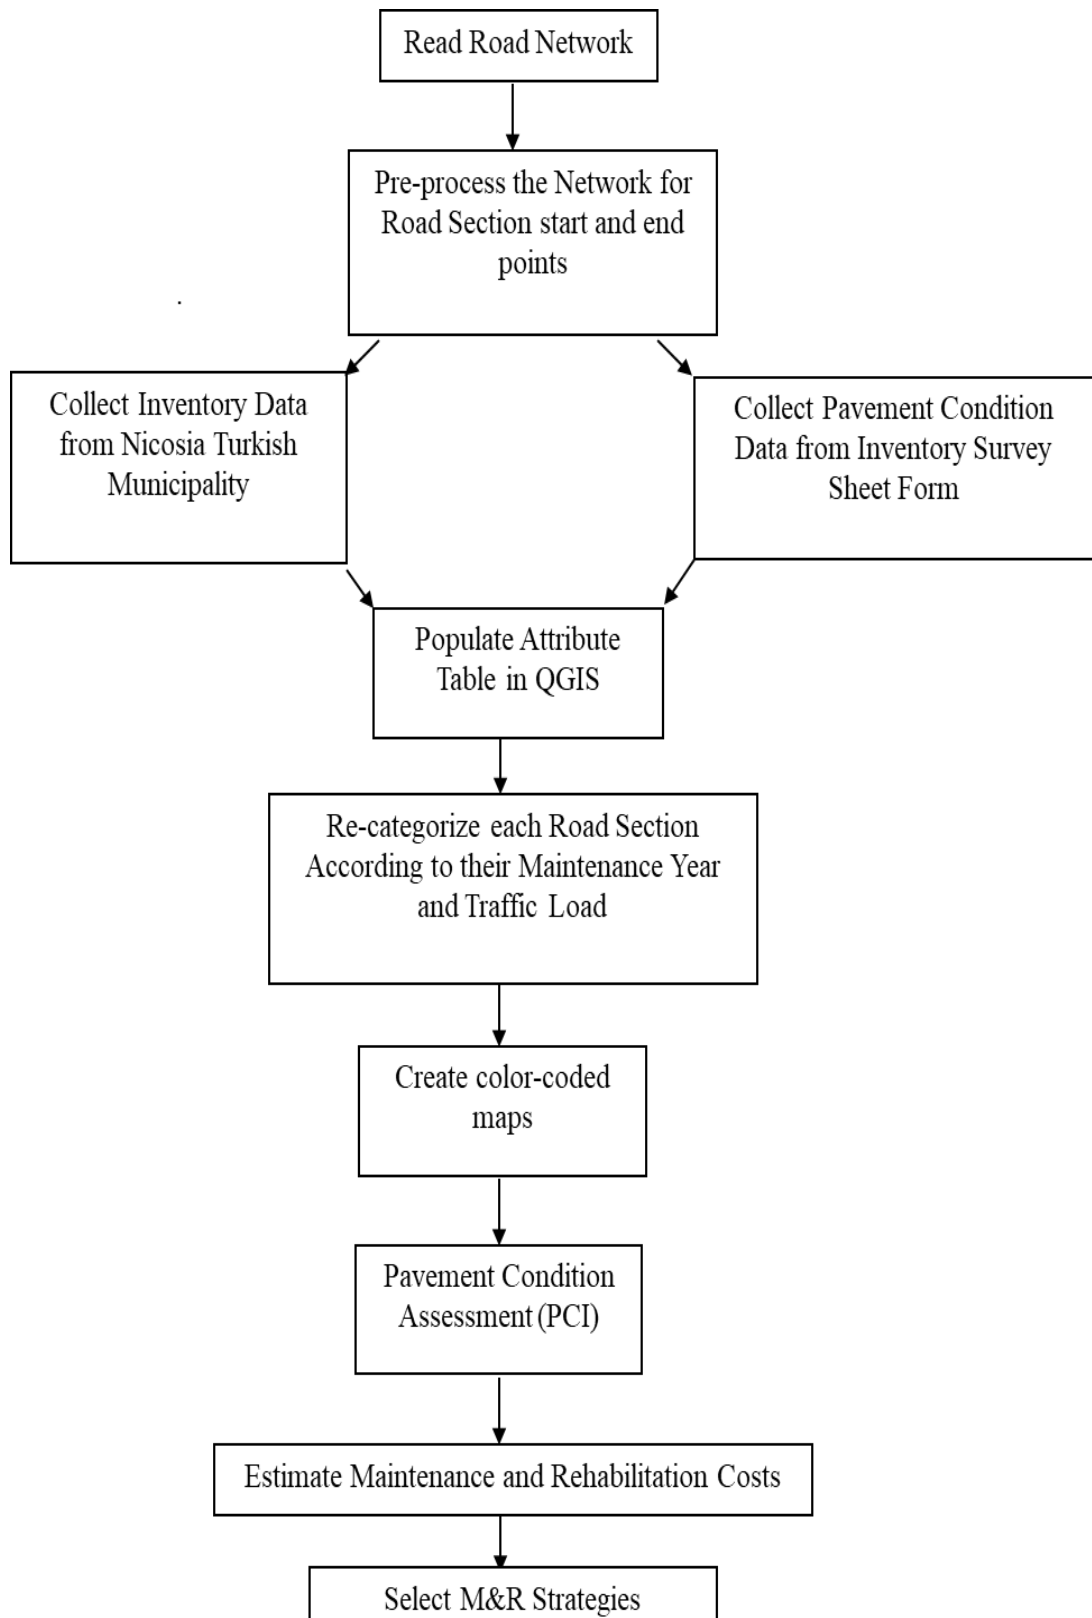
Figure 3: Flowchart of Maintenance and Rehabilitation for This Thesis

The thesis initially retrieved the GIS map from the Nicosia Turkish Municipality and defined the road network using this map. Once the network was defined, inventory data and pavement condition data were collected manually in field research. Then, a database was created to thoroughly illustrate the condition of the roads in the pavement condition assessment. After assessing pavement conditions of the roads, the cost for maintenance and rehabilitation strategies were calculated. Accordingly, appropriate M&R techniques were identified and recommended.

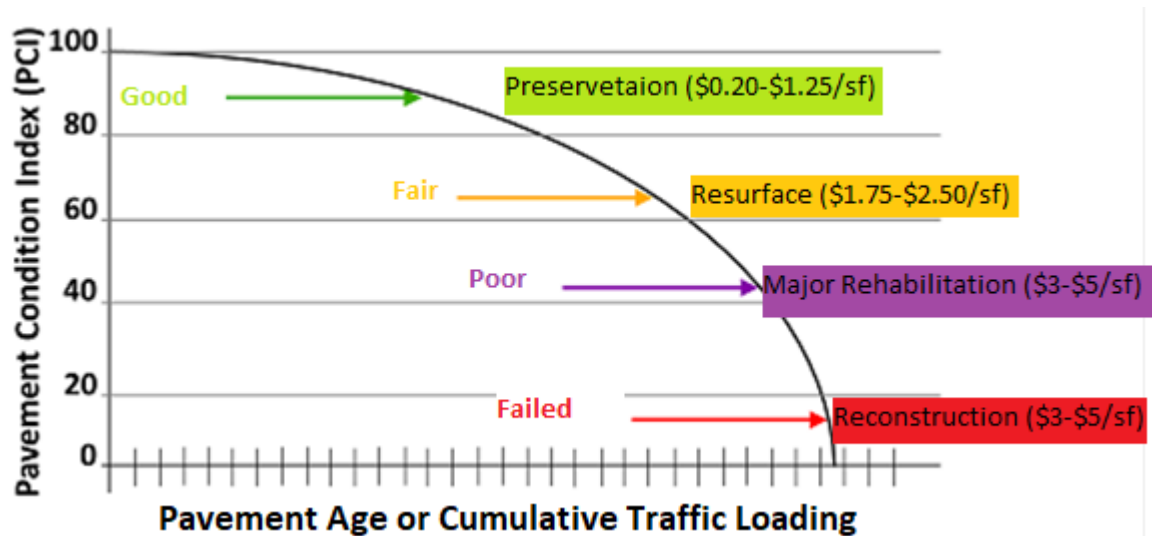
Figure 4: Pavement Condition Index vs Pavement Age (Department of Public Works, 2017)

The pavements of the mostly used streets should always be in reasonable working condition. The transport departments generally aim to maintain the segments of streets in useable condition without reconstructing them. Therefore, the distressed pavements on the streets should be addressed promptly to prevent them from needing reconstruction (Public Works Maintenance, 2015). This type of maintenance is called proactive maintenance in which the pavements are preserved and kept in reasonable condition to prevent complete reconstruction. This method does not only save money to be spent on repairing and rehabilitation but it also enables a relatively long lifespan for the pavement. Figure 4 below describes the general life-cycle of a pavement according to its PCI level and the money to be spent on the rehabilitation of the pavement (Department of Public Works, 2017).

The first couple of years of the pavement when it is in good condition, require only 0.20 USD for preservation. A standard pavement is forecasted to stand for approximately 20 years. However, when the preservation rehabilitations are not done, the rehabilitation costs get higher as the pavement gets older. The graph above indicates that the reconstruction of a standard pavement would cost 3 USD when it completely fails. If effective rehabilitation and maintenance is done on time, the lifespan of a pavement can increase by 15 years, substantially saving money which would be spent on reconstruction. Treating the pavement before it deteriorates completely is called preventative street maintenance, a process which is also known as overlaying (Public Works Maintenance, 2015).

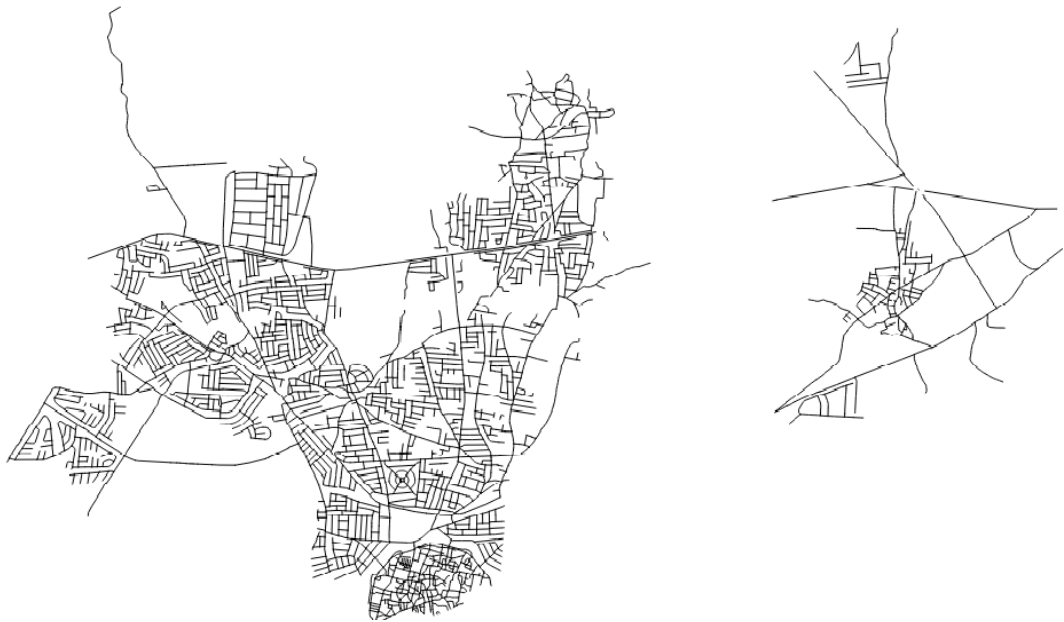
Figure 8: Adding Vectors in QGIS

The road network data that are entered into QGIS includes 3237 rows of data which contain the name of the streets, location of each road and the length of the roads. Apart from the entered data, the maintenance date for each road that have been attended before 2016 as well as the tonnage of asphalt used for the maintenance done have been calculated according to the type of road, the road width and the area of the road. These extra data were collected for the maintained roads only. Maintained roads formed a total of 1492 rows that gives a sum of approximately 6000 data points that have been processed for the purpose of this research. The data were entered manually. Figure 8 illustrates the road network of the city of Nicosia.

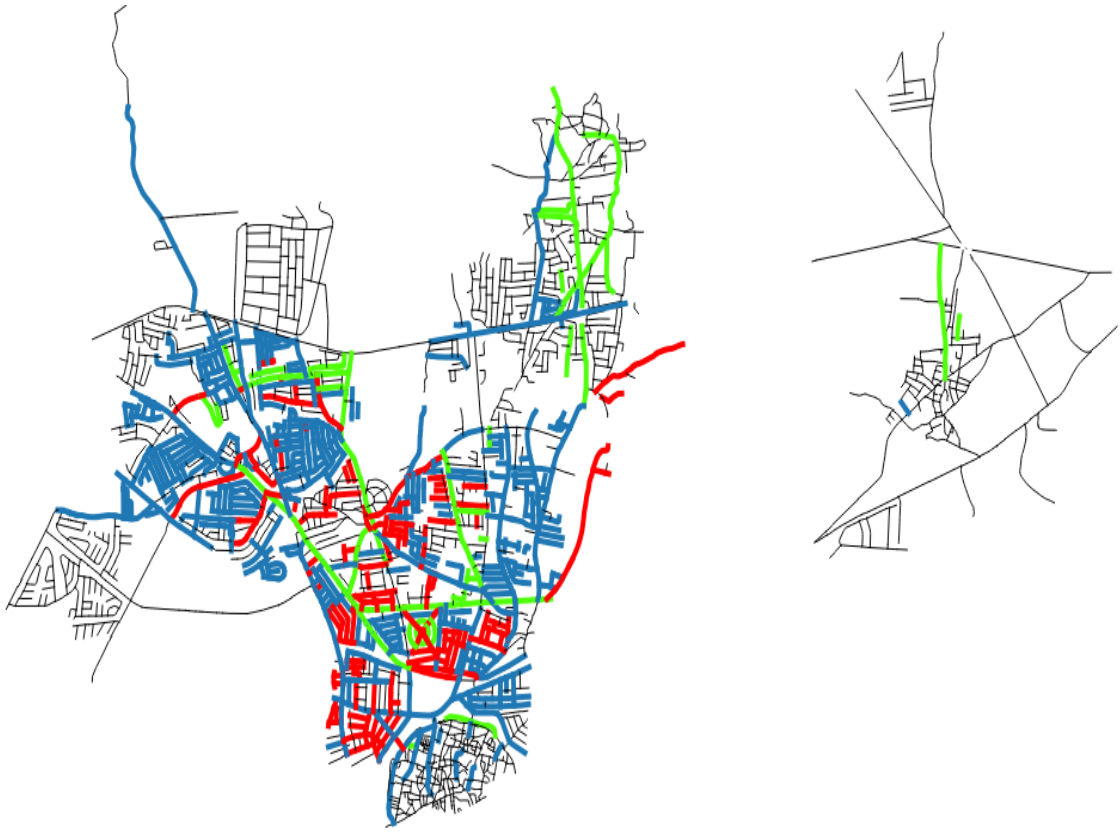
Figure 10: Categorized Road Network

Finally, Nicosia Turkish Municipality road network was classified and colored according to pavement age which can be seen in Figure 10.

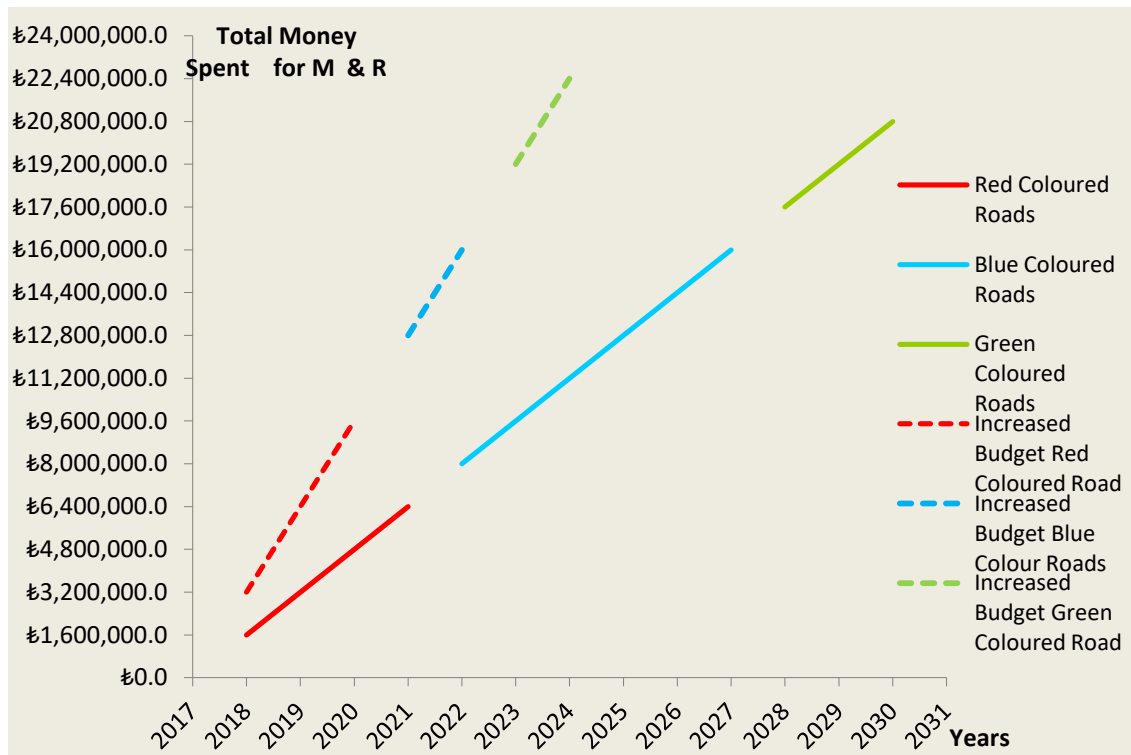
Figure 17: Total Money Required for M&R

The green roads are the newest roads that do not need urgent attention for M&R. The red colored roads should be attended first and urgently and the blue colored roads should then be treated with maintenance and rehabilitation. Figure 17 illustrates the length of time required to mill and overlay all colored roads with the current budget of 1,600,000 TL.

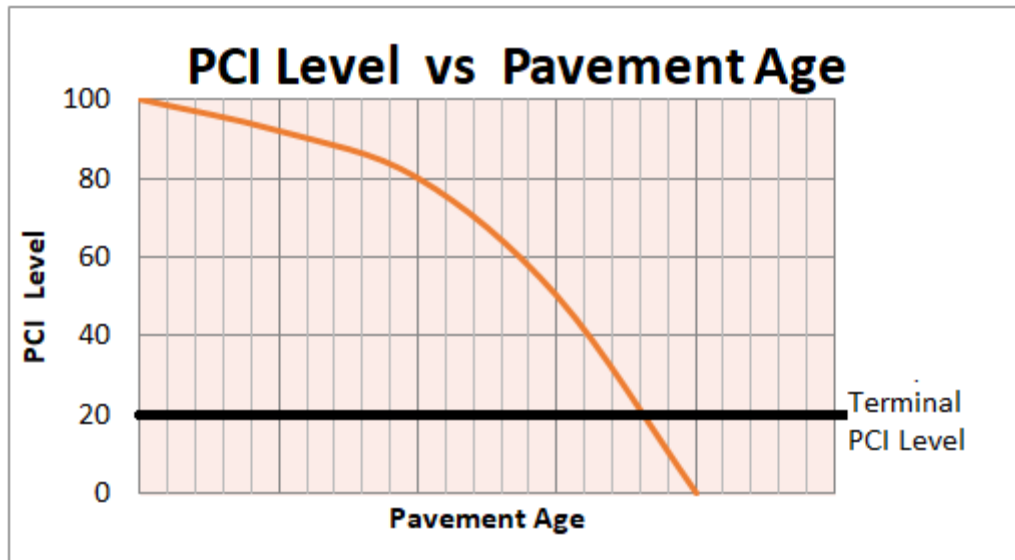
Figure 18: PCI level vs. Pavement Age

Time plays a vital role for the maintenance and rehabilitation work. Figure 18 shows the graph plotted to show the correlation between the PCI levels and the age of the roads.

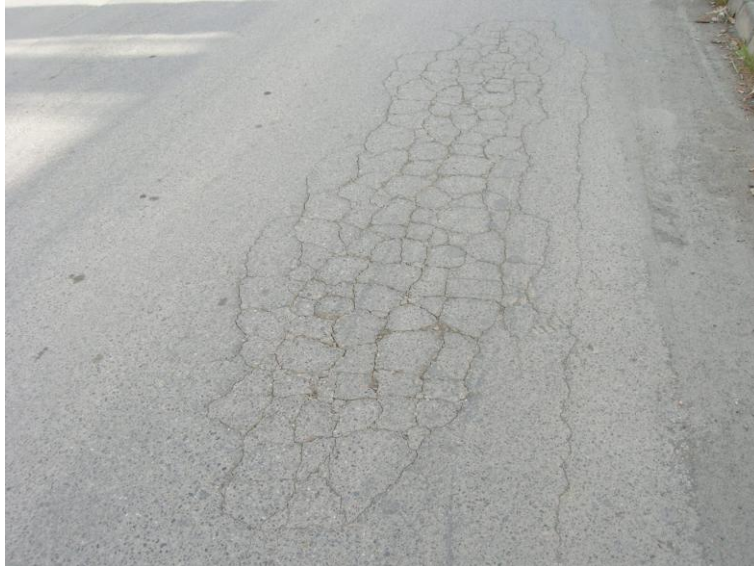
Figure A1. Alligator crack

The name of this type of distress comes from the look of the crack. When the side cracks occur it looks like an alligator/crocodile back which gives the name of the crack type (Lanham, 2012). This distress type involves a series of interconnected cracks (Federal Highway Administration, 2009) that include longitudinal cracks and side cracks. Longitudinal cracks start forming first and then side cracks form stemming from the longitudinal crack.

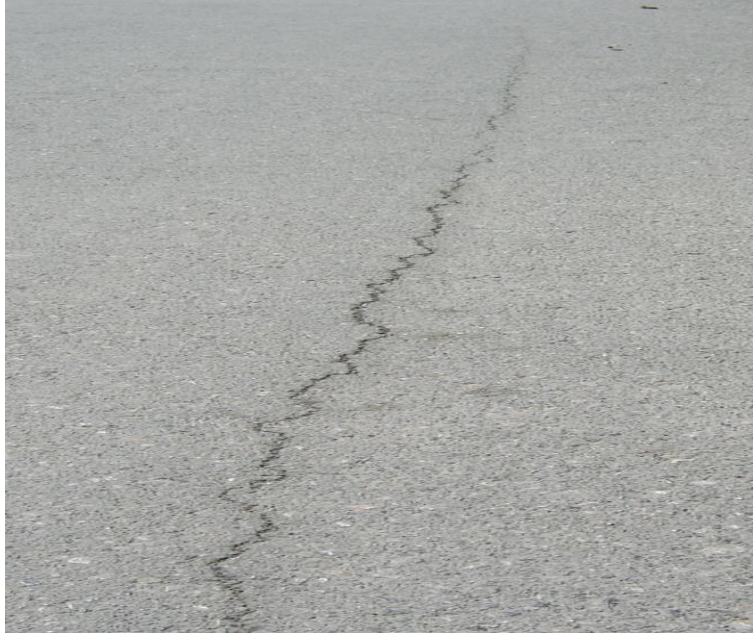
Figure A2. Longitudinal & Transverse Crack

Longitudinal cracks, which can occur anywhere within the pavement, are primarily parallel to the centreline of the road. Transverse cracks primarily occur perpendicularly to the centreline of the road, and they can be visible anywhere in the lane (Federal Highway Administration, 2009).

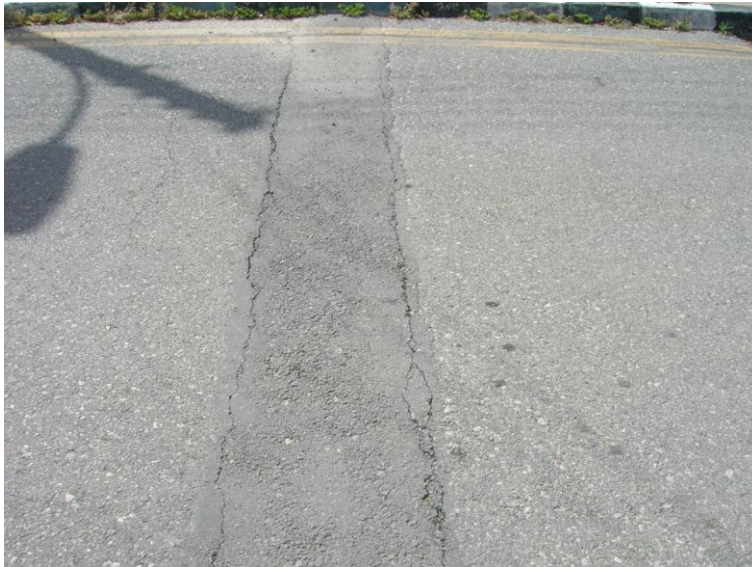
Figure A3. Patching

Patching occurs when an area of the pavement is replaced with new materials in order to restore the pavement in to its original condition (Lanham, 2012).

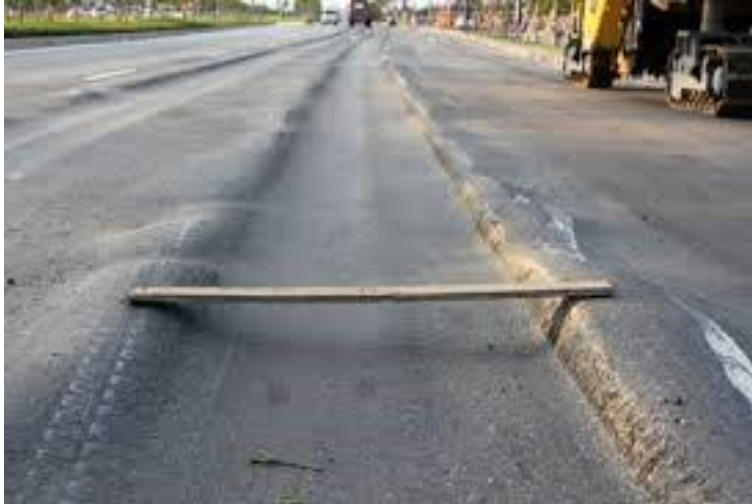
Figure A5. Rutting, (BMT, 2013)

It can be repaired by milling the problematic part and apply a thin HMA overlay (Asphalt Institute, 2017).
