**Conservation and Adaptive Reuse of 20th Century
Industrial Heritage Buildings in North Cyprus: Case
of Narpak Factory Complex**

Master of Science
in
Cultural Heritage Studies

Eastern Mediterranean University
September 2021
Gazimağusa, North Cyprus

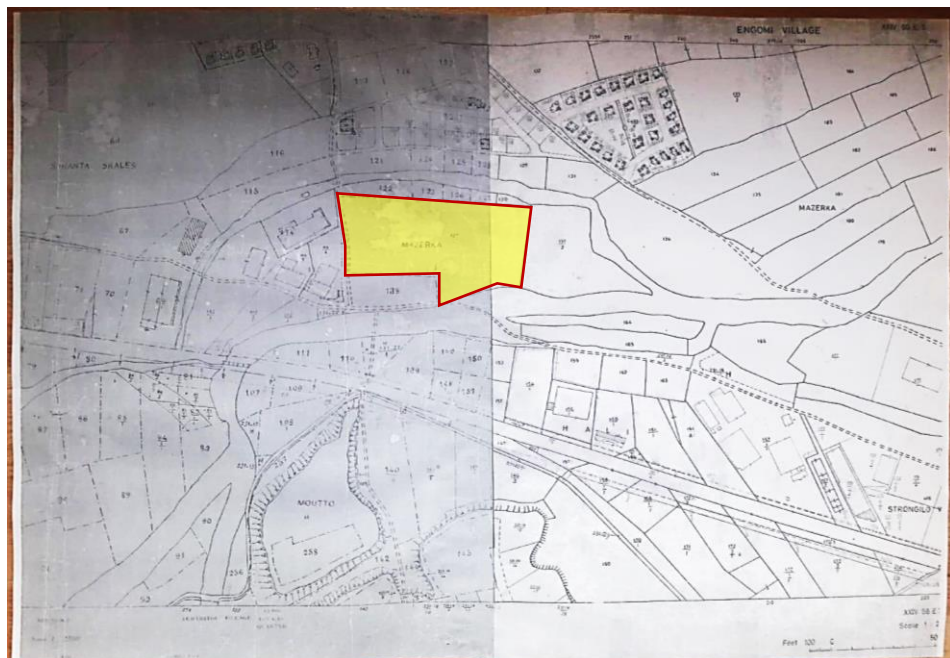
Figure 3.17: Site Plan of Engomi Village in 1960s (Nicosia Land Registry Archive)

The parcel number of the factory complex was 137/1 and the sheet number was XXIV.58.W.2 on the old map, obtained from Nicosia Land Registry archive which belongs to British Colonial Period on the island. The name “Mazerka” was used to define the neighbourhood on the same map. However, the buildings were not shown on the map because it was not totally completed and officially registered at that time.

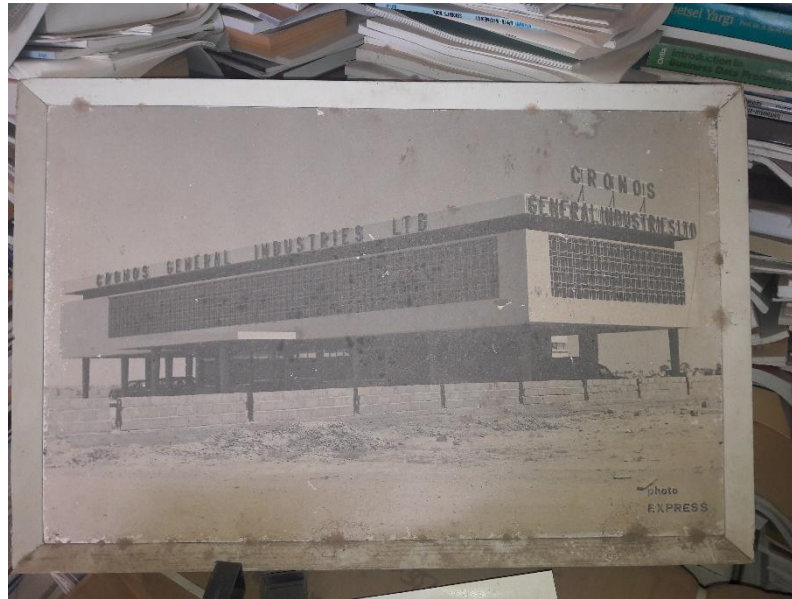
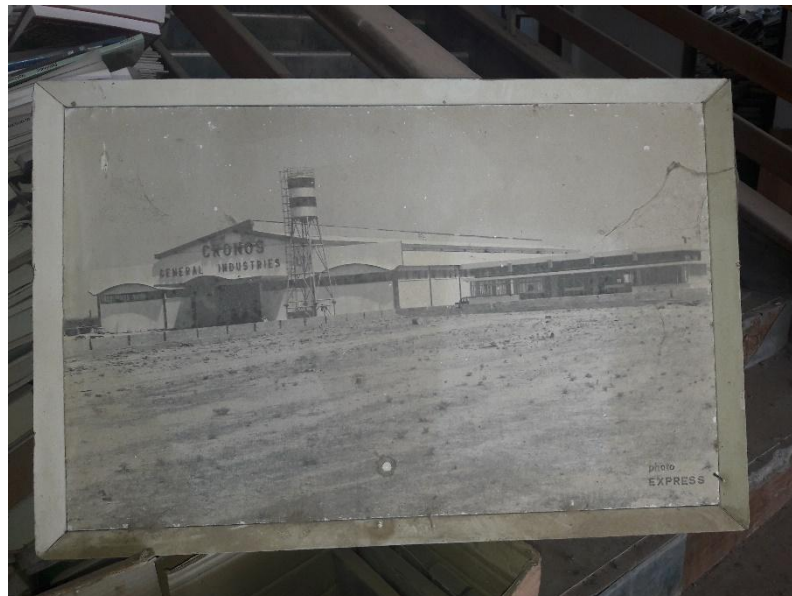
Figure 3.23: Original Photo of Administration Building (Author)

Figure 3.24: Original Photo of Factory Building (Author)

Administration and factory have not changed significantly considering the original photos from the early 1970s (Figures 3.23 and 3.24). The garden walls were under construction and buildings were newly completed on these aforementioned photos. The factory has been operated until 1974 with fully equipped machines and raw materials.

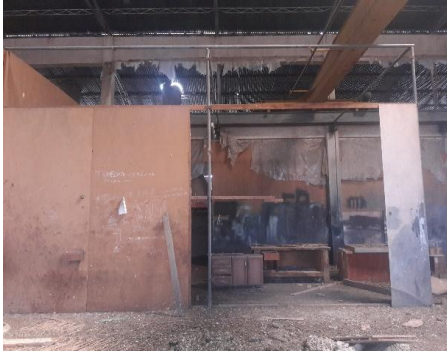
Later on, the parcel of Narpak Factory and some neighbour parcels were assigned to control and administration of Ministry of Education and Culture on 19/4/2006 with a decision number of S-987-2006. (Appendix A) However, the complex was operated between 1988 and 2008 as a workshop until the next decision. During this period, some small-scale interventions were made inside of the factory and ground floor of administration buildings. For instance, wooden partition walls were added to divide painting rooms in the factory and new brick walls were built up to enclose semi-open areas under offices.

Figure 3.42: Wooden Partition Walls Inside Factory (Author)

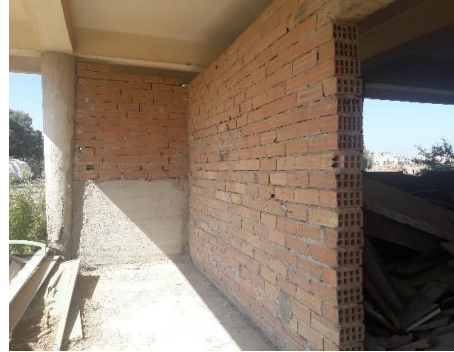
Figure 3.43: Brick Wall Additions on Ground Floor of Offices (Author)

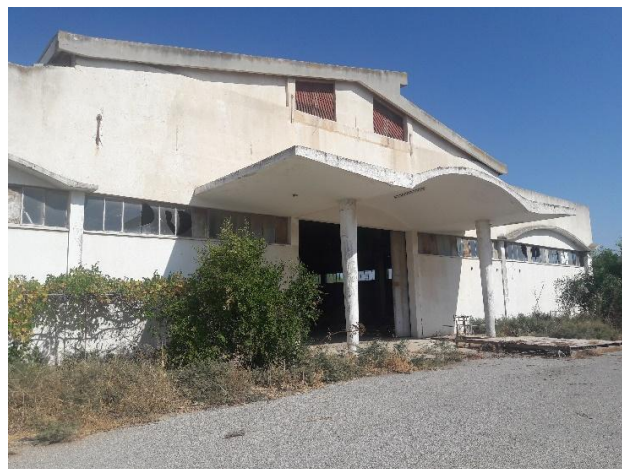
Figure 3.51: West Facade of Factory Building (Author)

The building block has a rectangular form lying along with east-west directions with dimensions of 40x100 meters. The building has a mixture of reinforced concrete frame systems and steel truss systems for the roof. The structure system relies on a grid system of 8x8 meters to form the interior divisions.

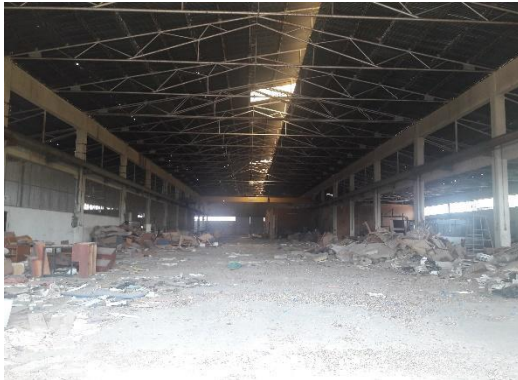
Figure 3.52: Structure System of Factory Building (Author)

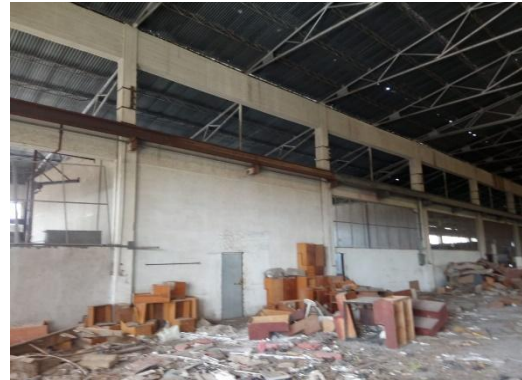
Figure 3.53: Grid System (Author)

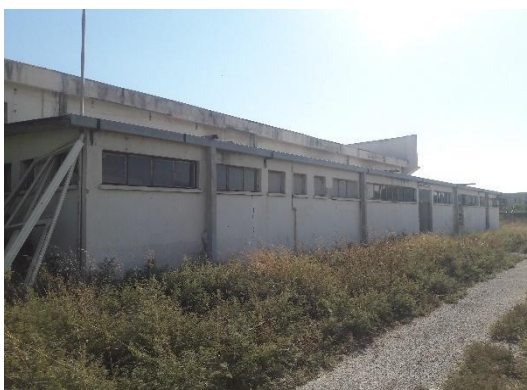
On the other hand, there is another single-story office block attached to the north façade with the same construction type. Contrary to this, a single-story storage room is attached to the south façade of the main block. Both of these units have a shed roof type whereas the factory has a clerestory roof.

Figure 3.54: Office Block on North Facade (Author)

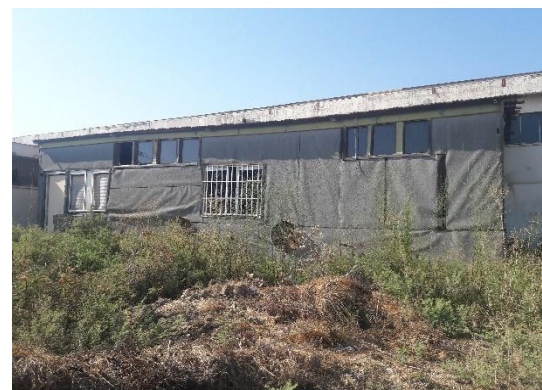
Figure 3.55: Storage Block on South Facade (Author)

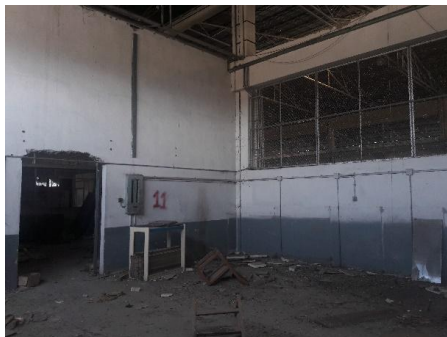
Figure 3.56: Brick Masonry Walls
(Author)

For all blocks, interior walls are plastered brick masonry with a thickness of 10 cm. Also, wooden partition walls are found at the factory and office block. Only in WC 15x15 cm, ceramic tiles are used to cover up walls. In some units such as control rooms, a mixture of glass and brick walls was used as a division to allow easier communication. Similarly, exterior walls are plastered brick masonry with a thickness of 25 cm for the factory and 20 cm for the office except for the storage room which is covered by wooden panels.

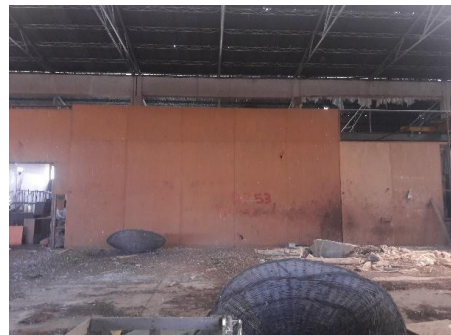
Figure 3.57: Wooden Partition Panels
(Author)

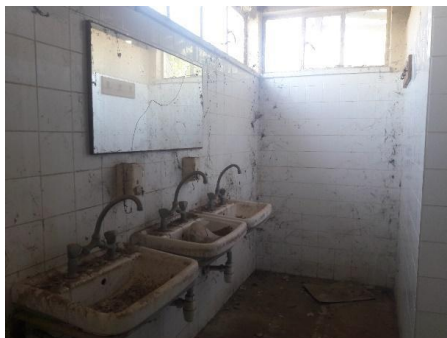
Figure 3.58: Ceramic Tiles in Restrooms
(Author)

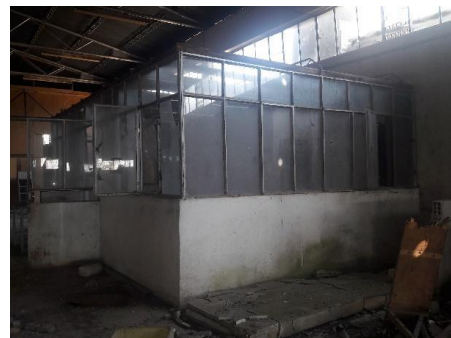
Figure 3.59: Transparent Control Unit
(Author)

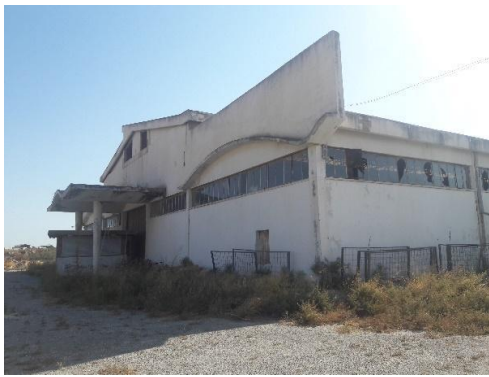
Figure 3.60: East Entrance (Author)

Special columns have been used to define east and west main entrances with a reinforced concrete curvy eave. For all facades, ribbon windows were used continuously to allow daylight for the interior as well as giving a character and creating unity as a whole. On the other hand, various sizes and types of windows were used at facades of other blocks depending on the functions. Especially, additional storage building is incompatible with the rest of the buildings through material and design.

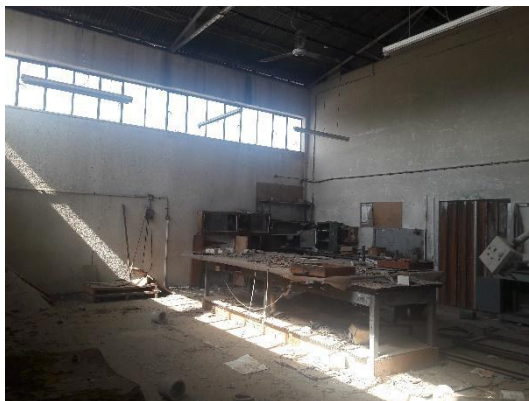
Figure 3.64: Workshop Example on North Wing (Author)

About plan organization, the factory is simply divided into four sections; repeating units of workshops aligned on the north side, later additions of workshops aligned in the south-east corner, restrooms for workers and officers and the main production area in the middle with a small control unit in the south side.

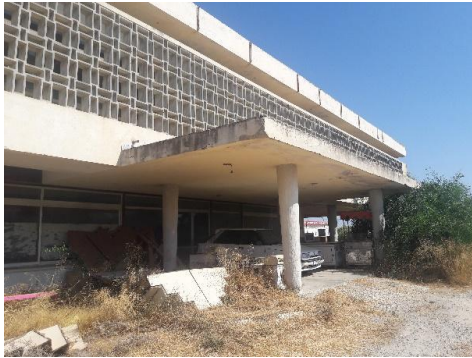
Figure 3.68: Entrance Eave (Author)

The building block has a T-shape form lying along with north-south-east directions. Also, the single-story eave is covering the main entrance of the building in the west direction. The building has a reinforced concrete frame system and walls are made up of brick masonry.

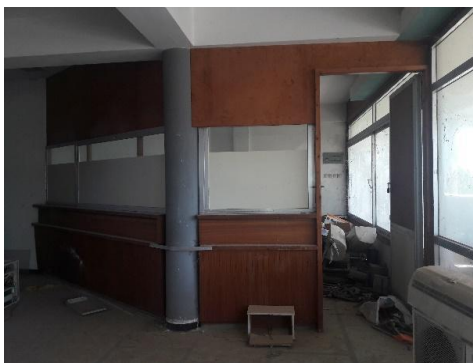
Figure 3.70: Wooden Partition Walls (Author)

Interior walls are plastered brick masonry with a thickness of 10 cm. Also, wooden and aluminium partition walls are found at the sides of the entrance. In addition, wooden panels were added on walls for staff offices. Only in all WC and kitchen, 15x15 cm tiles are used to cover up walls. Similarly, exterior walls are plastered brick masonry with a thickness of 20 cm. On the other hand, the north exterior wall of the kitchen service room has fallen so it requires immediate repair.

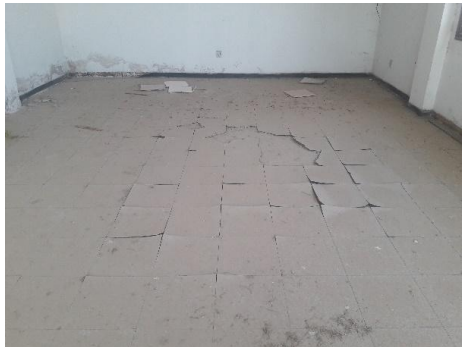
Figure 3.72: Lost Original Floor Covers (Author)

Floor slabs are built in reinforced concrete with a thickness of 15 cm. On the ground floor, terraces and rooms are covered with 30x30 cm ceramic tiles. On the first floor, rooms and terraces are covered with 30x30 cm ceramic marble while some office rooms have lost the original covering material.

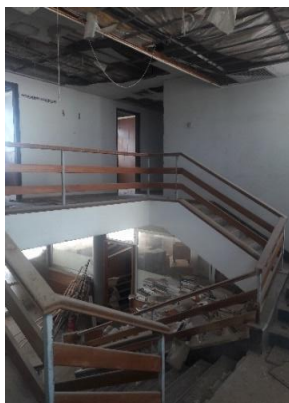
Figure 3.74: Collapsed Suspended Ceiling (Author)

On the first floor, all the rooms except WC have a suspended ceiling with a height of 110 cm to cover the mechanical system. However, most of the panels have fallen and missing leaving behind the steel frame especially in the gallery, corridor and staff rooms. In terms of structural and material condition, the administration building is in good condition except only the missing wall found in the kitchen on the north façade.

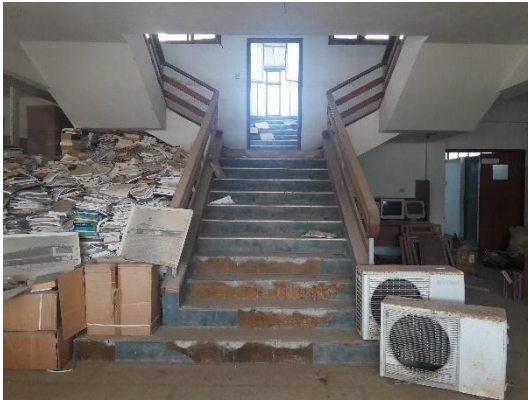
Figure 3.76: Double Wing Staircase
(Author)

As mentioned above, the main access to the interior is from the west side terrace. On the ground floor, there is a total of nine rooms. Since the plan scheme is symmetrical, the two-winged staircase is located in the middle of the entrance hall where the information room and storage is located on the south and the meeting room is located on the north side.

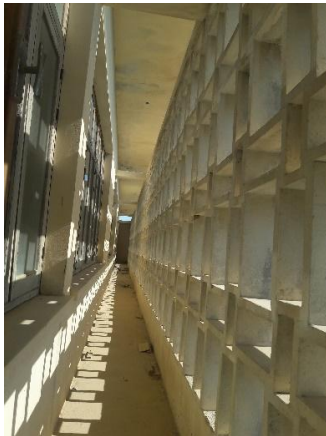
Figure 3.84: Double Façade
(Author)

The north, south and west facades on the first floor have a special double-façade made up of brick masonry where the exterior wall acts as a shading element for the interior functions. For the interior walls, a mixture of fixed and casement windows were used in all rooms. On the other hand, various sizes and types of windows were used at the east facade depending on the functions.

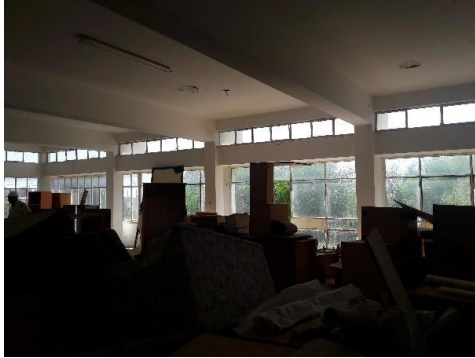
Figure 3.88: Grid System (Author)

The building block has a rectangular form lying along with north-south directions. The building has a reinforced concrete frame system and relies on a grid system.

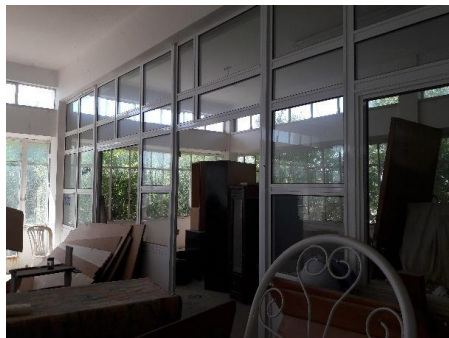
Figure 3.90: PVC Partition Wall (Author)

Interior walls are plastered brick masonry with a thickness of 10 cm. Also, aluminium partition walls are found in the dining hall. Only in WC and kitchen, 15x15 cm tiles are used to cover up walls. Similarly, exterior walls are plastered brick masonry with a thickness of 20 cm. The ground is covered with 30x30 cm ceramic marble including terraces.

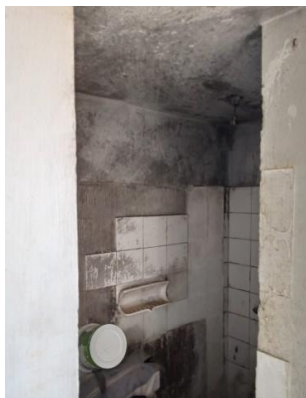
Figure 3.108: WC (Author)

The ground is covered with 30x30 cm ceramic marble. In terms of structural condition, the building is in good condition but most of the materials such as wall tiles, plaster and paint need immediate repair.

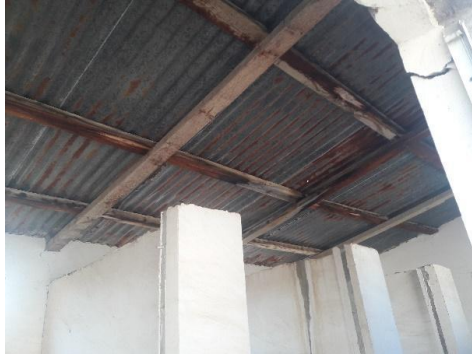
Figure 3.120: Roof Damages (Author)

In terms of the structural condition, the building is in poor condition, especially the walls started to cracked seriously and separated on north and east facades at the corners.

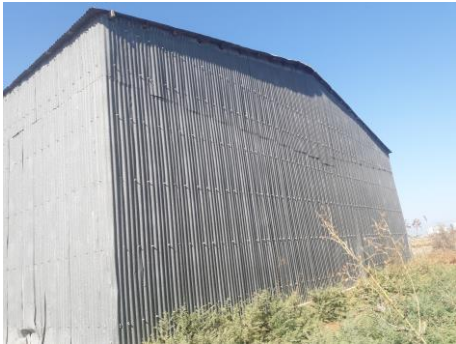
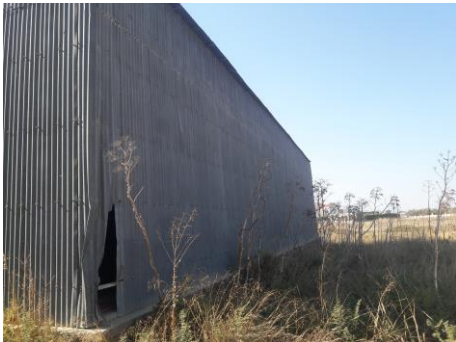
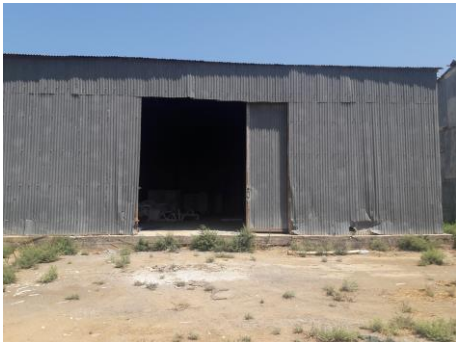
- 1. No structural problems
- 2. Rusted steel columns which are exposed to exterior
- 3. Some damaged corrugated metal sheet used as the exterior panel.

Table 3.12: Structural and Material Deteriorations in Double Storage Building (Author)

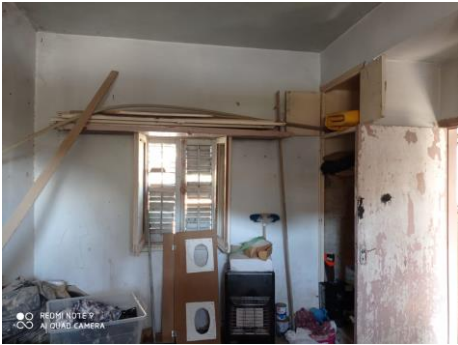
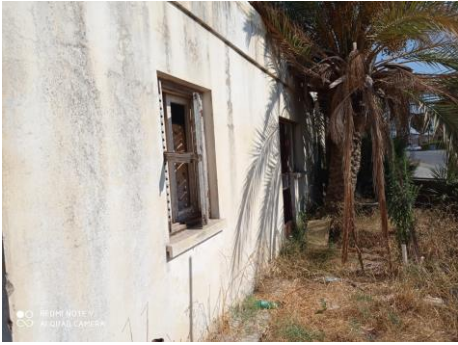
1. No structural problems
2. Loss of material on the exterior and interior walls (plaster + paint)
3. Rusted metal gutter
4. Moisture on parapet walls
5. Moisture on walls of WC and bathroom
6. Loss of ceramic tiles on walls in kitchen and bathroom
7. Damaged and missing interior doors
8. Deteriorated wooden door frames
9. Damaged wooden shutters
10. Salination on WC ceiling
11. Rusted metal window and door frames
12. Broken door glass at kitchen.

Table 3.13: Structural and Material Deteriorations in Security Building (Author)

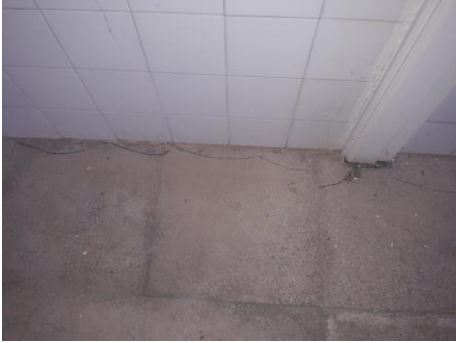
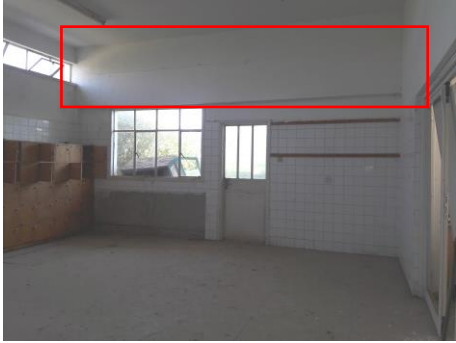
1	2

1. Some serious structural problems such as slight ground/floor movement
2. Loss of material on the exterior and interior walls (plaster + paint)
3. Medium crack on WC floor
4. Medium crack on the kitchen wall
5. Partial floor collapse in meeting room and kitchen
6. Rusted metal window and door frames
7. Vegetation growth on the entrance terrace floor
8. Peeling off ceiling paint partially
9. Missing and broken interior doors.

Table 3.14: Structural and Material Deteriorations in Refectory Building (Author)

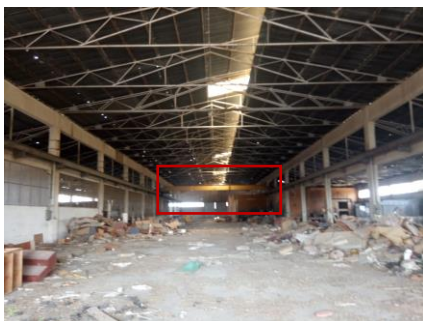
Figure 4.3: Crane in Factory
(Author)

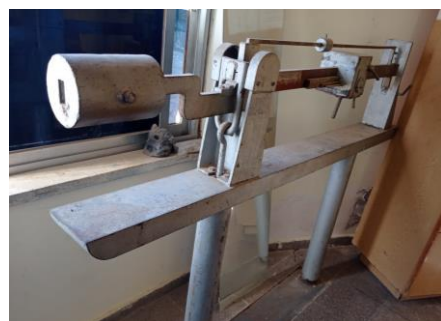
Figure 4.4: Weighing Machine
(Author)

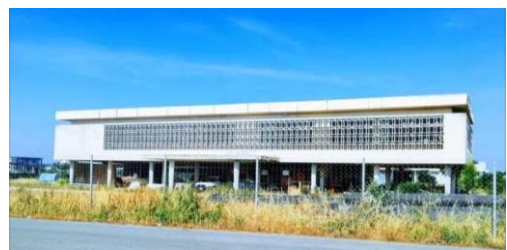
Figure 4.9: Administration Building (Author)

Through its plan organisation and façade elements, it reflects the ideology of the modernist architects on the island. For example, the open floor concept in plan schema, high transparency by use of continuous windows and grid systems for space organisations are regarded as modern touches which affect people's perceptions.

Moreover, the administration and factory buildings include cantilevers, eaves and ribbon windows with simple masses elevated on special design columns like in le Corbusier's designs (See Appendix C). Also, the perforated sun shading wall on the first floor of the administration building gives a character to the complex at its best (Figure 4.9). All of these architectural elements increase the aesthetic value and lighten the bulky view of the structures. The use of simple materials and light colours in the buildings are balanced as well as distribution of different functions is easy on the eye (See Chapter 3).

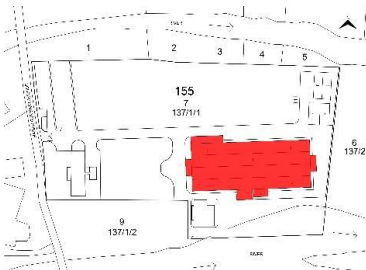
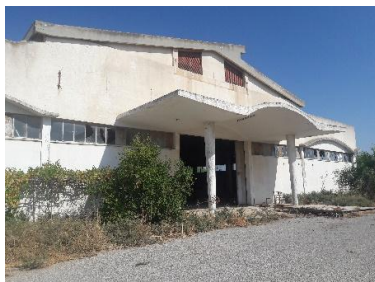
Observations: Plan and façade characteristics are highly conserved but some partition walls inside and annexe are added. The structure system is durable and material deteriorations are quite excessive.

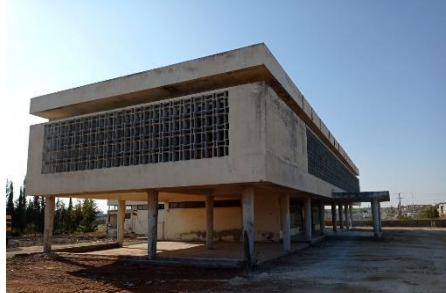
Front Façade

Observations: Façade characteristics are highly changed except for sun shading elements and columns. Plan organization partially changed by removal of some walls. The structure system is damaged and material deteriorations are quite excessive. Loss of interior elements and covering materials.

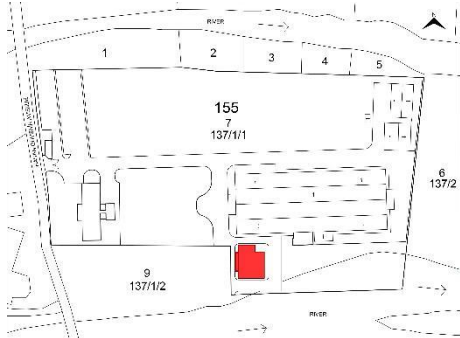
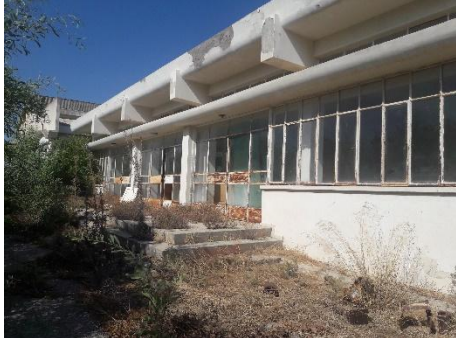
Observations: Plan and façade characteristics are highly conserved but some partition walls inside are added. Structure system is durable and material deteriorations are quite excessive.

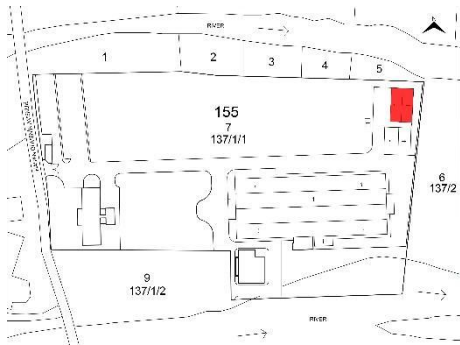
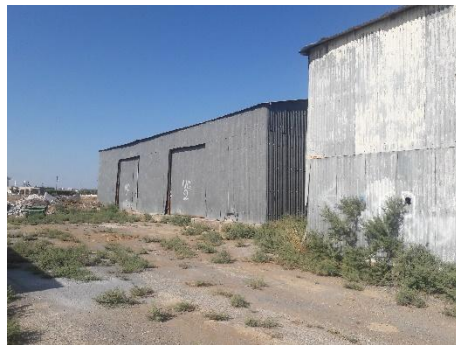
Observations: Plan and façade characteristics are highly conserved. Structure system is durable and material deteriorations are quite a few.						
Ownership: Foundation			Current User: Famagusta Municipality

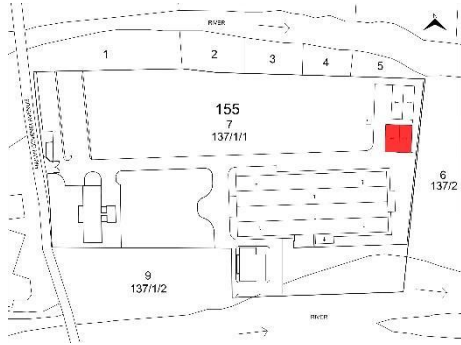
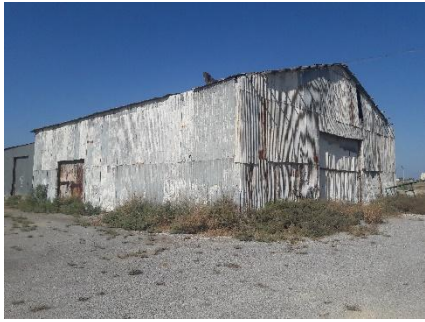
Observations: Plan and façade characteristics are highly conserved. The structure system is mostly durable and material deteriorations are quite excessive.						
Ownership: Foundation			Current User: Famagusta Municipality

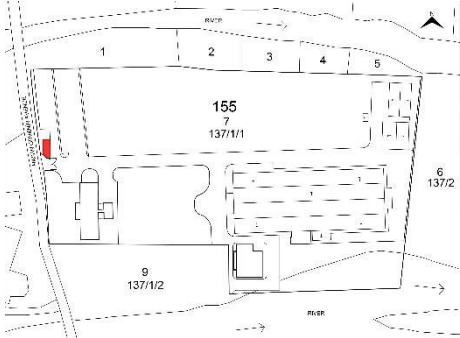
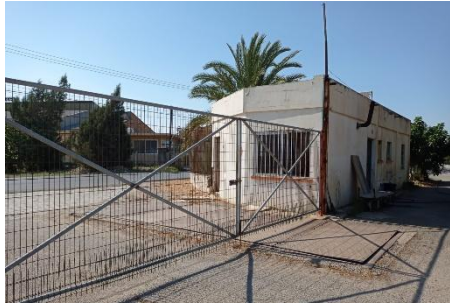
Observations: Plan and façade characteristics are highly conserved. The structure system is durable and material deteriorations are excessive.

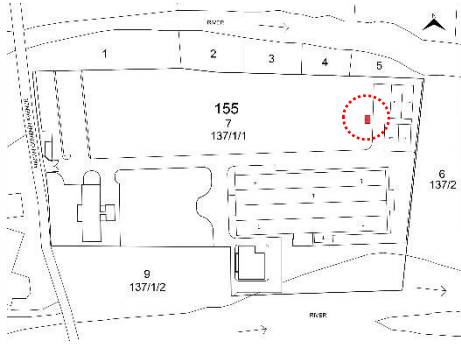
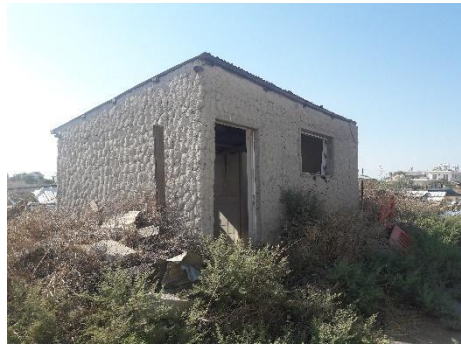
Observations: Plan and façade characteristics are highly conserved. The structure system is highly damaged with cracks on north and west facades and material deteriorations are quite excessive.
