Rural carob warehouses in Cyprus: an assessment of architectural and structural characteristics

Beser Oktay Vehbi, Hülya Yuceer & Yonca Hurol

To cite this article: Beser Oktay Vehbi, Hülya Yuceer & Yonca Hurol (2016) Rural carob warehouses in Cyprus: an assessment of architectural and structural characteristics, Journal of Architectural Conservation, 22:1, 18-47, DOI: [10.1080/13556207.2016.1208473](https://doi.org/10.1080/13556207.2016.1208473)

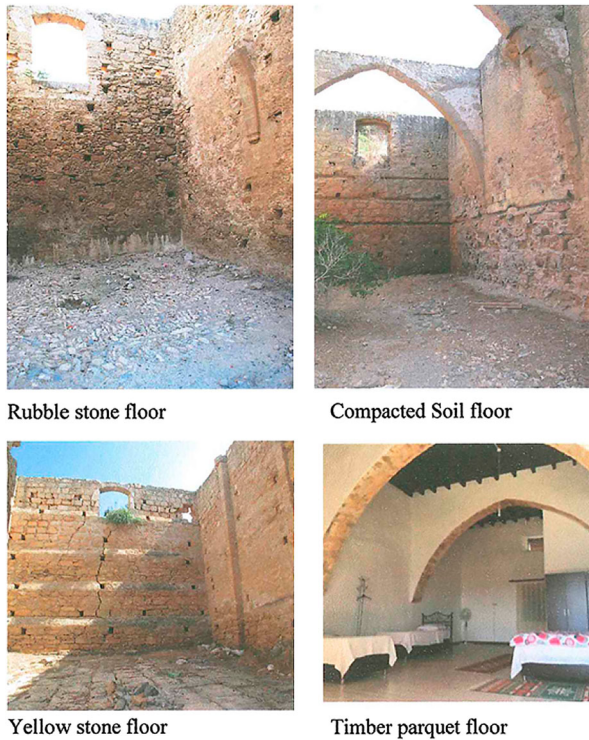
3.1.3.5. Floor surfaces. Most warehouses have a rubble stone floor but some had larger yellow stone flags. There are a few warehouses that have compacted soil as the floor covering (Figure 7). The contemporary floor coverings like marble and timber parquet are only found in the warehouses that were adapted later.

Figure 7. Different type of floor covers (Photos by Beser Oktay Vehbi).

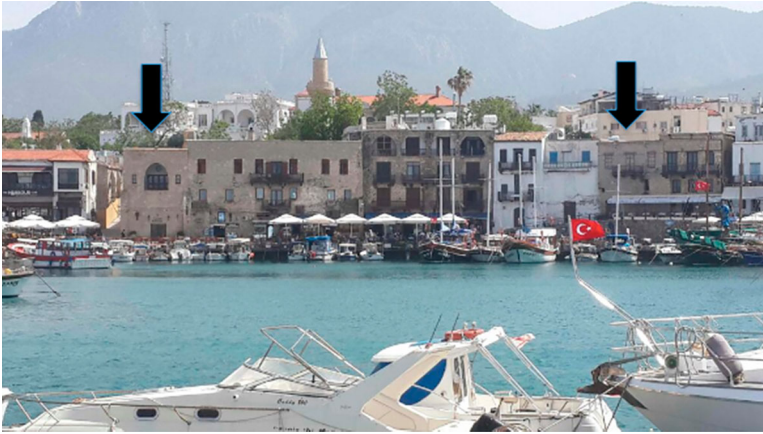
Figure 9. Warehouses at the Kyrenia harbour (Photo by Beser Oktay Vehbi).

the Kyrenia museum and Kyrenia café which have both contributed to the historical value of Kyrenia harbour for many years (Figure 9).
