**Geotechnical Asset Management for the Highway
Route Between Değirmenlik and Kyrenia, North
Cyprus**

Master of Science
in
Civil Engineering

Eastern Mediterranean University
January 2017
Gazimağsa, North Cyprus

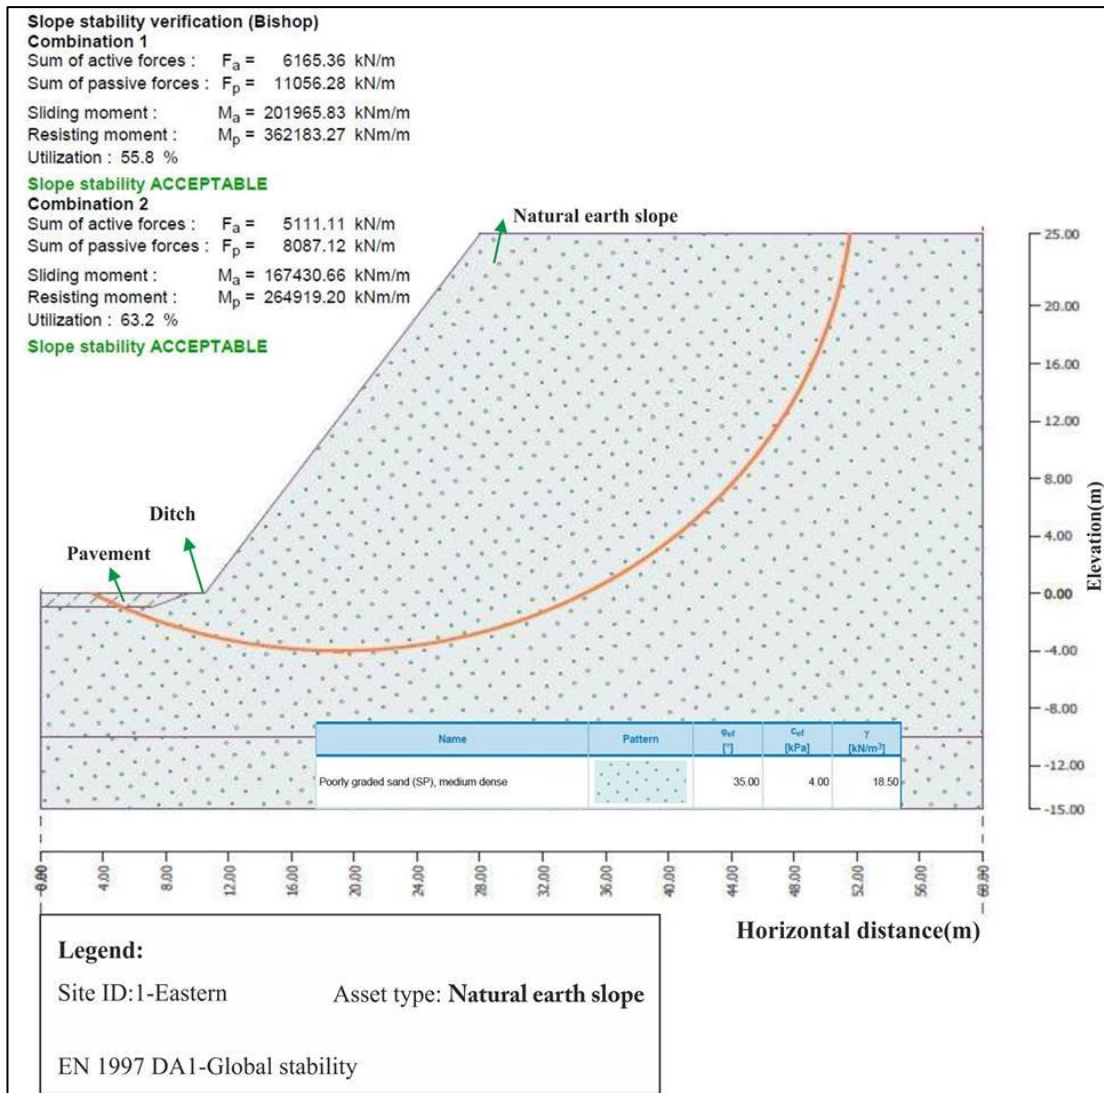
Figure 3.2. Site1-Eastern-EN1997-Global stability.

The asset management process is a continuous or in other words “never-ending” process, decision requires routine periodic data collection, analysis, and assessments. The results should be continuously fed into risk analyses and life cycle cost analyses to update decisions. So that, the planed budgets can be checked and corrected if there is an urgent need. Figure 3.2 shows the global stability analysis for site eastern side according to EN1997DA1.

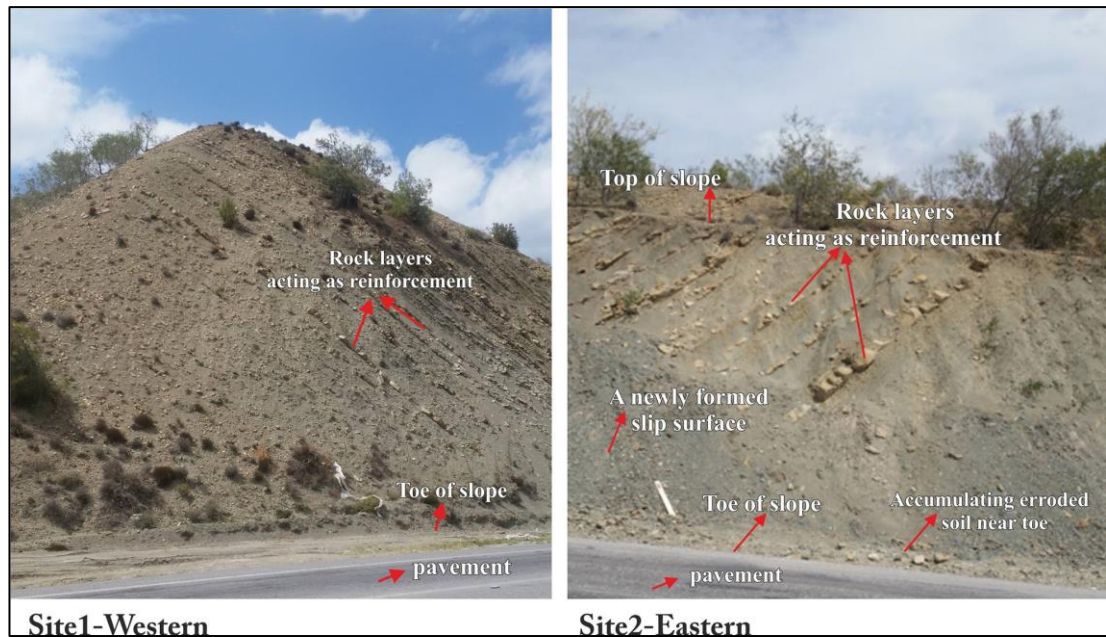
Figure 4.1. Front elevation of site1-western and site2-eastern with rock layers.

According to the global factor of safety and the EN1997DA1, analyses carried out for the natural earth slopes, all of the sites indicated exceedance of the acceptable limits as presented in Table4.11. At some of the sites such as site 1 and site 2, deposits of sandstones/siltstones with alternating layers of sand/silty sand, have made it difficult to model the actual conditions on site in the computer analyses. At these sites, those layers of rock may act like reinforcement perpendicular to the plane of slip.

Photos of the front elevation of the slopes at site 1 and 2 are presented in Figure4.1, which shows the rock layers in the slope. The shear strength properties of the soil between the rock layers are considered in the stability analyses, hence the reason for low factors of safety in the analyses results. The reinforcement effect from those interbedded rock layers are considered to affect the overall (mass) shear strength and the stability of the slopes.

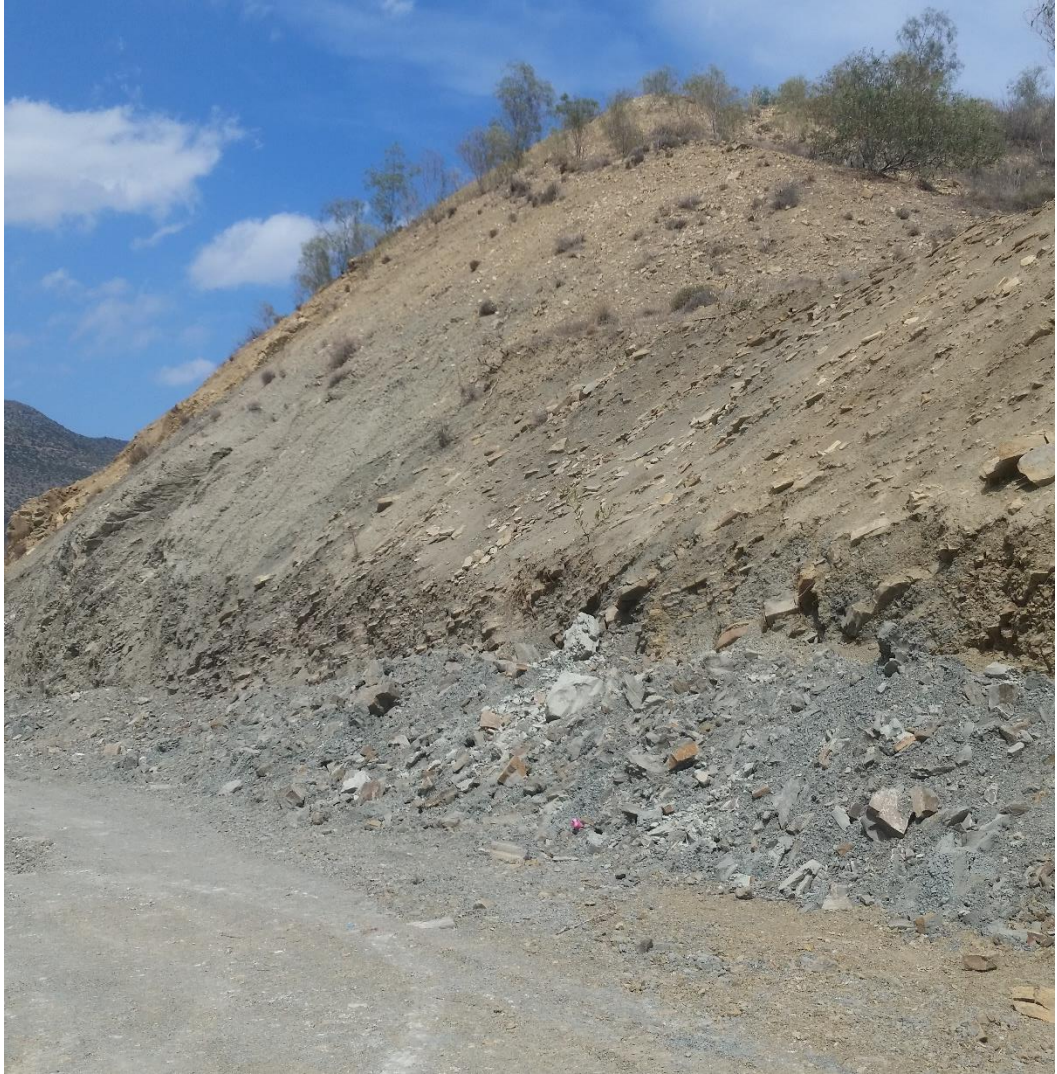
Figure D.3. Site 1-Eastern.

Condition appraisal for slopes	
Number of asset on the map:	1(Eastern side)
Coordinates:	
Longitude	33.461521
latitude	35.251198
Date:	21.07.16
Name of inspector:	Ahmad Alkhouzei
Approximate slope height (m):	25
Ditch distance (m):	3.5
Approximate slope length (m):	84
Daily traffic (vehicle/day):	9416
Speed limit (km/hr):	80
Approximate Roadway width (from paved edge to another edge):	6m
Presence of any spring, seep or saturated soil:	No, there is no spring or saturated soil as the inspector saw.
Ground cracks at the head of slope:	yes
Soil pulling away from foundation of structures or retaining walls:	No, there were no structures near the site.
Offset fence lines appearing on the slope:	No, there were no offset fence lines on the slope.
Unusual bulges or elevation changes in pavement or sidewalk next to slope:	Yes
Tilting of telephone poles , trees, fences or retaining walls:	Yes
Broken water lines or other underground utilities inside the slopes:	No

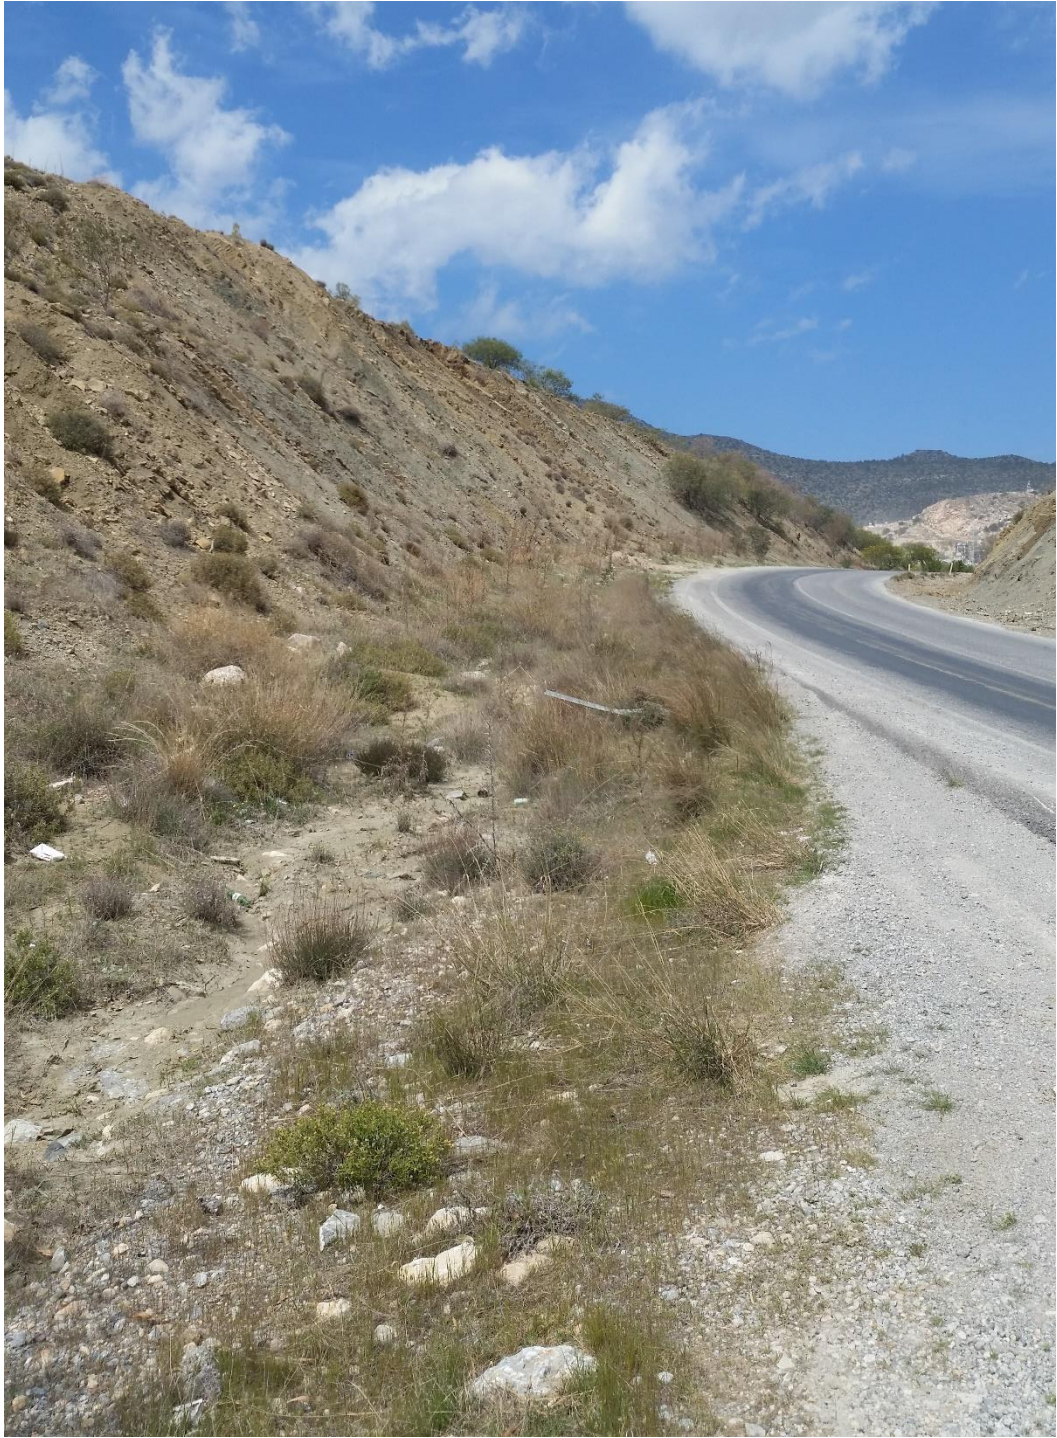
Figure D.5. Site 2-Western.

Condition appraisal for slopes	
Number of asset on the map:	2(Western side)
Coordinates:	
Longitude	33.458351
latitude	35.25634
Date:	21.07.16
Time:	
Name of inspector:	Ahmad Alkhouzei
Approximate slope height (m):	30
Ditch distance (m):	4.5
Approximate slope length (m):	110
Daily traffic (vehicle/day)	9416
Speed limit (km/hr):	80
Approximate Roadway width (from paved edge to another edge):	6m
Presence of any spring, seep or saturated soil:	No, there is no spring or saturated soil as the inspector saw.
Ground cracks at the head of slope:	yes
Soil pulling away from foundation of structures or retaining walls:	No, there were no structures near the site.
Offset fence lines appearing on the slope:	No, there were no offset fence lines on the slope.
Unusual bulges or elevation changes in pavement or sidewalk next to slope:	Yes
Tilting of telephone poles , trees, fences or retaining walls:	No
Broken water lines or other underground utilities inside the slopes:	No

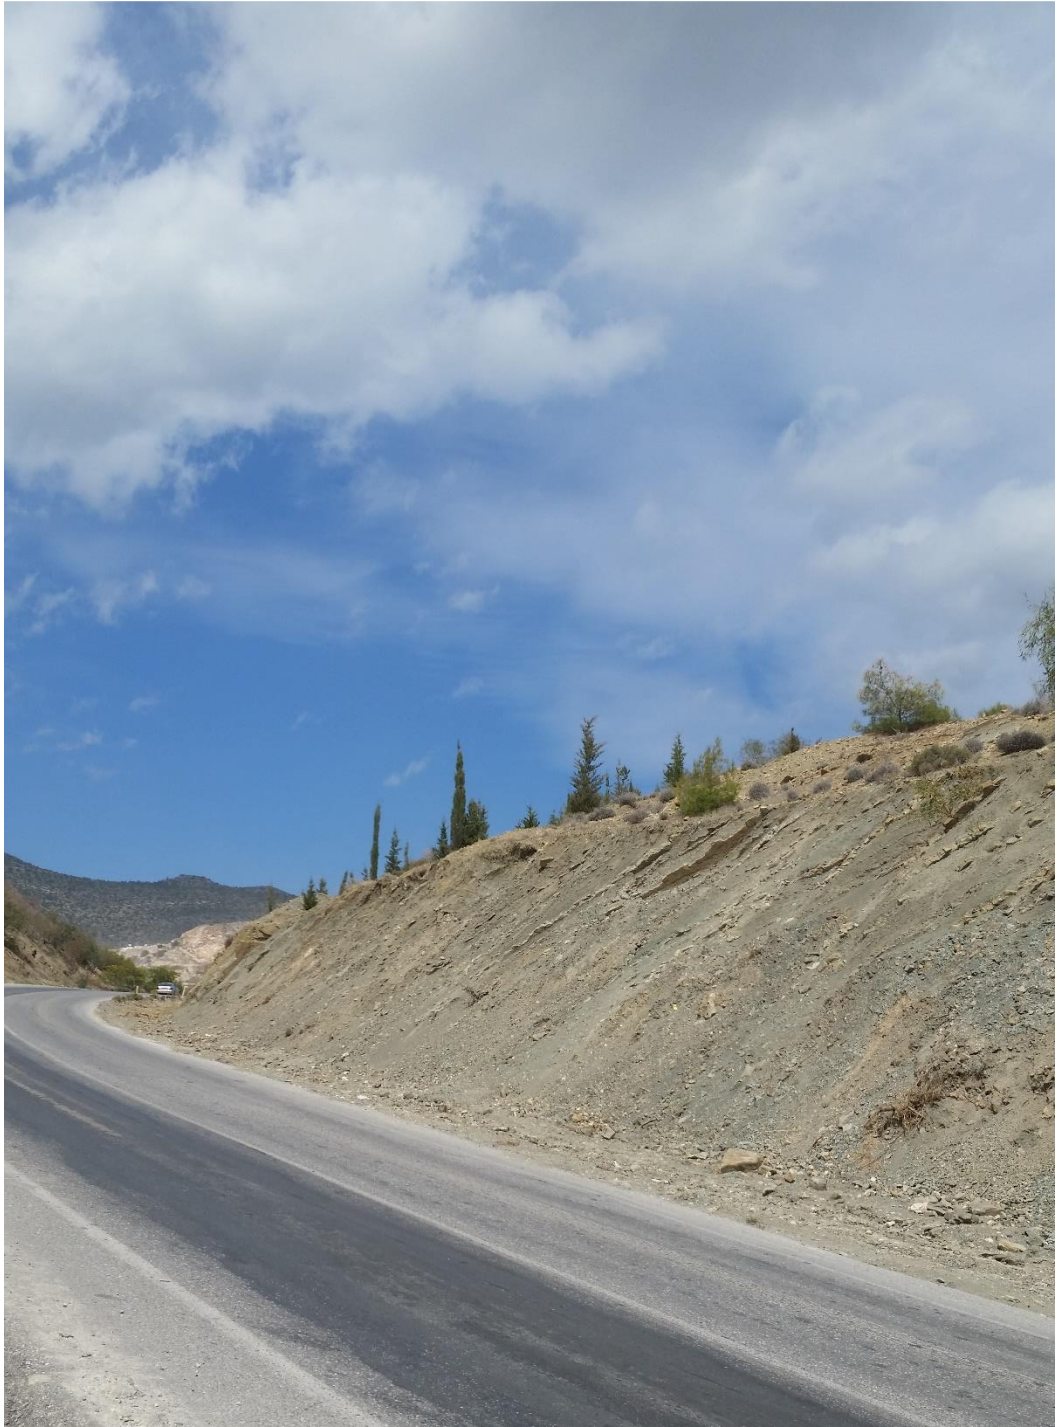
Figure D.6. Site 2-Eastern.

Condition appraisal for slopes	
Number of asset on the map:	2(Eastern side)
Coordinates:	
Longitude	33.458351
latitude	35.25634
Date:	21.07.16
Time:	
Name of inspector:	Ahmad Alkhouzei
Approximate slope height (m):	10
Ditch distance (m):	1.5
Approximate slope length (m):	87
Daily traffic (vehicle/day)	9416
Speed limit (km/hr):	80
Approximate Roadway width (from paved edge to another edge):	6m
Presence of any spring, seep or saturated soil:	No, there is no spring or saturated soil as the inspector saw.
Ground cracks at the head of slope:	yes
Soil pulling away from foundation of structures or retaining walls:	No, there were no structures near the site.
Offset fence lines appearing on the slope:	yes
Unusual bulges or elevation changes in pavement or sidewalk next to slope:	Yes
Tilting of telephone poles , trees, fences or retaining walls:	Yes
Broken water lines or other underground utilities inside the slopes:	No

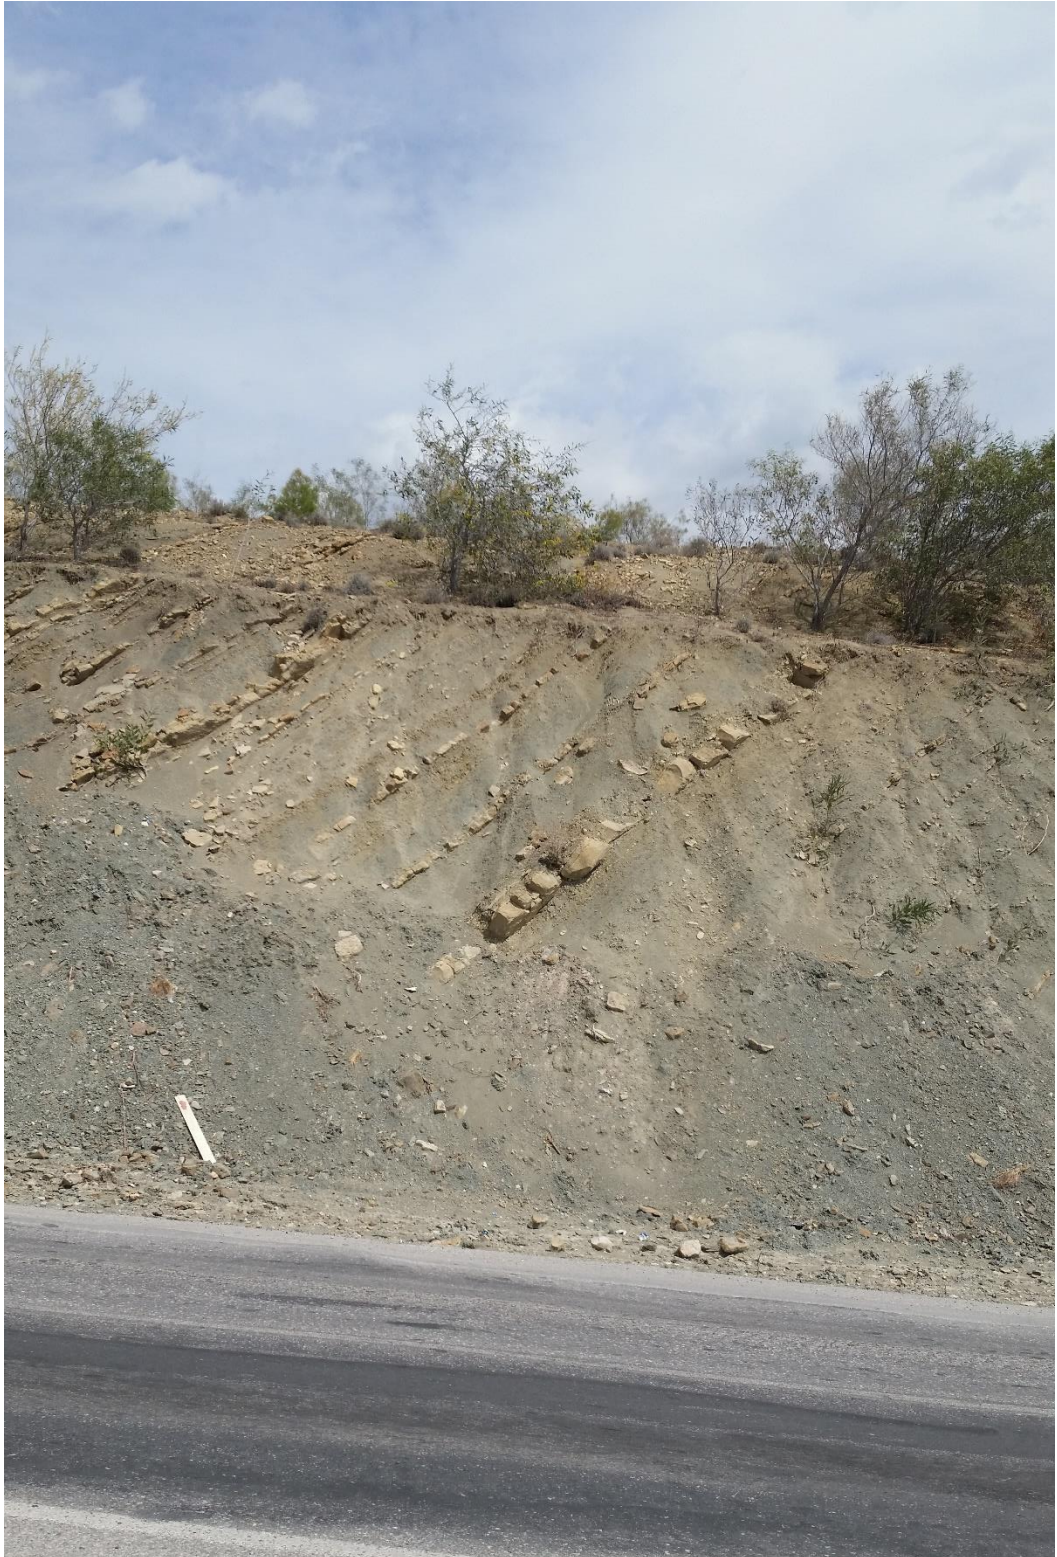
Figure D.7. Site 2-Eastern-the rock layers.

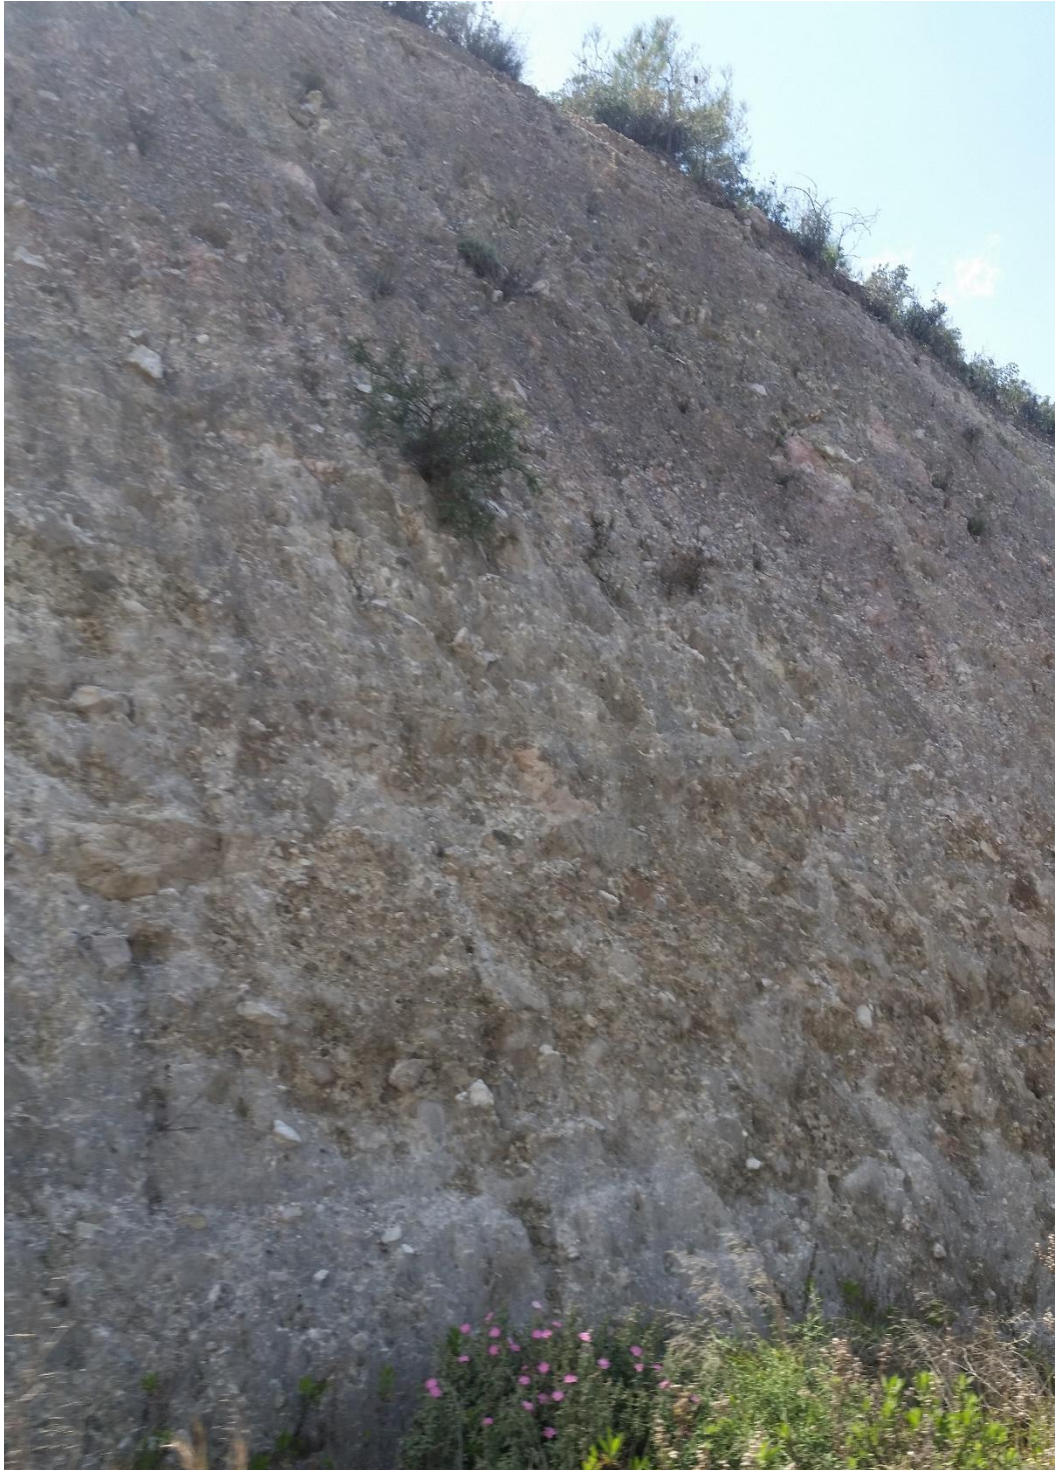
Figure D.8. Site 8.

Condition appraisal for slopes	
Number of asset on the map:	8
Coordinates:	
Longitude	33.460434
latitude	35.286411
Date:	21.07.16
Time:	
Name of inspector:	Ahmad Alkhouzei
Approximate slope height (m):	10
Ditch distance (m):	1
Approximate slope length (m):	46
Daily traffic (vehicle/day)	9416
Speed limit (km/hr):	80
Approximate Roadway width (from paved edge to another edge):	5.5m
Presence of any spring, seep or saturated soil:	No, there is no spring or saturated soil as the inspector saw.
Ground cracks at the head of slope:	Yes
Soil pulling away from foundation of structures or retaining walls:	No, there were no structures near the site.
Offset fence lines appearing on the slope:	Yes
Unusual bulges or elevation changes in pavement or sidewalk next to slope:	Yes
Tilting of telephone poles , trees, fences or retaining walls:	No
Broken water lines or other underground utilities inside the slopes:	No
Sunken or down dropped paths or roads:	No

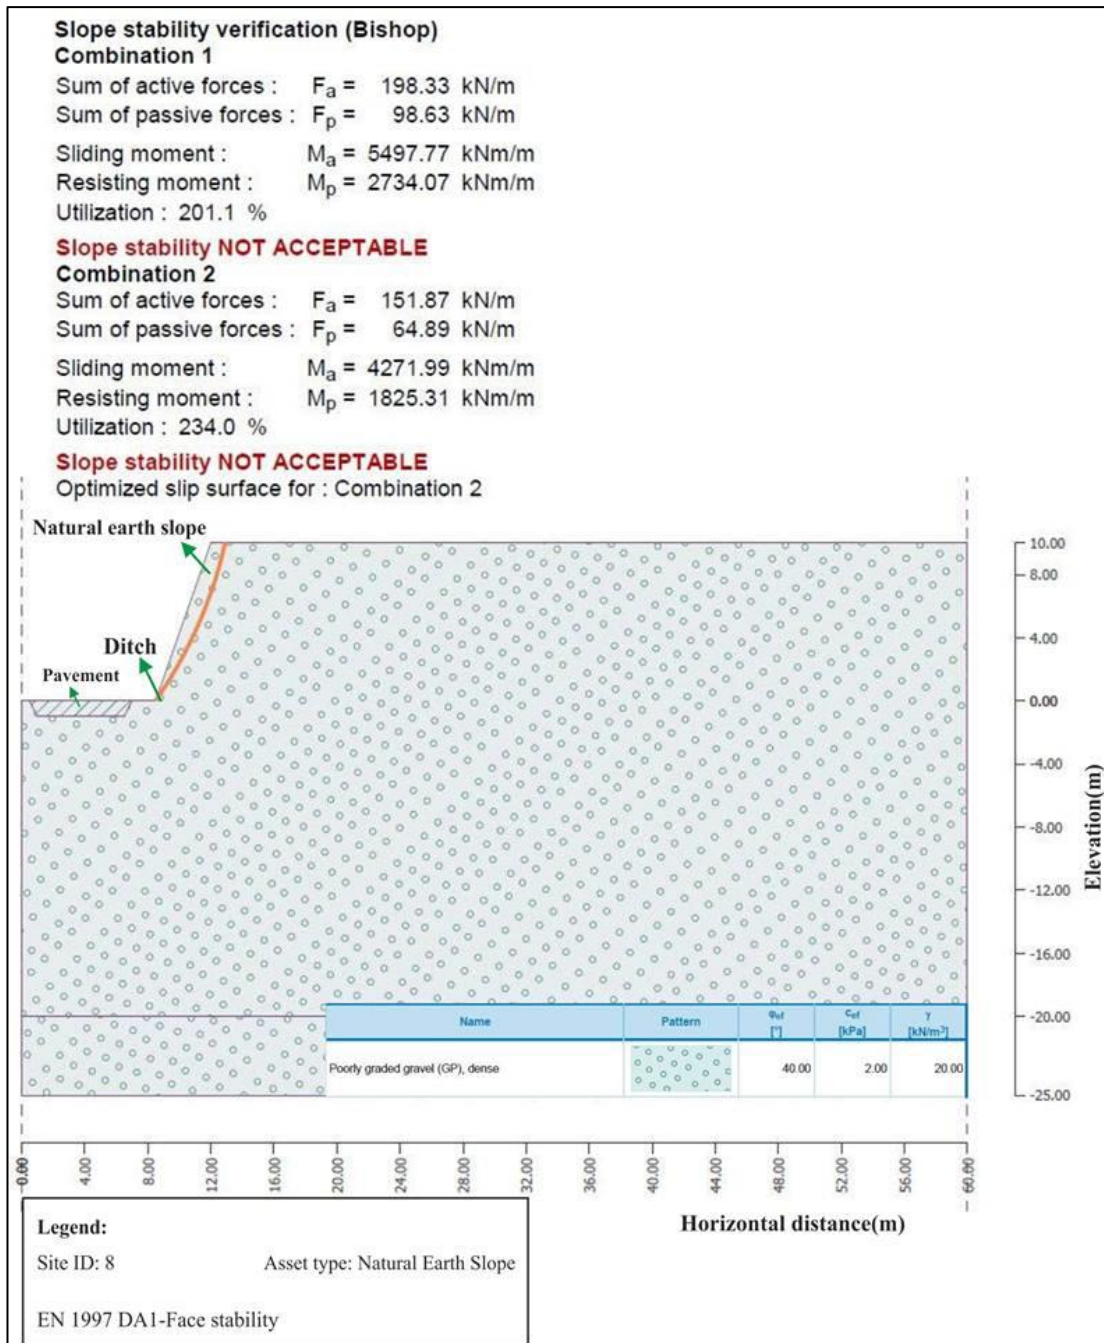
Figure G.20. Site 8-EN1997-Face stability.

Factor of safety = $0.64 < 1.35$

Slope stability NOT ACCEPTABLE

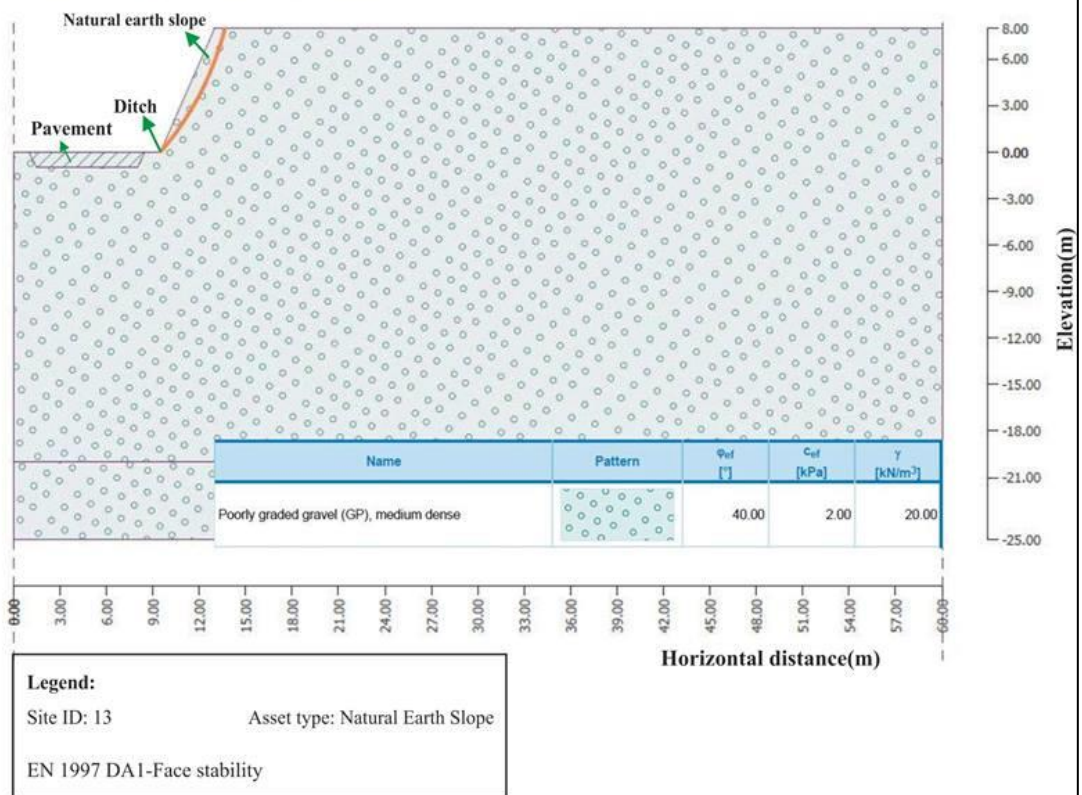
Slope stability NOT ACCEPTABLE

Figure G.22. Site 13-EN1997-Face stability.

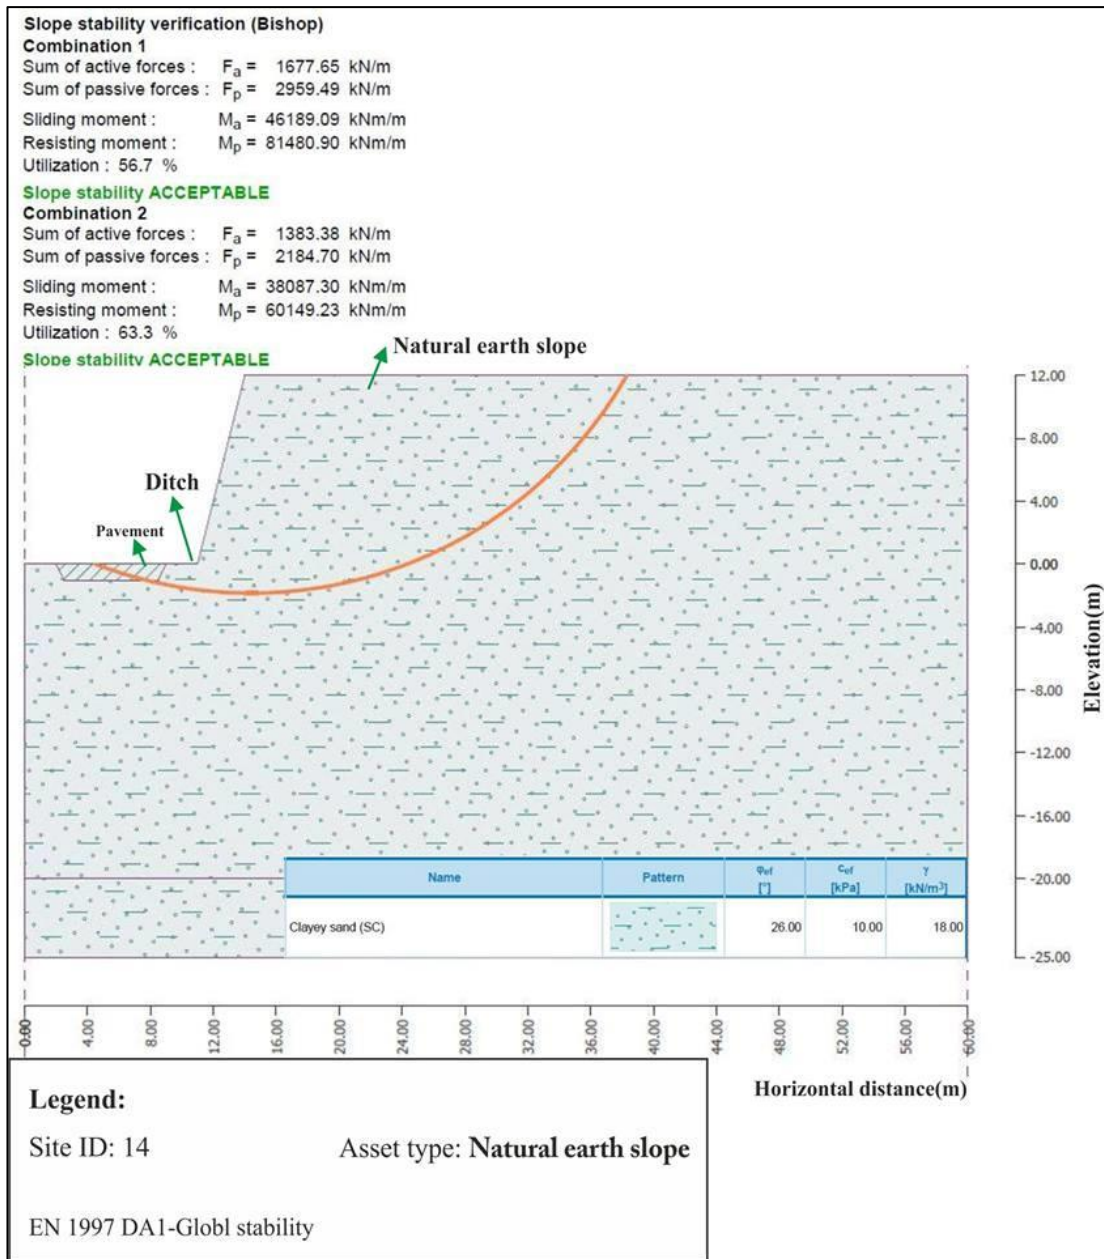
Figure G.26. Site 14-EN1997-Global stability.

Factor of safety = $0.59 < 1.35$

Slope stability NOT ACCEPTABLE
