Common Defects and Structural Problems in the Buildings of Northern Cyprus, their Reasons and Prevailing Applicable Solutions

Master of Science
in
Civil Engineering

Eastern Mediterranean University
August 2017
Gazimağusa, North Cyprus

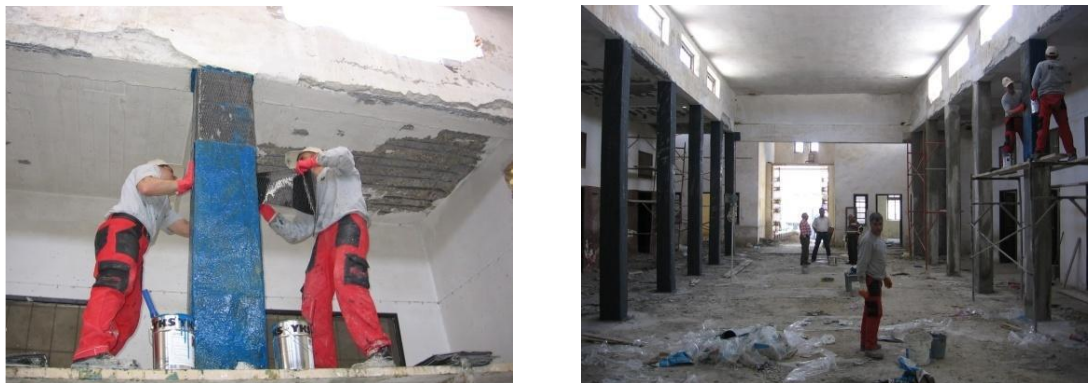
which is one of the materials being used recently for strengthening of RC buildings in North Cyprus (Figure: 3.7). The old bazaar in İskele was also built around 40 years ago. The use of salty water and aggregate were the main reasons for the deterioration of the building and the corrosion of reinforcing bars in the structural members. This building is currently being repaired and strengthened by using CFRP. Also new columns and new foundations were introduced for proper strengthening of this old building (Naimi and Celikag, 2010).

Figure 3.7: Strengthening of the Old Bazaar by Using CFRP in İskele, North Cyprus (Naimi and Celikag, 2010)

After carrying out the proper repairs of cracks, spalls and corroded bars, structural members can be strengthened using Carbon Fiber Reinforced Polymer (CFRP)

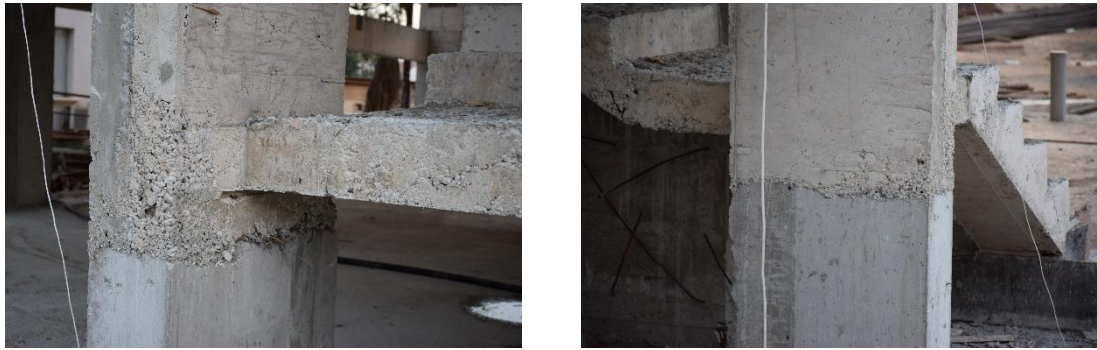
Cold joints are regions of discontinuity within a member where concrete may not tightly bond to itself. Cold joints may occur within a planned placement if a part of concrete in one placement sets, and then the rest of the concrete is placed on it. During the set, laitances form, providing for a weakened plane. The result is a weak connection between placements that could rebuilt in weakness. To achieve proper bond and water-tightness, the surface of hardened concrete must be free of dirt, debris, and laitance. Figures 3.12 and 3.13 shows some cold joints in columns.

Figure 3.12: Cold Joints in Columns. Residential Buildings, Mağusa, North Cyprus. (Case Study #111 (Page 203)).

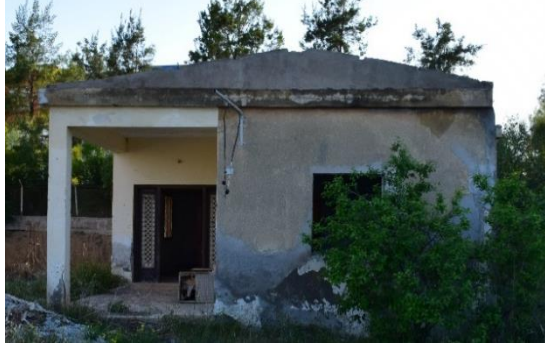
Case Study #1 (M1)				
Profile		Seismic Design Faults

Week column-strong beam		
		Structural configuration	Horizontal structural configuration	Irregularity in plan
Floor discontinuity				
Beam elementary design faults	Projections in plan			
	Non-continuous beams			
Slab elementary design faults	Non-uniform beam span and cross-section			
	Absence of vertical support at beams intersection			
District:	Mağusa	Broken axis beams and frames		
Area:	Sakarya			
Street name:	Salamis Yolu	Over-stretched one-way slab		
Latitude:	N 35°8.789' (35°8'47.3")	Poorly supported or heavily loaded cantilevered slabs		
Longitude:	E 33°54.630' (33°54'37.8")	Pounding and separation problem		
Structure age:	<14 years	Date (if available):		
	Between 14 and 43 years (1974-2003)		Weak storey	
	>43 years (Before 1974)		Soft storey	
Building type:	Residential	Apartment	Discontinuity of columns or shear walls	
		House		Broken axis columns

Dormitory	Irregular column and/or shear-wall plan configuration	
	Public	Short column		
Commercial				
Building status:	Under Construction		Non-Structural Defects	
	Occupied		Waterproofing defects, water leakage and seepage	
	Abandoned		Defected wooden door	
Reinforced Concrete Defects				
Drying shrinkage cracks		Surface defects	dampness	Condensation
Corrosion of metals embedded in concrete	Corrosion-induced cracking			Rising damp
	Corrosion-induced spalling			Rain penetration
	Cracks due to embedment of dissimilar metals (handrails)			Leaking pipes, spills and other moisture sources
Construction defects (faulty workmanship): designer, detailer, and contractor	Improper reinforcing steel placement	Surface cracks on wall finishes	crazing	
	Premature removal of forms			Map/pattern cracking
	Cold joints	Efflorescence		
	Segregation	Paint peeling		
Cracks in RC due to load effects (structural cracks)	Slab/beam-to column shear (punching shear) cracks	Non-structural cracks	Joint cracks	Mouldiness

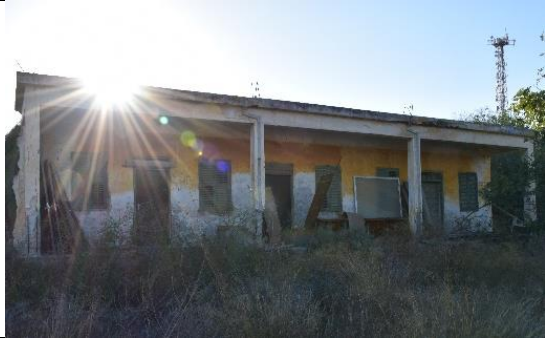
Case Study #2 (M2)

Week column-strong beam			
		Structural configuration	Horizontal structural configuration	Irregularity in plan	Torsional Irregularity (Torsion eccentricity)
					Floor discontinuity
				Beam elementary design faults	Projections in plan
			Non-continuous beams		
			Non-uniform beam span and cross-section		
Slab elementary design faults	Absence of vertical support at beams intersection				
	Broken axis beams and frames				
		Over-stretched one-way slab			
		Poorly supported or heavily loaded cantilevered slabs			
		Pounding and separation problem			
		Vertical structural configuration	Irregularity in elevation	Weak storey	
				Soft storey	
			Discontinuity of columns or shear walls		
			Broken axis columns		
		Vertical structural element elementary design fault	Irregular column and/or shear-wall plan configuration		
			Short column		
		Non-Structural Defects			
		Waterproofing defects, water leakage and seepage

Defected wooden door			
		Surface defects	dampness	Condensation	
				Rising damp	
				Rain penetration	
				Leaking pipes, spills and other moisture sources	
			Surface cracks on wall finishes	cr crazing	
				Map/pattern cracking	
			Efflorescence		
			Paint peeling		
			Mouldiness		
			Wall finishes workmanship problem		
		Staining			
		Non-structural cracks	Joint cracks		
		Reinforced Concrete Defects			
Drying shrinkage cracks					
Corrosion of metals embedded in concrete	Corrosion-induced cracking				
	Corrosion-induced spalling				
	Cracks due to embedment of dissimilar metals (handrails)				
Construction defects (faulty workmanship): designer, detailer, and contractor	Improper reinforcing steel placement				
	Premature removal of forms				
	Cold joints				
	Segregation				
	Honeycombing				
	Improper grades of slab surfaces				
Cracks in RC due to load effects (structural cracks)	Slab/beam-to column shear (punching shear) cracks

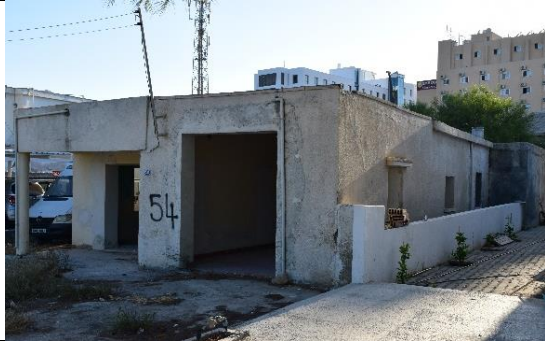
Case Study #3 (M3)

Week column-strong beam		
		Structural configuration	Horizontal structural configuration	Irregularity in plan
Floor discontinuity				
Beam elementary design faults	Projections in plan			
	Non-continuous beams			
	Non-uniform beam span and cross-section			
Slab elementary design faults	Absence of vertical support at beams intersection			
	Broken axis beams and frames			
District:	Mağusa	Over-stretched one-way slab		
Area:	Sakarya			
Street name:	Salamis Yolu	Poorly supported or heavily loaded cantilevered slabs		
Latitude:	N 35°9.137' (35°9'8.2")			
Longitude:	E 33°54.365' (33°54'21.9")	Pounding and separation problem		
Structure age:	<14 years	Date (if available):	Weak storey	
	Between 14 and 43 years (1974-2003)		Soft storey	
	>43 years (Before 1974)		Discontinuity of columns or shear walls	
Building type:	Residential	Apartment	Broken axis columns	
		House	Irregular column and/or shear-wall plan configuration

Dormitory		
	Public	Short column		
Building status:	Commercial	Non-Structural Defects		
	Under Construction	Waterproofing defects, water leakage and seepage		
	Occupied	Defected wooden door		
Reinforced Concrete Defects Drying shrinkage cracks Corrosion of metals embedded in concrete Construction defects (faulty workmanship): designer, detailer, and contractor Cracks in RC due to load effects (structural cracks)	Abandoned	Condensation		
	Surface defects	dampness	Rising damp	
			Rain penetration	
			Leaking pipes, spills and other moisture sources	
			Surface cracks on wall finishes	crazing
	Non-structural cracks	Surface defects	dampness	Map/pattern cracking
				Efflorescence
				Paint peeling
				Mouldiness
				Wall finishes workmanship problem
Staining				
Cracks in RC due to load effects (structural cracks)	Joint cracks	<u>Other notes (if available):</u>		
	Slab/beam-to column shear (punching shear) cracks

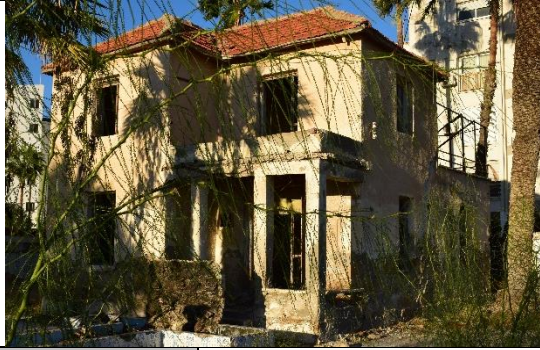
Case Study #23 (M23)

Surface defects	dampness	Waterproofing defects, water leakage and seepage		
		Defected wooden door		
		Condensation		
		Rising damp		
		Rain penetration		
		Leaking pipes, spills and other moisture sources		
		Surface cracks on wall finishes	crazing	
			Map/pattern cracking	
		Efflorescence		
		Paint peeling		
		Mouldiness		
		Wall finishes workmanship problem		
		Staining		
		Non-structural cracks	Joint cracks	
Other notes (if available):				
Cracks in RC due to load effects (structural cracks)		Slab/beam-to column shear (punching shear) cracks		
		Cantilevered member cracks		
		Settlement cracks		
<p style="color: red;">The structural system of this house is mixed between loadbearing walls and reinforced concrete frames.</p>

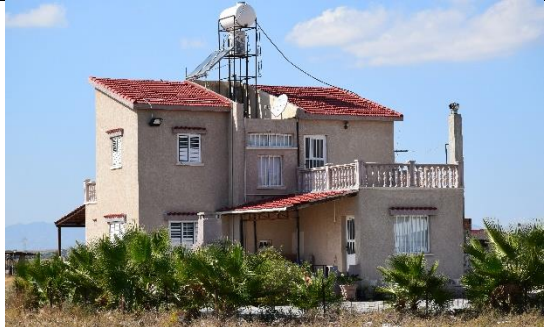
Case Study #26 (I1)

Surface cracks on wall finishes	crazing			
			Map/pattern cracking			
		Efflorescence				
		Paint peeling				
		Mouldiness				
		Wall finishes workmanship problem				
		Staining				
		Joint cracks				
Other notes (if available):						
Rain penetration in this case is evident on the terrace which acts as a flat roof (not the pitched roof)

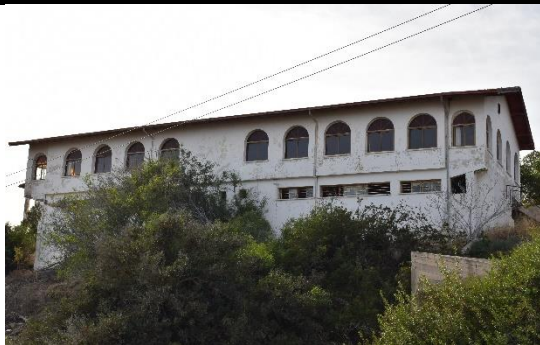
Case Study # Case Study # 29 (I4)

Settlement cracks			
<u>Other notes (if available):</u>				
<p style="color: red;">This non-functional hotel was hosting what seemed to be like construction workers who were sleeping there.</p>

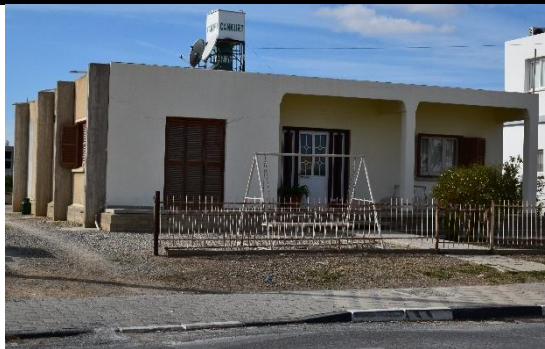
Case Study #51 (L1)

Week column-strong beam			
		Structural configuration	Horizontal structural configuration	Irregularity in plan	Torsional Irregularity (Torsion eccentricity)
					Floor discontinuity
				Beam elementary design faults	Projections in plan
			Non-continuous beams		
			Non-uniform beam span and cross-section		
			Slab elementary design faults	Absence of vertical support at beams intersection	
		Broken axis beams and frames			
				Over-stretched one-way slab	
				Poorly supported or heavily loaded cantilevered slabs	
		Pounding and separation problem			
		Vertical structural configuration	Irregularity in elevation	Weak storey	
				Soft storey	
				Discontinuity of columns or shear walls	
			Vertical structural elementary design fault	Broken axis columns	
				Irregular column and/or shear-wall plan configuration	
		Short column			
Non-Structural Defects					
		Waterproofing defects, water leakage and seepage

Defected wooden door			
Reinforced Concrete Defects		Surface defects	dampness	Condensation	
				Rising damp	
				Rain penetration	
				Leaking pipes, spills and other moisture sources	
				Surface cracks on wall finishes	cracking
Efflorescence					
				Paint peeling	
				Mouldiness	
				Wall finishes workmanship problem	
				Staining	
		Non-structural cracks	Joint cracks		
Other notes (if available):

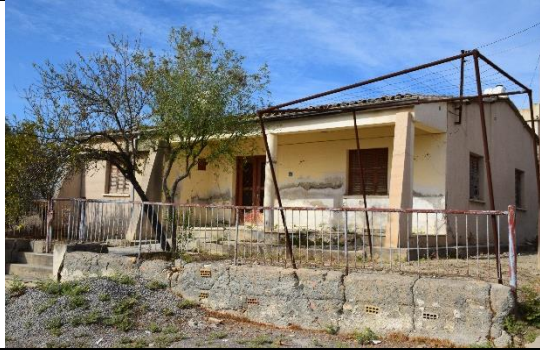
Case Study #52 (L2)

Week column-strong beam		
		Structural configuration	Horizontal structural configuration	Irregularity in plan
Floor discontinuity				
Projections in plan				
Beam elementary design faults	Non-continuous beams			
	Non-uniform beam span and cross-section			
	Absence of vertical support at beams intersection			
Slab elementary design faults	Over-stretched one-way slab			
	Poorly supported or heavily loaded cantilevered slabs			
		Pounding and separation problem		
		Vertical structural configuration	Irregularity in elevation	Weak storey
				Soft storey
Discontinuity of columns or shear walls				
Vertical structural elementary design fault	Broken axis columns			
	Irregular column and/or shear-wall plan configuration			
	Short column			
Non-Structural Defects				
		Waterproofing defects, water leakage and seepage		
		Defected wooden door		
Reinforced Concrete Defects		Surface defects	dampness	Condensation

Rising damp
				Rain penetration
				Leaking pipes, spills and other moisture sources
		Surface cracks on wall finishes	crazing	
Map/pattern cracking				
Corrosion of metals embedded in concrete	Corrosion-induced cracking			
	Corrosion-induced spalling			
	Cracks due to embedment of dissimilar metals (handrails)			
	Efflorescence			
	Paint peeling			
	Mouldiness			
Construction defects (faulty workmanship): designer, detailer, and contractor	Improper reinforcing steel placement			
	Premature removal of forms			
	Cold joints			
	Segregation			
Cracks in RC due to load effects (structural cracks)	Honeycombing			
	Improper grades of slab surfaces			
	Joint cracks			
		Non-structural cracks		
<u>Other notes (if available):</u>				
District:		Lefkoşa (Nicosia)		
Area:		Değirmenlik (Kythrea)		
Street name:		No street names were found in the town		
Latitude:		35°14'23.84"N		
Longitude:		33°29'19.65"E		
Structure age:	<14 years	Date (if available):

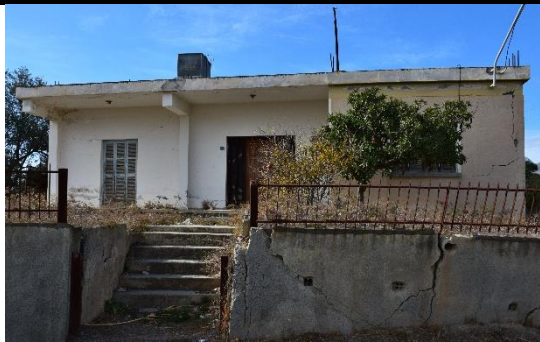
Case Study #53 (L3)

Week column-strong beam			
		Structural configuration	Horizontal structural configuration	Irregularity in plan	Torsional Irregularity (Torsion eccentricity)
					Floor discontinuity
				Projections in plan	
			Beam elementary design faults	Non-continuous beams	
				Non-uniform beam span and cross-section	
				Absence of vertical support at beams intersection	
		Slab elementary design faults	Over-stretched one-way slab		
			Poorly supported or heavily loaded cantilevered slabs		
		Pounding and separation problem			
Vertical structural configuration	Irregularity in elevation	Weak storey			
		Soft storey			
		Discontinuity of columns or shear walls			
	Vertical structural element elementary design fault	Broken axis columns			
		Irregular column and/or shear-wall plan configuration			
Short column					
Non-Structural Defects		Waterproofing defects, water leakage and seepage

Building status:	Under Construction	Defected wooden door			
	Occupied	Condensation			
	Abandoned	Rising damp			
Reinforced Concrete Defects		Surface defects	Rain penetration		
Drying shrinkage cracks			Leaking pipes, spills and other moisture sources		
Corrosion of metals embedded in concrete	Corrosion-induced cracking		Surface cracks on wall finishes	crazing	
	Corrosion-induced spalling			Map/pattern cracking	
	Cracks due to embedment of dissimilar metals (handrails)		Efflorescence		
Construction defects (faulty workmanship): designer, detailer, and contractor	Improper reinforcing steel placement		Paint peeling		
	Premature removal of forms		Mouldiness		
	Cold joints		Wall finishes workmanship problem		
	Segregation		Staining		
	Honeycombing		Non-structural cracks	Joint cracks	
	Improper grades of slab surfaces	<u>Other notes (if available):</u>			
Cracks in RC due to load effects (structural cracks)	Slab/beam-to column shear (punching shear) cracks

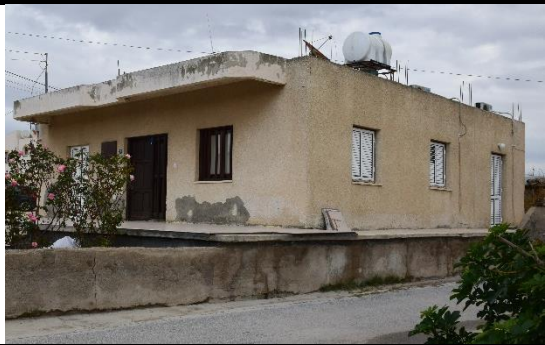
Case Study #54 (L4)

Week column-strong beam			
		Structural configuration	Horizontal structural configuration	Irregularity in plan	Torsional Irregularity (Torsion eccentricity)
					Floor discontinuity
					Projections in plan
		Structural configuration	Horizontal structural configuration	Beam elementary design faults	Non-continuous beams
					Non-uniform beam span and cross-section
Absence of vertical support at beams intersection					
Structural configuration	Horizontal structural configuration	Slab elementary design faults	Broken axis beams and frames		
			Over-stretched one-way slab		
			Poorly supported or heavily loaded cantilevered slabs		
		Pounding and separation problem			
Structure age:	<14 years	Date (if available):	Weak storey		
	Between 14 and 43 years (1974-2003)		Soft storey		
	>43 years (Before 1974)		Discontinuity of columns or shear walls		
Building type:	Residential	Apartment	Broken axis columns

House	Irregular column and/or shear-wall plan configuration		
		Dormitory			
	Public		Short column		
	Commercial				
Non-Structural Defects					
Building status:	Under Construction		Waterproofing defects, water leakage and seepage		
	Occupied		Defected wooden door		
	Abandoned				
Reinforced Concrete Defects					
Drying shrinkage cracks		Surface defects	dampness		
Corrosion of metals embedded in concrete	Corrosion-induced cracking		Condensation		
	Corrosion-induced spalling		Rising damp		
	Cracks due to embedment of dissimilar metals (handrails)		Rain penetration		
Construction defects (faulty workmanship): designer, detailer, and contractor	Improper reinforcing steel placement		Leaking pipes, spills and other moisture sources		
	Premature removal of forms		Surface cracks on wall finishes		
	Cold joints		crazing		
	Segregation		Map/pattern cracking		
	Honeycombing		Efflorescence		
	Improper grades of slab surfaces		Paint peeling

Cracks in RC due to load effects (structural cracks)	Slab/beam-to column shear (punching shear) cracks	Mouldiness			
	Cantilevered member cracks	Wall finishes workmanship problem			
	Settlement cracks	Staining			
		Non-structural cracks	Joint cracks		
<u>Other notes (if available):</u>

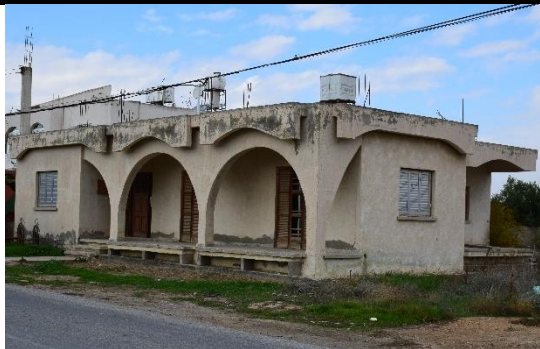
Case Study #55 (L5)

Week column-strong beam		
		Structural configuration	Horizontal structural configuration	Irregularity in plan
Floor discontinuity				
Projections in plan				
Beam elementary design faults	Non-continuous beams			
	Non-uniform beam span and cross-section			
	Absence of vertical support at beams intersection			
Slab elementary design faults	Broken axis beams and frames			
	Over-stretched one-way slab			
			Poorly supported or heavily loaded cantilevered slabs	
			Pounding and separation problem	
		Vertical structural configuration	Irregularity in elevation	Weak storey
				Soft storey
				Discontinuity of columns or shear walls
			Vertical structural elementary design fault	Broken axis columns
				Irregular column and/or shear-wall plan configuration
		Short column		
Non-Structural Defects				
Building status:		Under Construction		
		Waterproofing defects, water leakage and seepage

Occupied		
		Defected wooden door		
		Surface defects	dampness	Condensation
				Rising damp
				Rain penetration
				Leaking pipes, spills and other moisture sources
Corrosion of metals embedded in concrete			Surface cracks on wall finishes	Cracking
				cr crazing
				Map/pattern cracking
				Efflorescence
				Paint peeling
				Mouldiness
			Wall finishes workmanship problem	
			Staining	
		Non-structural cracks	Joint cracks	
Reinforced Concrete Defects				
Drying shrinkage cracks				
Construction defects (faulty workmanship): designer, detailer, and contractor		Improper reinforcing steel placement		
		Premature removal of forms		
		Cold joints		
		Segregation		
		Honeycombing		
		Improper grades of slab surfaces		
Cracks in RC due to load effects (structural cracks)		Slab/beam-to column shear (punching shear) cracks		
		Cantilevered member cracks		
		Settlement cracks		
Other notes (if available):

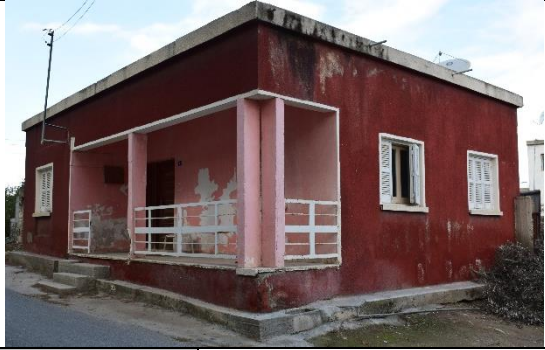
Case Study #56 (L6)

Week column-strong beam			
		Structural configuration	Horizontal structural configuration	Irregularity in plan	Torsional Irregularity (Torsion eccentricity)
Floor discontinuity					
Beam elementary design faults	Projections in plan				
	Non-continuous beams				
	Non-uniform beam span and cross-section				
Slab elementary design faults	Absence of vertical support at beams intersection				
	Broken axis beams and frames				
District:	Lefkoşa				
Area:	Yiğitler (Arsos)				
Street name:	No street names were found				
Latitude:	35° 5'17.64"N				
Longitude:	33°37'39.63"E				
Structure age:	<14 years	Date (if available):			
	Between 14 and 43 years (1974-2003)				
	>43 years (Before 1974)				
Building type:	Residential	Apartment			
		House			
		Dormitory			
	Public				
	Commercial				
Building status:	Under Construction				
	Occupied				
	Abandoned				
Reinforced Concrete Defects

Drying shrinkage cracks		Surface defects	dampness	Condensation	
				Rising damp	
				Rain penetration	
				Leaking pipes, spills and other moisture sources	
Corrosion of metals embedded in concrete	Corrosion-induced cracking		Surface cracks on wall finishes		cr crazing
	Corrosion-induced spalling				Map/pattern cracking
Construction defects (faulty workmanship): designer, detailer, and contractor	Cracks due to embedment of dissimilar metals (handrails)				Efflorescence
	Improper reinforcing steel placement				Paint peeling
	Premature removal of forms				Mouldiness
	Cold joints				Wall finishes workmanship problem
	Segregation			Staining	
	Honeycombing				
	Improper grades of slab surfaces				
Cracks in RC due to load effects (structural cracks)	Slab/beam-to column shear (punching shear) cracks	Non-structural cracks		Joint cracks	
	Cantilevered member cracks				
	Settlement cracks				
				Other notes (if available):

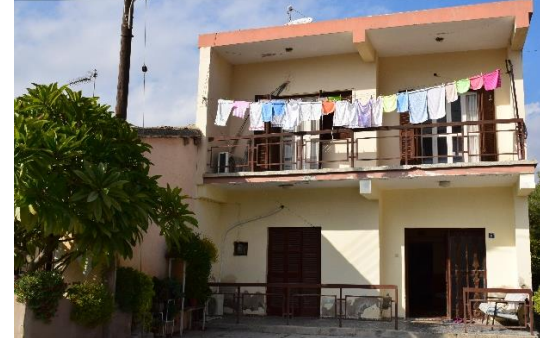
Case Study #57 (L7)

Week column-strong beam			
		Structural configuration	Horizontal structural configuration	Irregularity in plan	Torsional Irregularity (Torsion eccentricity)
Floor discontinuity					
Beam elementary design faults	Projections in plan				
	Non-continuous beams				
	Non-uniform beam span and cross-section				
Slab elementary design faults	Absence of vertical support at beams intersection				
	Broken axis beams and frames				
Over-stretched one-way slab					
Poorly supported or heavily loaded cantilevered slabs					
Pounding and separation problem					
Vertical structural configuration	Irregularity in elevation	Weak storey			
		Soft storey			
Vertical structural elementary design fault	Discontinuity of columns or shear walls				
	Broken axis columns				
Irregular column and/or shear-wall plan configuration					
Short column					
Non-Structural Defects					
Building status:	Under Construction	Waterproofing defects, water leakage and seepage

Occupied	Defected wooden door			
	Abandoned				
Reinforced Concrete Defects					
Drying shrinkage cracks		Surface defects	dampness	Condensation	
Corrosion of metals embedded in concrete	Corrosion-induced cracking			Rising damp	
	Corrosion-induced spalling			Rain penetration	
	Cracks due to embedment of dissimilar metals (handrails)			Leaking pipes, spills and other moisture sources	
Construction defects (faulty workmanship): designer, detailer, and contractor	Improper reinforcing steel placement			Surface cracks on wall finishes	cr crazing
	Premature removal of forms		Efflorescence	Map/pattern cracking	
	Cold joints		Paint peeling		
	Segregation		Mouldiness		
	Honeycombing		Wall finishes workmanship problem		
Cracks in RC due to load effects (structural cracks)	Slab/beam-to column shear (punching shear) cracks		Non-structural cracks	Staining	
	Cantilevered member cracks	Joint cracks			
	Settlement cracks	Other notes (if available):

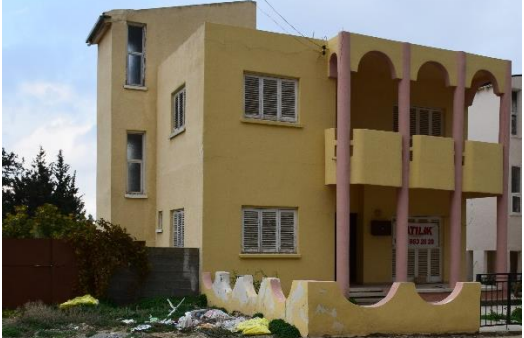
Case Study #58 (L8)

Week column-strong beam			
		Structural configuration	Horizontal structural configuration	Irregularity in plan	Torsional Irregularity (Torsion eccentricity)
Floor discontinuity					
Projections in plan					
Beam elementary design faults	Non-continuous beams				
	Non-uniform beam span and cross-section				
	Absence of vertical support at beams intersection				
Slab elementary design faults	Broken axis beams and frames				
	Over-stretched one-way slab				
		Poorly supported or heavily loaded cantilevered slabs			
		Pounding and separation problem			
District: Lefkoşa Area: Erdemli (Tremetousia) Street name: No street names were found Latitude: 35° 5'4.14"N Longitude: 33°36'17.01"E		Vertical structural configuration	Irregularity in elevation	Weak storey	
				Soft storey	
				Discontinuity of columns or shear walls	
			Vertical structural elementary design fault	Broken axis columns

Irregular column and/or shear-wall plan configuration			
		Short column			
Non-Structural Defects					
Building status:		Waterproofing defects, water leakage and seepage			
		Defected wooden door			
		Dampness			
Reinforced Concrete Defects		Surface defects	dampness	Condensation	
				Rising damp	
				Rain penetration	
				Leaking pipes, spills and other moisture sources	
				Surface cracks on wall finishes	crazing
Corrosion of metals embedded in concrete				Map/pattern cracking	
				Efflorescence	
Construction defects (faulty workmanship): designer, detailer, and contractor				Paint peeling	
				Mouldiness	
				Wall finishes workmanship problem	
				Staining	
				Non-structural cracks	Joint cracks
Cracks in RC due to load effects (structural cracks)		Other notes (if available):			
		The house is for sale			
		Slab/beam-to column shear (punching shear) cracks Cantilevered member cracks Settlement cracks

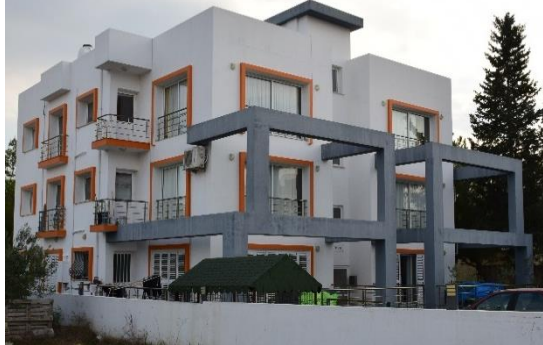
Case Study #59 (L9)

Week column-strong beam					
			Structural configuration	Horizontal structural configuration	Irregularity in plan	Torsional Irregularity (Torsion eccentricity)		
Floor discontinuity								
Projections in plan								
Beam elementary design faults	Non-continuous beams							
	Non-uniform beam span and cross-section							
	Absence of vertical support at beams intersection							
Slab elementary design faults	Broken axis beams and frames							
	Over-stretched one-way slab							
	Poorly supported or heavily loaded cantilevered slabs							
			Pounding and separation problem					
Vertical structural configuration	Irregularity in elevation	Weak storey						
		Soft storey						
		Discontinuity of columns or shear walls						
	Vertical structural element elementary design fault	Broken axis columns						
Irregular column and/or shear-wall plan configuration

Short column					
Non-Structural Defects								
			Waterproofing defects, water leakage and seepage					
			Defected wooden door					
Reinforced Concrete Defects			Surface defects			dampness		
						Condensation		
			Rising damp					
			Rain penetration					
Drying shrinkage cracks			Leaking pipes, spills and other moisture sources					
Corrosion of metals embedded in concrete			Surface cracks on wall finishes			crazing		
						Map/pattern cracking		
Cracks due to embedment of dissimilar metals (handrails)			Efflorescence					
Construction defects (faulty workmanship): designer, detailer, and contractor			Non-structural cracks			Paint peeling		
						Mouldiness		
			Improper reinforcing steel placement			Wall finishes workmanship problem		
			Premature removal of forms			Staining		
Cold joints			Joint cracks					
Segregation								
Honeycombing								
Improper grades of slab surfaces			<u>Other notes (if available):</u>

Cracks in RC due to load effects (structural cracks)						Slab/beam-to column shear (punching shear) cracks		
						Cantilevered member cracks		
Settlement cracks

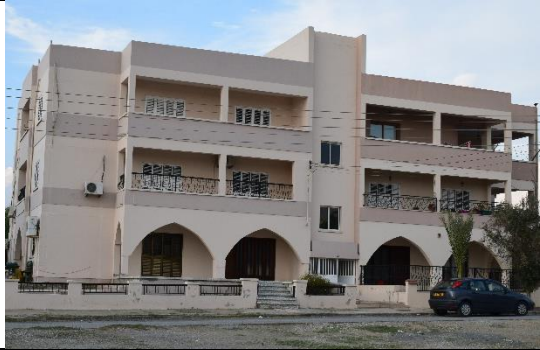
Case Study #60 (L10)

Week column-strong beam			
		Structural configuration	Horizontal structural configuration	Irregularity in plan	Torsional Irregularity (Torsion eccentricity)
Floor discontinuity					
Projections in plan					
Beam elementary design faults	Non-continuous beams				
	Non-uniform beam span and cross-section				
	Absence of vertical support at beams intersection				
Slab elementary design faults	Over-stretched one-way slab				
	Poorly supported or heavily loaded cantilevered slabs				
				Pounding and separation problem	
		Vertical structural configuration	Irregularity in elevation	Weak storey	
				Soft storey	
Discontinuity of columns or shear walls					
Vertical structural elementary design fault	Broken axis columns				
	Irregular column and/or shear-wall plan configuration				
	Short column				
Non-Structural Defects					
		Waterproofing defects, water leakage and seepage

Defected wooden door			
		Surface defects	dampness	Condensation	
				Rising damp	
Rain penetration					
Leaking pipes, spills and other moisture sources					
			Surface cracks on wall finishes	cr crazing	
		Map/pattern cracking			
		Non-structural cracks	Efflorescence		
			Paint peeling		
		Non-structural cracks	Mouldiness		
			Wall finishes workmanship problem		
		Non-structural cracks	Staining		
			Joint cracks		
Reinforced Concrete Defects					
Drying shrinkage cracks					
		Non-structural cracks	Corrosion-induced cracking		
			Corrosion-induced spalling		
			Cracks due to embedment of dissimilar metals (handrails)		
		Non-structural cracks	Improper reinforcing steel placement		
			Premature removal of forms		
			Cold joints		
			Segregation		
			Honeycombing		
		Non-structural cracks	Improper grades of slab surfaces		
			Slab/beam-to column shear (punching shear) cracks		
			Cantilevered member cracks		
		Non-structural cracks	Settlement cracks

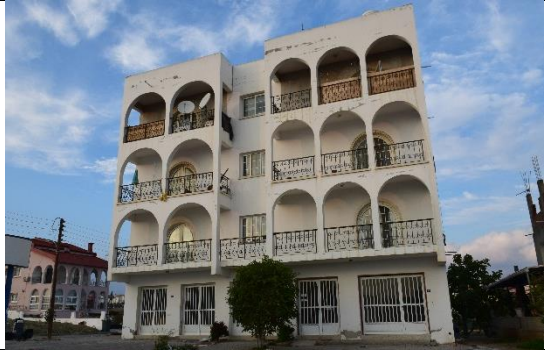
Case Study #61 (L11)

Week column-strong beam					
		Structural configuration	Horizontal structural configuration	Irregularity in plan	Torsional Irregularity (Torsion eccentricity)		
Floor discontinuity							
Projections in plan							
Beam elementary design faults	Non-continuous beams						
	Non-uniform beam span and cross-section						
	Absence of vertical support at beams intersection						
Slab elementary design faults	Over-stretched one-way slab						
	Poorly supported or heavily loaded cantilevered slabs						
		Pounding and separation problem					
		Vertical structural configuration	Irregularity in elevation	Weak storey			
				Soft storey			
			Discontinuity of columns or shear walls				
Vertical structural elementary design fault	Broken axis columns						
	Irregular column and/or shear-wall plan configuration						
	Short column						
Non-Structural Defects							
		Waterproofing defects, water leakage and seepage

Defected wooden door					
Reinforced Concrete Defects		Surface defects	dampness	Condensation			
				Rising damp			
				Rain penetration			
				Leaking pipes, spills and other moisture sources			
			Surface cracks on wall finishes	crazing			
Map/pattern cracking							
		Efflorescence					
		Paint peeling					
		Mouldiness					
		Wall finishes workmanship problem					
		Staining					
		Non-structural cracks	Joint cracks				
Other notes (if available):							
					Cracks in RC due to load effects (structural cracks)		Slab/beam-to column shear (punching shear) cracks
							Cantilevered member cracks
		Settlement cracks

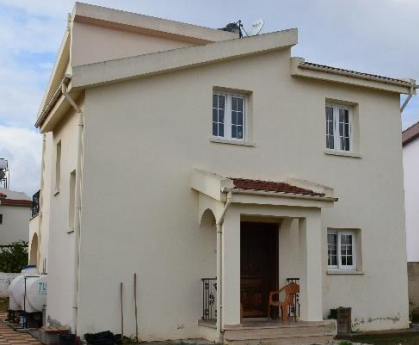
Case Study #62 (L12)

Week column-strong beam			
		Structural configuration	Horizontal structural configuration	Irregularity in plan	Torsional Irregularity (Torsion eccentricity)
Floor discontinuity					
Projections in plan					
Beam elementary design faults	Non-continuous beams				
	Non-uniform beam span and cross-section				
	Absence of vertical support at beams intersection				
Slab elementary design faults	Over-stretched one-way slab				
	Poorly supported or heavily loaded cantilevered slabs				
			Pounding and separation problem		
Vertical structural configuration	Irregularity in elevation	Weak storey			
		Soft storey			
		Discontinuity of columns or shear walls			
	Vertical structural elementary design fault	Broken axis columns			
Irregular column and/or shear-wall plan configuration					
			Short column		
Non-Structural Defects					
Building status:	Under Construction		Waterproofing defects, water leakage and seepage

Occupied		Defected wooden door		
	Abandoned				
Reinforced Concrete Defects					
Drying shrinkage cracks		Surface defects	dampness	Condensation	
				Rising damp	
				Rain penetration	
				Leaking pipes, spills and other moisture sources	
Corrosion of metals embedded in concrete	Corrosion-induced cracking		Surface cracks on wall finishes	cr crazing	
	Corrosion-induced spalling			Map/pattern cracking	
Construction defects (faulty workmanship): designer, detailer, and contractor	Cracks due to embedment of dissimilar metals (handrails)		Efflorescence		
	Improper reinforcing steel placement		Paint peeling		
	Premature removal of forms		Mouldiness		
	Cold joints		Wall finishes workmanship problem		
	Segregation	Staining			
	Honeycombing	Non-structural cracks	Joint cracks		
Improper grades of slab surfaces		Other notes (if available):			
Cracks in RC due to load effects (structural cracks)	Slab/beam-to column shear (punching shear) cracks

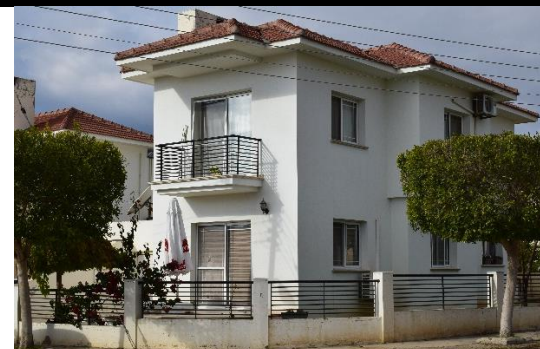
Case Study #63 (L13)

Week column-strong beam			
		Structural configuration	Horizontal structural configuration	Irregularity in plan	Torsional Irregularity (Torsion eccentricity)
Floor discontinuity					
Projections in plan					
Beam elementary design faults	Non-continuous beams				
	Non-uniform beam span and cross-section				
	Absence of vertical support at beams intersection				
Slab elementary design faults	Over-stretched one-way slab				
	Poorly supported or heavily loaded cantilevered slabs				
		Pounding and separation problem			
District: Lefkoşa		Vertical structural configuration	Irregularity in elevation	Weak storey	
				Soft storey	
Discontinuity of columns or shear walls					
Area: Hamitköy			Vertical structural element elementary design fault	Broken axis columns	
				Irregular column and/or shear-wall plan configuration	
Street name: Anittepe Cd			Short column		
		Non-Structural Defects

Latitude: 35°12'52.53"N		Waterproofing defects, water leakage and seepage			
		Defected wooden door			
Longitude: 33°22'24.62"E		Surface defects	dampness	Condensation	
				Rising damp	
Rain penetration					
Leaking pipes, spills and other moisture sources					
Structure age:			Surface cracks on wall finishes	Surface cracks	
		cr crazing			
Date (if available): 2004-2005		Non-structural cracks	Map/pattern cracking		
			Efflorescence		
Between 14 and 43 years (1974-2003)		Paint peeling			
		Mouldiness			
>43 years (Before 1974)		Wall finishes workmanship problem			
		Staining			
Building type:		Joint cracks			
		Other notes (if available):			
Apartment					
				House	
Dormitory					
				Public	
Commercial					
				Under Construction	
Occupied					
				Abandoned	
Reinforced Concrete Defects					
Drying shrinkage cracks					
Corrosion of metals embedded in concrete		Slab/beam-to column shear (punching shear) cracks

Cantilevered member cracks	
Improper reinforcing steel placement					
		Premature removal of forms			
Cold joints					
		Segregation			
Honeycombing					
		Improper grades of slab surfaces			
Slab/beam-to column shear (punching shear) cracks					
		Cantilevered member cracks			
Settlement cracks

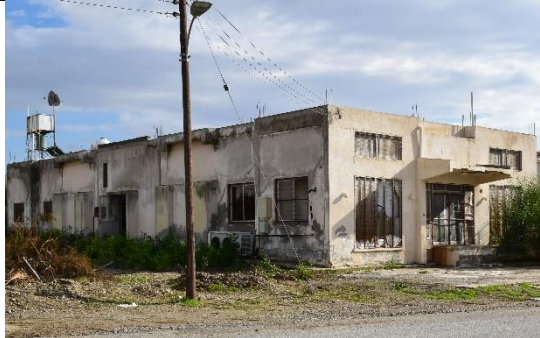
Case Study #64 (L14)

Week column-strong beam				
			Structural configuration	Horizontal structural configuration	Irregularity in plan	Torsional Irregularity (Torsion eccentricity)	
Floor discontinuity							
Projections in plan							
Beam elementary design faults	Non-continuous beams						
	Non-uniform beam span and cross-section						
Slab elementary design faults	Absence of vertical support at beams intersection						
	Broken axis beams and frames						
	Over-stretched one-way slab						
				Pounding and separation problem			
				Vertical structural configuration	Irregularity in elevation	Weak storey	
			Soft storey				
			Discontinuity of columns or shear walls				
			Vertical structural element elementary design fault		Broken axis columns		
					Irregular column and/or shear-wall plan configuration		
			Short column				
Non-Structural Defects							
Building status:			Under Construction			Waterproofing defects, water leakage and seepage

Occupied			Defected wooden door	
			Abandoned				
Reinforced Concrete Defects							
Drying shrinkage cracks			Surface defects	dampness	Condensation		
					Rising damp		
Rain penetration							
Leaking pipes, spills and other moisture sources							
Corrosion of metals embedded in concrete	Corrosion-induced cracking			Surface cracks on wall finishes	crazing		
	Corrosion-induced spalling		Map/pattern cracking				
	Cracks due to embedment of dissimilar metals (handrails)		Efflorescence				
Construction defects (faulty workmanship): designer, detailer, and contractor	Improper reinforcing steel placement		Paint peeling				
	Premature removal of forms		Mouldiness				
	Cold joints		Wall finishes workmanship problem				
	Segregation		Staining				
	Honeycombing		Non-structural cracks	Joint cracks			
	Improper grades of slab surfaces						
Cracks in RC due to load effects (structural cracks)	Slab/beam-to column shear (punching shear) cracks		<u>Other notes (if available):</u> The building is used as fruits storage.

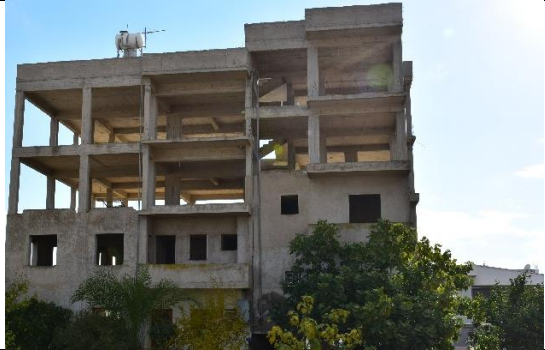
Case Study #65/103 (L15/C3)

Week column-strong beam		
		Structural configuration	Horizontal structural configuration	Irregularity in plan
Floor discontinuity				
Projections in plan				
Beam elementary design faults	Non-continuous beams			
	Non-uniform beam span and cross-section			
	Absence of vertical support at beams intersection			
Slab elementary design faults	Over-stretched one-way slab			
	Poorly supported or heavily loaded cantilevered slabs			
			Pounding and separation problem	
			Vertical structural configuration	Irregularity in elevation
		Soft storey		
		Discontinuity of columns or shear walls		
		Vertical structural elementary design fault		Broken axis columns
				Irregular column and/or shear-wall plan configuration
		Short column		
Non-Structural Defects				
Building status:		Under Construction		
		Waterproofing defects, water leakage and seepage		
		Occupied		
		Defected wooden door

Abandoned		
Reinforced Concrete Defects				
Drying shrinkage cracks		Surface defects	dampness	Condensation
				Rising damp
				Rain penetration
				Leaking pipes, spills and other moisture sources
				Surface cracks on wall finishes
			Map/pattern cracking	
Corrosion of metals embedded in concrete			Corrosion-induced cracking	
			Corrosion-induced spalling	
			Cracks due to embedment of dissimilar metals (handrails)	
Construction defects (faulty workmanship): designer, detailer, and contractor			Improper reinforcing steel placement	
		Premature removal of forms		
		Cold joints		
		Segregation		
		Honeycombing		
		Non-structural cracks	Improper grades of slab surfaces	
			Joint cracks	
Cracks in RC due to load effects (structural cracks)		Slab/beam-to column shear (punching shear) cracks		
		Cantilevered member cracks		
		Settlement cracks		
<u>Other notes (if available):</u>				
<p style="color: red;">The building is not finished except for the ground floor where it is furnished and occupied. Thus it is considered a shared case study between Lefcosa case study section and the under construction case study section.</p>

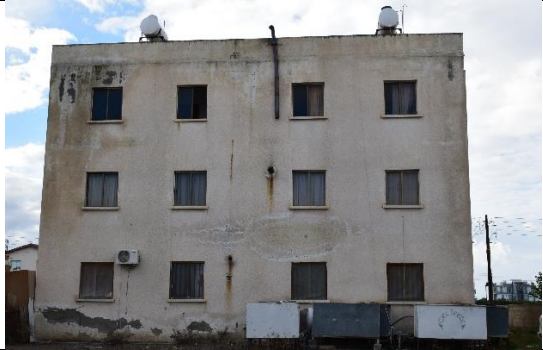
Case Study #67 (L17)

Short column			
Non-Structural Defects						
Building status:			Waterproofing defects, water leakage and seepage			
			Defected wooden door			
Reinforced Concrete Defects						
Drying shrinkage cracks			Surface defects	dampness	Condensation	
					Rising damp	
					Rain penetration	
					Leaking pipes, spills and other moisture sources	
Corrosion of metals embedded in concrete				Surface cracks on wall finishes	crazing	
					Map/pattern cracking	
Construction defects (faulty workmanship): designer, detailer, and contractor				Efflorescence		
				Paint peeling		
				Mouldiness		
				Wall finishes workmanship problem		
			Staining			
			Non-structural cracks	Joint cracks		
<u>Other notes (if available):</u>						
Cracks in RC due to load effects (structural cracks)			The profile picture shows the rear facade as the front facade had lots of parking cars.			
			Slab/beam-to column shear (punching shear) cracks

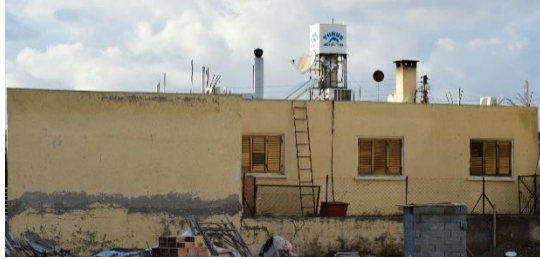
Case Study #70 (L20)

Segregation		Other notes (if available): The profile picture shows the rear facade as the front facade is covered with vegetation.					
Honeycombing							
Improper grades of slab surfaces							
Slab/beam-to column shear (punching shear) cracks							
Cantilevered member cracks							
Settlement cracks

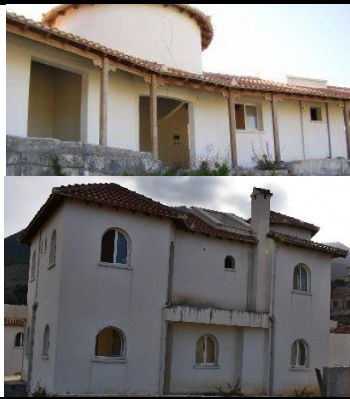
Case Study #100 (G25)

<14 years	Date (if available):	December 2004	Between 14 and 43 years (1974-2003)			>43 years (Before 1974)	
<14 years	Date (if available):	December 2004										
Between 14 and 43 years (1974-2003)												
>43 years (Before 1974)												
Building type:	Residential	Apartment	Broken axis beams and frames									
		House	Over-stretched one-way slab									
		Dormitory	Poorly supported or heavily loaded cantilevered slabs									
	Public	Pounding and separation problem										
Commercial	Vertical structural configuration	Irregularity in elevation	Weak storey									
Building status:			Under Construction	Soft storey								
		Occupied	Discontinuity of columns or shear walls									
Abandoned		Broken axis columns										
Reinforced Concrete Defects		Vertical structural element elementary design fault	Irregular column and/or shear-wall plan configuration	Short column								
Drying shrinkage cracks				Non-Structural Defects								
Corrosion of metals embedded in concrete	Corrosion-induced cracking	Waterproofing defects, water leakage and seepage										
	Corrosion-induced spalling	Defected wooden door										
Construction defects (faulty workmanship): designer, detailer, and contractor	Cracks due to embedment of dissimilar metals (handrails)	Surface defects	dampness	Condensation								
	Improper reinforcing steel placement			Rising damp								
	Premature removal of forms			Rain penetration								
	Cold joints			Leaking pipes, spills and other moisture sources								
	Segregation	Surface cracks on wall finishes	cr crazing									
	Honeycombing		Map/pattern cracking									
Improper grades of slab surfaces		Efflorescence										
Cracks in RC due to load effects (structural cracks)	Slab/beam-to column shear (punching shear) cracks		Paint peeling									
	Cantilevered member cracks		Mouldiness									
	Settlement cracks		Wall finishes workmanship problem									
		Non-structural cracks	Staining									
			Joint cracks									
		<u>Other notes (if available):</u>										
		<p style="color: red;">This case study is about a suspended project called Amaranta valley project which contain many unfinished houses due to technical and legal problems.</p>

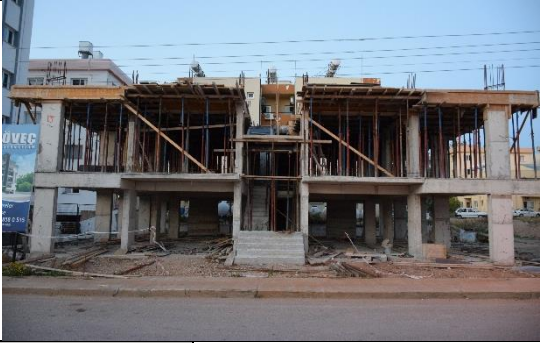
Case Study #112 (C12)

Week column-strong beam			
District:	Mağusa	Structural configuration	Horizontal structural configuration	Irregularity in plan	Torsional Irregularity (Torsion eccentricity)
Area:	Çanakkale				Floor discontinuity
Street name:	Hacı Bektaş Sk			Beam elementary design faults	Projections in plan
Latitude:	35° 7'44.46"N				Non-continuous beams
Longitude:	33°55'4.14"E		Non-uniform beam span and cross-section		
Structure age:	<14 years		Vertical structural configuration	Irregularity in elevation	Absence of vertical support at beams intersection
	Between 14 and 43 years (1974-2003)				Broken axis beams and frames
	>43 years (Before 1974)				Over-stretched one-way slab
Building type:	Residential		Vertical structural element elementary design fault	Vertical structural element elementary design fault	Poorly supported or heavily loaded cantilevered slabs
					Apartment
		House			Inter-storey strength irregularity (Weak storey)

Dormitory	Inter-storey stiffness irregularity (Soft storey)			
	Public			Discontinuity of columns or shear walls	
	Commercial			Broken axis columns	
Building status:	Under Construction	Non-Structural Defects			
	Occupied	Waterproofing defects, water leakage and seepage			
	Abandoned	Defected wooden door			
Reinforced Concrete Defects		Surface defects	dampness	Condensation	
Drying shrinkage cracks				Rising damp	
Corrosion of metals embedded in concrete	Corrosion-induced cracking			Rain penetration	
	Corrosion-induced spalling			Leaking pipes, spills and other moisture sources	
Construction defects (faulty workmanship): designer, detailer, and contractor	Cracks due to embedment of dissimilar metals (handrails)		Surface cracks on wall finishes	crazing	
	Improper reinforcing steel placement			Map/pattern cracking	
	Premature removal of forms		Efflorescence		
	Cold joints		Paint peeling		
	Segregation		Mouldiness

Honeycombing		Wall finishes workmanship problem		
Cracks in RC due to load effects (structural cracks)	Improper grades of slab surfaces	Non-structural cracks	Staining		
	Slab/beam-to column shear (punching shear) cracks		Joint cracks		
	Cantilevered member cracks		<u>Other notes (if available):</u>		
	Settlement cracks

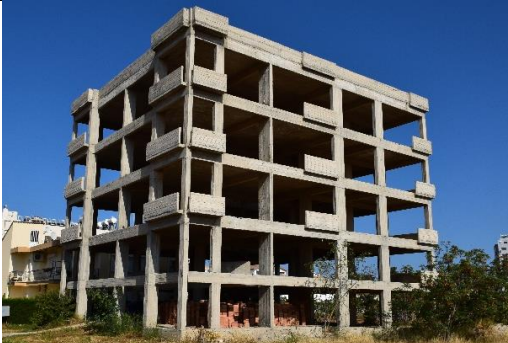
Case Study #113 (C13)

Week column-strong beam				
			Structural configuration	Horizontal structural configuration	Irregularity in plan	Torsional Irregularity (Torsion eccentricity)	
						Floor discontinuity	
						Projections in plan	
					Beam elementary design faults	Non-continuous beams	
						Non-uniform beam span and cross-section	
				Slab elementary design faults	Absence of vertical support at beams intersection		
					Broken axis beams and frames		
					Over-stretched one-way slab		
							Poorly supported or heavily loaded cantilevered slabs
				Pounding and separation problem			
			Inter-storey strength irregularity (Weak storey)				
			Inter-storey stiffness irregularity (Soft storey)				
			Discontinuity of columns or shear walls				
			Broken axis columns				
			Irregular column and/or shear-wall plan configuration				
			Short column				
Non-Structural Defects							
			Waterproofing defects, water leakage and seepage

Defected wooden door				
			Condensation				
			Rising damp				
			Rain penetration				
			Leaking pipes, spills and other moisture sources				
Reinforced Concrete Defects							
Drying shrinkage cracks							
Corrosion of metals embedded in concrete	Corrosion-induced cracking						
	Corrosion-induced spalling						
	Cracks due to embedment of dissimilar metals (handrails)						
Construction defects (faulty workmanship): designer, detailer, and contractor	Improper reinforcing steel placement						
	Premature removal of forms						
	Cold joints						
	Segregation						
	Honeycombing						
	Improper grades of slab surfaces						
Cracks in RC due to load effects (structural cracks)	Slab/beam-to column shear (punching shear) cracks						
	Cantilevered member cracks						
	Settlement cracks						
			Surface defects				
			dampness				
			Surface cracks on wall finishes	crazing			
				Map/pattern cracking			
				Efflorescence

Paint peeling			
				Mouldiness			
				Wall finishes workmanship problem			
				Staining			
			Non-structural cracks	Joint cracks			
<u>Other notes (if available):</u>

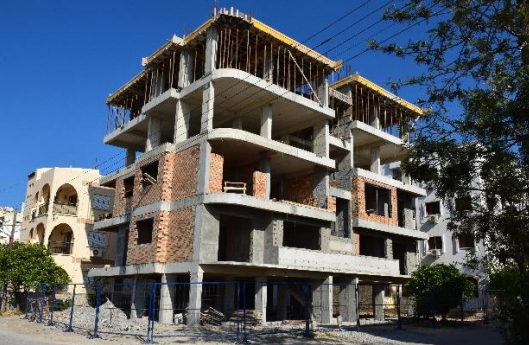
Case Study #114 (C14)

Week column-strong beam			
		Structural configuration	Horizontal structural configuration	Irregularity in plan	Torsional Irregularity (Torsion eccentricity)
Floor discontinuity					
Beam elementary design faults	Non-continuous beams				
	Non-uniform beam span and cross-section				
	Absence of vertical support at beams intersection				
Slab elementary design faults	Broken axis beams and frames				
	Over-stretched one-way slab				
				Poorly supported or heavily loaded cantilevered slabs	
		Pounding and separation problem			
		Vertical structural configuration	Irregularity in elevation	Weak storey	
				Soft storey	
			Vertical structural elementary design fault	Discontinuity of columns or shear walls	
				Broken axis columns	
		Irregular column and/or shear-wall plan configuration			
		Short column			
		Non-Structural Defects			
		Waterproofing defects, water leakage and seepage

Defected wooden door			
		Surface defects	dampness	Condensation	
				Rising damp	
				Rain penetration	
				Leaking pipes, spills and other moisture sources	
		Surface cracks on wall finishes		crazing	
				Map/pattern cracking	
		Efflorescence			
		Paint peeling			
		Mouldiness			
		Wall finishes workmanship problem			
		Staining			
		Non-structural cracks	Joint cracks		
		Reinforced Concrete Defects			
		Drying shrinkage cracks			
Corrosion of metals embedded in concrete	Corrosion-induced cracking				
	Corrosion-induced spalling				
	Cracks due to embedment of dissimilar metals (handrails)				
Construction defects (faulty workmanship): designer, detailer, and contractor	Improper reinforcing steel placement				
	Premature removal of forms				
	Cold joints				
	Segregation				
	Honeycombing				
		Improper grades of slab surfaces			
Cracks in RC due to load effects (structural cracks)	Slab/beam-to column shear (punching shear) cracks

Cantilevered member cracks				
	Settlement cracks				
		Other notes (if available):

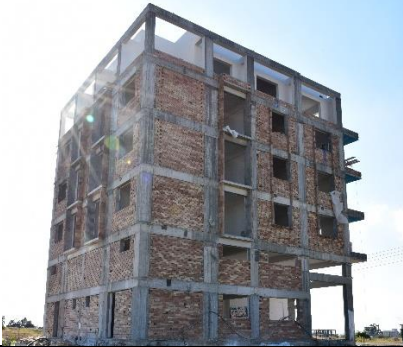
Case Study #115 (C15)

Week column-strong beam								
		Structural configuration	Horizontal structural configuration	Irregularity in plan	Torsional Irregularity (Torsion eccentricity)					
Floor discontinuity										
Projections in plan										
Beam elementary design faults	Non-continuous beams									
	Non-uniform beam span and cross-section									
	Absence of vertical support at beams intersection									
Slab elementary design faults	Over-stretched one-way slab									
	Poorly supported or heavily loaded cantilevered slabs									
		Pounding and separation problem								
District:	Mağusa	Vertical structural configuration	Irregularity in elevation	Weak storey						
Area:	Çanakkale			Soft storey						
Street name:	No street names were found			Discontinuity of columns or shear walls						
Latitude:	35° 7'19.23"N		Vertical structural element elementary design fault	Broken axis columns						
Longitude:	33°55'22.74"E			Irregular column and/or shear-wall plan configuration						
Structure age:

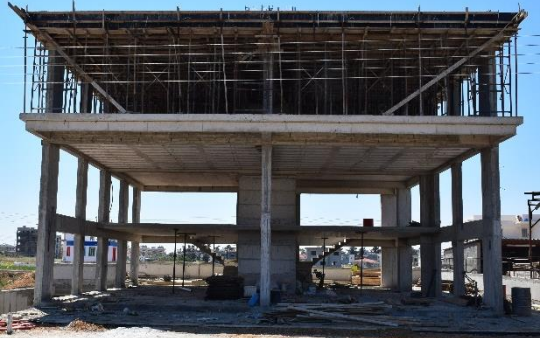
Case Study #116 (C16)

Week column-strong beam				
		Structural configuration	Horizontal structural configuration	Irregularity in plan	Torsional Irregularity (Torsion eccentricity)	
Floor discontinuity						
Projections in plan						
Beam elementary design faults	Non-continuous beams					
	Non-uniform beam span and cross-section					
	Absence of vertical support at beams intersection					
Slab elementary design faults	Over-stretched one-way slab					
	Poorly supported or heavily loaded cantilevered slabs					
		Pounding and separation problem				
Structure age:	<14 years	Date (if available):				
		Mid 2016				
	Between 14 and 43 years (1974-2003)					
	>43 years (Before 1974)					
Building type:	Residential	Apartment				
		House				
		Dormitory				
	Public					
		Commercial				
Building status:	Under Construction		Waterproofing defects, water leakage and seepage			
	Occupied		Defected wooden door

Abandoned					
Reinforced Concrete Defects						
Drying shrinkage cracks		Surface defects	dampness	Condensation		
				Rising damp		
				Rain penetration		
				Leaking pipes, spills and other moisture sources		
Corrosion of metals embedded in concrete	Corrosion-induced cracking		Surface cracks on wall finishes	crazing		
	Corrosion-induced spalling			Map/pattern cracking		
	Cracks due to embedment of dissimilar metals (handrails)		Efflorescence			
Construction defects (faulty workmanship): designer, detailer, and contractor	Improper reinforcing steel placement		Paint peeling			
	Premature removal of forms		Mouldiness			
	Cold joints		Wall finishes workmanship problem			
	Segregation		Staining			
	Honeycombing					
	Improper grades of slab surfaces					
		Non-structural cracks	Joint cracks			
Other notes (if available):						
Cracks in RC due to load effects (structural cracks)	Slab/beam-to column shear (punching shear) cracks

Cantilevered member cracks					
	Settlement cracks

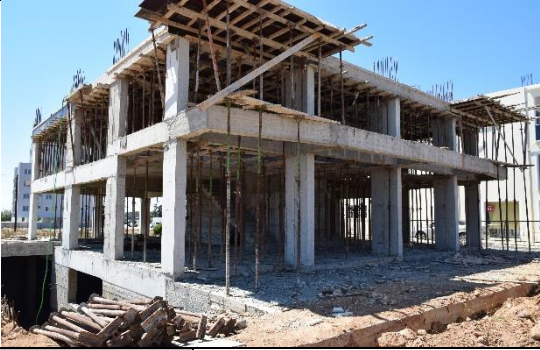
Case Study #117 (C17)

Week column-strong beam			
			Structural configuration	Horizontal structural configuration	Irregularity in plan	Torsional Irregularity (Torsion eccentricity)
Floor discontinuity						
Projections in plan						
Beam elementary design faults	Non-continuous beams					
	Non-uniform beam span and cross-section					
	Absence of vertical support at beams intersection					
Slab elementary design faults	Over-stretched one-way slab					
	Poorly supported or heavily loaded cantilevered slabs					
Pounding and separation problem						
Vertical structural configuration	Irregularity in elevation	Weak storey				
		Soft storey				
		Discontinuity of columns or shear walls				
	Vertical structural elementary design fault	Broken axis columns				
		Irregular column and/or shear-wall plan configuration				
	Short column					
Non-Structural Defects						
			Waterproofing defects, water leakage and seepage

Defected wooden door			
Reinforced Concrete Defects			Surface defects	dampness	Condensation	
					Rising damp	
					Rain penetration	
					Leaking pipes, spills and other moisture sources	
Corrosion of metals embedded in concrete	Surface cracks on wall finishes	Cracking	crazing			
		Corrosion-induced spalling	Map/pattern cracking			
		Cracks due to embedment of dissimilar metals (handrails)	Efflorescence			
Construction defects (faulty workmanship): designer, detailer, and contractor	Improper reinforcing steel placement					
	Premature removal of forms					
	Cold joints					
	Segregation					
	Honeycombing					
Cracks in RC due to load effects (structural cracks)	Improper grades of slab surfaces					
	Slab/beam-to column shear (punching shear) cracks					
	Cantilevered member cracks					
		Settlement cracks				
Other notes (if available):						
District:	Mağusa					
Area:	Çanakkale					
Street name:	Sht. İbrahim Kazım Cd

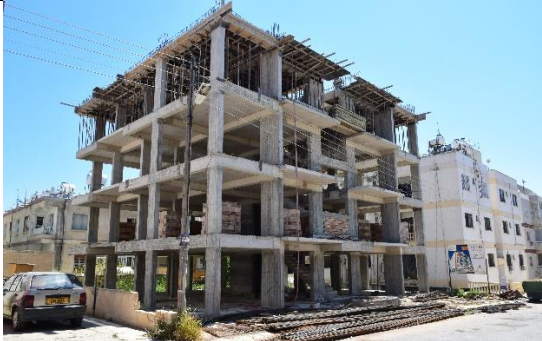
Case Study #118 (C18)

Week column-strong beam			
		Structural configuration	Horizontal structural configuration	Irregularity in plan	Torsional Irregularity (Torsion eccentricity)
Floor discontinuity					
Beam elementary design faults	Projections in plan				
	Non-continuous beams				
	Non-uniform beam span and cross-section				
Slab elementary design faults	Absence of vertical support at beams intersection				
	Broken axis beams and frames				
	Over-stretched one-way slab				
			Pounding and separation problem		
			Vertical structural configuration	Irregularity in elevation	Weak storey
		Soft storey			
		Discontinuity of columns or shear walls			
		Vertical structural element elementary design fault		Broken axis columns	
				Irregular column and/or shear-wall plan configuration	
		Short column			
Non-Structural Defects					
		Waterproofing defects, water leakage and seepage			
		Defected wooden door

Reinforced Concrete Defects		Surface defects	dampness	Condensation	
				Rising damp	
				Rain penetration	
				Leaking pipes, spills and other moisture sources	
		Corrosion of metals embedded in concrete	Surface cracks on wall finishes	crazing	
Map/pattern cracking					
Construction defects (faulty workmanship): designer, detailer, and contractor	Efflorescence				
	Paint peeling				
	Mouldiness				
	Wall finishes workmanship problem				
	Staining				
	Non-structural cracks		Joint cracks		
Other notes (if available):					
				Cracks in RC due to load effects (structural cracks)	Slab/beam-to column shear (punching shear) cracks
					Cantilevered member cracks
					Settlement cracks
