Common Defects and Structural Problems in the Buildings of Northern Cyprus, their Reasons and Prevailing Applicable Solutions

Master of Science
in
Civil Engineering

Eastern Mediterranean University
August 2017
Gazimağusa, North Cyprus

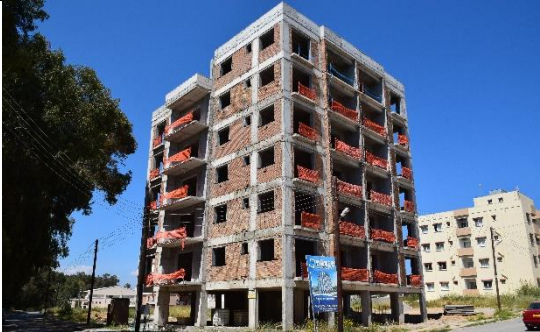
Case Study #119 (C19)

Week column-strong beam			
		Structural configuration	Horizontal structural configuration	Irregularity in plan	Torsional Irregularity (Torsion eccentricity)
					Floor discontinuity
				Projections in plan	
			Beam elementary design faults	Non-continuous beams	
				Non-uniform beam span and cross-section	
				Absence of vertical support at beams intersection	
		Slab elementary design faults	Over-stretched one-way slab		
			Poorly supported or heavily loaded cantilevered slabs		
				Pounding and separation problem	
		Vertical structural configuration	Irregularity in elevation	Weak storey	
				Soft storey	
			Discontinuity of columns or shear walls		
			Broken axis columns		
		Vertical structural element elementary design fault	Irregular column and/or shear-wall plan configuration		
			Short column		
		Non-Structural Defects			
		Waterproofing defects, water leakage and seepage

Defected wooden door			
		Surface defects	dampness	Condensation	
				Rising damp	
				Rain penetration	
				Leaking pipes, spills and other moisture sources	
		Surface cracks on wall finishes	Non-structural cracks	crazing	
				Map/pattern cracking	
				Efflorescence	
				Paint peeling	
				Mouldiness	
				Wall finishes workmanship problem	
				Staining	
				Joint cracks	
Reinforced Concrete Defects					
Drying shrinkage cracks					
Corrosion of metals embedded in concrete	Corrosion-induced cracking				
	Corrosion-induced spalling				
	Cracks due to embedment of dissimilar metals (handrails)				
Construction defects (faulty workmanship): designer, detailer, and contractor	Improper reinforcing steel placement				
	Premature removal of forms				
	Cold joints				
	Segregation				
	Honeycombing				
	Improper grades of slab surfaces				
Cracks in RC due to load effects (structural cracks)	Slab/beam-to column shear (punching shear) cracks

Cantilevered member cracks				
	Settlement cracks				
		<u>Other notes (if available):</u>

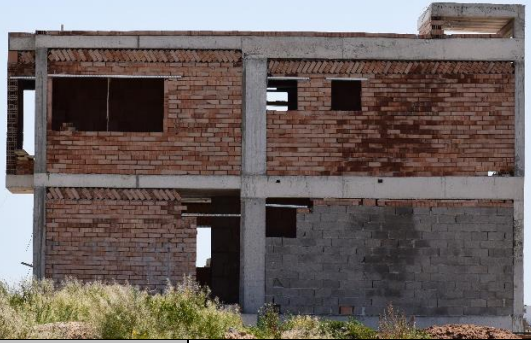
Case Study #120 (C20)

Week column-strong beam				
		Horizontal structural configuration	Irregularity in plan	Torsional Irregularity (Torsion eccentricity)		
				Floor discontinuity		
Structural configuration	Beam elementary design faults	Vertical structural configuration	Irregularity in elevation	Projections in plan		
				Non-continuous beams		
				Non-uniform beam span and cross-section		
				Absence of vertical support at beams intersection		
	Slab elementary design faults	Vertical structural element elementary design fault	Vertical structural element elementary design fault	Broken axis beams and frames		
				Over-stretched one-way slab		
			Poorly supported or heavily loaded cantilevered slabs			
		Pounding and separation problem				
District: Mağusa						
Area: Tuzla (Enkomi)						
Street name: Sadık Cemil Sk						
Latitude: 35° 9'16.43"N						
Longitude: 33°53'44.12"E						
Structure age:	<14 years	Date (if available):

2015				
	Between 14 and 43 years (1974-2003)					
	>43 years (Before 1974)					
Building type:	Residential	Apartment				
		House				
		Dormitory				
	Public					
	Commercial					
Building status:	Under Construction					
	Occupied					
	Abandoned					
Non-Structural Defects						
		Waterproofing defects, water leakage and seepage				
		Defected wooden door				
		Surface defects	dampness	Condensation		
				Rising damp		
				Rain penetration		
				Leaking pipes, spills and other moisture sources		
Corrosion of metals embedded in concrete	Corrosion-induced cracking		Surface cracks on wall finishes	crazing		
	Corrosion-induced spalling			Map/pattern cracking		
	Cracks due to embedment of dissimilar metals (handrails)		Efflorescence			
Construction defects (faulty workmanship): designer, detailer, and contractor	Improper reinforcing steel placement		Paint peeling			
	Premature removal of forms		Mouldiness			
	Cold joints		Wall finishes workmanship problem

Segregation		Staining			
	Honeycombing		Non-structural cracks	Joint cracks		
	Improper grades of slab surfaces					
<u>Other notes (if available):</u>						
Cracks in RC due to load effects (structural cracks)	Slab/beam-to column shear (punching shear) cracks					
	Cantilevered member cracks					
	Settlement cracks

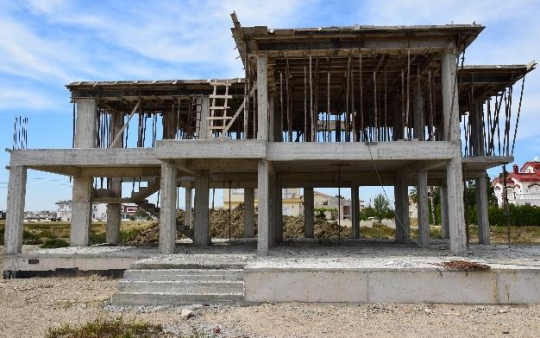
Case Study #121 (C21)

Week column-strong beam										
District:	Mağusa	Structural configuration	Horizontal structural configuration	Irregularity in plan	Torsional Irregularity (Torsion eccentricity)							
Area:	Tuzla (Enkomi)				Floor discontinuity							
Street name:	No street names were found				Projections in plan							
Latitude:	35° 9'18.67"N			Beam elementary design faults	Non-continuous beams							
Longitude:	33°53'23.00"E				Non-uniform beam span and cross-section							
Structure age:

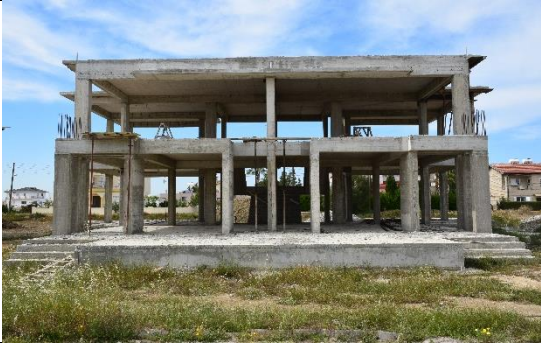
Case Study #122 (C22)

Week column-strong beam		
		Structural configuration	Horizontal structural configuration	Irregularity in plan
Floor discontinuity				
Beam elementary design faults	Projections in plan			
	Non-continuous beams			
	Non-uniform beam span and cross-section			
Slab elementary design faults	Absence of vertical support at beams intersection			
	Broken axis beams and frames			
District: <b style="color: red;">Mağusa		Pounding and separation problem		
				Area: <b style="color: red;">Tuzla (Enkomi)
Street name: <b style="color: red;">No street names were found		Vertical structural configuration		
Latitude: <b style="color: red;">35° 9'18.93"N				
Longitude: <b style="color: red;">33°53'23.79"E		Irregularity in elevation	Weak storey	
Structure age:			Soft storey	
			Discontinuity of columns or shear walls	
Building type:		Vertical structural elementary design fault	Broken axis columns

Irregular column and/or shear-wall plan configuration	
		Short column		
Building status:		Non-Structural Defects		
		Waterproofing defects, water leakage and seepage		
		Defected wooden door		
Reinforced Concrete Defects		Surface defects	dampness	Condensation
Drying shrinkage cracks				Rising damp
				Rain penetration
Corrosion of metals embedded in concrete				Leaking pipes, spills and other moisture sources
			Surface cracks on wall finishes	crazing
Construction defects (faulty workmanship): designer, detailer, and contractor				Map/pattern cracking
			Efflorescence	
Cracks in RC due to load effects (structural cracks)			Paint peeling	
			Mouldiness	
			Wall finishes workmanship problem	
Cracks in RC due to load effects (structural cracks)		Non-structural cracks	Staining	
			Joint cracks	
		Cracks in RC due to load effects (structural cracks)		Other notes (if available):
Settlement cracks

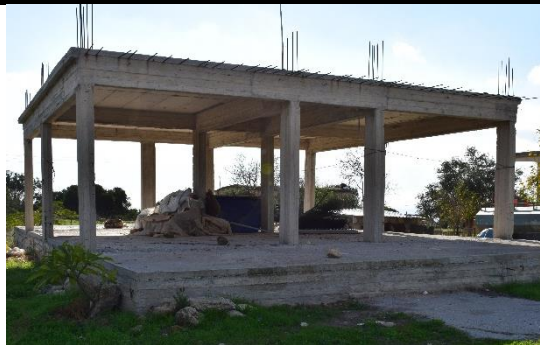
Case Study #123 (C23)

Weak column-strong beam		
		Structural configuration	Horizontal structural configuration	Irregularity in plan
Floor discontinuity				
Projections in plan				
Beam elementary design faults	Non-continuous beams			
	Non-uniform beam span and cross-section			
	Absence of vertical support at beams intersection			
Slab elementary design faults	Broken axis beams and frames			
	Over-stretched one-way slab			
	Poorly supported or heavily loaded cantilevered slabs			
			Pounding and separation problem	
Vertical structural configuration	Irregularity in elevation	Weak storey		
		Soft storey		
		Discontinuity of columns or shear walls		
Vertical structural element elementary design fault	Broken axis columns			
	Irregular column and/or shear-wall plan configuration			
	Short column			
Non-Structural Defects				
Building status:	Under Construction	Waterproofing defects, water leakage and seepage

Occupied	Defected wooden door		
	Abandoned			
Reinforced Concrete Defects				
Drying shrinkage cracks		Surface defects	dampness	Condensation
				Rising damp
				Rain penetration
				Leaking pipes, spills and other moisture sources
Corrosion of metals embedded in concrete	Corrosion-induced cracking		Surface cracks on wall finishes	cracking
	Corrosion-induced spalling			Map/pattern cracking
	Cracks due to embedment of dissimilar metals (handrails)		Efflorescence	
Construction defects (faulty workmanship): designer, detailer, and contractor	Improper reinforcing steel placement		Paint peeling	
	Premature removal of forms		Mouldiness	
	Cold joints		Wall finishes workmanship problem	
	Segregation	Staining		
	Honeycombing			
	Improper grades of slab surfaces			
		Non-structural cracks	Joint cracks	
<u>Other notes (if available):</u>				
Cracks in RC due to load effects (structural cracks)	Slab/beam-to column shear (punching shear) cracks

Cantilevered member cracks			
	Settlement cracks

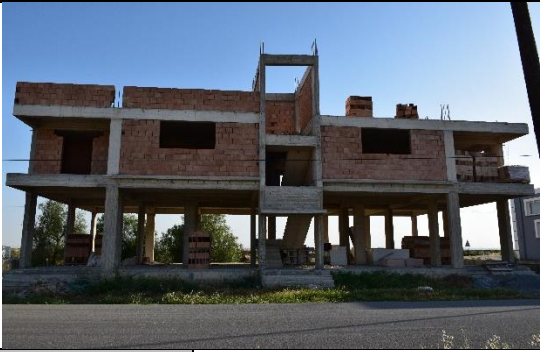
Case Study #124 (C24)

Week column-strong beam		
		Structural configuration	Horizontal structural configuration	Irregularity in plan
Floor discontinuity				
Projections in plan				
Beam elementary design faults	Non-continuous beams			
	Non-uniform beam span and cross-section			
	Absence of vertical support at beams intersection			
Slab elementary design faults	Over-stretched one-way slab			
	Poorly supported or heavily loaded cantilevered slabs			
		Pounding and separation problem		
Vertical structural configuration	Irregularity in elevation	Weak storey		
		Soft storey		
		Discontinuity of columns or shear walls		
	Vertical structural elementary design fault	Broken axis columns		
Irregular column and/or shear-wall plan configuration				
		Short column		
Non-Structural Defects				
		Waterproofing defects, water leakage and seepage		
		Defected wooden door		
Reinforced Concrete Defects		Surface defects	dampness	Condensation

Rising damp
				Rain penetration
				Leaking pipes, spills and other moisture sources
Corrosion of metals embedded in concrete	Surface cracks on wall finishes	cr crazing		
		Map/pattern cracking		
Construction defects (faulty workmanship): designer, detailer, and contractor	Efflorescence			
	Paint peeling			
	Mouldiness			
	Wall finishes workmanship problem			
	Staining			
	Joint cracks			
		Non-structural cracks		
<u>Other notes (if available):</u>				
Cracks in RC due to load effects (structural cracks)	Slab/beam-to column shear (punching shear) cracks			
	Cantilevered member cracks			
	Settlement cracks

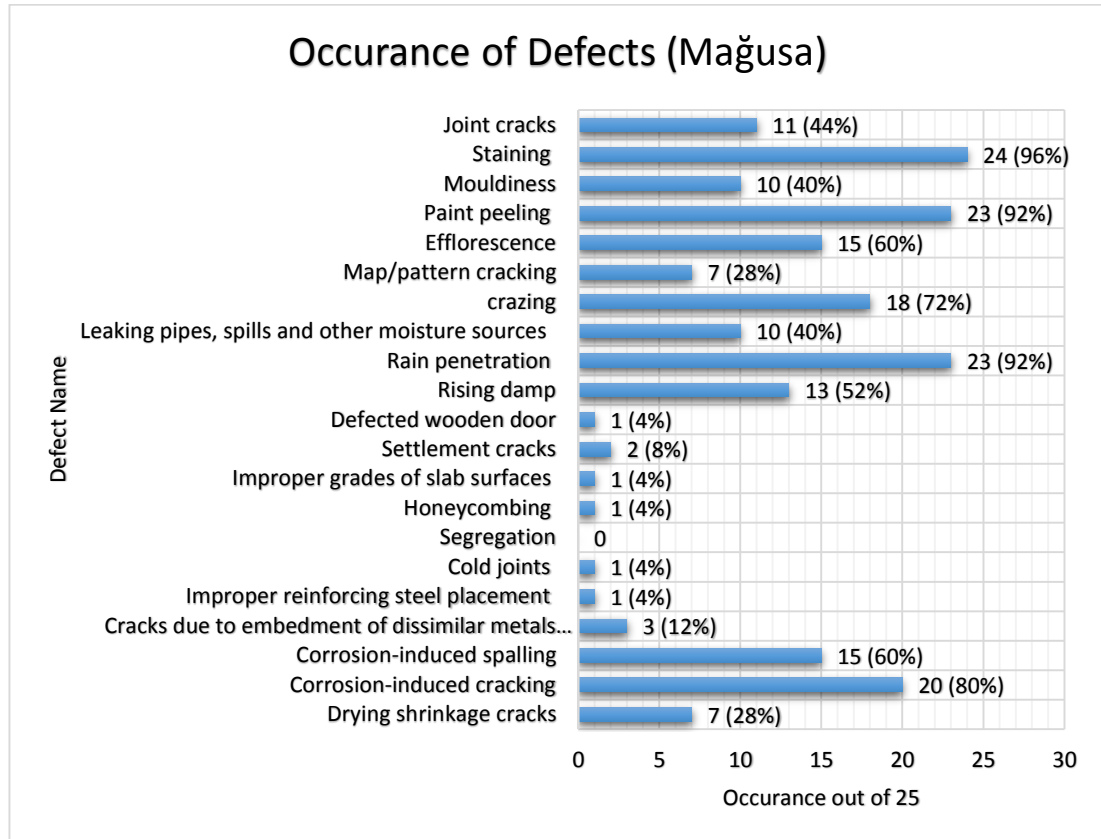
Figure 5.6: Bar Chart Showing the Occurrence of Defects in Mağusa District (M1-M25)

Mağusa had the highest percentage of crazing (72%). Besides, it had the highest corrosion-induced cracking and spalling with percentages of 80% and 60% respectively. This is reasonable since Mağusa's sample contained the most numbers of old buildings. Moreover it had the highest percentage of dampness due to leaking pipes, spills and other moisture sources (40%). This is reasonable since Mağusa's sample contained the highest number of apartments. On the other hand it had the lowest settlement cracks and rising damp (8% and 52% respectively).

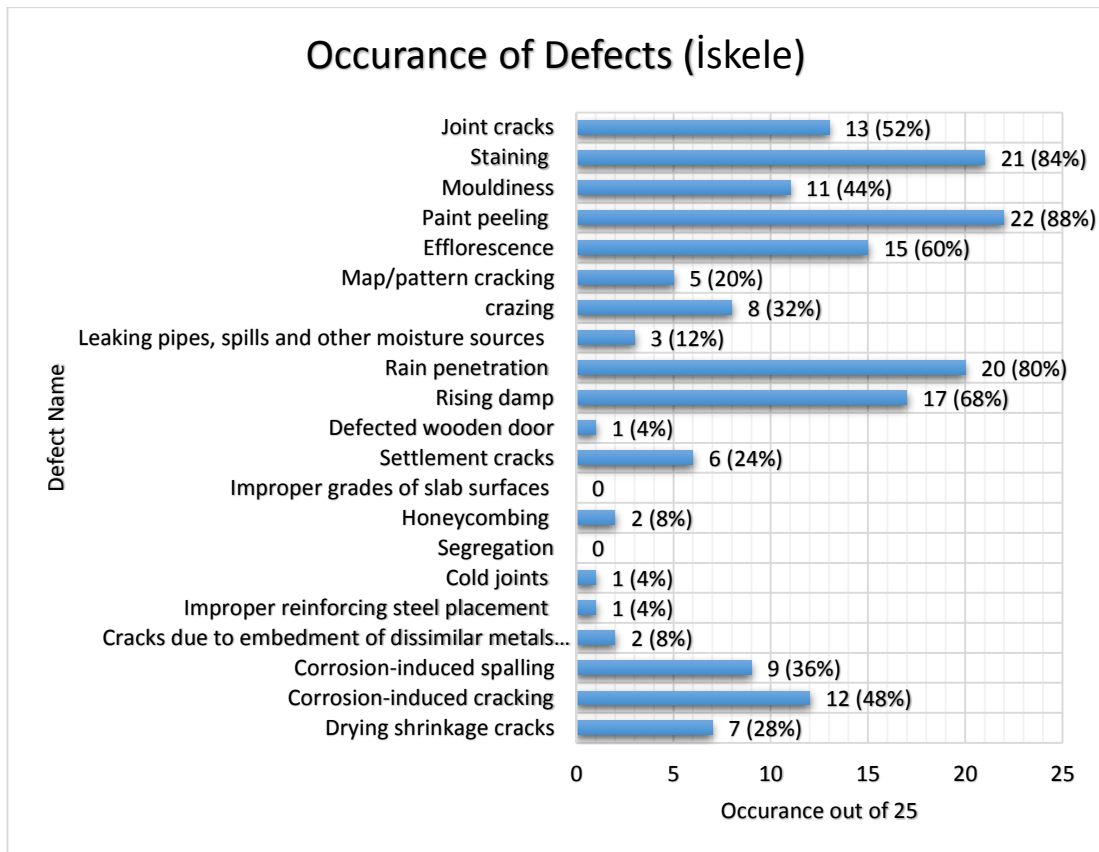
Figure 5.7: Bar Chart Showing the Occurrence of Defects in İskele District (İ1- İ25)

İskele had the highest percentage of settlement cracks (24%), but the lowest crazing and map/pattern cracking (32% and 20% respectively). Additionally, it had the lowest percentage of dampness due to leaking pipes, spills and other moisture sources (12%). This is reasonable since İskele's sample contained the least number of apartments.

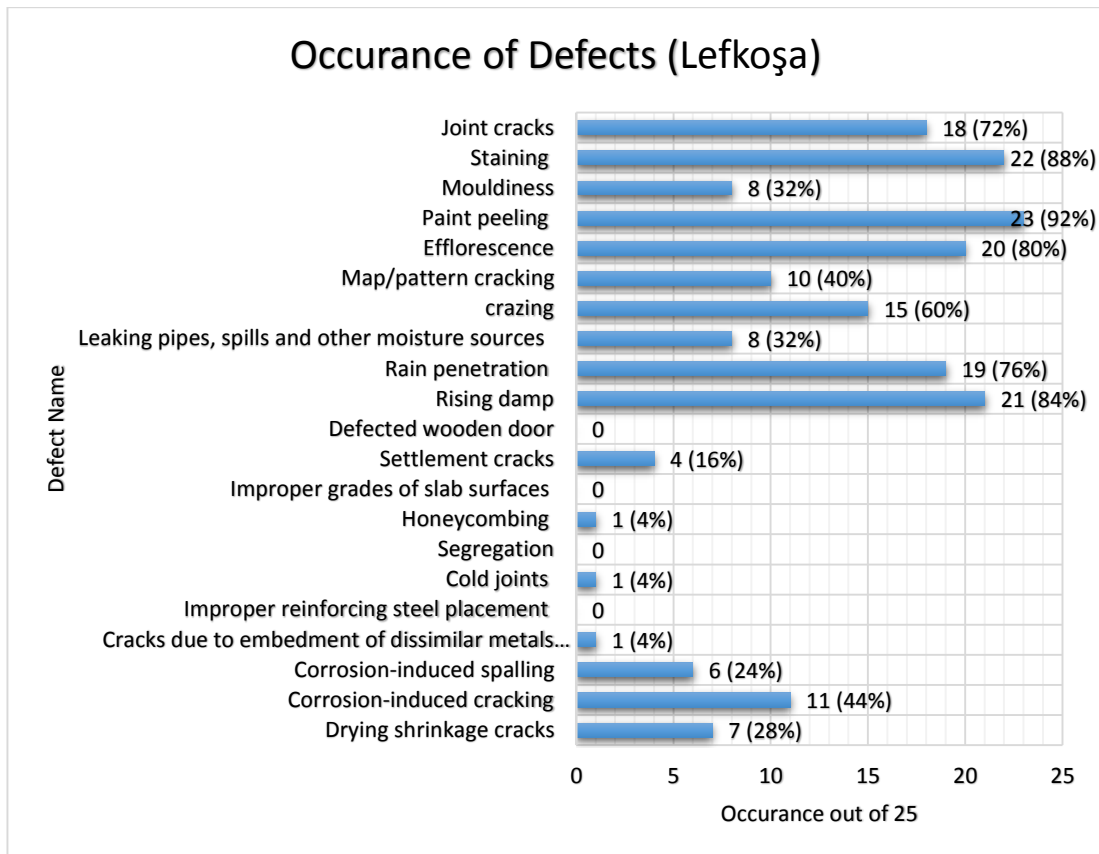
Figure 5.8: Bar Chart Showing the Occurrence of Defects in Lefkoşa District (L1-L25)

Lefkoşa had the least rain penetrations dampness (76%), besides the least corrosion-induced cracking with a percentage of 44%. This is reasonable since Lefkoşa is not a coastal city. However, it had the highest rising damp with a percentage of 84% and as a result the highest percentage of efflorescence with a percentage of 80%.

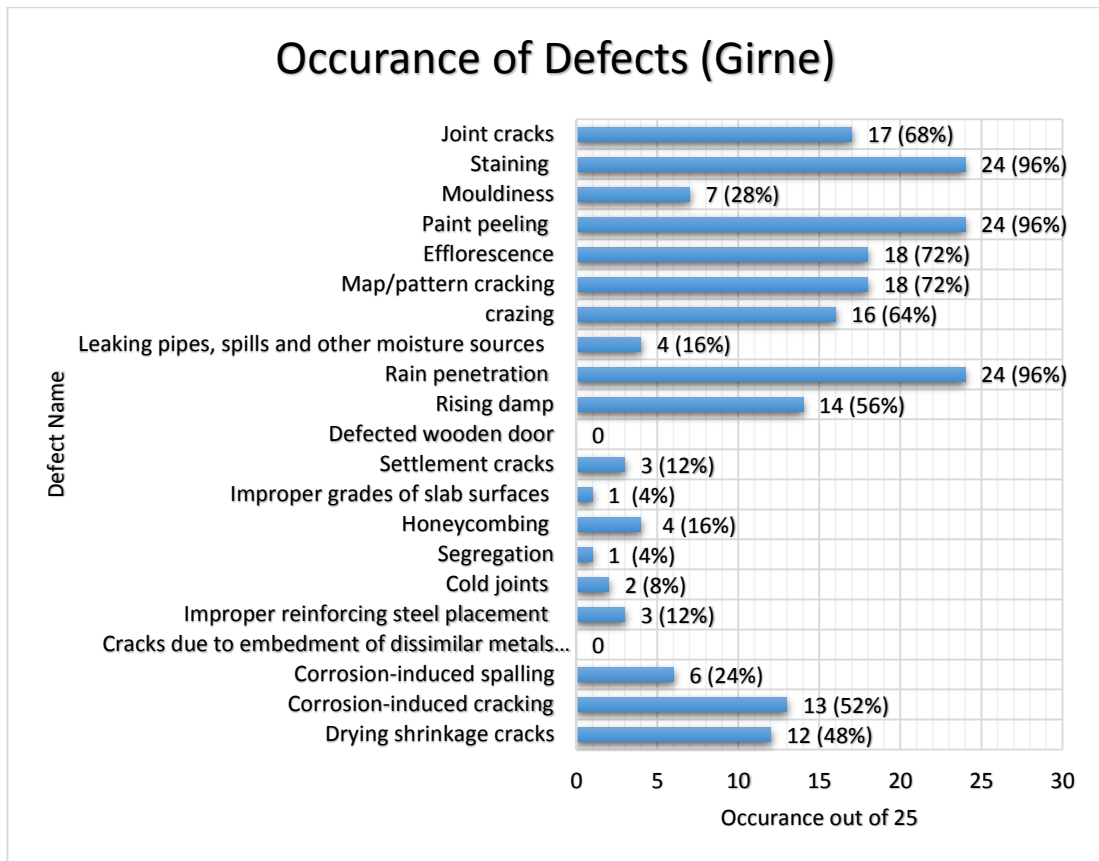
Figure 5.9: Bar Chart Showing the Occurrence of Defects in Girne District (G1-G25)

Girne had the highest drying shrinkage cracks with a percentage of 48% compared to 28% each for the other cities. Additionally, it had the highest rain penetration dampness with a percentage of 96%.

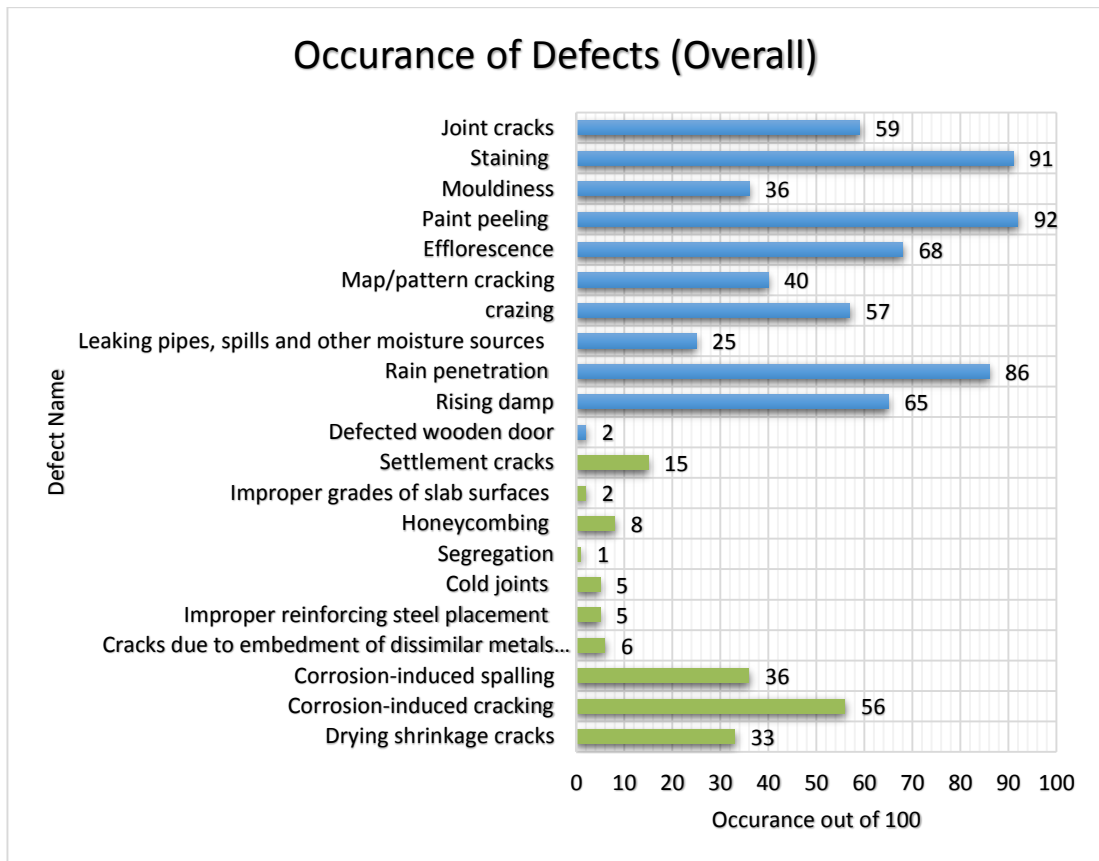
Figure 5.10: Bar Chart Showing the Overall Occurrence of Defects (M1-M25, I1-I25, L1-L25 and G1-G25)

Joint cracks and crazing were fairly evident in the building of the sample having percentages of 59 % and 57% respectively. On the other hand, map/pattern cracking was found to be less than crazing by having a percentage of 40% (compared to 57% for crazing).

The surface defects of staining and paint peeling were the most common defects found having percentages of 91% and 92% respectively. While segregation was the least common having a percentage of 1% each. The reason for this could be because segregation would be hard to detect in this sample since the buildings here are mostly completed so any form of segregation would be covered under finishes. However, they are much easier to detect in the buildings under construction sample (see section 5.5.2).

33% of the buildings had drying shrinkage cracks. 6% of the buildings were found to have cracks due to embedment of dissimilar metals which can be found around metal handrails. Corrosion-induced cracking were found to be in 56% of the building, while corrosion-induced spalling which can be consider as a severe of the former one were found to be at 36%. Mouldiness also shares the same percentage of corrosion-induced spalling (36%).

Efflorescence and one of its causes; rising damp, were found to be at 68% and 65% respectively. Dampness due to rain penetration was the most common type of dampness with a percentage of 86%. Dampness due to leaking pipes, spills and other moisture sources was found in quarter of the sample (25%). The structural cracks of settlement cracks were found in 15% of the building of the sample.

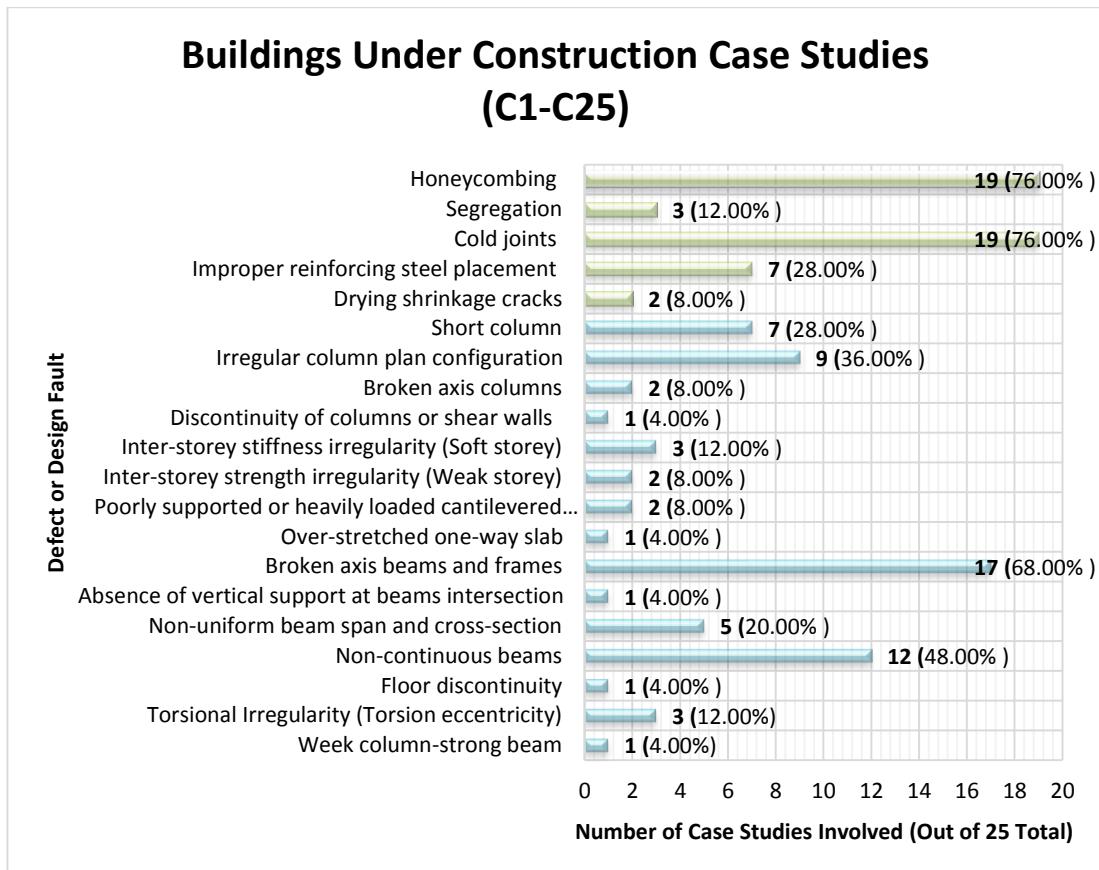
Figure 5.11: Bar Chart Showing the Statistics for the Under Construction Case Study Group (C1-C25)

The concrete defects of honeycombing and cold joint were found to be the most common defects among the under construction sample with a percentage of 76% each (nearly three quarters of the sample). The second common concrete defect was found to be the improper placement of reinforcing steel at 28% followed by segregation (12%) and drying shrinkage cracks (8%).

On the other hand, the most common design flaws were found to be related to beams; namely: broken axis beams at 68% followed by non-continuous beams at 48%. The third and fourth most common design flaws were related to columns; namely: irregular column plan configuration (36%) and short column (28%) respectively. Non-uniform beam span and cross-sections was found in 20% of the sample.

Torsional irregularity and soft storey were found in 12% each, while broken axis columns, weak storey and poorly supported or heavily loaded cantilevered slabs were found in 8% each. The least common design flaws were: floor discontinuity, discontinuity of columns or shear walls, over-stretched one-way slab and weak column-strong beam which each of them were found in only 4% of the sample.
