Repair and Maintenance of Historical Buildings of Cyprus Made of Natural Building Stones

Master of Science
in
Civil Engineering

Eastern Mediterranean University
February 2022
Gazimağusa, North Cyprus

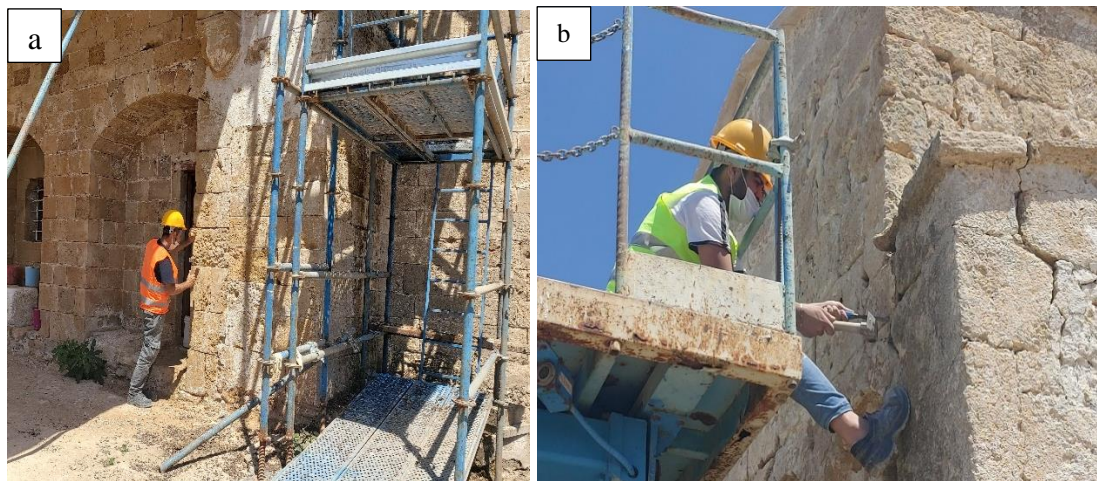
Figure 2.6: a) Pointing removal 1 b) Pointing removal 2

- Existing pointing was removed and joins of external walls of church cleaned (see Figure 2.6).

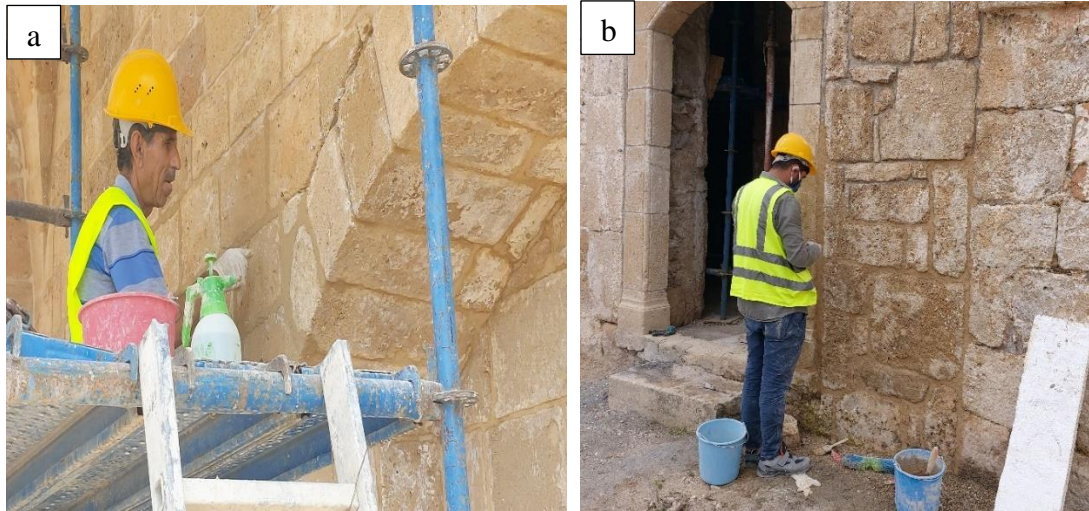
Figure 2.7: a) Repointing 1 b) Repointing 2

- The external walls of church were repointed with lime mortar in same colour and hardness as the original (see Figure 2.7).

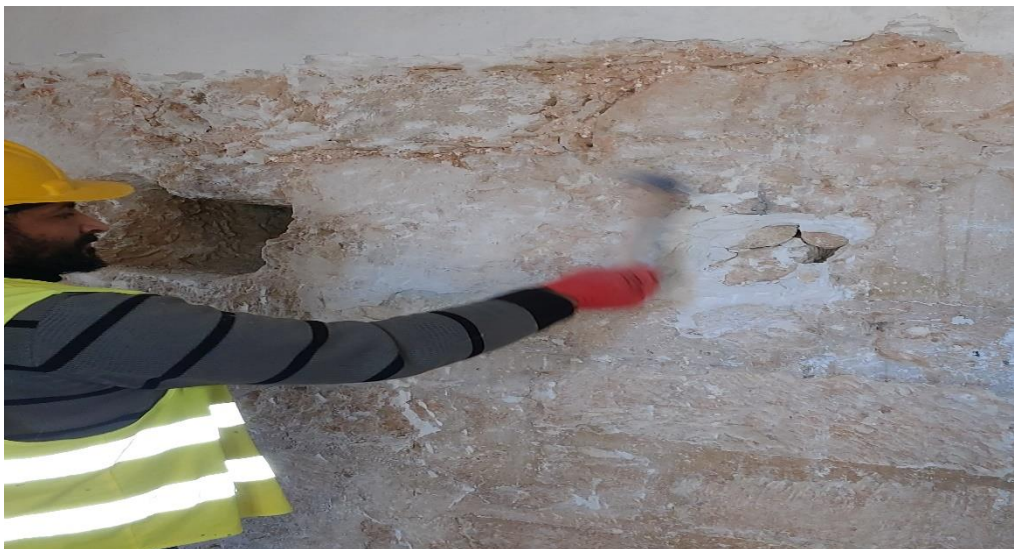
Figure 2.13: Cleaning of stone surfaces with brushes

- Cleaning of surface deposits using flat brushes natural fibre brooms (see Figure 2.13).

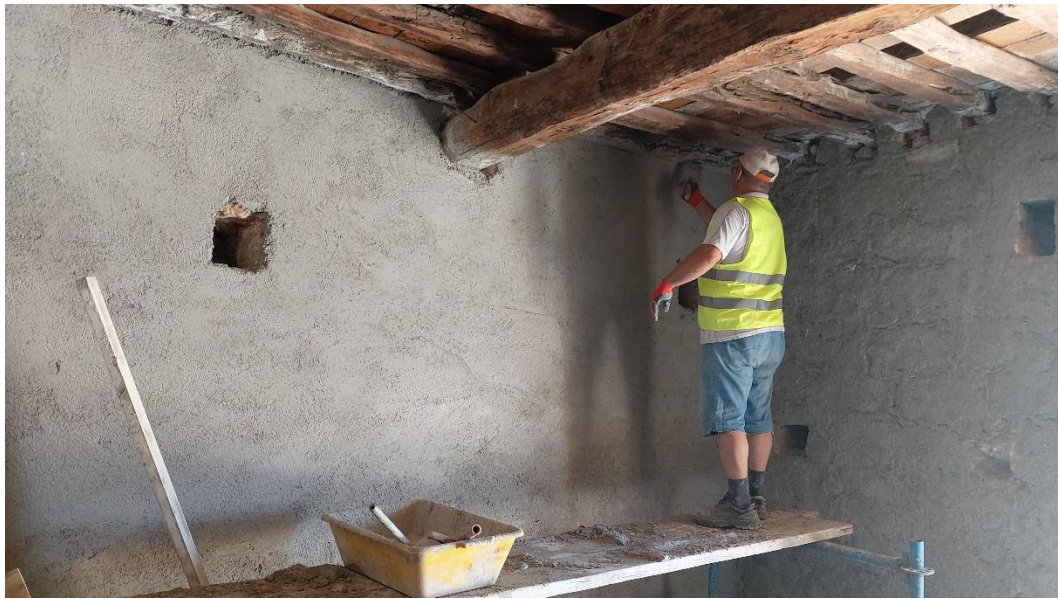
Figure 2.14: Plastering stage 1

- Vegetation (roots etc.) was removed from walls after application of approved biocide.
- New plastering applied to internal surfaces (wall, arch, etc.) with Hydraulic lime mortar (material property of Hydraulic lime mortar is given at Appendix D) (see Figure 2.14, 2.15, 2.16 and 2.17).

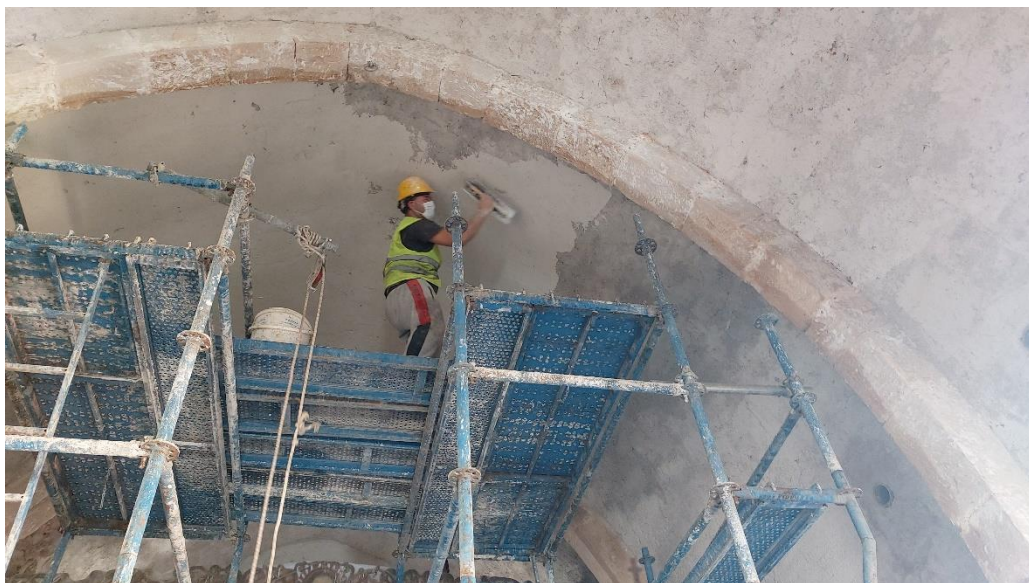
Figure 2.15: Plastering stage 2

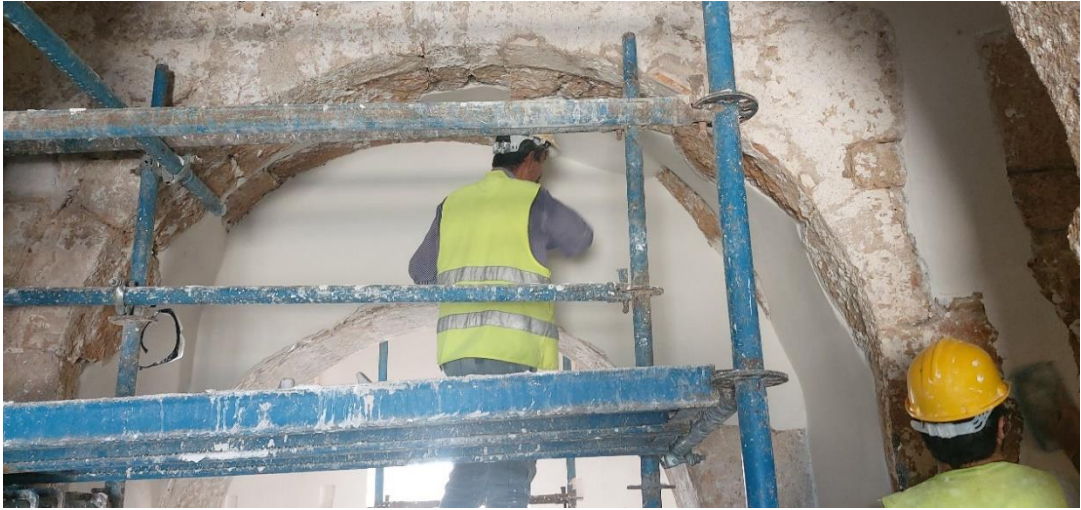
Figure 2.16: Plastering stage 3

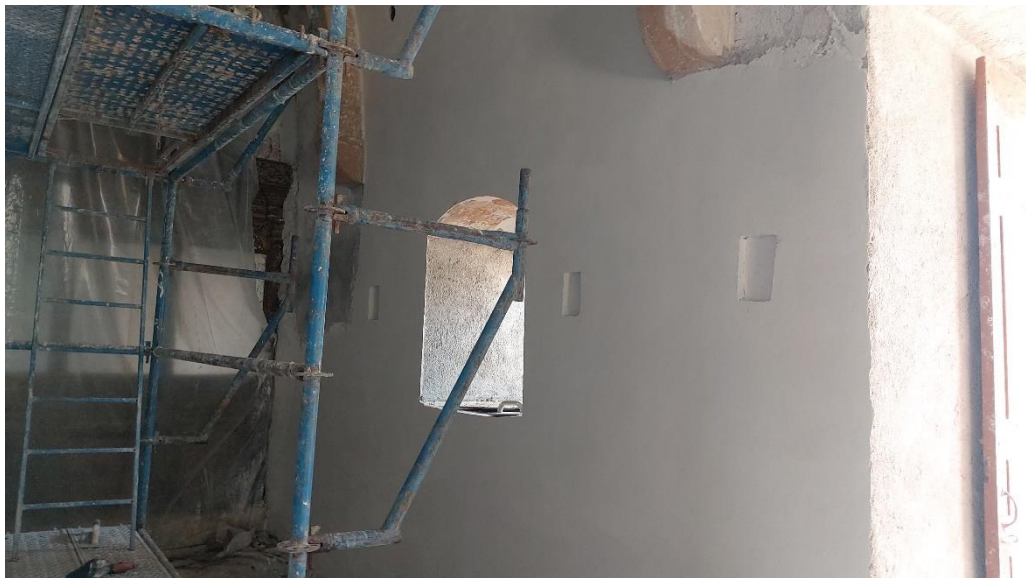
Figure 2.17: Plastering stage 4

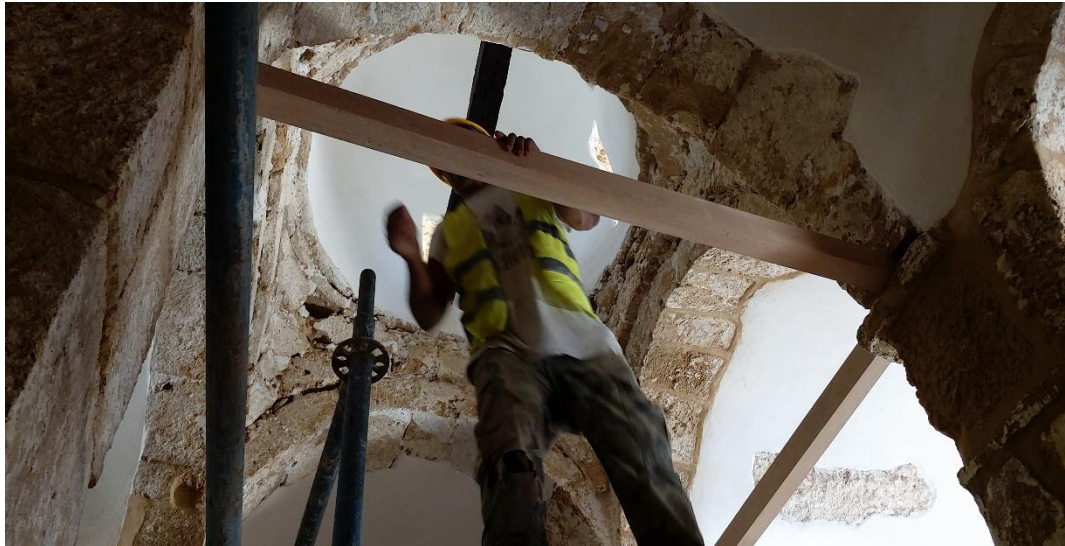
Figure 2.18: New wooden tie beams

- New wooden tie beams (be of class C22 or higher, which means minimum bending strength value of wood should be 22 N/mm²) were inserted at the places where the original ones were cut off or removed at the east, west and north dome base/arch (see Figure 2.18 and 2.19).

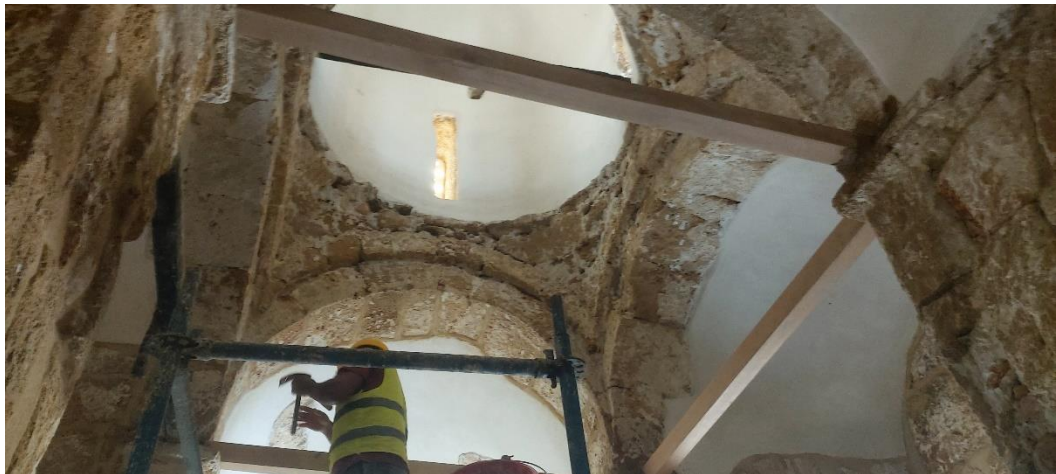
Figure 2.19: New wooden tie beams

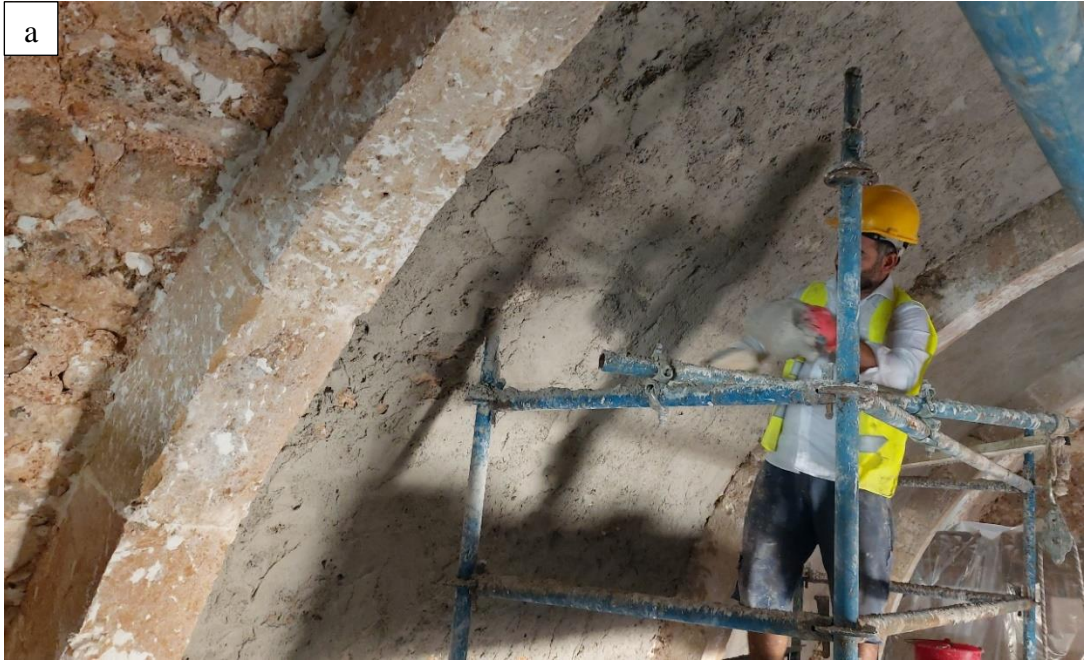
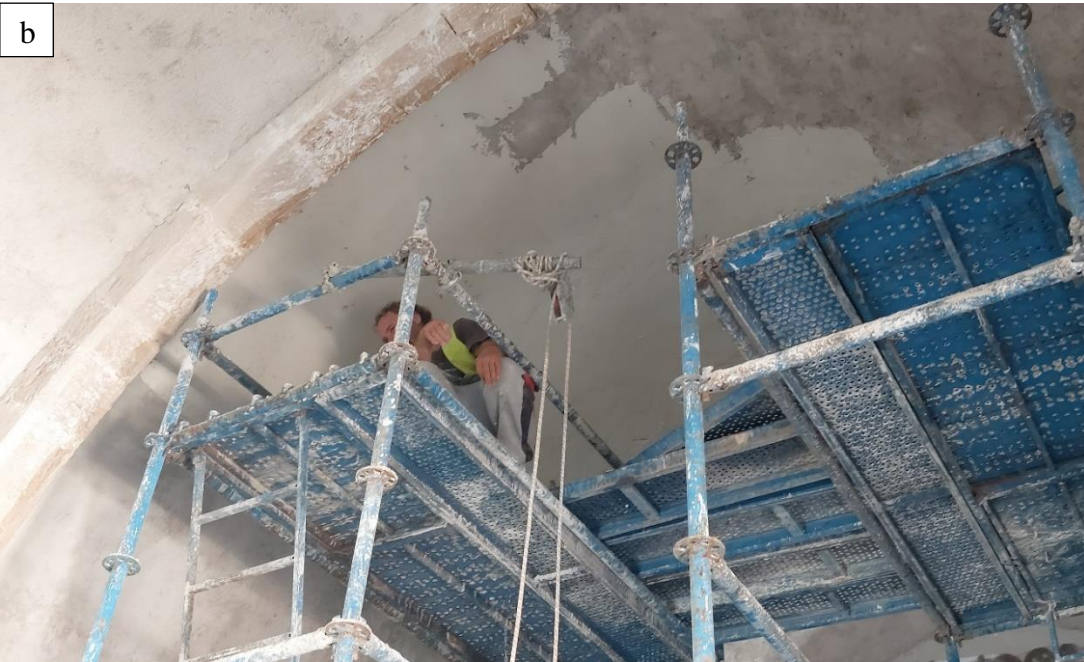
Figure 2.26: a) Plastering of ceiling stage 1 b) Plastering of ceiling stage 2

Existing lime or gypsum or cement removed from internal surfaces except areas with frescoes. Work has been done by hand tools only (chisels, hand hammers), without use of heavy machinery. Loose deposits were removed by air under pressure and the surfaces washed with water under pressure. Then new plastering applied to surfaces with Hydraulic mortar (see Figure 2.26 and 2.27).

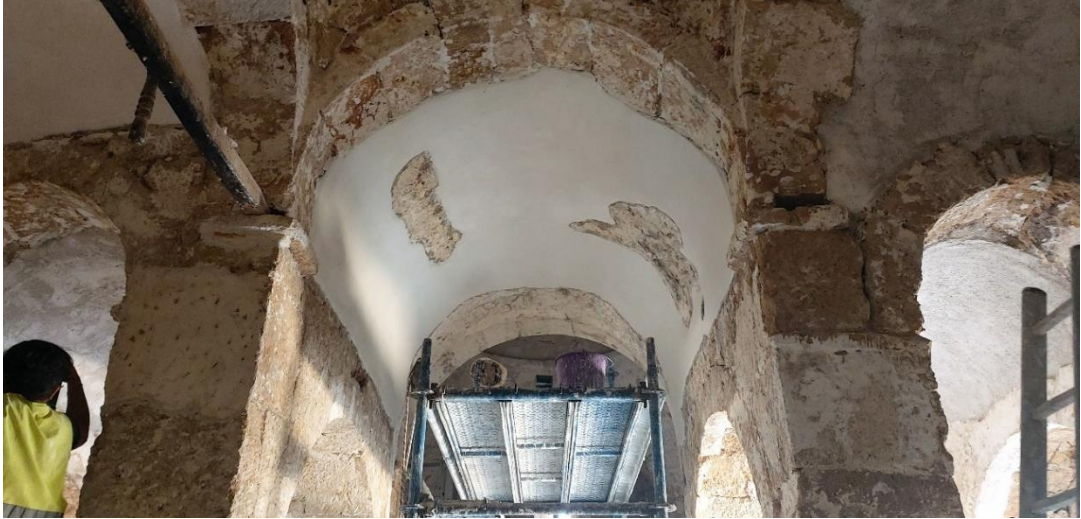
Figure 2.27: Final stage of plastering at ceiling

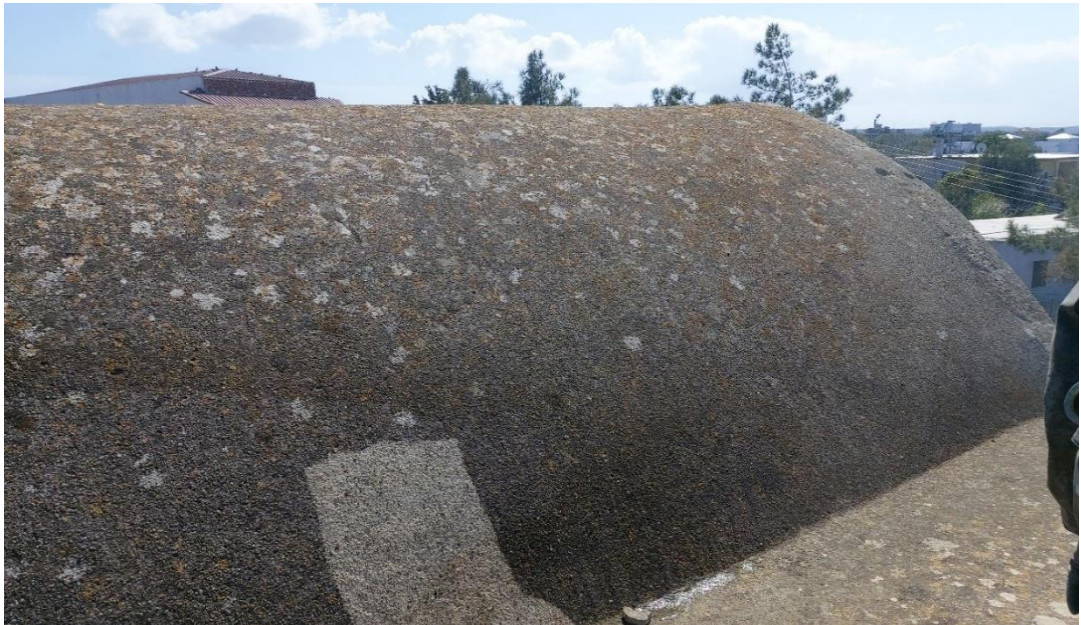
Figure 2.28: Cleaning of loose deposits stage 1

- Loose deposits were cleaned and removed, loose roof materials near cracks cleaned with brush and water under pressure (see Figure 2.28, 2.29 and 2.30).

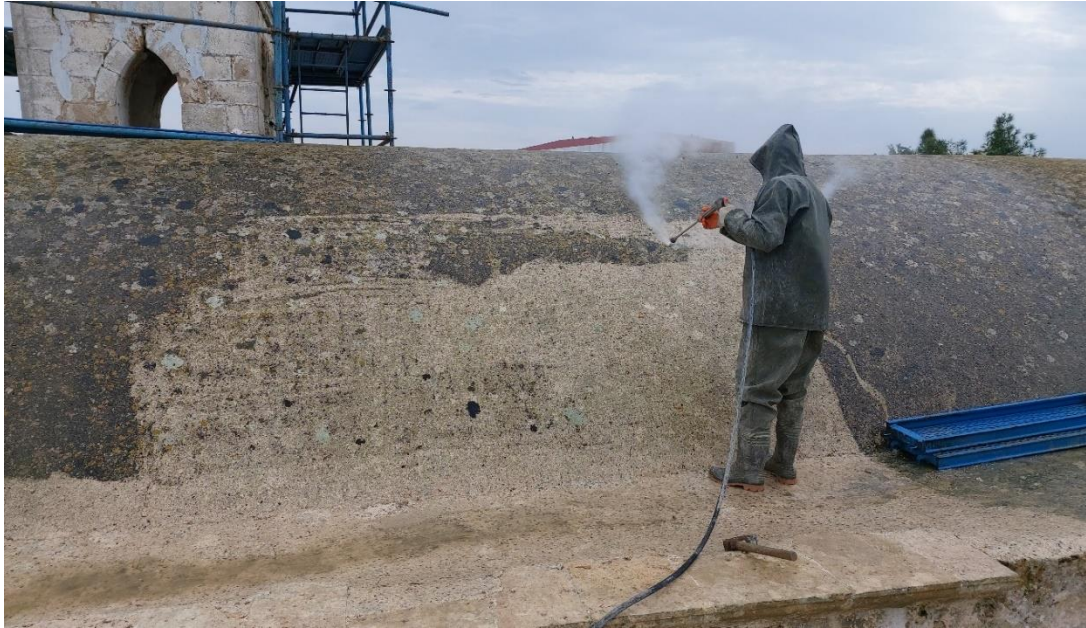
Figure 2.29: Cleaning of loose deposits stage 2

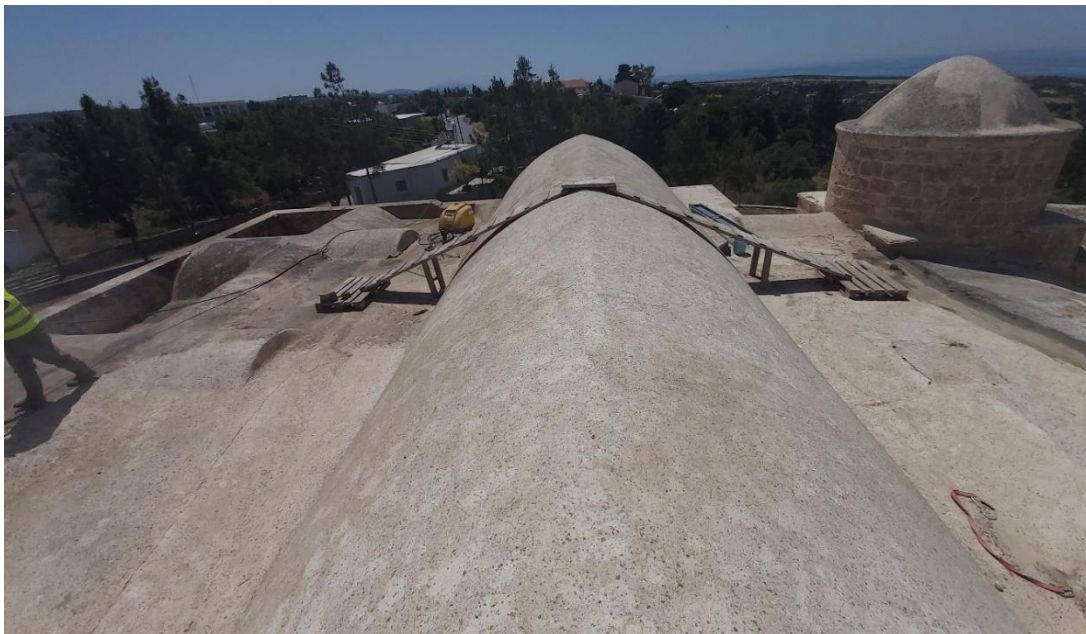
Figure 2.30: Cleaning of loose deposits stage 3

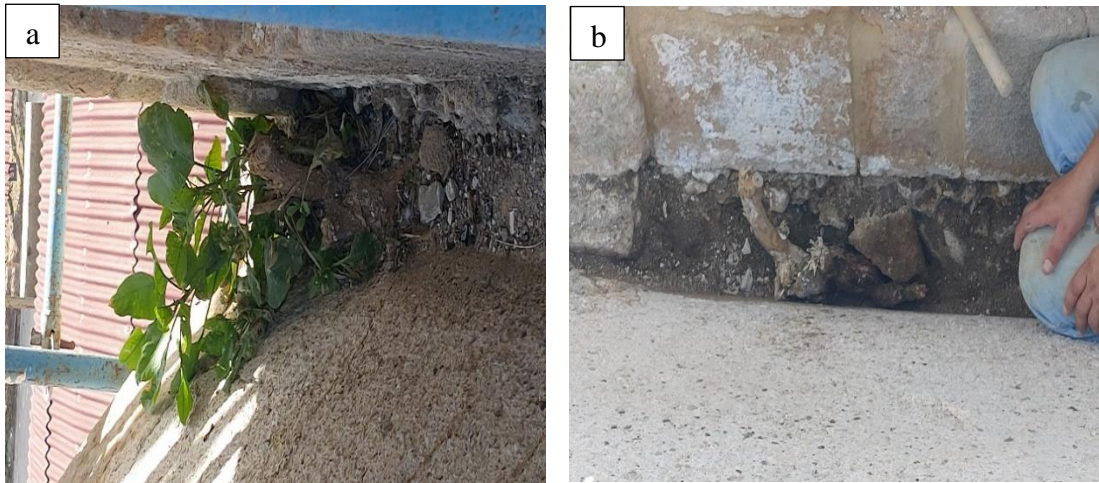
Figure 2.31: a) Vegetation cleaning stage 1 b) Vegetation cleaning stage 2

- Vegetation and roots removed and approved biocide applied (see Figure 2.31).

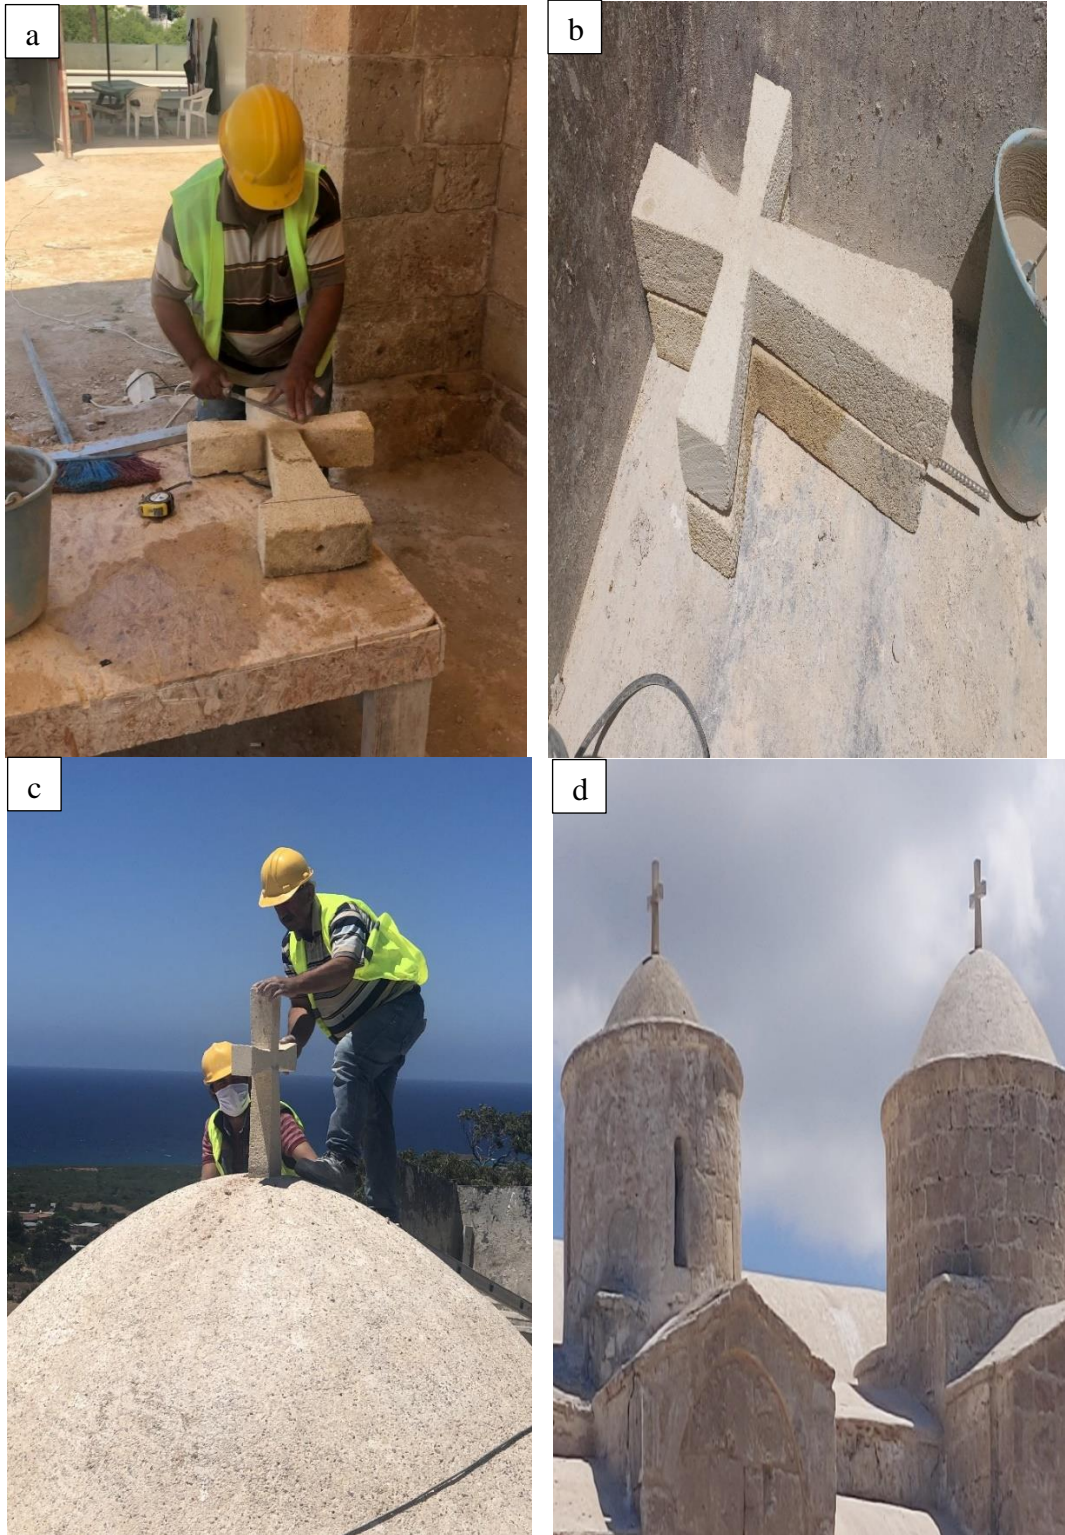
Figure 2.34: a) Construction and placing of new stone crosses stage 1 b) Stage 2 c) Stage 3 d) Stage 4

- Cracks and voids repaired with grouting. (see more detailly at Chapter 2.8.3)
- New stone crosses constructed and placed (see Figure 2.34).

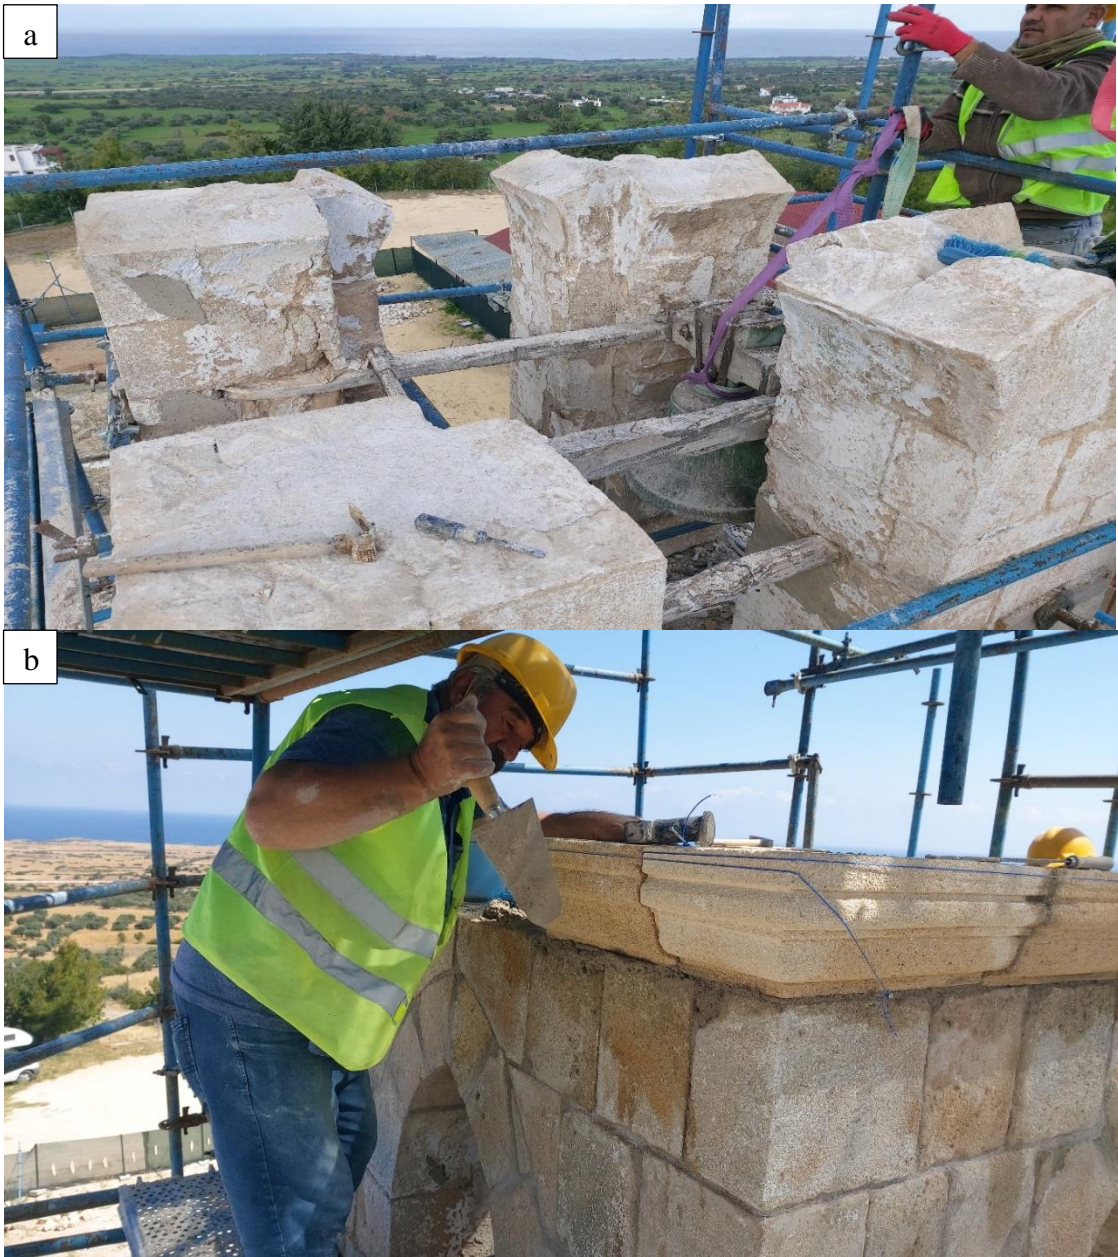
Figure 2.36: a) Dismantled condition b) Adding new cornice stones at 23th row of belfry

Upper part of belfry from row 19th to 23rd (the top small cupola with four columns, the stone/cement rail with four corner posts, the cornice and five row of stones) dismantled and rebuilt. Then cracked cornice stones at row 23rd were removed and new ones added in same style and dimensions (see Figure 2.35 and 2.36).

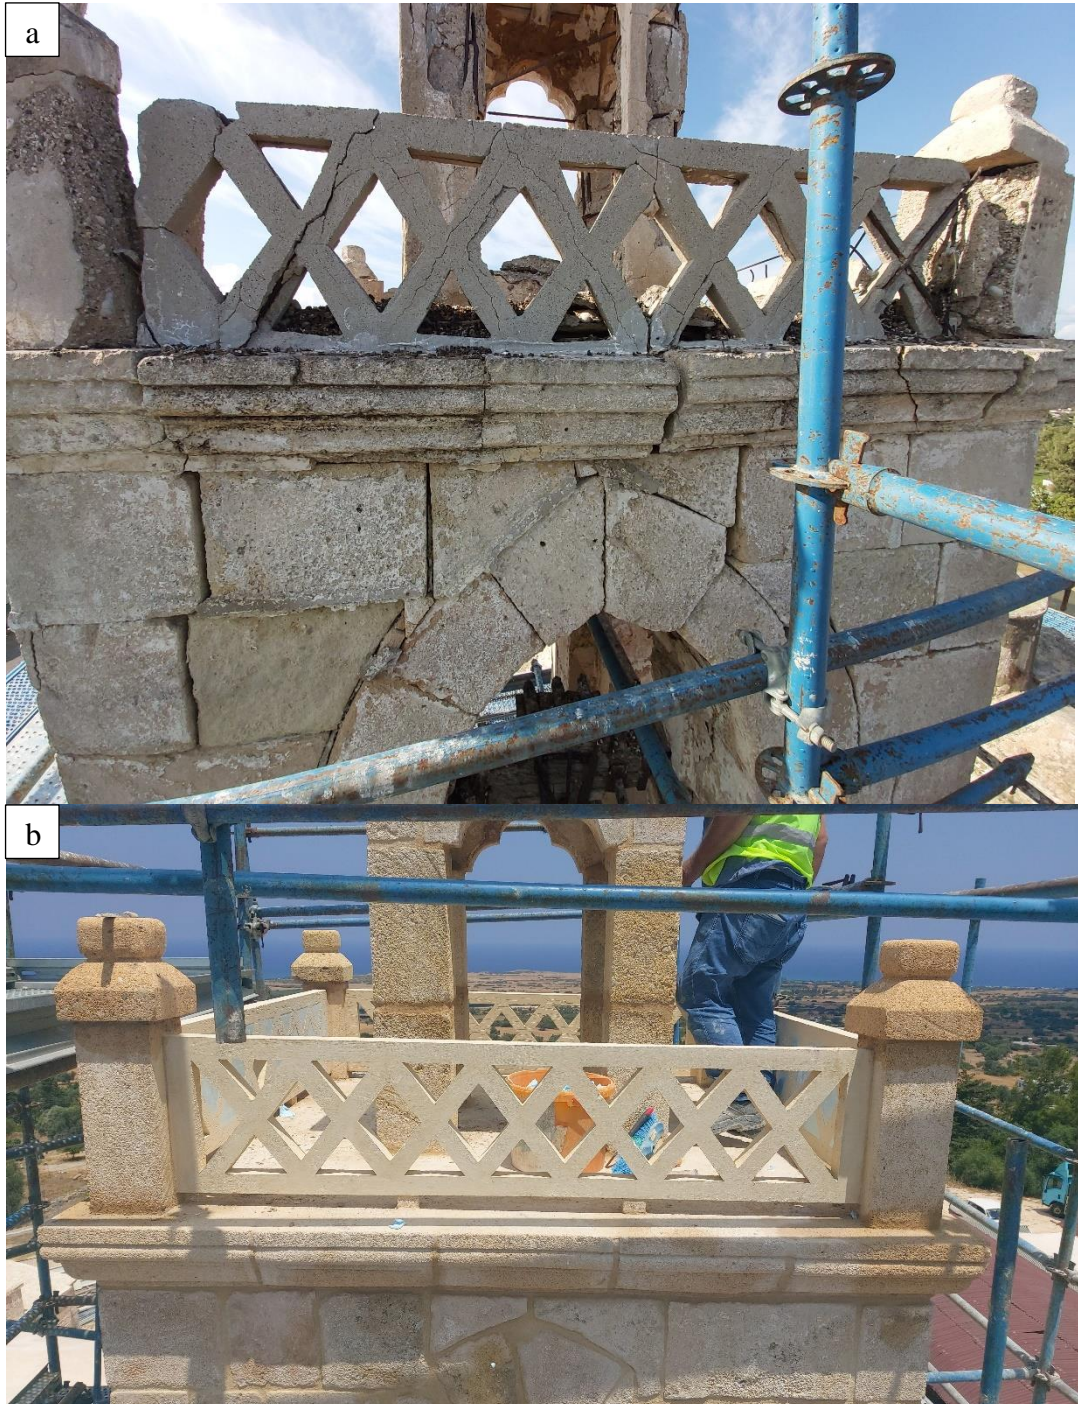
Figure 2.37: a) Initial condition b) Construction of new stone rail and corner posts

- New stone corner posts and new stone rail were constructed in same pattern and dimensions as original (see Figure 2.37).

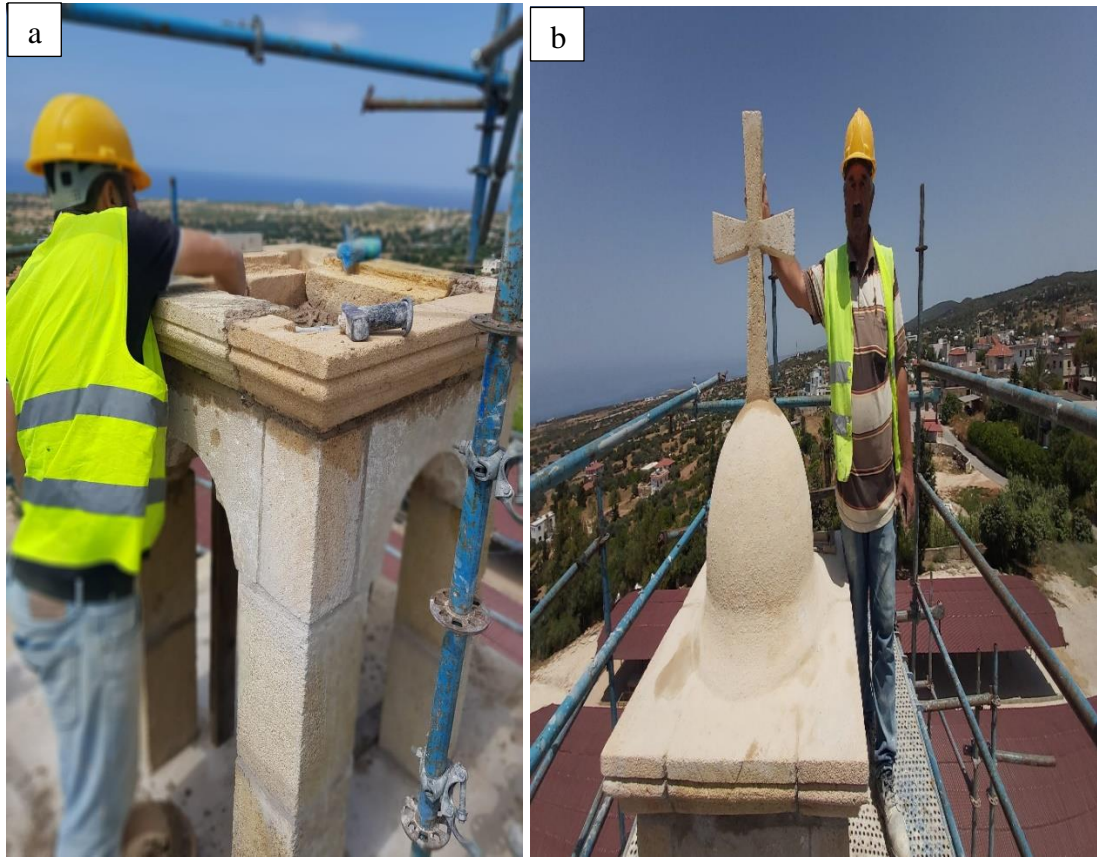
Figure 2.38: a) Rebuilding of new stone columns and arches b) Rebuilding of new stone coupole

- Rebuilding of new stone columns and arches (from row 25th to 29th) (see Figure 2.38).

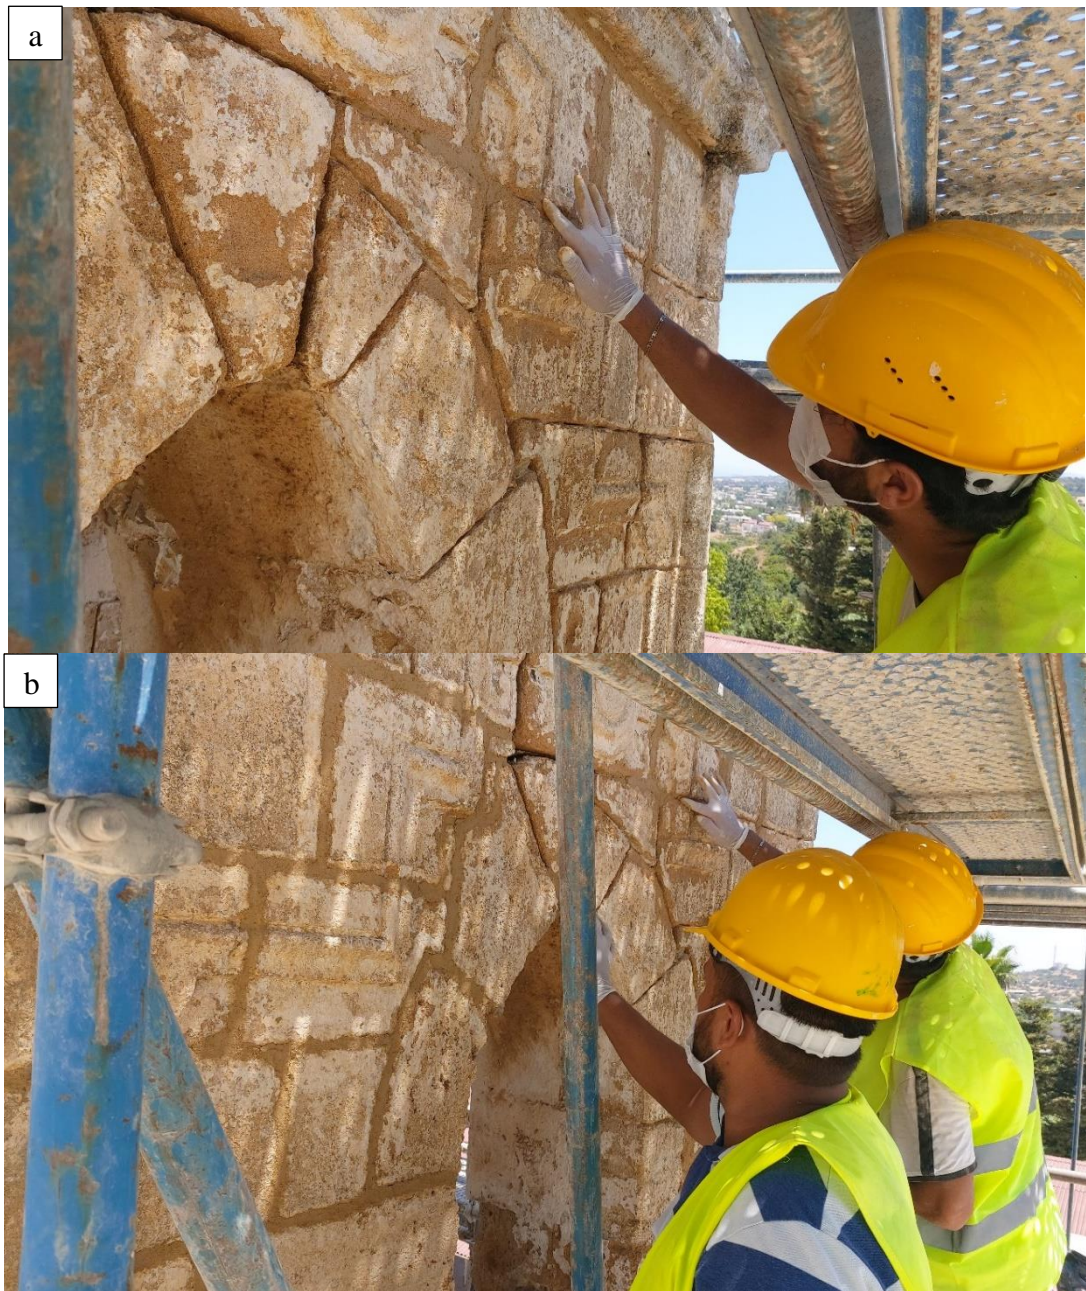
Figure 2.42: a) Repointing of belfry 1 b) Repointing of belfry 2

- Repointing of belfry (from row 2nd to 29th) (see Figure 2.42).

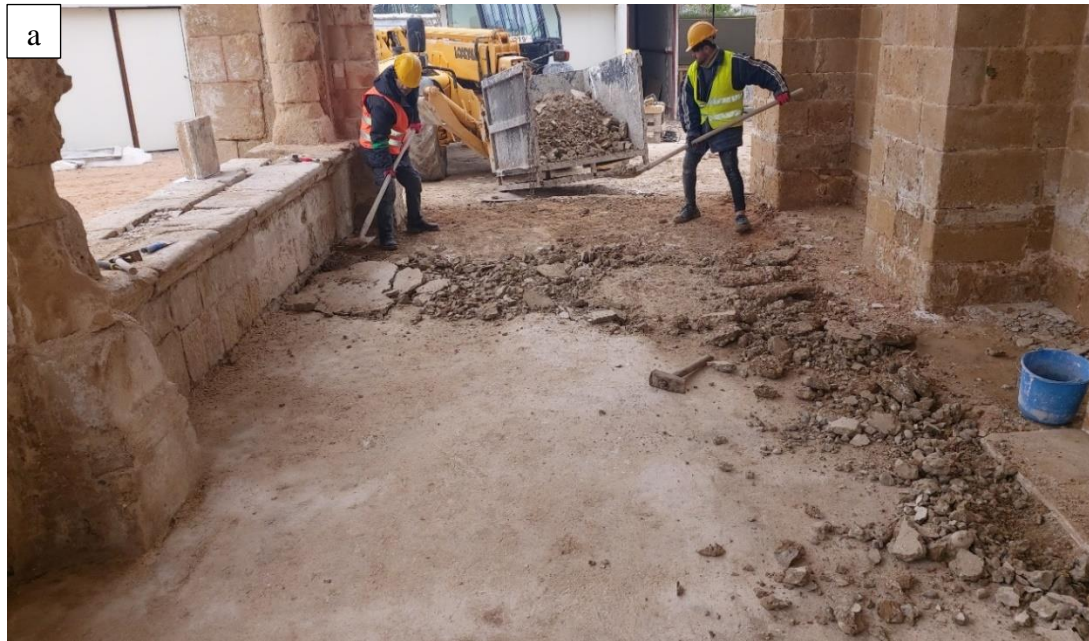
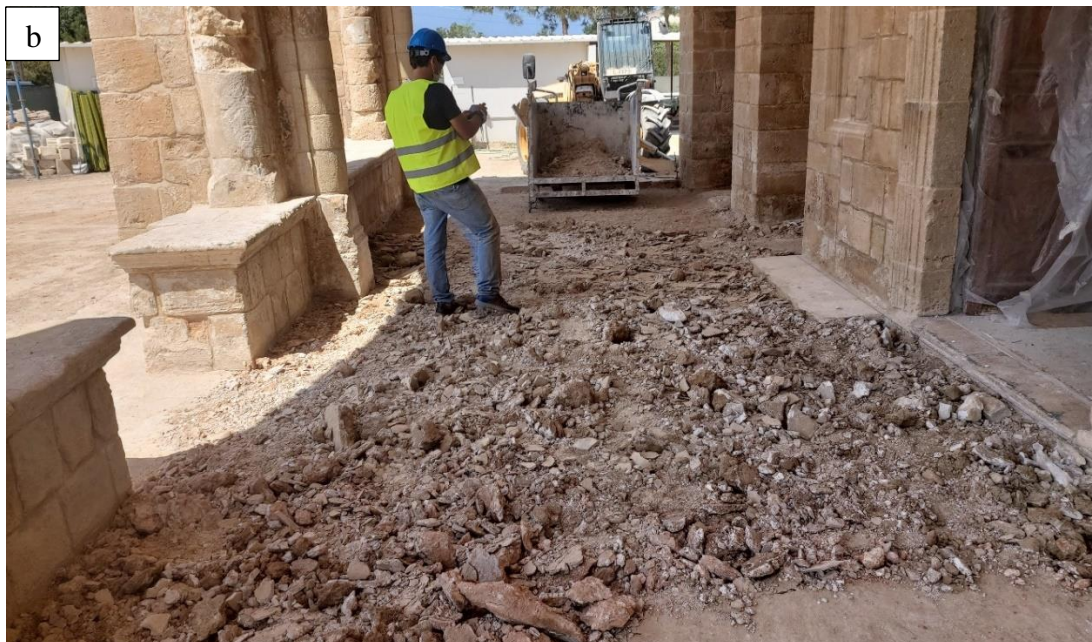
Figure 2.44: a) Removal of existing floor stage 1 b) Stage 2

- Removal of existing floor materials and substructures and construction of new floor using local stones (see Figure 2.44 and 2.45).

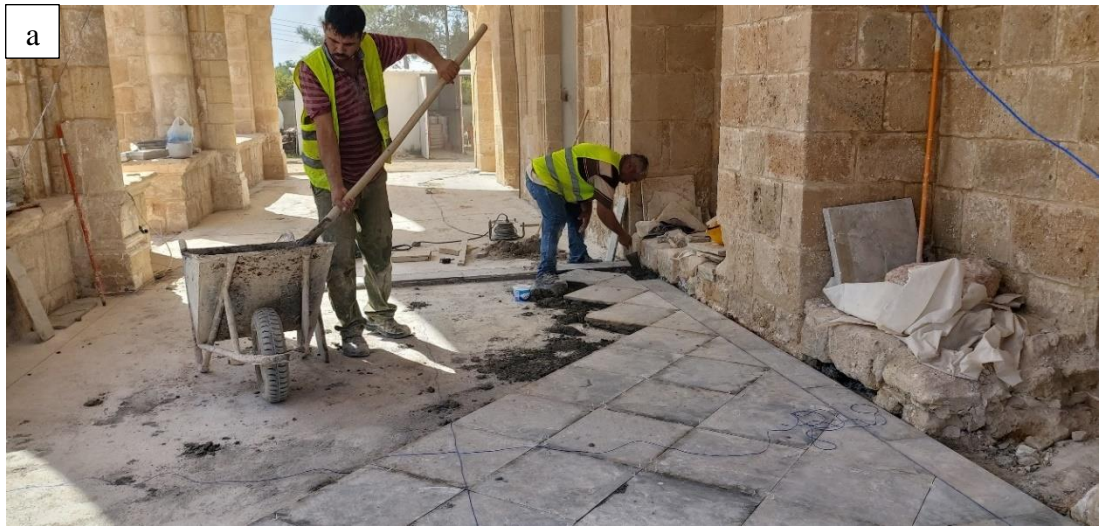
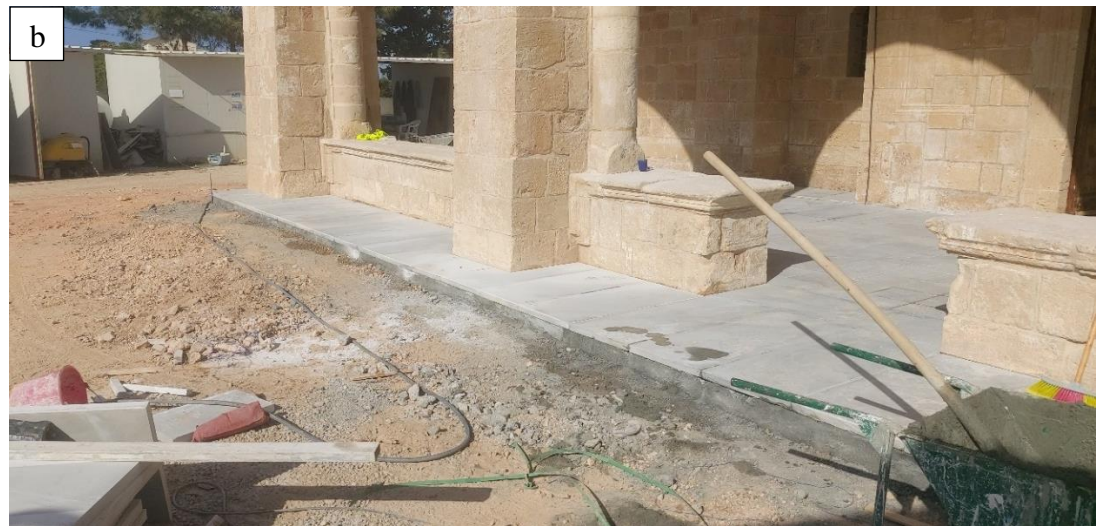
Figure 2.45: a) Construction of new floor with Local stone stage 1 b) Stage 2

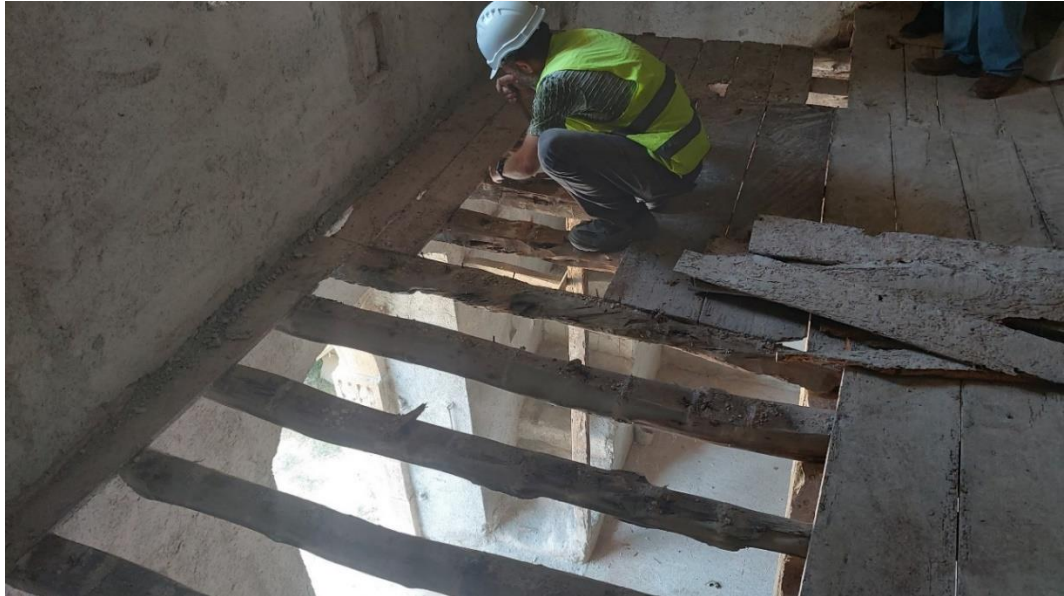
Figure 2.46: Removal of existing substructure floor

- Existing floor material and substructure were removed (see Figure 2.46).

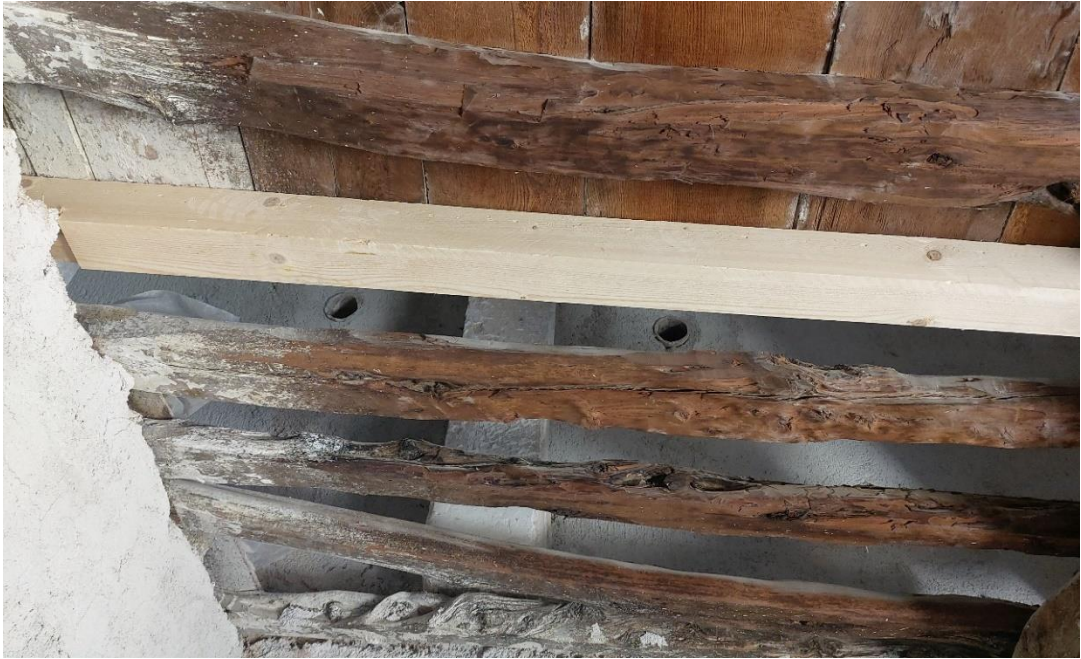
Figure 2.48: New wooden beam

- Wooden structure (planking and beams) was checked and damaged elements were removed and replaced (see Figure 2.47, 2.48, 2.49 and 2.50).

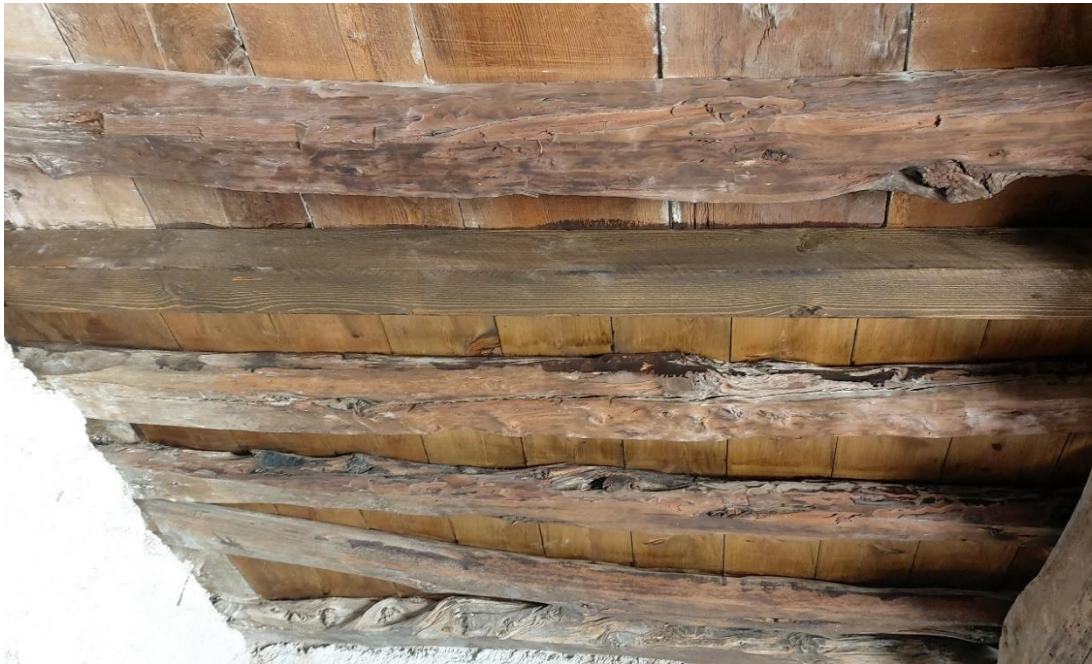
Figure 2.49: New wooden beam

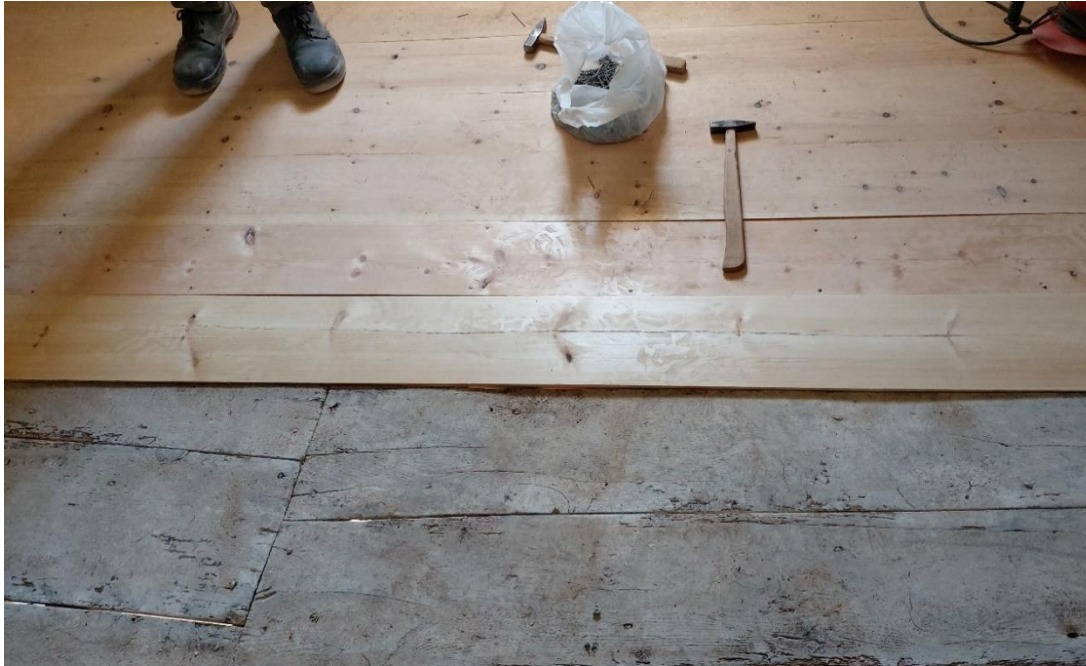
Figure 2.50: New floor
