Repair and Maintenance of Historical Buildings of Cyprus Made of Natural Building Stones

Master of Science
in
Civil Engineering

Eastern Mediterranean University
February 2022
Gazimağusa, North Cyprus

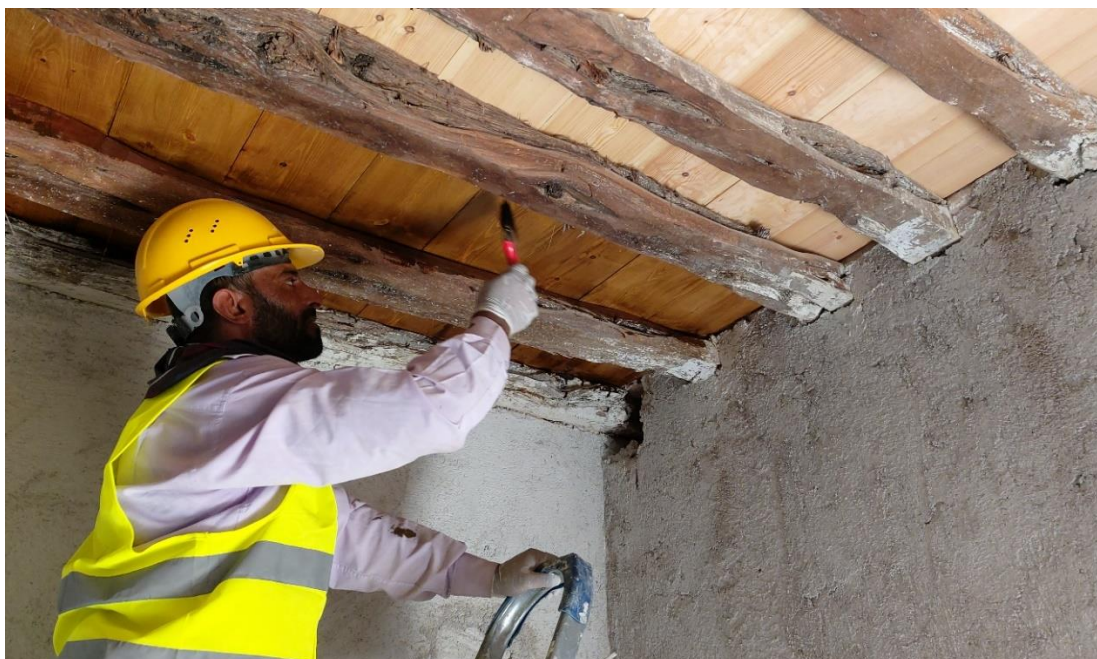
Figure 2.51: Cleaning of beams and parapet with paint-remover and applying of water-based varnish

- All beams and parapet were cleaned with paint remover and new water-based varnish applied (see Figure 2.51).

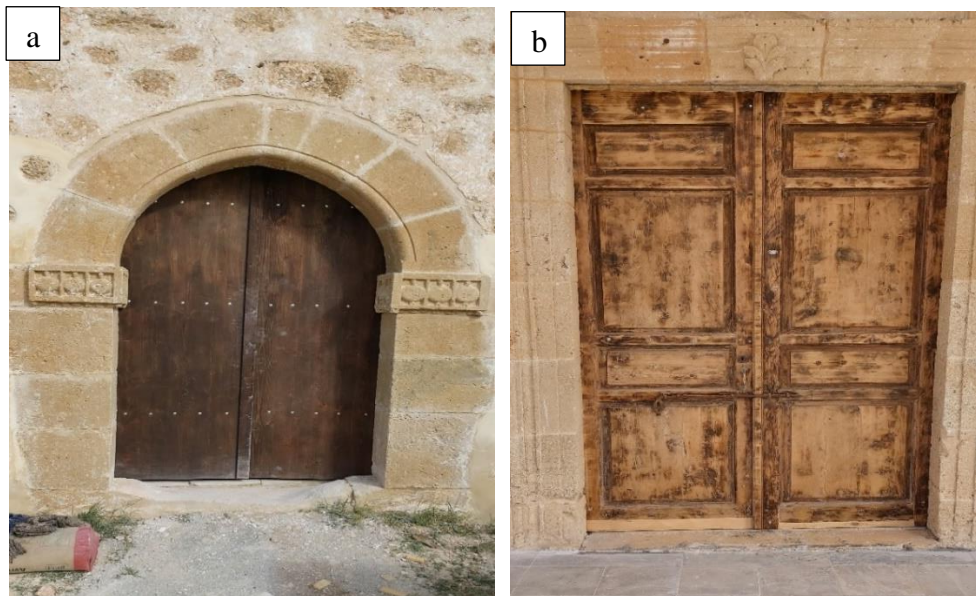
Figure 2.53: a) New door 1 b) New door 2

- New doors and windows were constructed at different locations of church (see Figure 2.53, 2.54 and 2.55).

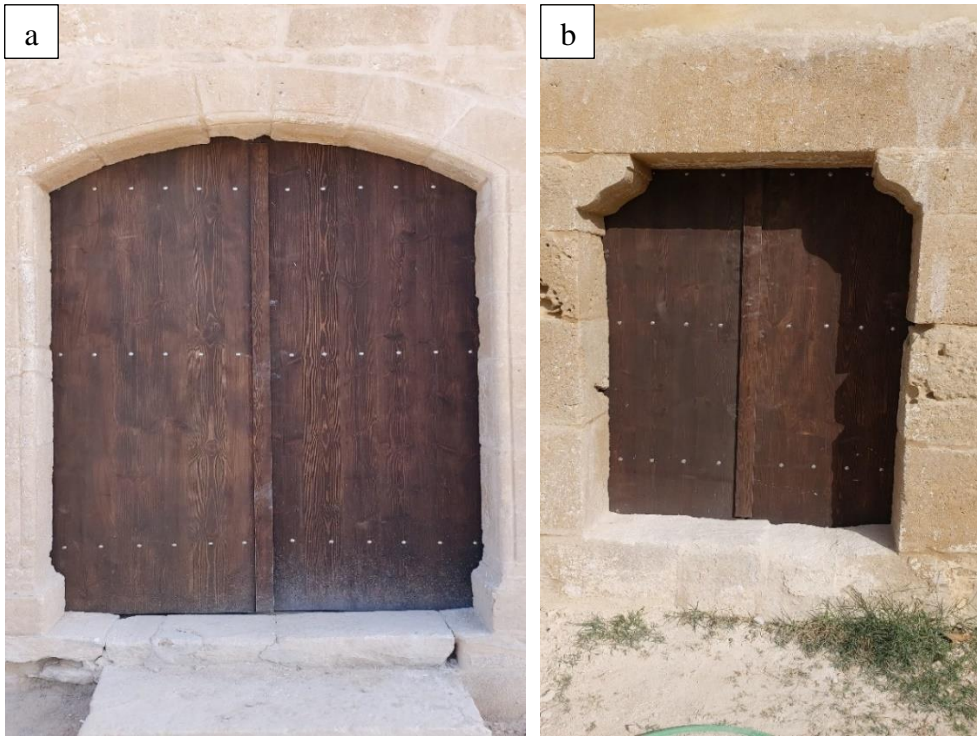
Figure 2.54: a) New door 3 b) New door 4

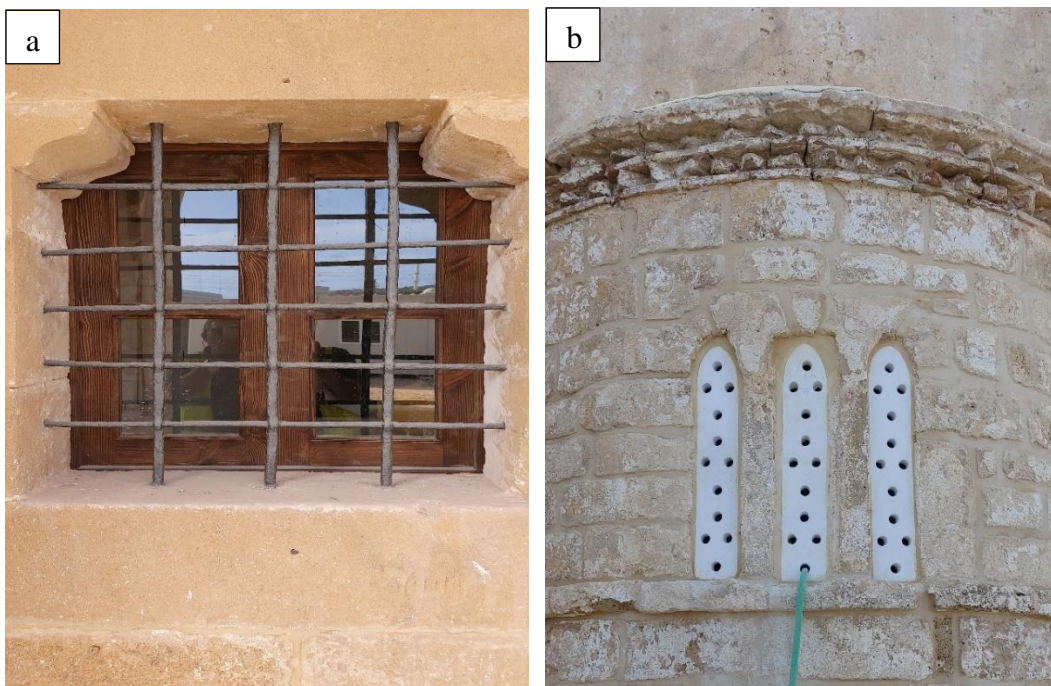
Figure 2.55: a) New window 1 b) New window 2

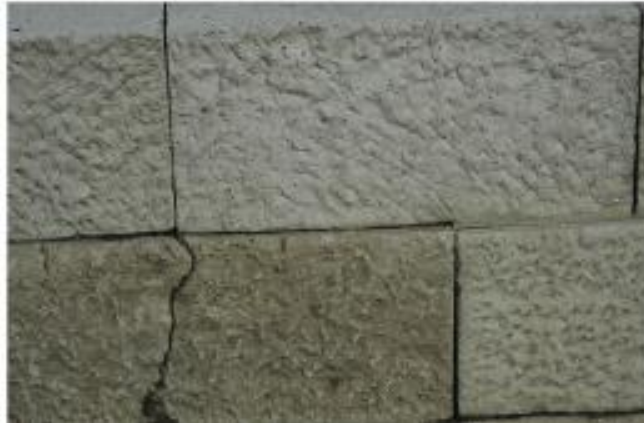
Figure 2.63 Artificial stones at archeological site of Pella [23]

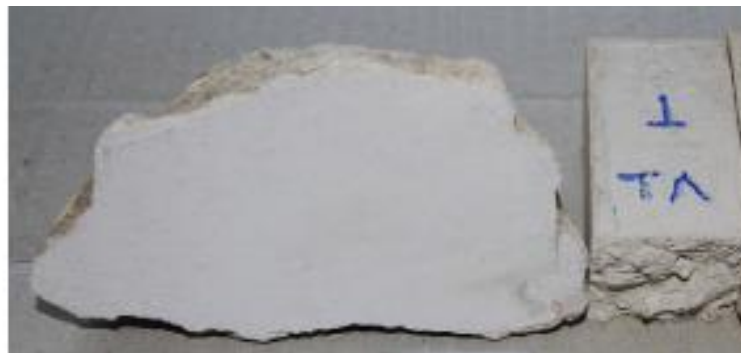
Figure 2.64: Natural and artificial stone (at right) of ancient theatre of Maronia [23]

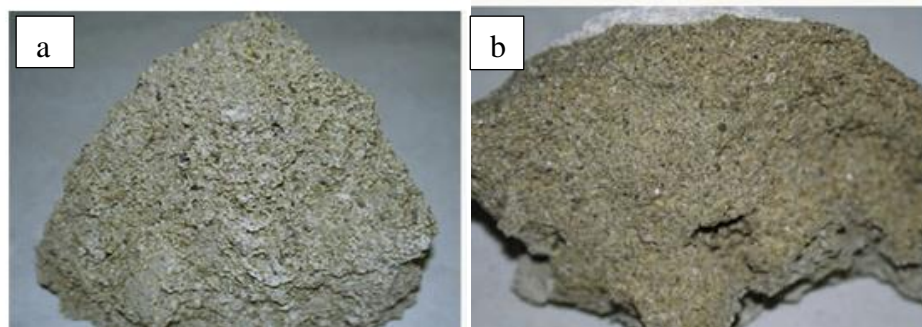
Figure 2.65: a) Natural stone b) Artificial stone at Fortress of Saint Nicolao [23]

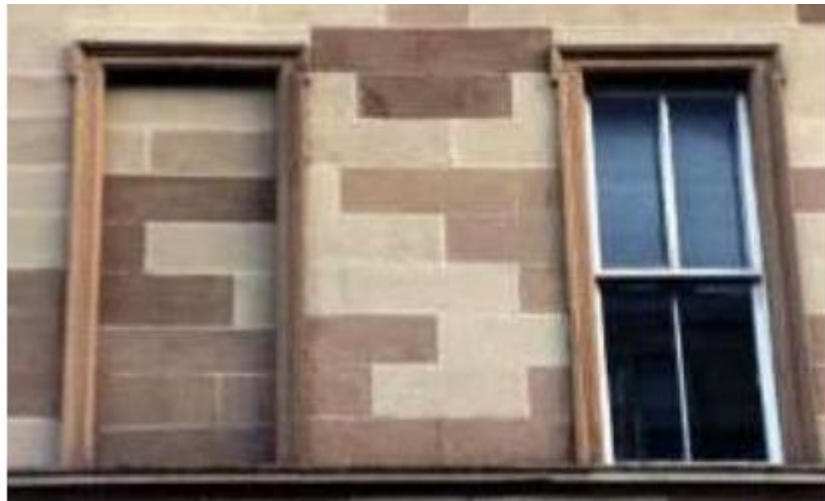
Figure 2.66: Example of mortar application (light parts) as a mortar repair of deteriorated stone units in Glasgow. Scotland [24]

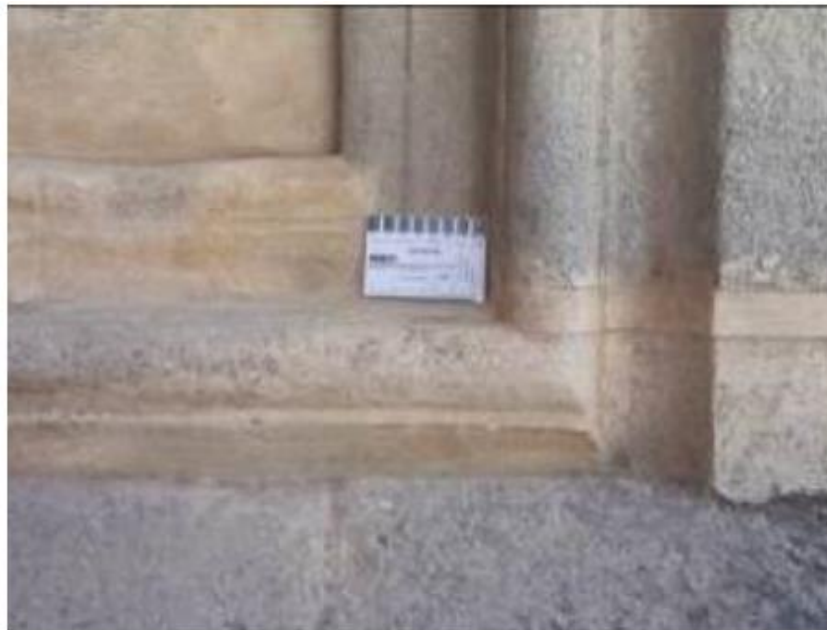
Figure 2.67: Mortar used to repair deteriorated stone parts and detailing of the main entrance portal of the cathedral in Évora. Portugal [24]

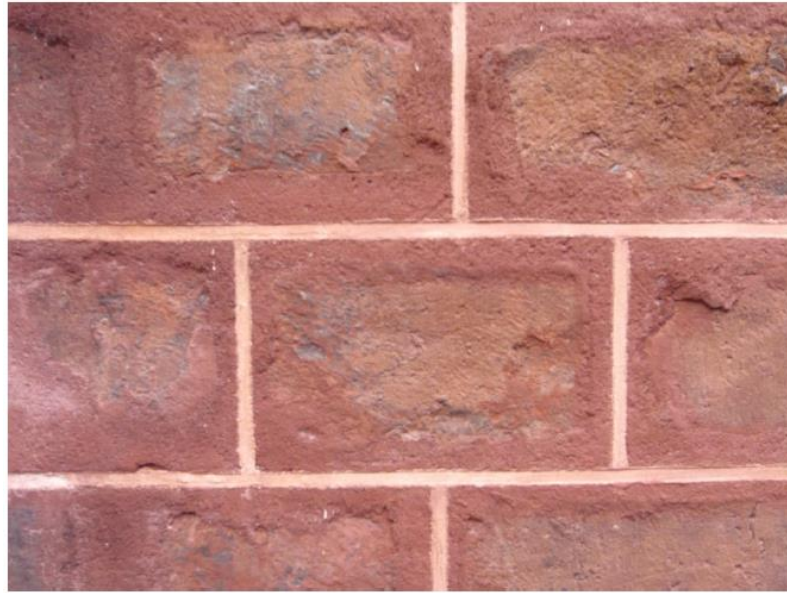
Figure 2.68: Mortar repair of degraded bricks [24]

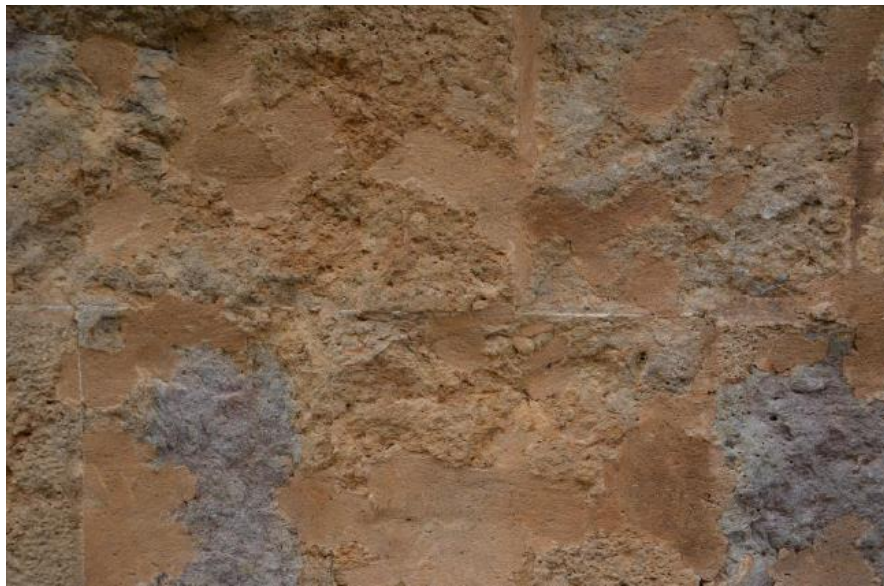
Figure 2.69: Mortar repair carried out on multi-coloured degraded sandstone blocks
Palazzo Piccolomini, Pienza, Italy [24]

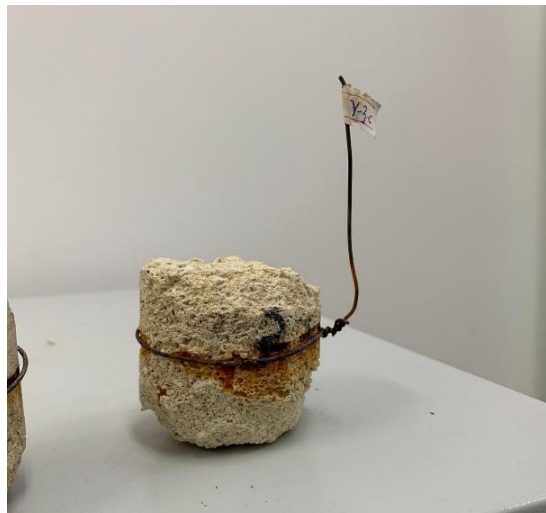
Figure 3.7: sample Y-3-C after 15th cycle

Y-1-C	279,679	282,804	198,814	-30,03	Group Y -17,24 (also 2 samples broke up before Cycle 15)
Y-1-E	266,741	270,282	238,559	-11,89	
Y-2-B	345,421	348,556	Cycle 12		
Y-2-C	324,831	327,88	Cycle 9		
Y-3-C	318,999	322,217	263,769	-18,32	
Y-3-C	308,488	312,020	285,171	-8,70	
E-1-A	361,600	365,500	338,698	-7,41	Group E -7,63
E-1-B	372,951	376,382	337,279	-10,48	
E-1-C	376,507	380,130	355,475	-6,55	
E-2-A	275,979	279,842	279,181	-0,24	
E-2-B	287,250	290,505	288,425	-0,72	
E-3-C	381,966	385,035	307,338	-20,34
