**Seismic Vulnerability Assessment
In Vernacular Houses:**

The Rapid Visual Screening Procedure for Non
Engineered Building with Application to Java Indonesia

Doctor of Philosophy
in
Architecture

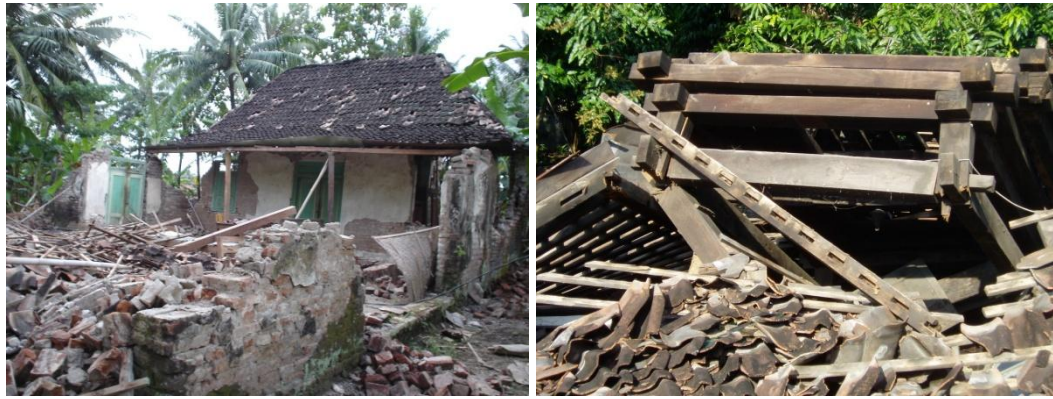
Figure 1-4 : Collapsed Houses; Brick wall bearing construction and wooden frame structure

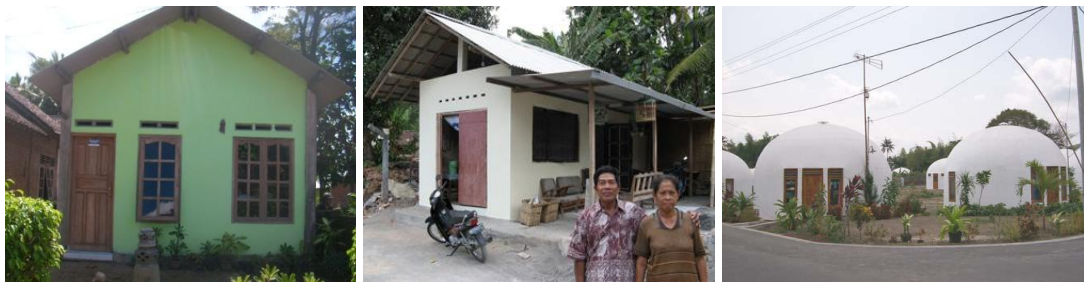
Figure 1-5: Some Results of Reconstruction House Program

In order to be less vulnerable to the quake, the proposed models for the houses were mostly based on the conventional structural systems for earthquake protection, completely new structural system, and even completely strange structure. The new built houses range from the simple light wooden structure (IAI-LBA-UII, 2006, PU, 2007), the brick-concrete frame structure (Sarwidi, 2006; Widodo, 2007; PU, 2007), to the ‘teletubbies house’ concrete-shell dome structure (DFTW, 2007).

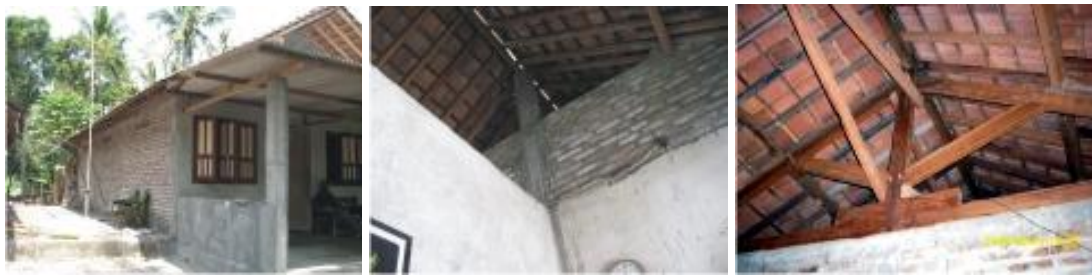
Figure 1-6: Some varieties in detail of New Reconstruction Houses

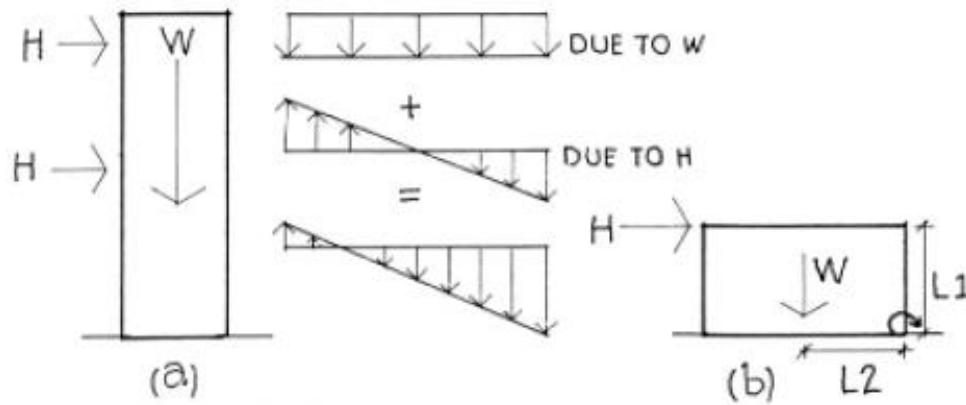
Figure 2-3: Effect of horizontal and vertical loads combination. Net overturning moment = $(H \times L_1) - (W \times L_2)$. (Ghaidan, U., 2002)

If strong earthquake causing high ground motion occurs under a building, it sets the building in trembling from its foundation transfers throughout the rest of building in complicated way. This dynamic displacement of the soil where building located causes lateral and vertical force on the building. Lateral movements are the most damaging effects on the buildings. Vertical forces due to shaking are usually less significant (Hamburger, R and Scawthorn, C 2006), yet for buildings located near to the epicenter. While buildings are traditionally built for gravity or vertical loads, earthquake bring horizontal force by certain acceleration will destroy the building. The vertical gravity effects and the lateral effects combinations of the of earthquakes will cause overturning moment of the building (see figure 2-3).

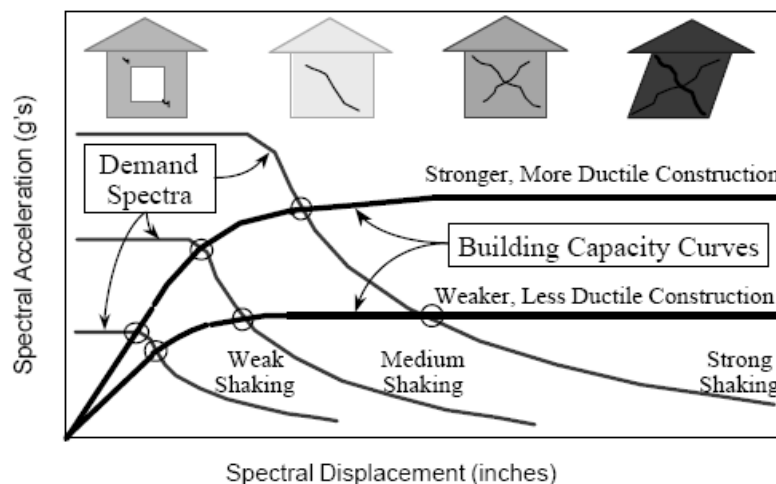
Figure 2-6: Example Intersection of Demand Spectra and Building Capacity Curves (FEMA, 2003)

Capacity curves and fragility curves are the two main aspects for the functions of damage in ground tremor (FEMA, 2003). The capacity curves are examined regarding on engineering principles that illustrate the nonlinear behavior of building types. All aspect related to the potential damage including structural system, nonstructural components but sensitive to drift, and nonstructural components sensitive to acceleration will be considered in the fragility curves. The curves distribute damage between four physical damage states: Slight, Moderate, Extensive and Complete.

Regarding to the earthquake intensity, the figure of spectral acceleration of ground motion of earthquake can be intersected. Higher acceleration in earthquake will always associated to bigger displacement of the building. Stronger and more ductile

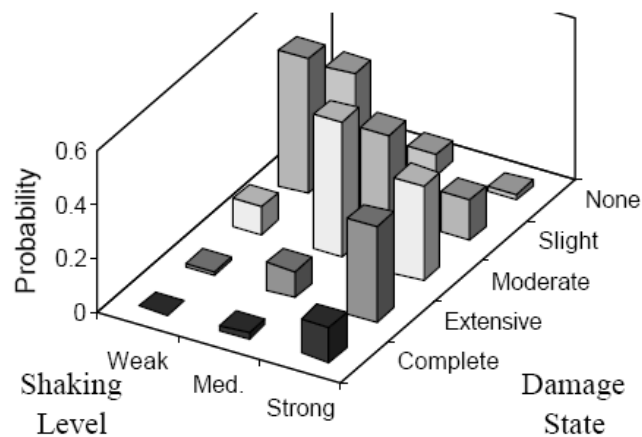
Figure 2-7: Example Damage-State Probabilities for Weak, Medium and Strong Shaking Levels (FEMA, 2003)

structure will displace less than weaker and less ductile one (see figure 2-9). The probability related to the shaking level and damage state then can be seen in figure 2-10 where the stronger the earthquake, the higher damage level is expected.

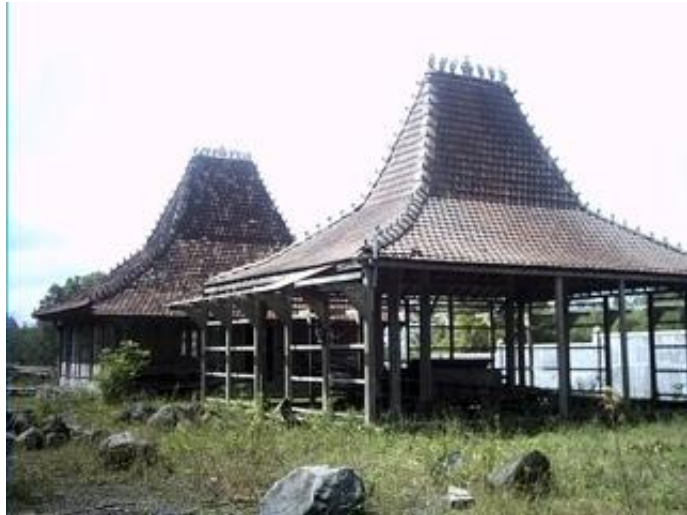
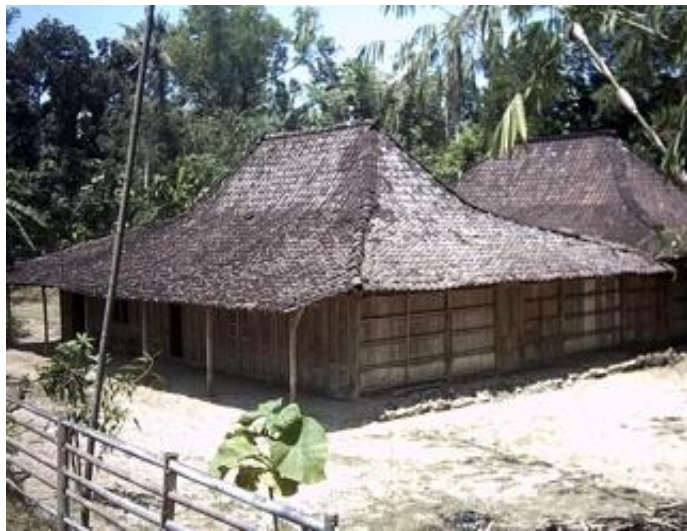
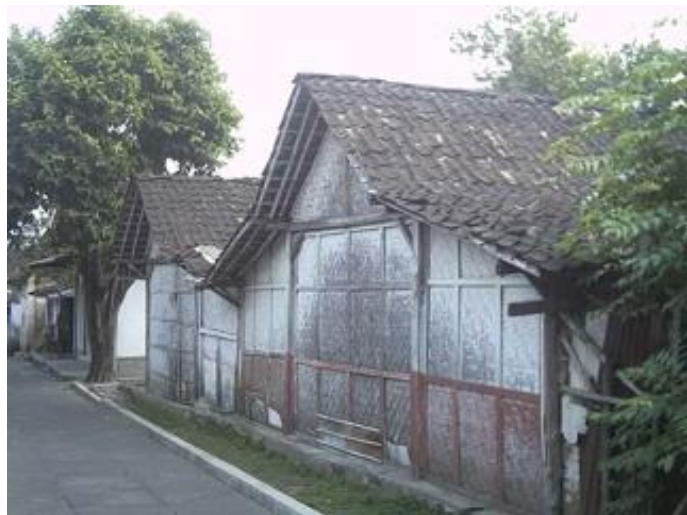
Figure 3-2 Original Javanese *Joglo*, *Limasan*, and *Kampung* types with clay roof tiles and wooden materials ranging from hardwood to bamboo (Idham, N., *et.al*, 2010b)

Traditional houses known as *Joglo, Limasan, and Kampung*. All main structural system members are constructed with wood, including hardwood, coconut palm tree wood, or bamboo. The use of wooden planks or woven bamboo was a common material used for walls, wooden tiles or thatch also was used for roof construction, but it is not any longer.

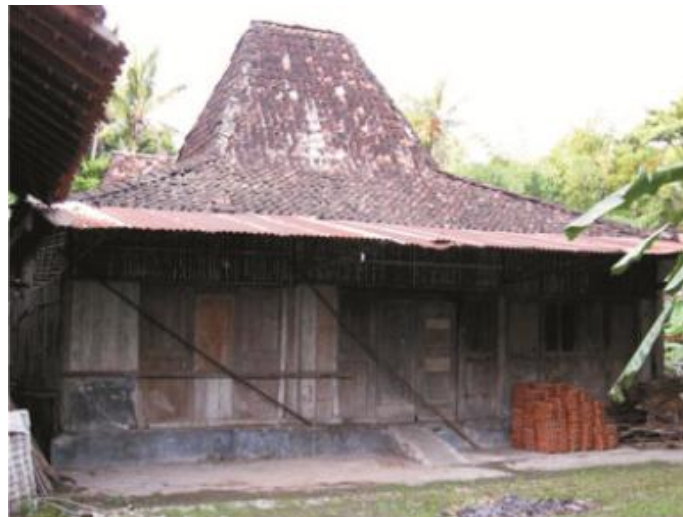
Figure 3-3: Survived Javanese traditional house *Joglo* after the May 27th earthquake

Houses are relatively large and are composed of more than one unit depending on the wealth of the owner. However, these types are rarely built for new houses nowadays although they still exist belong either to a rich owner, who still wishes to maintain his/ her status/ position in the towns and cities, therefore constructs the classic *Joglo*, or to villagers who live in remote area and require simpler wooden housing (see figure 3-2). In relation to the earthquake, these houses proved to be safer as a result of the use of lightweight materials, thus providing a more flexible structural system (figure 3-3).

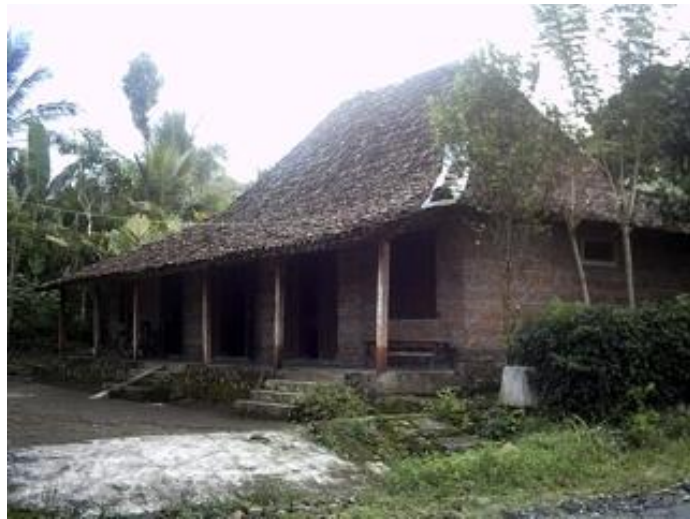
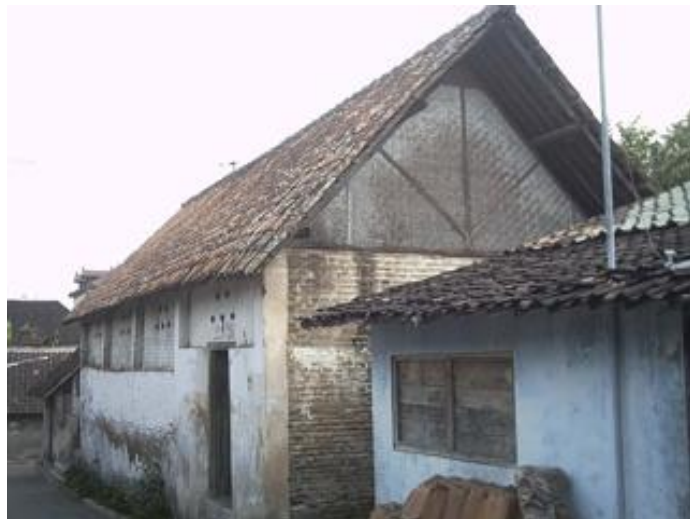
Figure 3-4: Old Culture houses Javanese *Limasan* and Javanese *Kampung* with masonry bearing wall structure (Idham, N., *et.al*, 2010b)

Traditional houses constructed by newer materials was popular for the Javanese since the people had the opinion and judgment that brick-walled houses are related directly to the wealth of the owner. In recent times, we can still easily find these houses throughout Java Island (figure 3-4). Unfortunately, the use of low quality heavy bricks for the construction of the bearing wall was one of the main reasons for the collapse of houses during the earthquake. It is also believed to a main causal factor for the high number of fatalities.

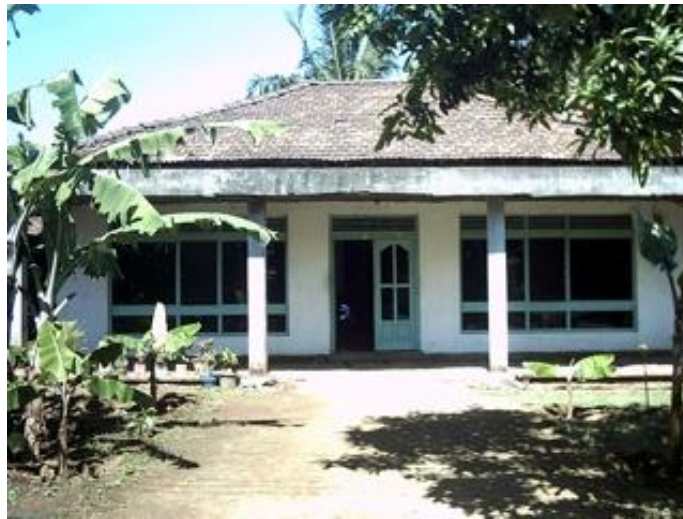
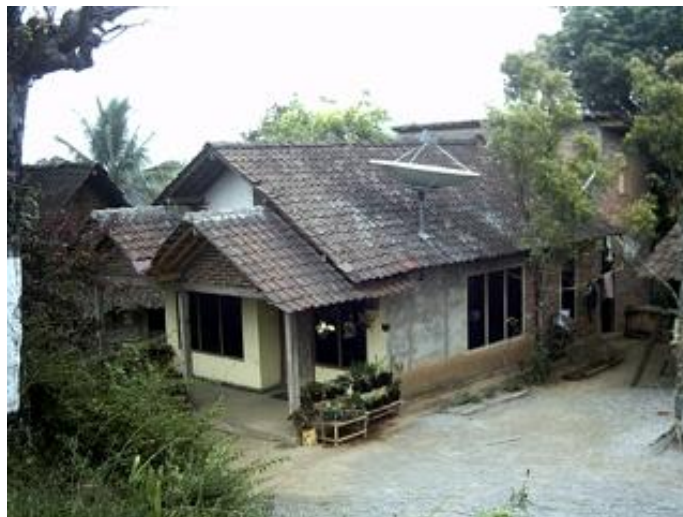
Figure 3-5: New Culture types: Combined hipped roof, hipped roof, and gable roof with a reinforced concrete frame structure (Idham, N., *et.al*, 2010b)

New culture type is used for contemporary or modern-vernacular type houses. Brick wall combined with a reinforced concrete (RC) frame structure is the common structural system of the houses. Ceramic roof and floor tiles are other important materials used. The size of the houses is mostly smaller than the two types described above (pure tradition and old culture types).

The form of the new culture type construction is also simpler. This type of housing was developed sharply between the 80's -90's when Portland cement and steel bars started to be widely used (figure 3-5). Unfortunately, a mixed application of the old

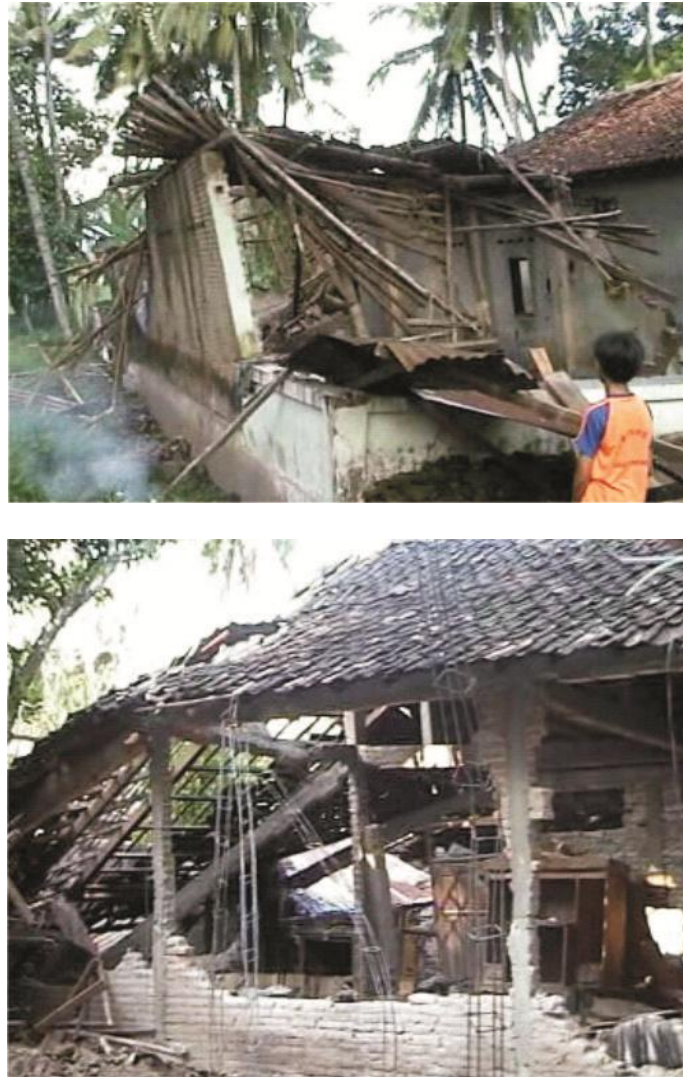
Figure 3-6: Sample of Destroyed houses from the 2006 earthquake; pure traditional, old culture, and new culture (Idham, N., *et.al*, 2010b)

and new was widely practiced. During or after the earthquake, many houses were collapsed or badly damaged as a result of weak connections and poor or quality of both the materials and the construction methods used (figure 3-6). The use of heavy material, which was applied also for the older houses, resulted in high numbers of casualties and fatalities.

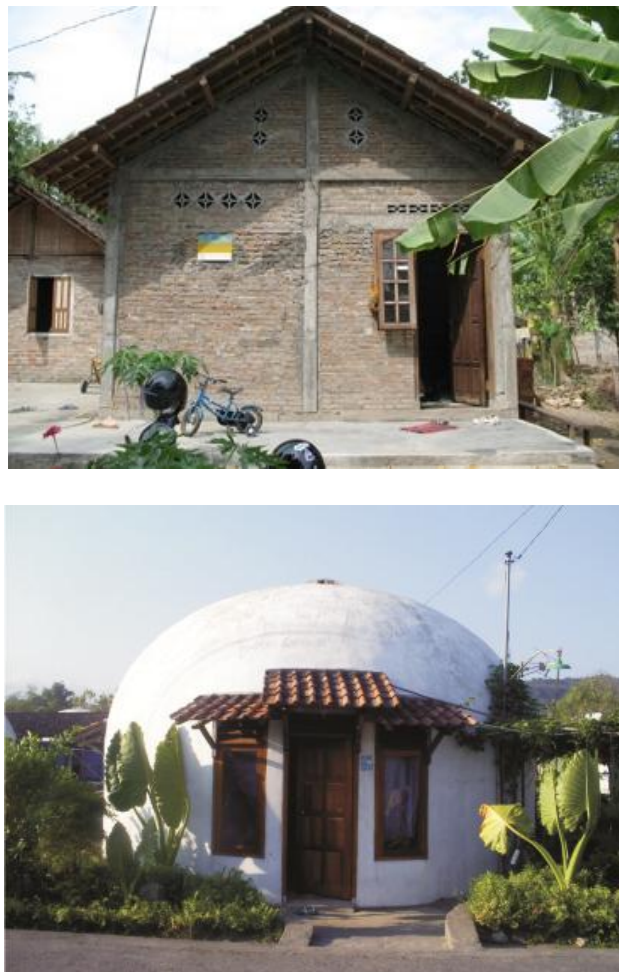
Figure 3-7: Reconstructed Houses: An ordinary - reinforced concrete frame structure and the unusual domed or shell-shaped structure

Reconstruction houses were built after the 2006 Java earthquake. They are constructed mostly using brick walls and a more complete reinforced concrete confining/framing system. Since the majority of collapsed houses had been rebuilt

within a limited time and budget, it was common practice to build a very simple, small house using a simple construction form, known as a core house (figure 3-7). These core houses vary in size (e.g. 18 -20 square meters). People have to extend the core houses according to their needs and financial budget. In one case study of this issue Ikaputra (2008) found that almost all core houses had been extended by up to 97.22%.

The strange reconstruction houses as a shell- shape or domed house was also built in the affected area (see figure 3-7) built by a DFTW (Dome for the World) donor. Seventy-one new units of this type were built to replace the destroyed village of

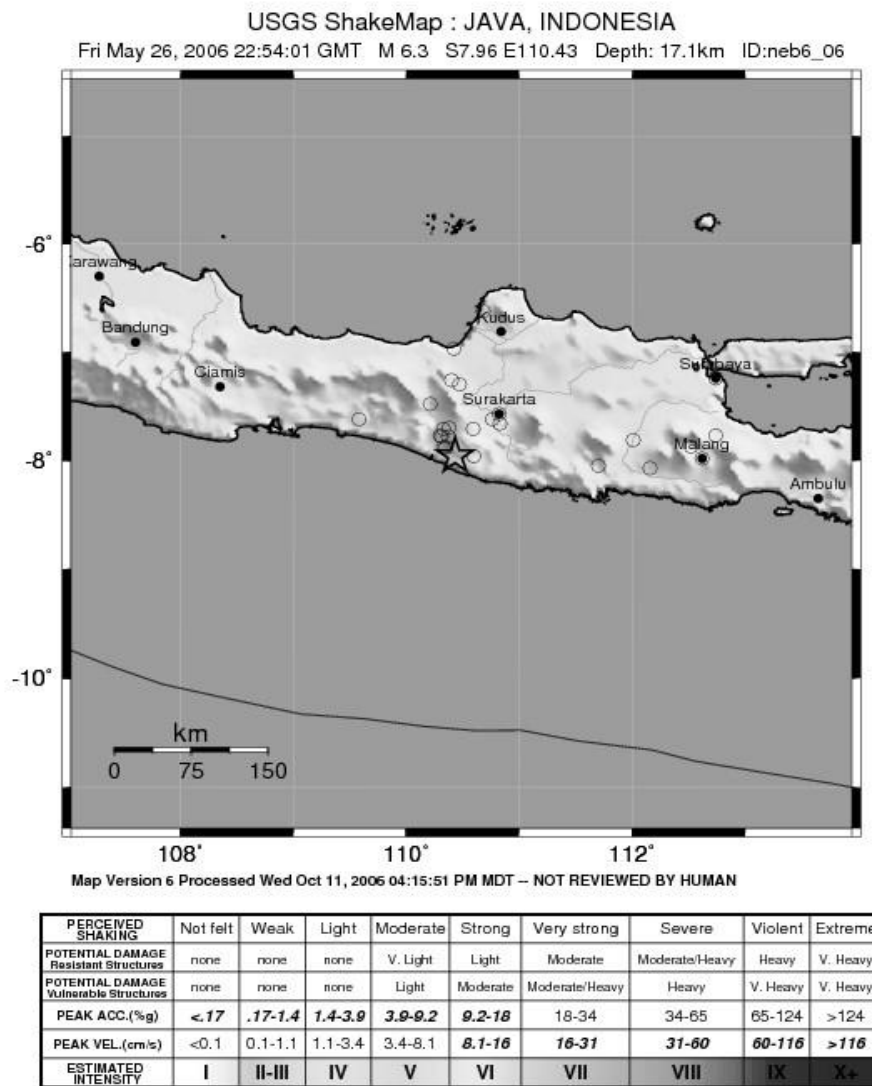
Figure 3-9: the May 27th, 2006 Java Earthquake Intensity (earthquake.usgs.gov)

The earthquake struck at 5:54 local time on May 27, 2006. The magnitude was 6.3, and the location coordinates were 7.962S-110.458E, with a focal depth of 10 km (6.2 miles) (USGS 2006). The distance from the epicenter was 20 km SSE of Yogyakarta which was severely affected and 455 km ESE of Jakarta. The intensity felt in the most affected area was up to IX MMI (figure 3-9).

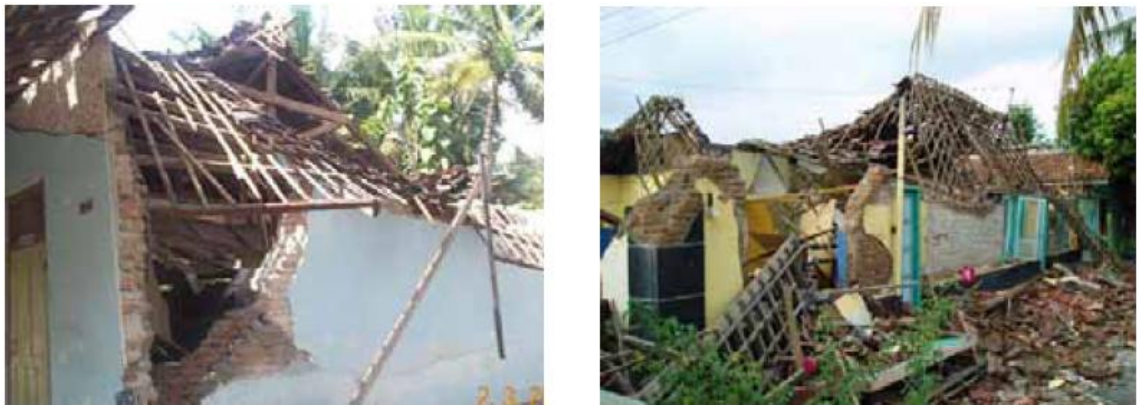
Figure 3-12: The destroyed masonry thick walled (old culture) (Boen, 2006)

Javanese houses were rigorously affected by the earthquake, more than 7 percent of the house population damaged in the six affected areas and in some villages in the most destructed area, about 70-90 percent of the houses were totally collapsed (EERI 2006, BAPPENAS, 2006a) (figure 3-12,13). Beside the unusual seismic data above, the factors causing the failure of Javanese house can be affected by: the epicenter

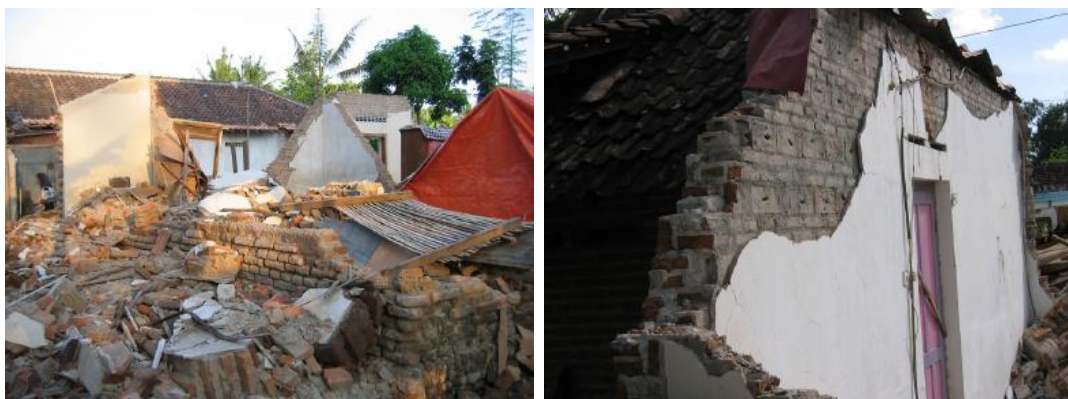
Figure 3-16: The most destroyed houses by weak unreinforced masonry wall (EERI 2006)

The houses structures were very weak and built without earthquake consideration. According to Boen (2006), the houses collapsed from Java 2006 were mostly built by masonry either with or without reinforced concrete confined-frame. However, most of the deaths and injuries were mainly caused by the collapse of unreinforced masonry buildings (EERI, 2006) (see figure 3-16). The weak masonry was the main factor to collapse of the building while for the newer with reinforced concrete; improper connection is the most aspect of structural failures. The most salient damage features of non-engineered buildings according to MAE were (Elnashai, A.S., *et.al*, (2007) :

- 1) Failures at corners of walls and at doors and window openings
- 2) Roof system sliding off the supporting walls
- 3) Shear, flexural or combined cracking of masonry brick walls
- 4) Failures at connection regions between roof, wall and foundations

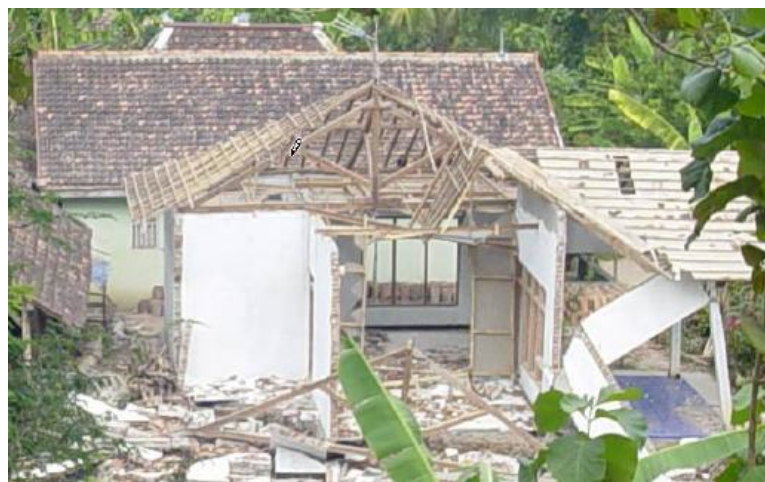
Figure 3-17: The destructed modern-vernacular type of Javanese Houses (Elnashai, A.S., *et.al*, 2007)

5) Heavy roof structure by using reinforced concrete trusses. This type of roof structure is easily found in newer houses and proven to contribute the heavily failure of the houses. Some houses have an open frame (no shear wall) for functional reasons such as for store or garage.

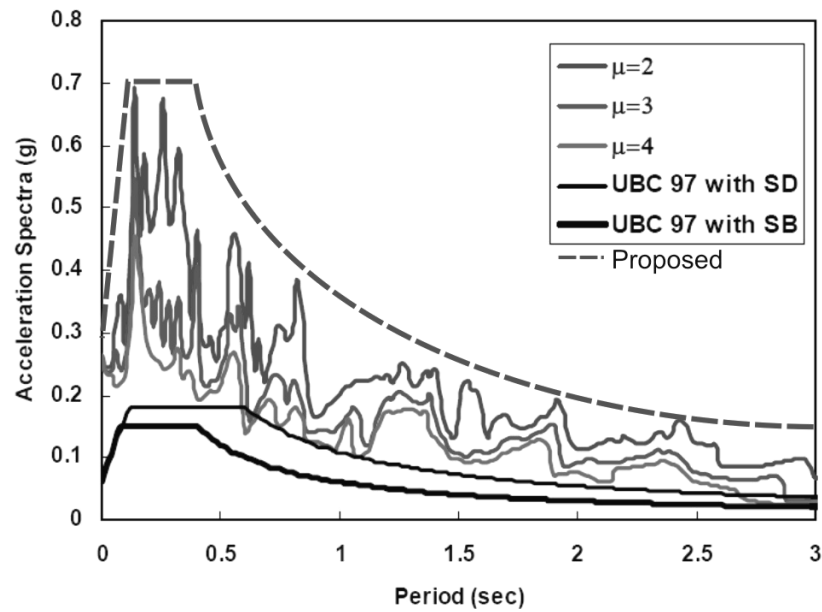
Figure 3-18: Demand Spectra Proposed after the May 27th, 2006 Java Earthquake (after Elnashai, M.A., *et.al* 2007)

In order to have a proper simulation, the May 27th 2006 Java earthquake properties including duration, amplitude or the level of displacement, velocity and acceleration, and also frequency data were identified and used for shaking parameter. Data were gathered from some resources including BMG, USGS and MAE (Elnashai, M.A., *et.al*, 2007) was inserted to the computer software to generate the actual movement simulation to the objects. The response spectra used here was according the May 27th 2006 Java earthquake. It showed that the maximum affect should be considered in earthquake simulation is even 3 to 4 times higher compare to the international code (UBC) used (see table 3-18). Time history method was also utilized in order to support the result of study.

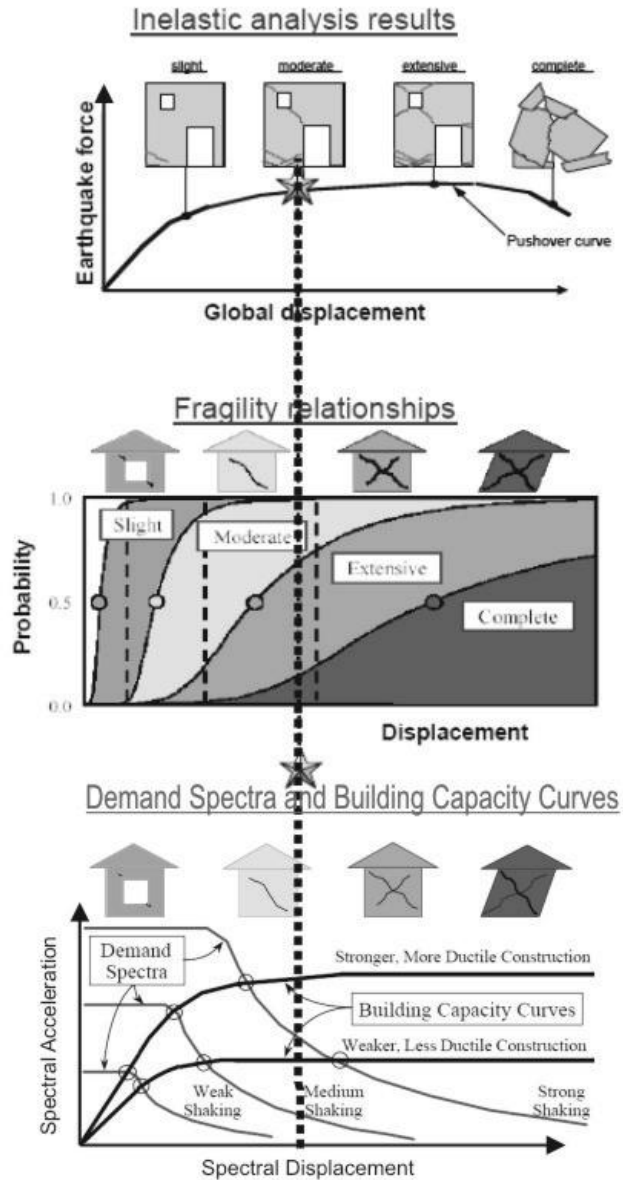
Figure 3-20: Building Capacity, Inelastic analysis, Fragility curve, and Demand Spectra relationship

In order to define the level of accepted damage level, building capacity curve is correlated to other aspects such as fragility and demand spectra figure (see figure 3-20). Fragility curve represents the probability displacements among the least to the most fragile level, while demand spectra decide in what displacement accepted from ground movement (acceleration) level. If maximum tolerable damage is putted in all figures, correlation among these charts will appear. For the moderate damage, fragility curve shows the moderate level in high probability under quake, and demand spectra shows the higher acceleration will need less displacement or stronger and more ductile building. 60 percent destructed is considered as the major damage as limit state for life safety (FEMA, 1988b).

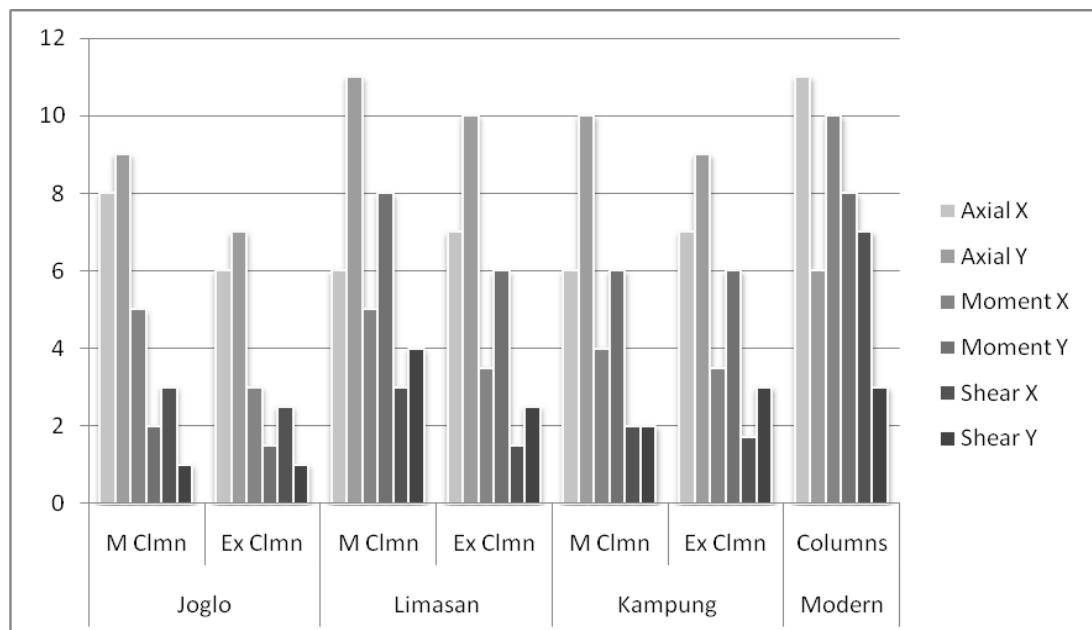
Figure 3-23: Combined forces resulted from four Javanese houses types by RC frames (in Ton)

frame but RC frame is used more instead. For this purpose, RC frame were also examined. The result is, unfortunately, Modern-vernacula type by complete RC frame both columns and roof frames, received very high loading and significantly higher compare to others. *Joglo* has the lowest followed by *Limasan* and *Kampung* (see figure 3-23).

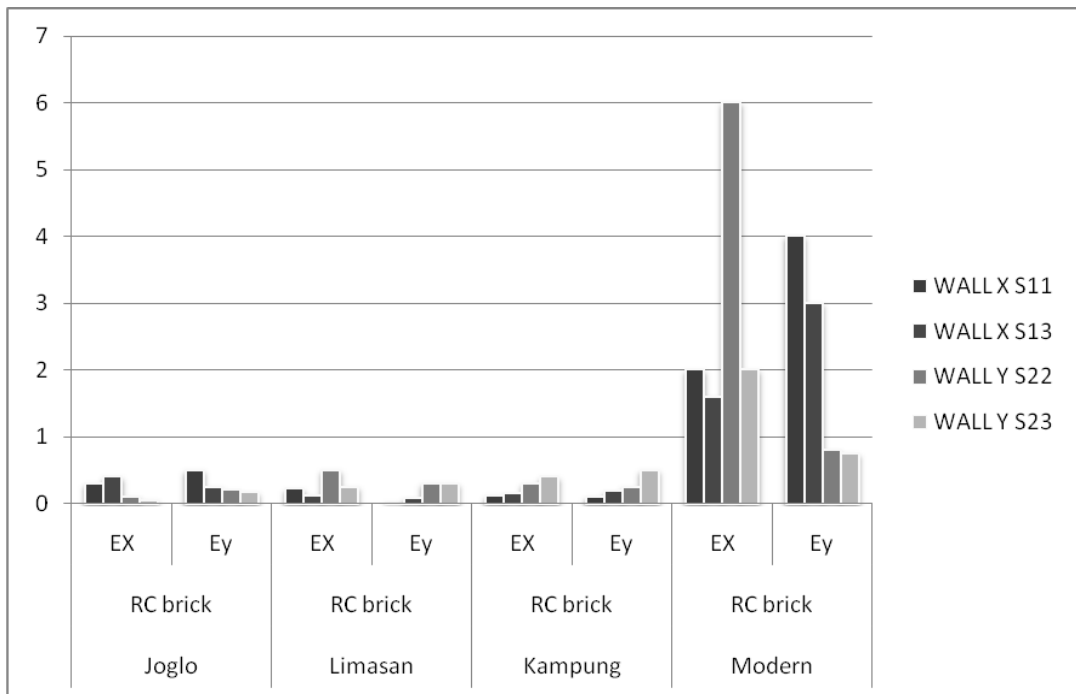
Figure 3-26: Comparison of stresses in RC brick walls between type of structures of the house (in Mpa)

The examination regarding level of the stress on the wall had been done for infill brick wall, masonry bearing wall, and RC frame brick wall. These three figures are important to define the influence of the wall for contributing the performance of the houses. Since walls were blamed for contributing the damages and casualties in the earthquake. Despite to the structural system type, the wall examinations show that heavy brick wall had high level of stress since it has high mass which trigger to accumulating the lateral force of the quake. This is the reason that masonry wall bearing house is not suggested to be constructed in the high seismic area. Comparing the masonry wall in the houses, *Kampung* has least performance compared to *Limasan* and *Joglo* (figure 3-25). Even if combined with frame, especially RC frame, the brick wall had the highest stress (see figure 3-26). This was the reason of why most *Kampung* and Modern-vernacular type house were badly damaged and collapsed in the May 27th 2006 earthquake.

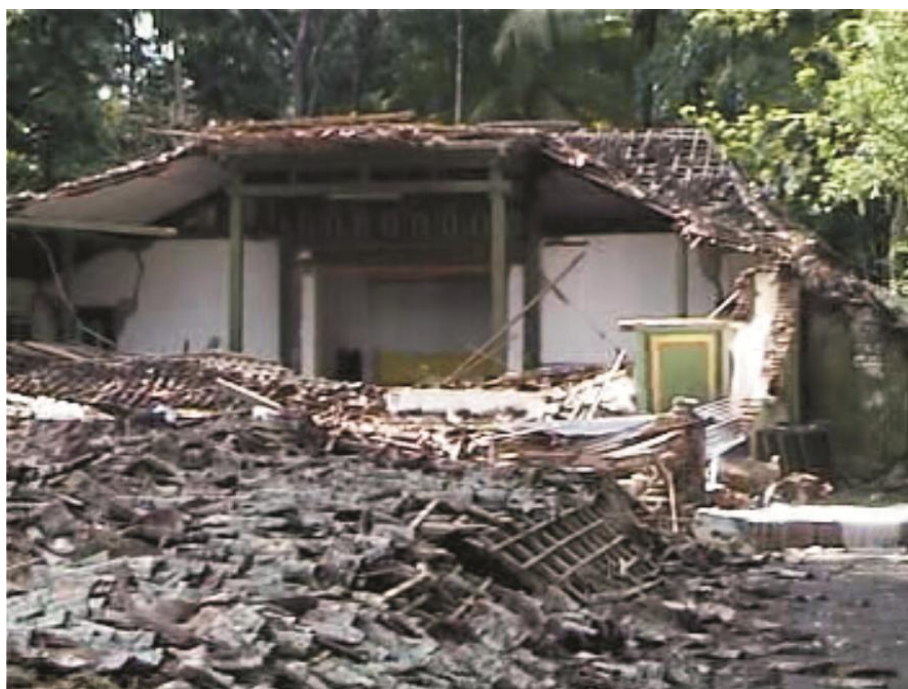
Figure 3-27: The remain standing four main columns *Saka Guru*

The four main columns in the central space for the three houses are the main structural properties of the houses. These main columns traditionally have main function to support the main space of the house in the central area of the building. The columns have a significant role in supporting the dead load of the building and acting as a ‘core’ of the house. Many studies consider only on these main four column *saka guru* and claimed as the main part of the houses to diver the earthquake force (Prihatmadji, Y.P., 2007; Maer, B.W., 2008).

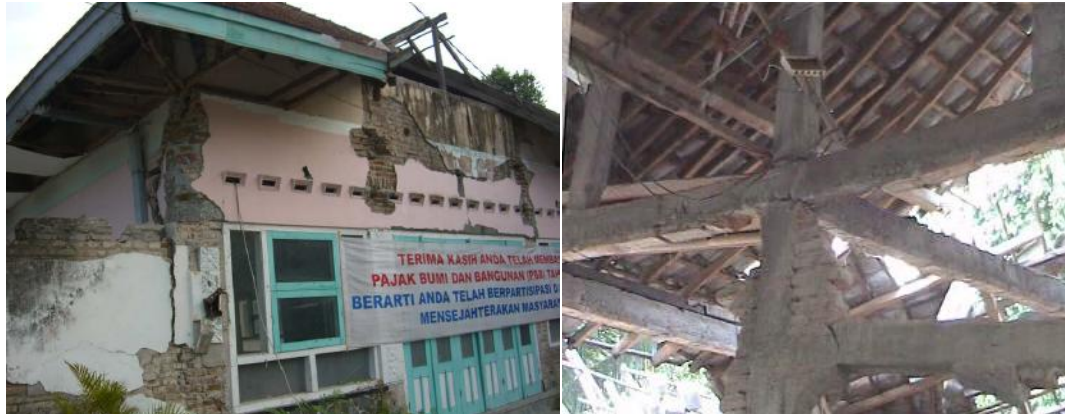
Figure 3-28: Damages on modern-vernacular type of the houses constructed by masonry and RC frame

However, the use of RC frame has somehow been exaggerated. The house which is completely built by RC frame with brick wall both for main and roof structure can be easily found even for the post earthquake houses. This brought the performance under the earthquake has jumped to the lowest one. Heavy RC material altogether

with massive brick wall gives more thrust to the frame and high displacement will occur. Confine RC which is common by 15 x 15 cm² most probably would not accommodate the load and the houses will easily collapse (see figure 3-28).

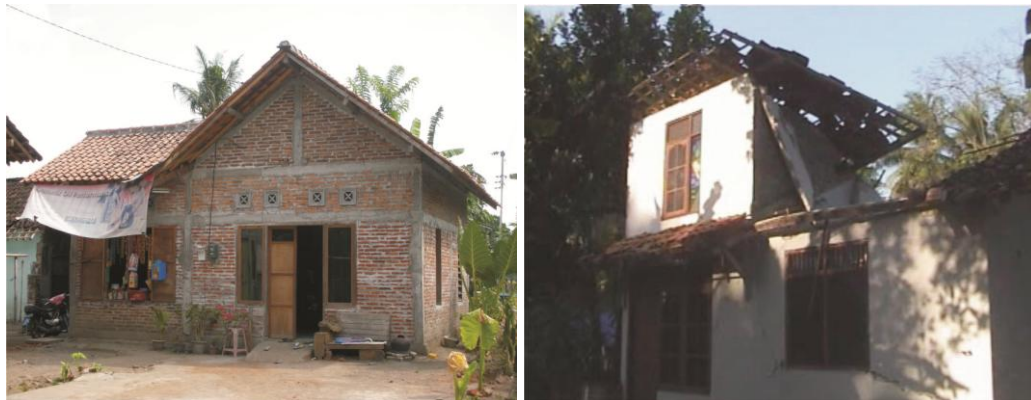
Column in single story building is mostly practical column as frame located between conjunctions of two or more walls. In some case especially in modern-vernacular type houses, column is easy to absent because of complicated room arrangement or just because of additional room with similar or different material. Missing column will directly decrease the compactness of the building (See figure 3-32).

Figure 3-32: Missing column sample and the sample result from earthquake

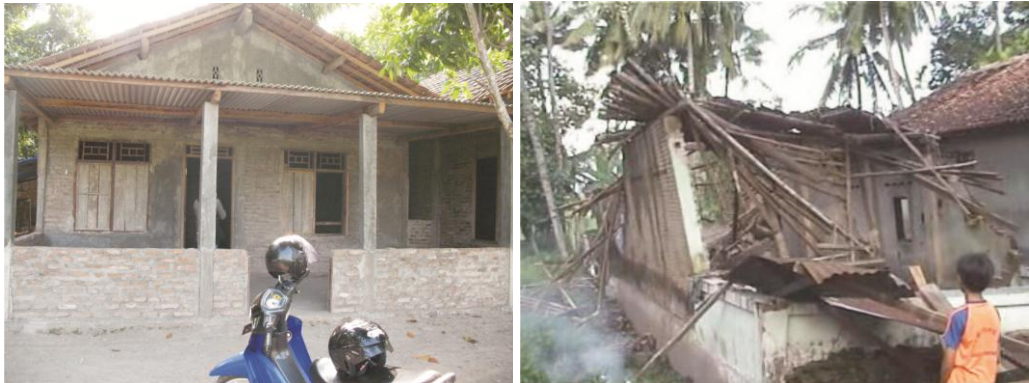
It was commonly found that using a PC column without following by horizontal frame or beam. Without beam tie, frame then act not as a frame anymore since there is no unity in reaction to the quake (see figure 3-33).

Figure 3-33: House sample without beam and the result from earthquake

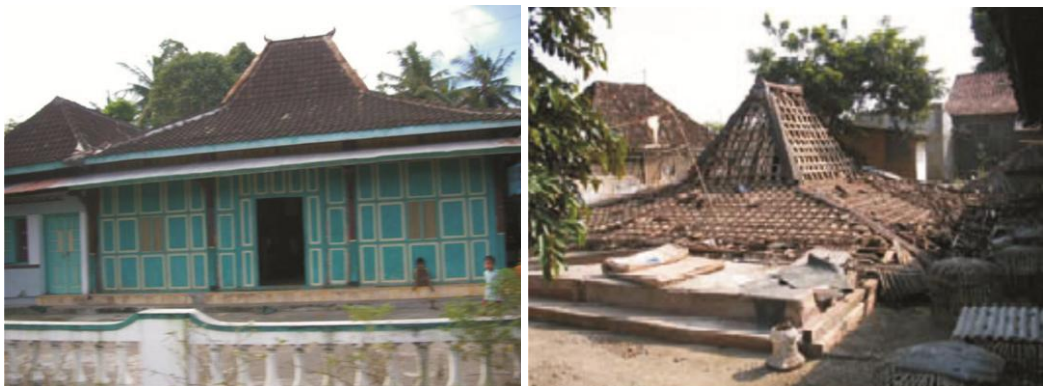
For tropical house, the absence of outer wall is practical to be used for eliminating the humidity in the room. The wall surrounding even though not as a main structural element will increase the rigidity of the building (figure 3-34).

Figure 3-34: Traditional house with and without envelope wall after earthquake
(right photo: Maer, B.W., 2008)

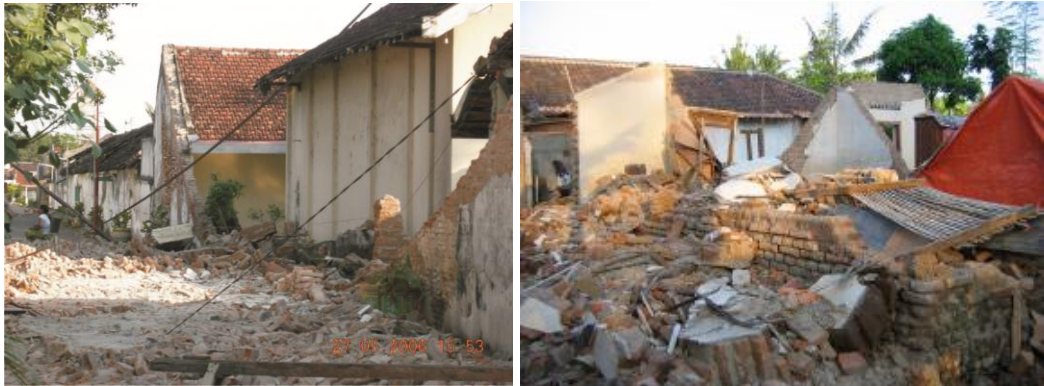
Heavy wall here is pointed to masonry wall that to be used in traditional way without sufficient column, anchor to the column, or to the wooden frame (figure 3-35)

Figure 3-35: Masonry heavy wall failures

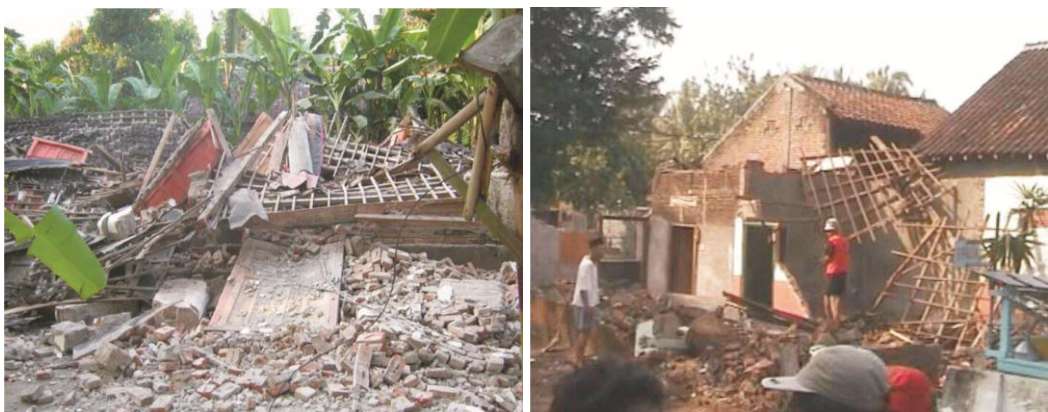
In contrary, thin wall is also suspected to the weakness of building, especially the traditional masonry houses that suppose to be has a thick wall to bear the weight of the roof (figure 3-36).

Figure 3-36: The result of thin and weak masonry wall usage after earthquake

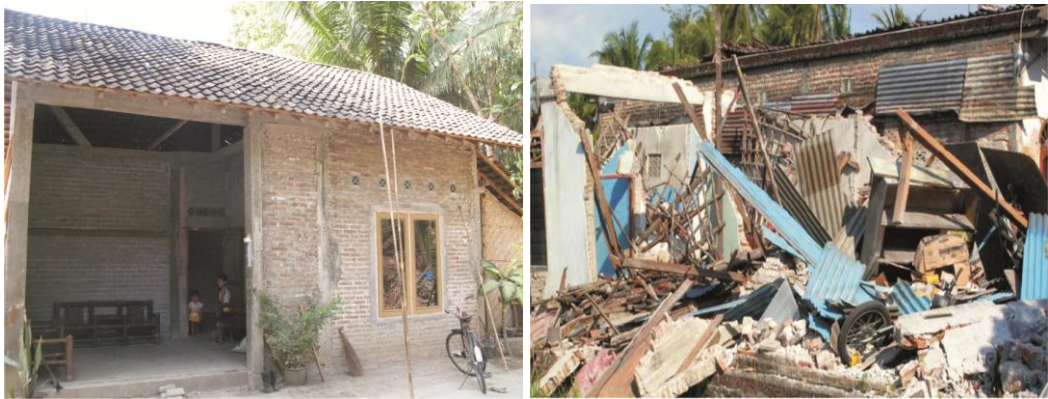
Wide opening for window or door between two vertical frames will decrease the support to the building rigidity. It also will be easy damaged and collapsed during a quake. This opening was mostly used for kiosk or garage door (figure 3-37).

Figure 3-37: Wide opening house and the result sample after earthquake

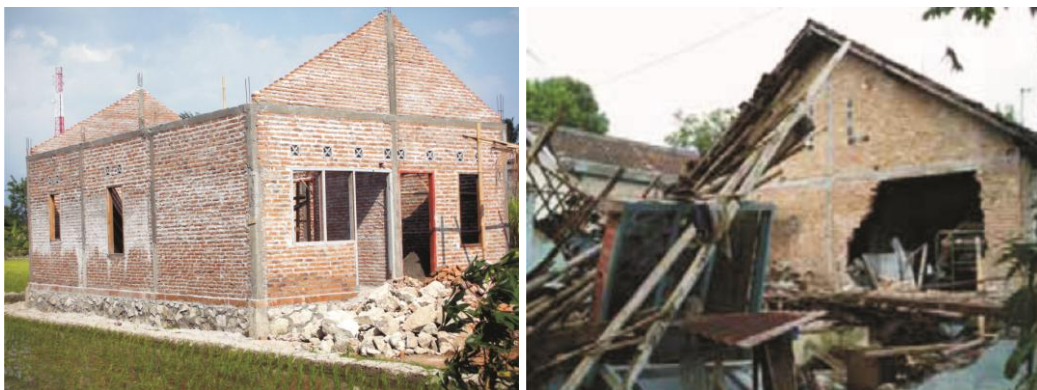
Figure 3-39: Incomplete frame for roof structure and its failure after earthquake (right photo: Boen, 2007)

Just like main structure, incomplete member in roof structure will create non-compacted roof system. The most neglected frame of the roof is commonly found

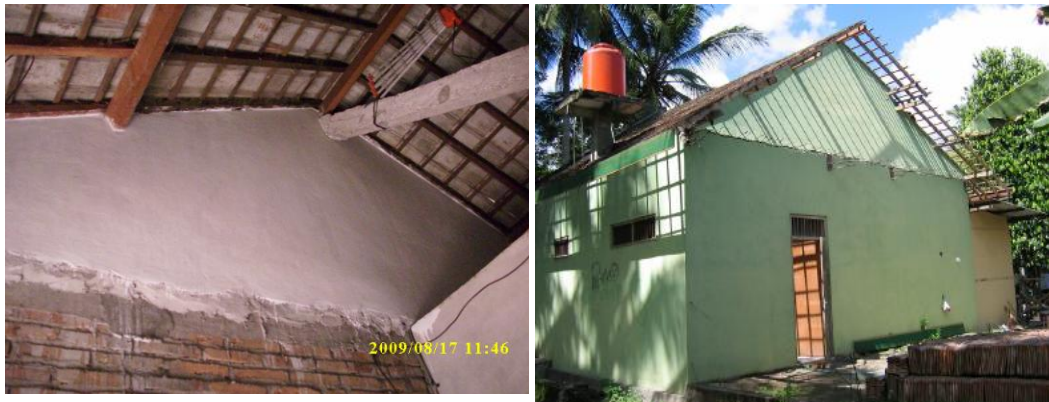
for inclined tie beam (figure 3-29). However, completely unframed or the absence of horizontal beam are also found frequently in the houses (figure 3-30).

Figure 3-40: Supported-heavy roof frame and failure of unsupported framed or the absence of horizontal beam in between of gable roof (right photo: EERI, 2006)

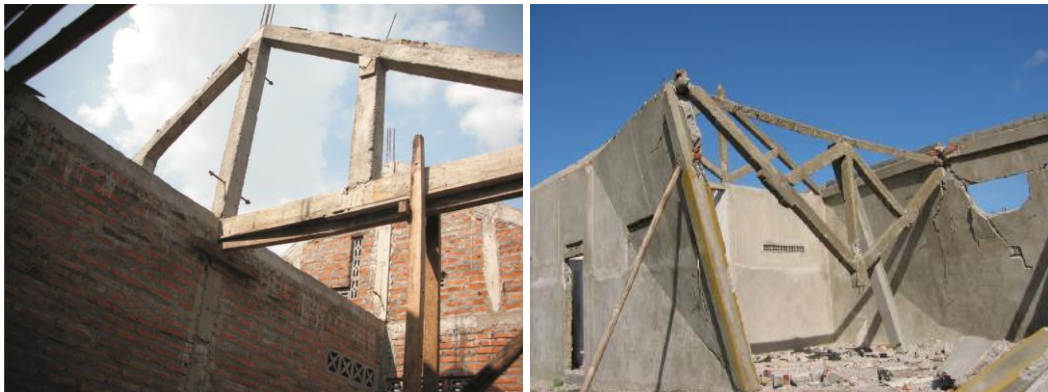
Heavy PC frame:

Using PC frame actually has been suggested due to the price of wood but exaggerated use of PC in less supported frame is always dangerous. Since the frame is heavy, the potential collapsed is high (figure 3-41).

Figure 3-41: Heavy roof frame and its failure after earthquake (right photo: EERI, 2006)

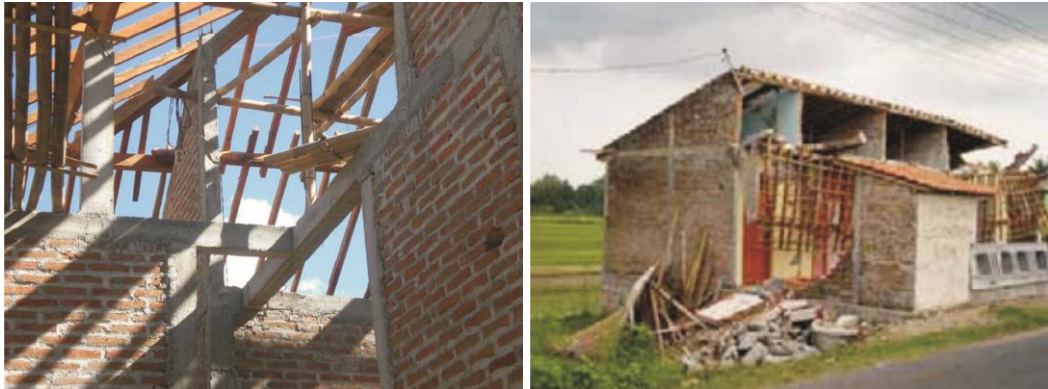
Complicated frame means the use of combined roof structure together between different material such as masonry, RC, and wood as a main structural system.

Since the material properties is different between wood, brick and RC, the unity reaction to the earthquake will absence (figure 3-42).

Figure 3-42: Complicated roof frame and result the failure after earthquake (right photo: Boen, 2007)

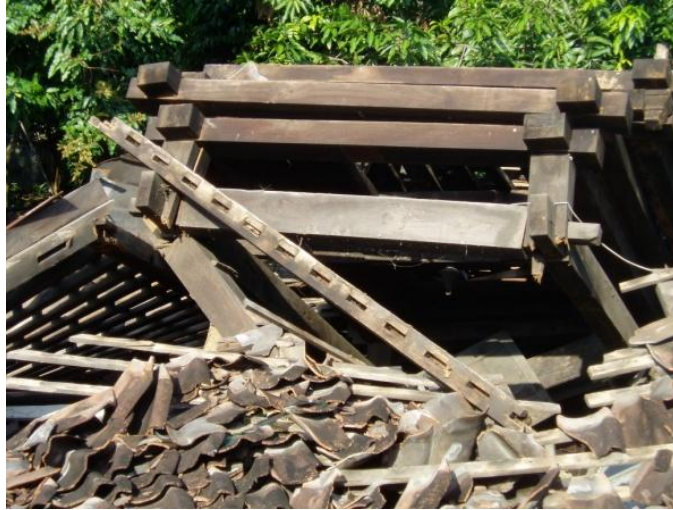
structures were found collapsed in the May 27, 2006 Java earthquake. One of the reasons was the deterioration of old or untreated wooden frame, especially in the connection where most suspected failure came from (see figure 3-43).

Figure 3-43: Connection failure of old and less maintained wooden structure

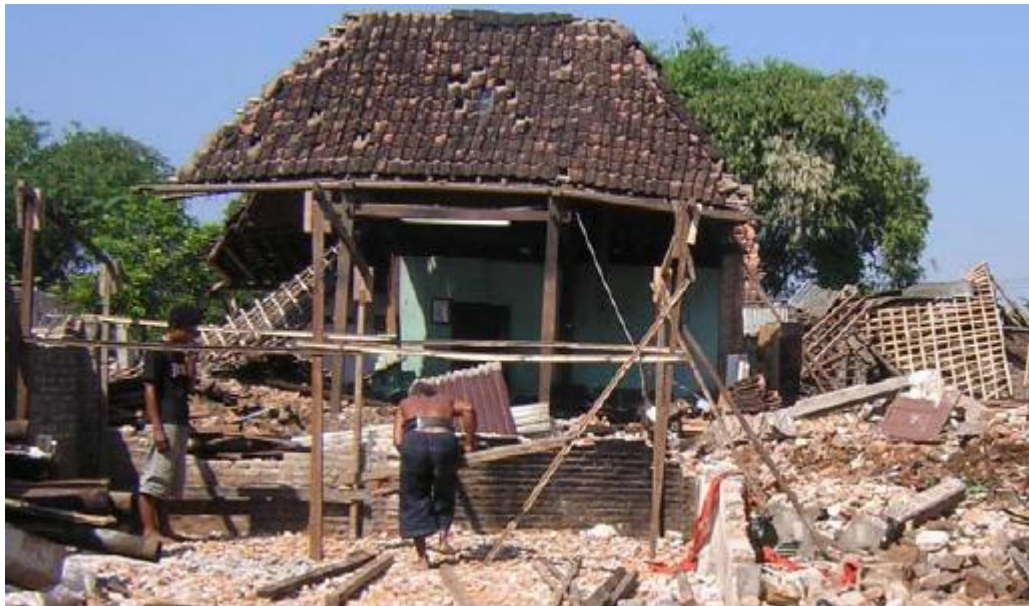
Figure 3-44. Destroyed traditional masonry house with remain four wooden columns standing (photo: BAPPENAS, 2006b)

After considering all circumstances including computer simulation and field data, instead of completely RC frame, RC main frame combined by wooden roof frame in Javanese house was commonly used for single floor house. This puts the RC frame - wooden roof frame is better than completely RC frame. Completely RC frame then considered as has ‘roof structure irregularities’ to be accounted in PMFs later. This was proved by some RC frame houses were still standing after the earthquake. Score ranges from 3 to 5 are applicable for this house type. Modification was also done for masonry type of structure where used in traditional house types. Regarding the previous similar reason, some masonry houses which uses traditional type (mostly *Joglo* and *Limasan* types), were still found standing with some degree of damage. Since the traditional houses uses the four main columns inside, the masonry then roles not as completely bearing wall for the houses. This is the reason to increase

masonry performance used by the traditional houses of *Joglo* and *Limasan* which will be used in BSM (see figure 3-44).
