**Seismic Vulnerability Assessment
In Vernacular Houses:**

The Rapid Visual Screening Procedure for Non
Engineered Building with Application to Java Indonesia

Doctor of Philosophy
in
Architecture

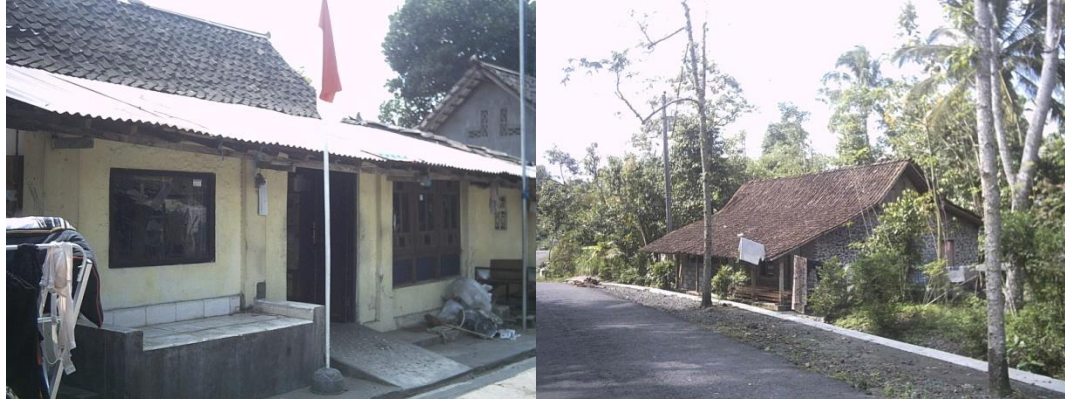
Figure 4-2: Similar *Kampung* type in Bantul before the earthquake (destroyed) and other area in Sleman after earthquake (undamaged)

The figure of Javanese house found outside the affected area from the quake are somehow similar to the houses were collapsed in 2006. Suppose that the similar earthquake occurs in that area, the damage result should not be far different from the

2006 catastrophe (see figure 4-2). Fortunately, these other houses are located in a distance such that the seismicity risk is less. For this reason, samples from outside area were only used as form reference in the previous discussion.

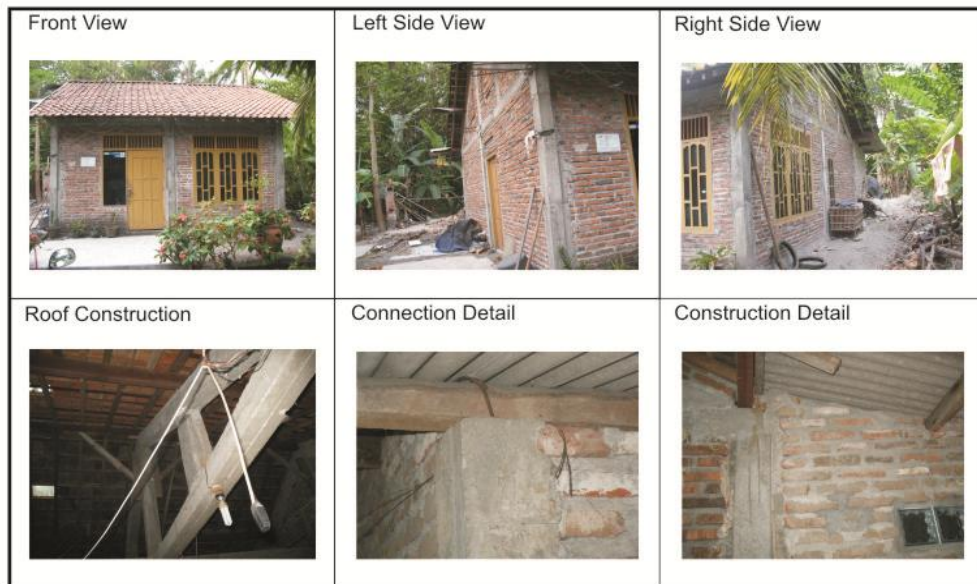
For the purpose of RVS screening, a specific form has been prepared as Java RVS. This form consists three parts main information, which are general information about house owner or user and location, drawing or photograph of the sample house, and RVS chart for examining the house. All these information is printed in single sheet of RVS examination for all seismicity area (figure 4-3).

RAPID VISUAL SCREENING (RVS) FORM	
Owner/User :	Nokerto
Location :	Paker, Mulyodadi
Data No :	1

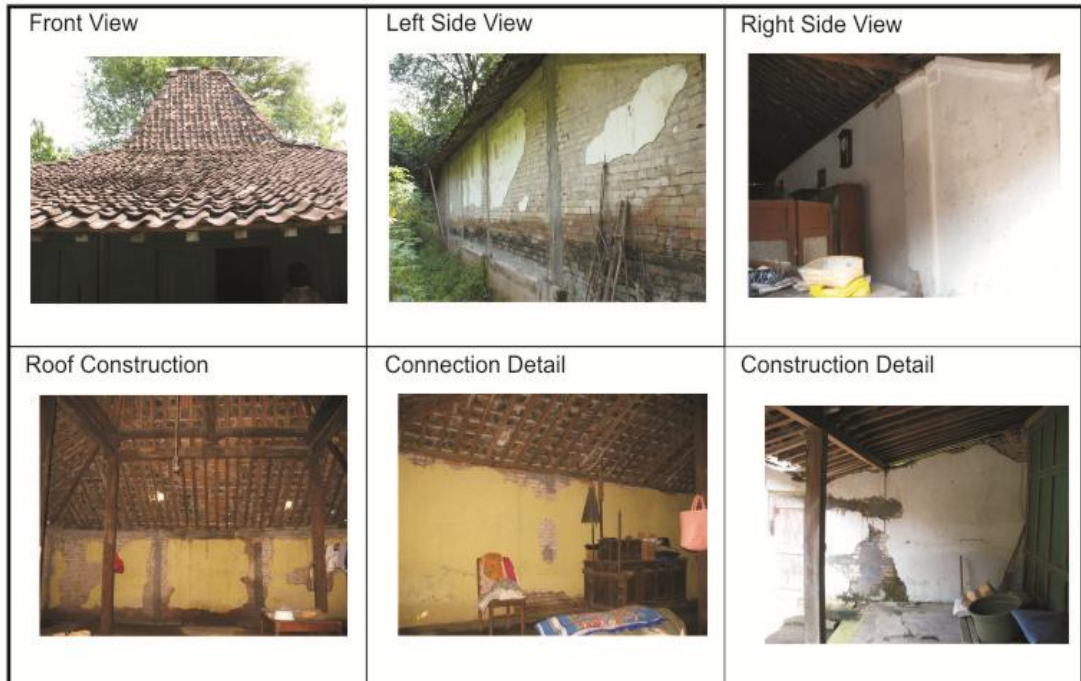
C.3. 1.6 to 2.4 scorer *Joglo* before and after the earthquake

RAPID VISUAL SCREENING (RVS) FORM	
Owner/User :	Sugeng Rahardjo
Location :	Pleret
Data No :	6

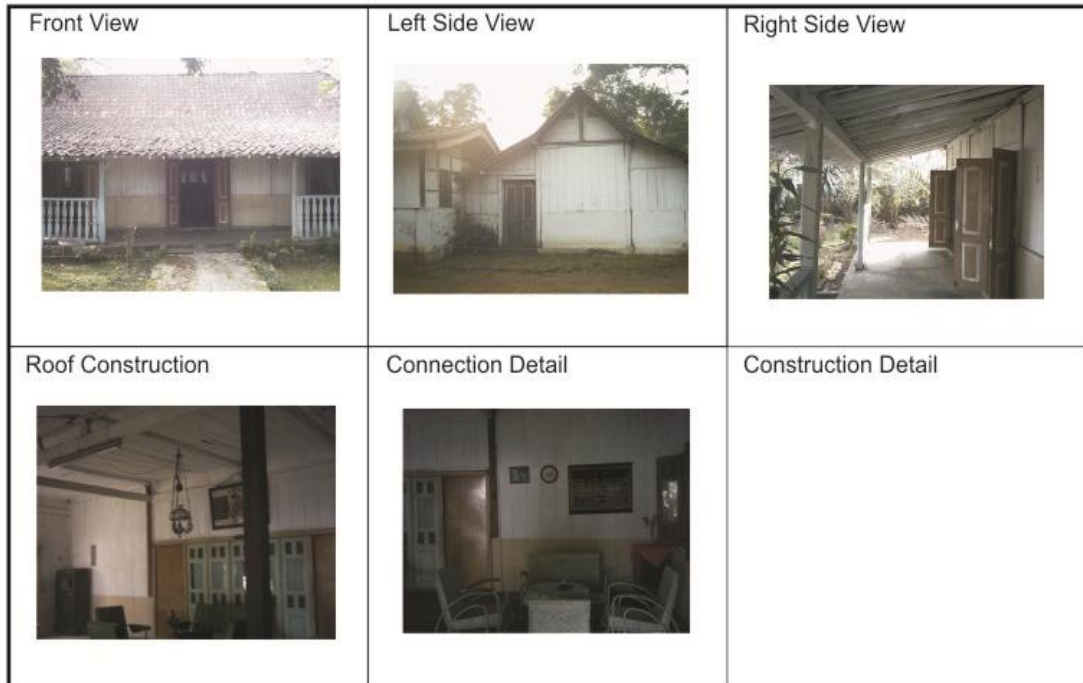
C.8. 2.55 scorer *Kampung* before and after the earthquake

RAPID VISUAL SCREENING (RVS) FORM	
Owner/User :	<i>Abdul Samad</i>
Location :	<i>Imogiri</i>
Data No :	<i>1</i>

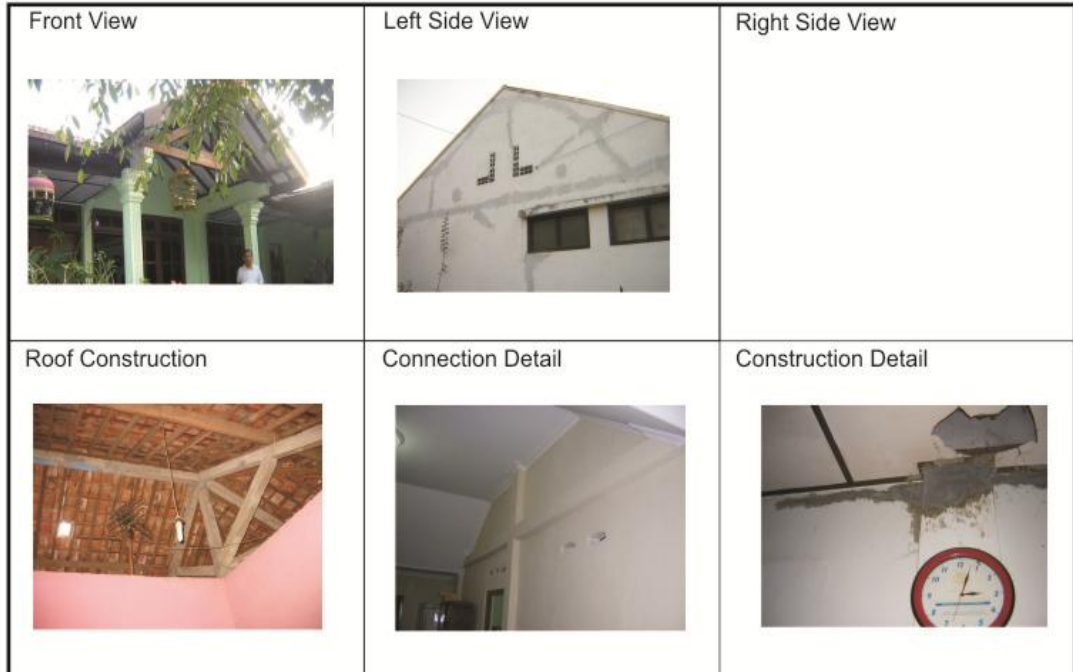
C.11. 2.25 scorer the Modern type before and after the earthquake

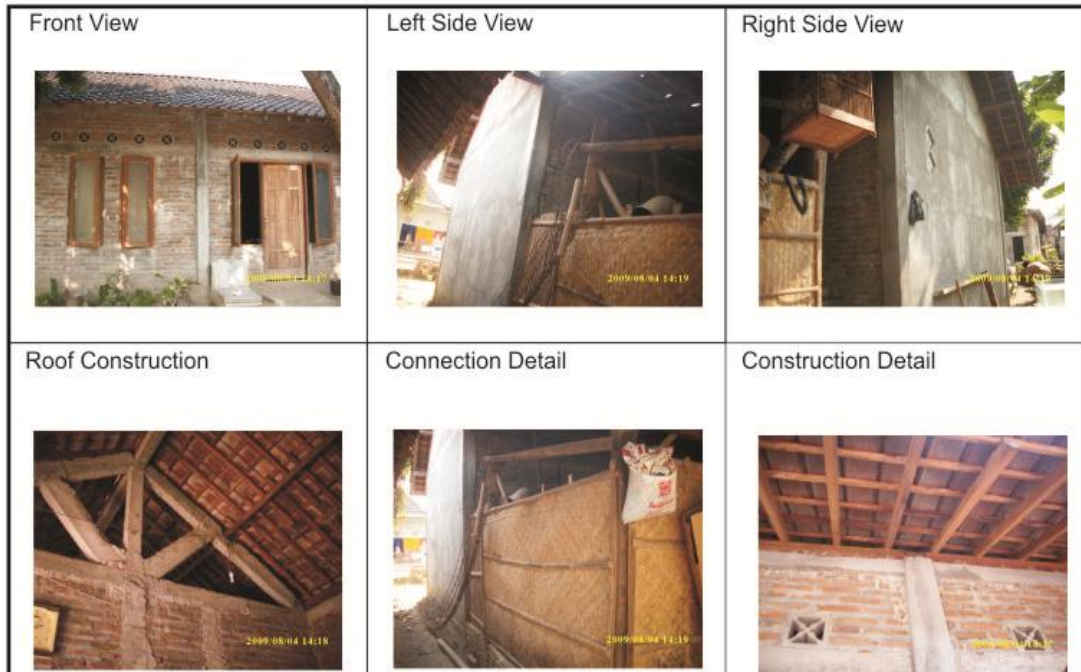
E.3. Medium score sample (1.8)

RAPID VISUAL SCREENING (RVS) FORM		
Owner/User :	Ny Tumijem	
Location :	Jetigan	Desa: Trirenggo Kecamatan: Bantul
Data No :	2

House Type:	Joglo			Limasan			Kampung			Modern		
	Low	Medium	High	Low	Medium	High	Low	Medium	High	Low	Medium	High
BASIC SCORE (BS)	8	6	5	7	5	4	6	4	3	5	4	3
BASIC STRUCTURAL MODIFIER (BSM)												
Mainly masonry wall	-4	-3	-3	-3	-2	-2	-3	-2	-2	-2	-2	-2
Mainly RC frame	-3	-2	-2	-2	-1	-1	-1	0	0	0	0	0
Mainly Wood frame	0	0	0	0	0	0	0	0	0	3	2	2
BASIC VULNERABILITY SCORE (BV)												3

PERFORMANCE MODIFIERS (PMFs)												
Soil Type	Joglo			Limasan			Kampung			Modern		
	Low	Medium	High	Low	Medium	High	Low	Medium	High	Low	Medium	High
C hard soil, soft rock	0	0	0	0	0	0	0	0	0	0	0	0
D stiff soil	-20	-20	-20	-20	-20	-20	-20	-20	-15	-20	-20	-15
E soft clay	-30	-30	-30	-30	-30	-25	-30	-25	-20	-30	-25	-20
Appearance Qualities:												
low	-30	-30	-30	-30	-30	-25	-30	-25	-25	-30	-25	-25
medium	-20	-20	-20	-20	-20	-10	-20	-10	-10	-20	-10	-10
good	0	0	0	0	0	0	0	0	0	0	0	0
Main Structure Irregularities	-40	-40	-40	-40	-40	-35	-40	-35	-35	-40	-35	-35
Roof Structure Irregularities	-30	-30	-30	-30	-30	-30	-30	-30	-30	-30	-30	-30
Total PMFs (%)												-40

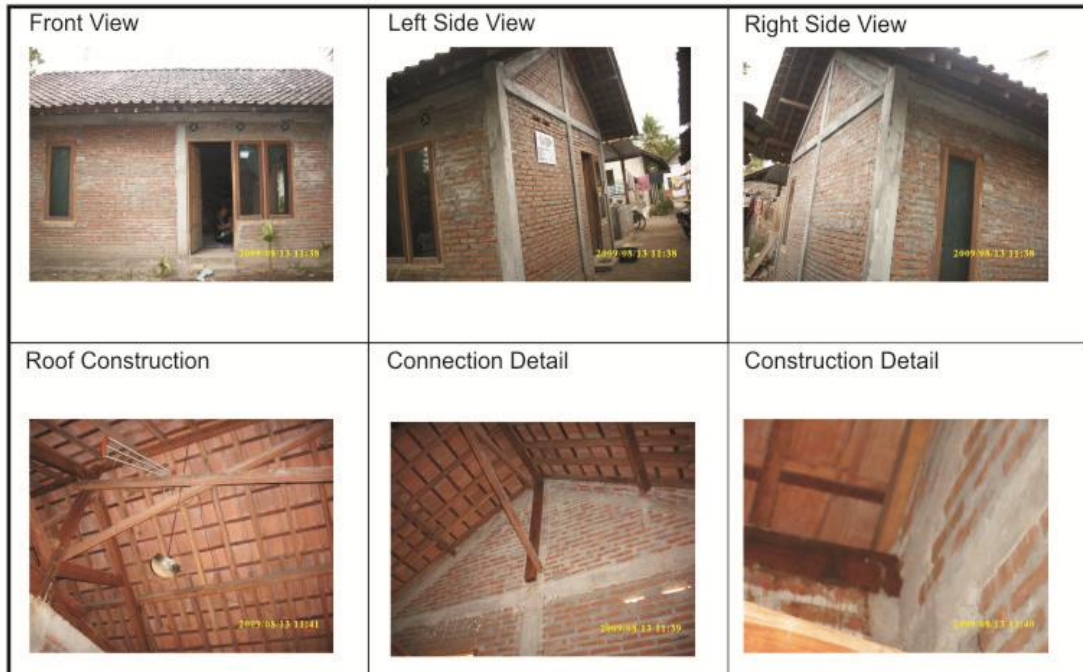
E.4. Higher score sample (2.55)

RAPID VISUAL SCREENING (RVS) FORM			
Owner/User :	Ibu Karsilah		
Location :	Sumuran	Desa: Palbapang	Kecamatan: Bantul
Data No :	8

House Type:	Joglo			Limasan			Kampung			Modern		
	Low	Medium	High	Low	Medium	High	Low	Medium	High	Low	Medium	High
BASIC SCORE (BS)	8	6	5	7	5	4	6	4	3	5	4	3
BASIC STRUCTURAL MODIFIER (BSM)												
Mainly masonry wall	-4	-3	-3	-3	-2	-2	-3	-2	-2	-2	-2	-2
Mainly RC frame	-3	-2	-2	-2	-1	-1	-1	0	0	0	0	0
Mainly Wood frame	0	0	0	0	0	0	0	0	0	3	2	2
BASIC VULNERABILITY SCORE (BV)												3

PERFORMANCE MODIFIERS (PMFs)												
Soil Type	Joglo			Limasan			Kampung			Modern		
	Low	Medium	High	Low	Medium	High	Low	Medium	High	Low	Medium	High
C hard soil, soft rock	0	0	0	0	0	0	0	0	0	0	0	0
D stiff soil	-20	-20	-20	-20	-20	-20	-20	-20	-15	-20	-20	-15
E soft clay	-30	-30	-30	-30	-30	-25	-30	-25	-20	-30	-25	-20
Appearance Qualities:												
low	-30	-30	-30	-30	-30	-25	-30	-25	-25	-30	-25	-25
medium	-20	-20	-20	-20	-20	-10	-20	-10	-10	-20	-10	-10
good	0	0	0	0	0	0	0	0	0	0	0	0
Main Structure Irregularities	-40	-40	-40	-40	-40	-35	-40	-35	-35	-40	-35	-35
Roof Structure Irregularities	-30	-30	-30	-30	-30	-30	-30	-30	-30	-30	-30	-30
Total PMFs (%)												-15
